Defects in Foundation Design Due to Miss-Interpretation of the Geological Data: A Case Study of Mosul Dam

Varoujan K. Sissakian¹, Nasrat Adamo², Nadhir Al-Ansari², Sven Knutsson², Jan Laue²

How to cite this paper: Sissakian, V.K., Adamo, N., Al-Ansari, N., Knutsson, S. and Laue, J. (2017) Defects in Foundation Design Due to Miss-Interpretation of the Geological Data: A Case Study of Mosul Dam. *Engineering*, 9, 683-702.
<https://doi.org/10.4236/eng.2017.97042>

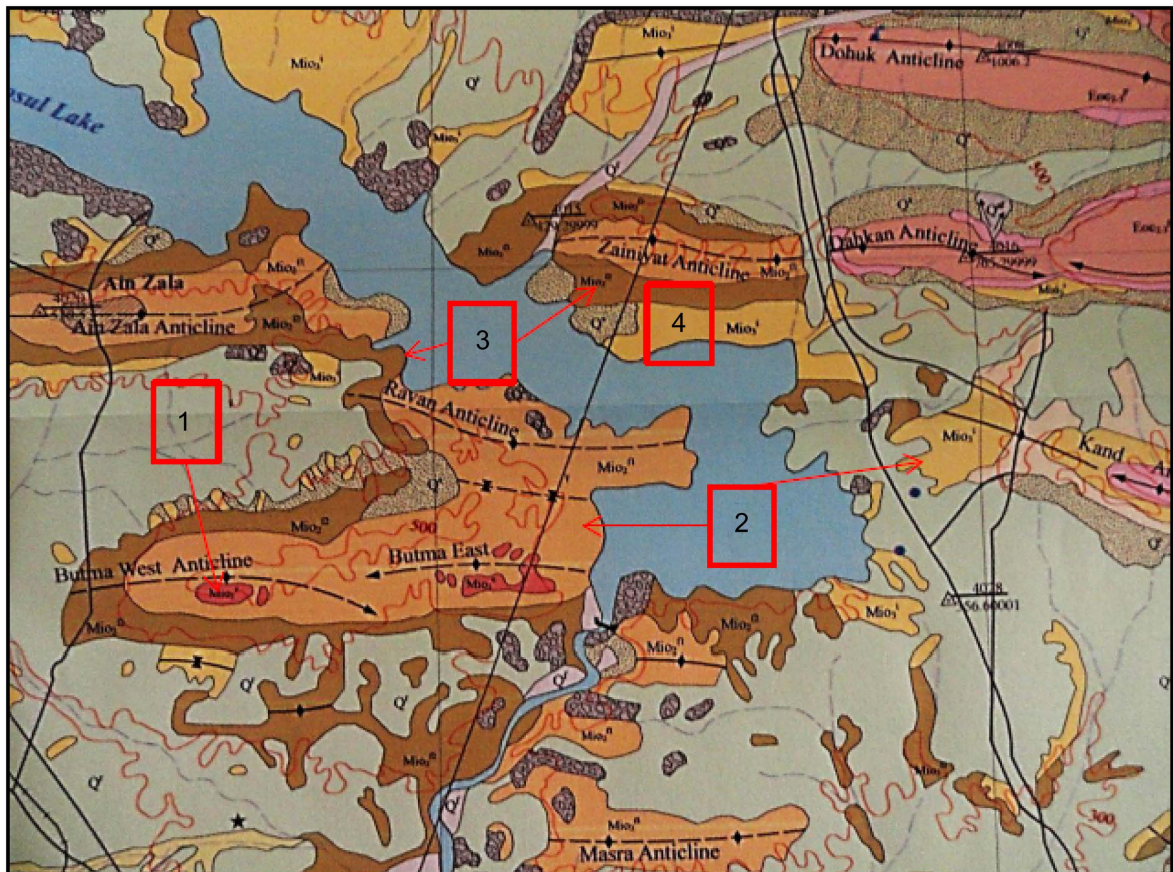
Figure 2. Geological Map of Mosul Dam site and near surroundings. Formations: 1 = Euphrates and Jeribe, 2 = Fatha Formation, Lower Member, 3 = Fatha Formation, Upper Member, 4 = Injana Formation.

The thickness of the Fatha Formation in Butmah anticline is 392 m [7]. In reviewing the geological map of Mosul Dam site (Figure 2), it is clear that the dam abutments are located within the Upper Member of the Fatha Formation. This means that the thickness of the subsurface section in the dam site is not less than (250 - 300) m, whereas the majority of the drilled boreholes didn't reach such depths. Consequently these boreholes did not reach the lowermost gypsum beds in the Fatha Formation. It is believed that the thick succession of the encountered marl and dolomite beds in some of the drilled boreholes belong to the Fatha Formation Unit A1 [6] and not to the Jeribe Formation that never shows karstification indications anywhere else in Iraq [45]. Consequently, the majority of the grouting drill holes did not reach the lowermost karstified horizons. It is worth mentioning that the Fatha Formation is underlain by the Jeribe Formation (20 - 50 m) thick as average in Mosul Dam site), and the Jeribe Formation is underlain by the Euphrates Formation (25 - 45 m) thick in Butmah anticline [7]. The latter is known to be highly karstified everywhere; therefore, the karstification zone extends in the foundations of Mosul Dam site down to (300 - 375) m. This depth has never been considered and/ or reached by the drilling and/or in planning for construction of the grout curtain.

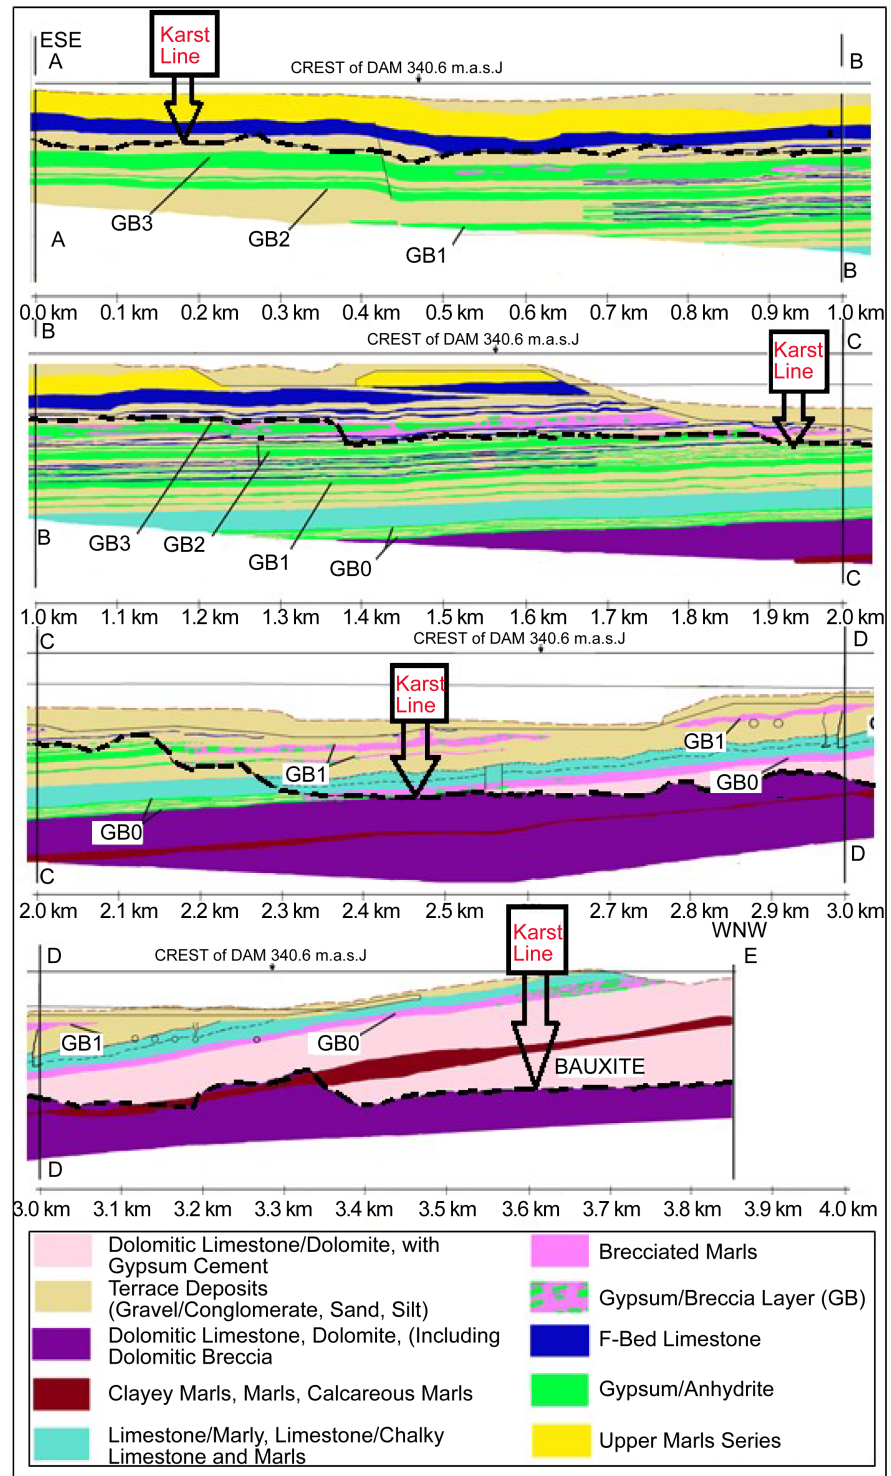
The constructed cross sections (**Figure 4**) show the karst line running in varying depths along the axis of the dam. The karst line was indicated on a long section of the dam axis by the Mosul Dam Supervisory staff [34]. The supervisory staff

Figure 4. Lithological cross sections showing the karstification line; (the thick dashed lines). After [34]. Note that the karst lines cross the Lithological bed.

was formed by a joint venture from the Swiss Consultants Consortium and Energoprojekt of Belgrade to conduct daily supervision of the works. As it is presented, the karst line doesn't follow certain bed or the regional dip, which is not possible from a geological point of view. Normally the karstification is related to certain bed(s) and therefore, it should follow the regional dip and not cross it (**Figure 4**). Moreover, the karst line as shown rises upwards against the dip, which means the karstification, is not related to a certain bed and/ or depth.

The misleading configuration of the karsts line projected at the Mosul dam (**Figure 4**) by site geologists made the geological picture of the foundation even

more disfigured, as the karst line cannot extend upwards in the geological beds against the dip as shown in the Mosul Dam geological literature. Thus the assumed karst line should have been questioned before construction.

100% efficiency to achieve this. The curtain was designed (depth and extension wise) based on the drawn karst line shown in the cross sections of (Figure 4). Accordingly, the curtain was not deep enough to stop seepage and dissolution of gypsum under the dam even if grouting itself would have been a successful solution.

- 10) The acquired geophysical data should be corrected using the drilling data, and vice versa.
- 11) According to the acquired data, the constructed karst lines, which are super imposed over the constructed geological cross sections should be corrected by a well experienced structural geologist and/ or field geologist.

- 12) Accordingly, all previously designed grouting programs and construction of the grout curtain should be redesigned.

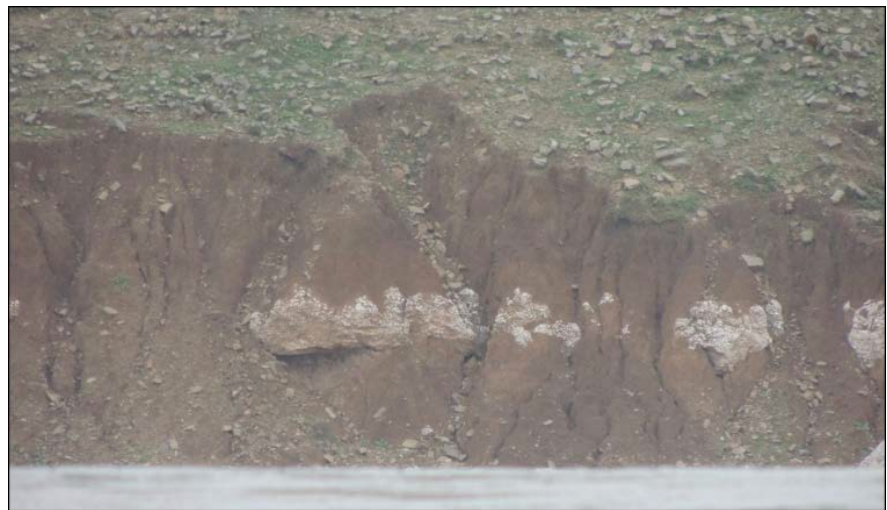
whole surroundings. Good example is the wax plant site, which is located 25 kilometres south of Mosul dam. There, the gypsum beds are highly karstified and characterized by large caverns filled by clay and marl (**Figure 5** and **Figure 6**). The dissolved gypsum beds had left large cavities filled with weathered clayey and marly materials as well as some limestone and gypsum fragments (**Figure 7**). Therefore, when a borehole is drilled in such location gypsum may be missed. The site geologist, especially when he is not familiar with such cases will most probably consider the next encountered gypsum bed in the borehole as the first one; and consequently will miss the true serial number of the gypsum beds.

Figure 5. Karstified gypsum beds in Wax plant site. Note the absence of the gypsum in the left side.

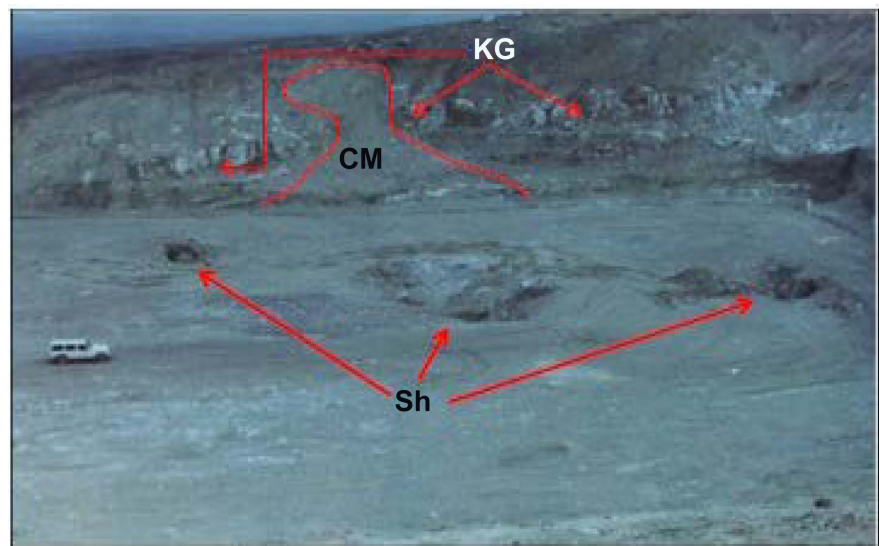
Figure 6. Karstified gypsum beds in Wax plant site. Note the karstified (**KG**) and/or absence of the gypsum in different sides of the site, presence of many sinkholes (**Sh**) in the floor, and the filled cavern by clayey and marly materials (**CM**).

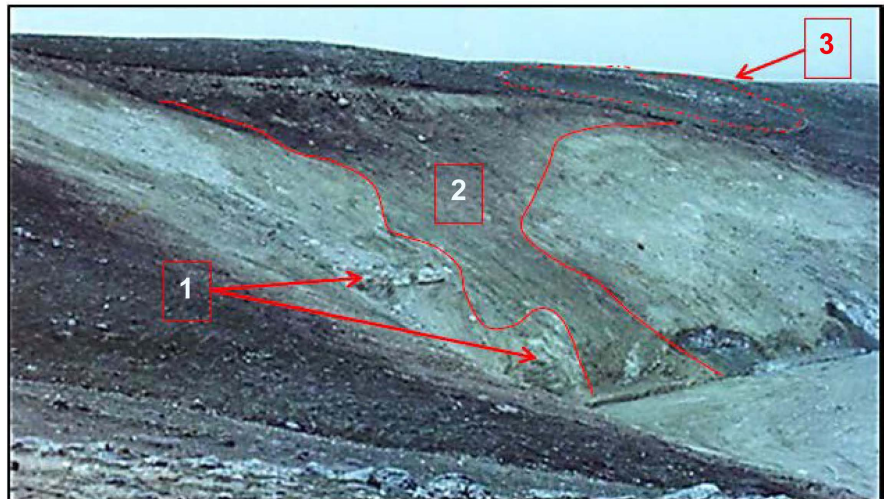
Figure 7. Karstified gypsum bed in the wax plant site (1). Note the large existing formed cavern (2) that is filled by clayey and marly materials. A circular form (3) indicating the presence of a karsts form below the surface.
