# Flood Hazards in Erbil City Kurdistan Region Iraq, 2021: A Case Study

## Abstract

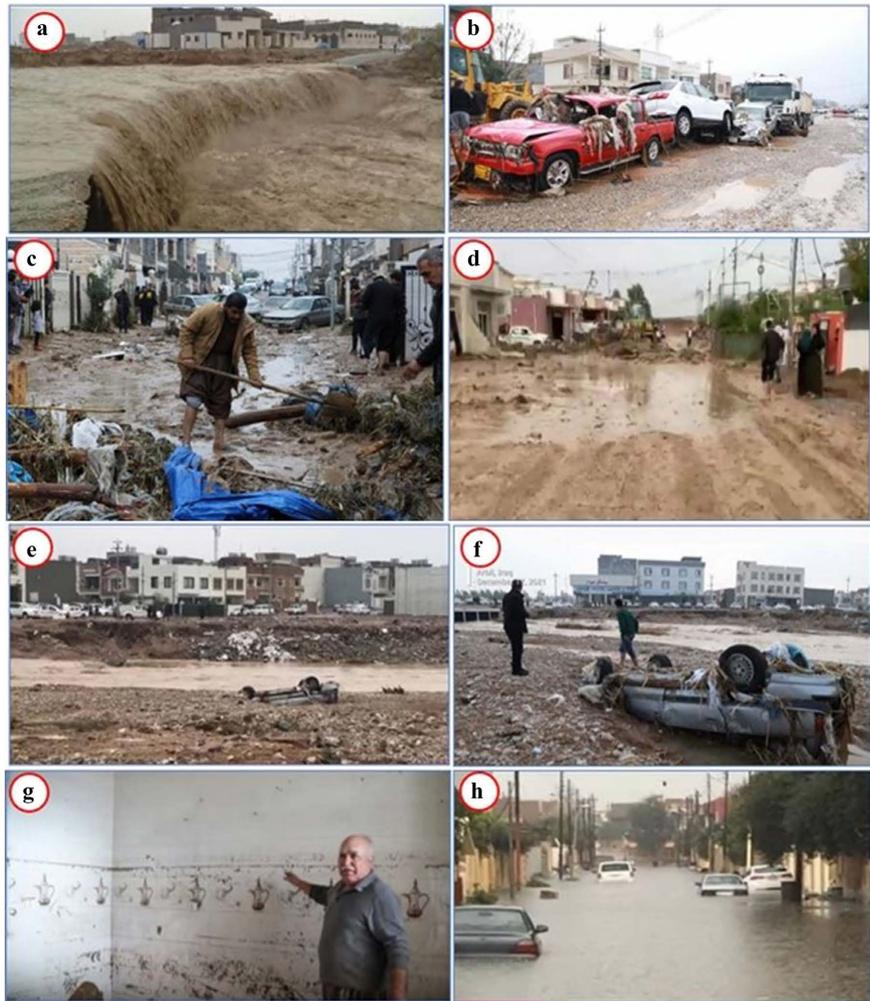
**Figure 4.** Erbil floods, 17 December 2021. (a) Flooded street; (b) Damaged vehicles blocking a street; (c) Remains of muddy flood water; (d) Blocked Street with mud; (e) and (f) Flooded streets; (g) A man referring to the height of the flood water in his house; (h) Inundated cars and height of the flood water in a street in Dara Too district.

on wadis which drain the area, and even some of the wadis that cross the city which were heavily flooded (**Figure 4(a)**, **Figure 4(e)** & **Figure 4(f)**). According to the Kurdish region government on 17 December 14 people were reported dead and 55 people injured by the floods, and more than 7000 people were affected by these floods, moreover, 1250 families had suffered heavy materials damages, and the swept vehicles blocked the flooded main roads (**Figure 4(b)** & **Figure 4(c)**). Three women from the same family drowned in Dara Too district (**Figure 2**) when their home was covered by about two meters of the torrent (**Figure 4(g)**) [10].

Heavy rainfall resulting from weather disturbances and high temperatures is a good indication for climate change [13] [14]. Other reasons for flash floods are: 1) Inadequate design of drainage channels and structures (**Figure 4(a)** & **Figure 4(f)**), 2) Inadequate maintenance of drainage facilities, blockage by debris brought by flood waters, 3) Construction of settlements in flood plains (**Figure 4** and **Figure 5**), 4) Removal or partial removal of existing earthfill barriers (**Figure 6**), and **Figure 5**) Blockage of the wadis inside Erbil city and in the surrounding residential sites where houses and roads were constructed (**Figure 7**). It can be said that the main reasons for what had happened in Erbil city during 30 October and 17 November 2022 are combination of all these factors.

are well developed. During the heavy rain showers, the claystone beds are easily weathered and eroded, they were the main reason for the muddy water during both mentioned flash flood events (**Figure 4(c)** and **Figure 4(d)**). The rainwater during the flash floods has attacked the residential sites such as Zeren and Dara Too covering all their streets and roads (**Figure 4(a)** and **Figure 4(h)**) as most of these roads were originally wadis (**Figure 9(a)**), which were backfilled and/or passed through undersized concrete culverts which were installed to drain the rainwater. In consequence to this rainwater storm discharge flooded the residential areas in both cases and the constructed culverts were unable to pass the floods.

The stockpiles of clay fill materials and the excavation of borrow areas of these material along portions of this road made the flood water muddier and increased more the destructive power of the floods “**Figure 4(c)** and **Figure 4(d)**” causing heavy damage especially inside the affected houses.

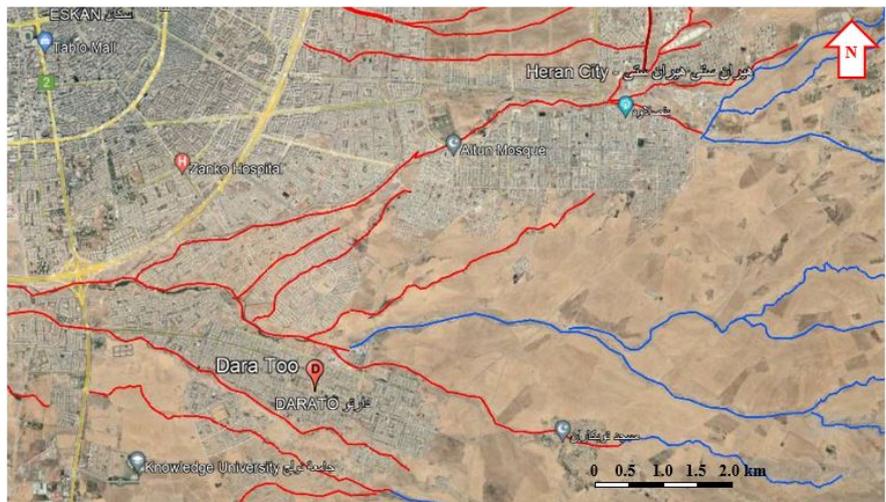
**Figure 5.** Satellite image showing the residential built-up sites within drainage basins.

The recently constructed residential sites, especially north and northeast of Erbil city (**Figure 5** and **Figure 7**) are built nearby the courses of wide and shallow wadis without any protective embankments. Locally, even in the courses of

these wadis (**Figure 5**). As the gradient of the wadis is high (**Table 1**) and since they flow directly towards the residential sites; therefore, majority of the houses in these sites were inundated by the flood rainwater causing heavy damages to houses, homes, cars (**Figure 4**) and even inflicting life losses.

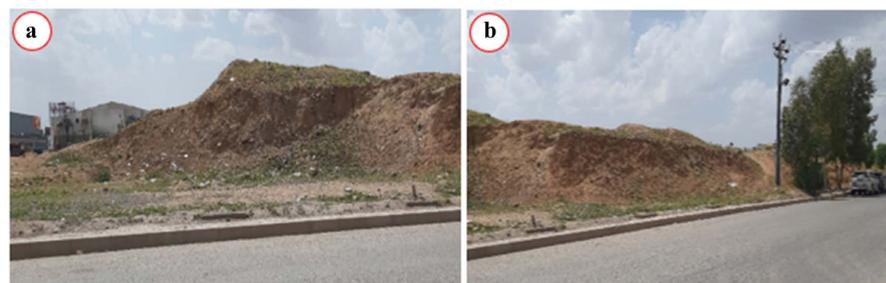
**Figure 6.** The remains of a previously built Earth fill dyke to protect the northwestern part of Erbil city, (a) the removed part; (b) northwest continuation of the earth fill dam.

The partial and/or total removal of some of the existing previously constructed protective dikes, “**Figure 6**” and the backfilling of and/or blockage of some existing drainage channels (**Figure 9(a)**), which were constructed during the last century to control the rainwater (northeast of Erbil city) have played a significant role in increasing the destructive power of the rainwater during the flush floods that had happened on 30 October and 17 December 2021. Therefore, it is very important to assess the management of water resources [15].

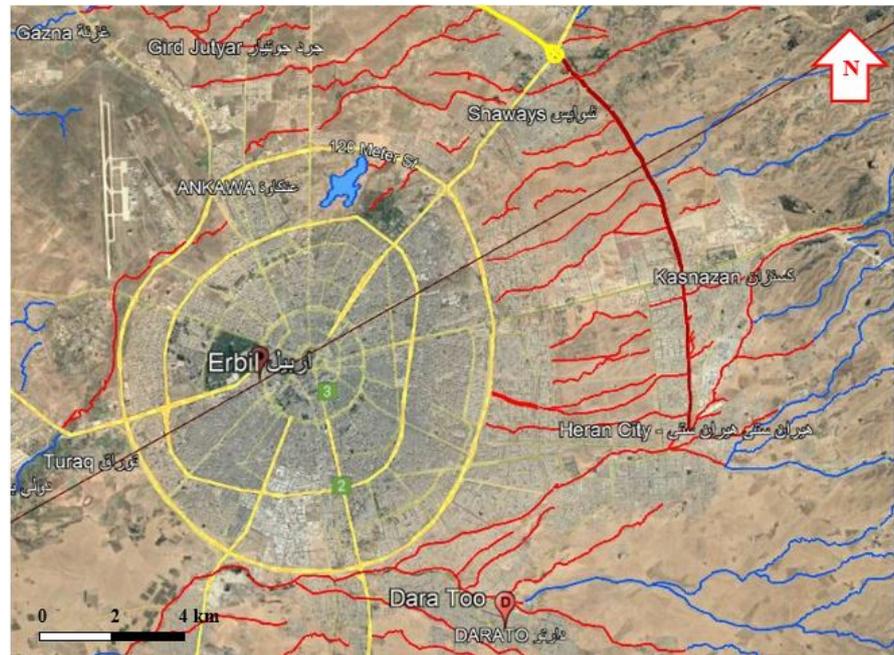
**Figure 7.** Satellite image showing large number of wadis which outflows into Erbil city area and some of the residential sites. Wadis in red are those parts inside residential sites. The thick brown color is the 150 Ring-road (Under construction).

The 150 Ring-road, which is under construction (**Figure 7** and **Figure 9(d)**) has played a big role in both mentioned flood events. Locally, it served as an easy passage to the flood water due to the low height of its embankment in most of its length and in other parts forming obstacles to the flood rainwater due to the backfilling of the crossing wadis, and due to the huge amounts of construction materials laid haphazardly along the road.

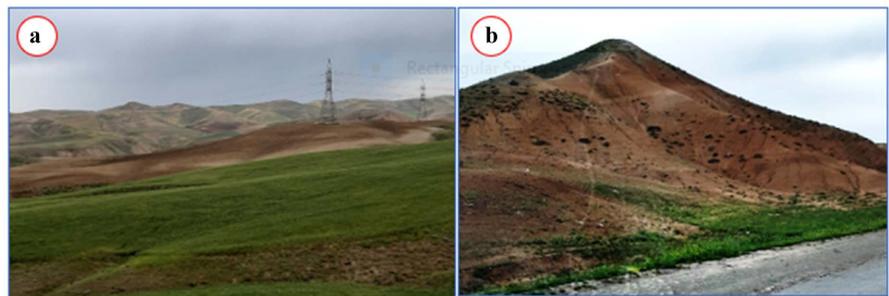
**Figure 8.** Thick claystone beds of the Bai Hassan Formation, which is exposed in the Highlands northeast of Erbil city, (a) General view, (b) Enlarged view.

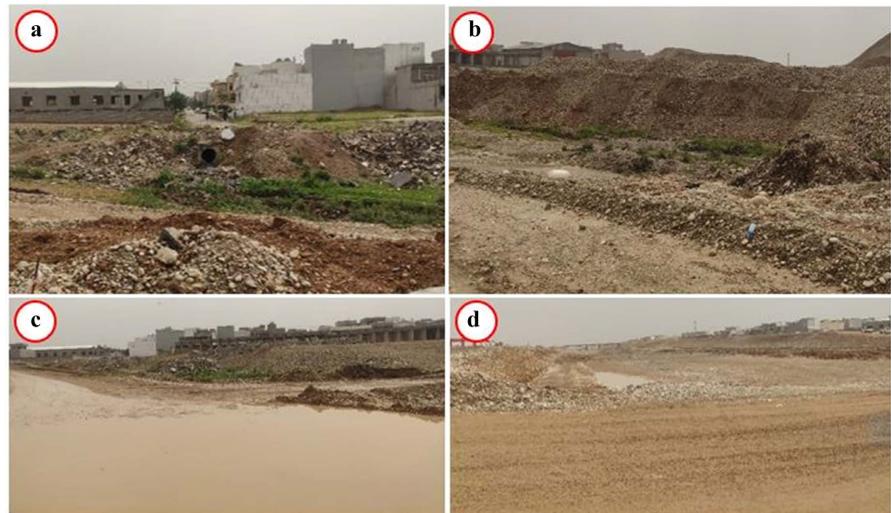
**Figure 9.** Filed photographs, (a) A concrete ditch below a paved road, previously was a valley, (b) The gravelly nature of the land north and northeast of Erbil city, (c) Flooded part of 150 Ring-road, which was a good source of the mud during the flash floods, (d) General view of the 150 Ring Road, note height difference between the road level and surrounding land.
