Is Mosul Dam the Most Dangerous Dam in the World? Review of Previous Work and Possible Solutions

Nadhir Al-Ansari¹, Nasrat Adamo¹, Varoujan Sissakian², Sven Knutsson¹, Jan Laue¹

Abstract

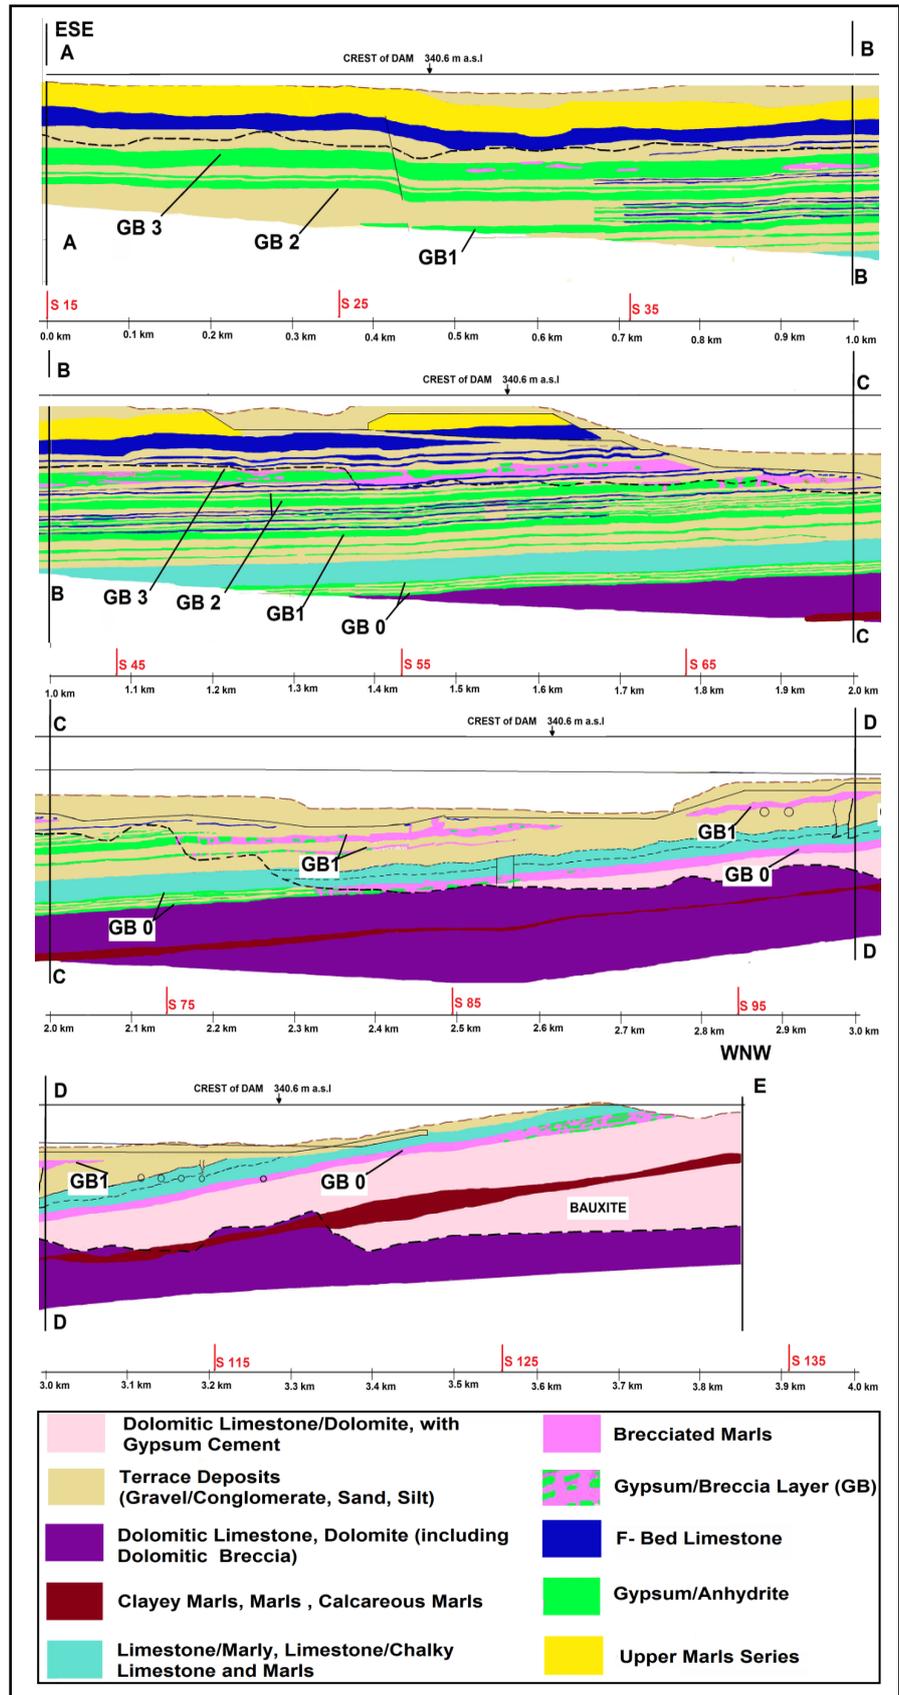
The most significant geological hazard that influences Mosul Dam is the Karstification, especially in the foundation's rocks. The influence of the Karstification is also confirmed by [2] [4] [7] [23]-[28]. The karst development extends to a depth of 100 m below the foundation of the dam. The Karstification enhanced the extensive dissolution of gypsum and gypsum anhydrite rocks present above and below the limestone layers. These dynamics caused the collapsing of whole layers of clayey marls into the underneath cavities forming beds composed of brecciated gypsum particles and anhydrite blocks embedded into a loose clayey matrix. Four such layers were discovered during the geological investigations (**Figure 4**).

Figure 4. Geological Cross Section along the axis of the dam.

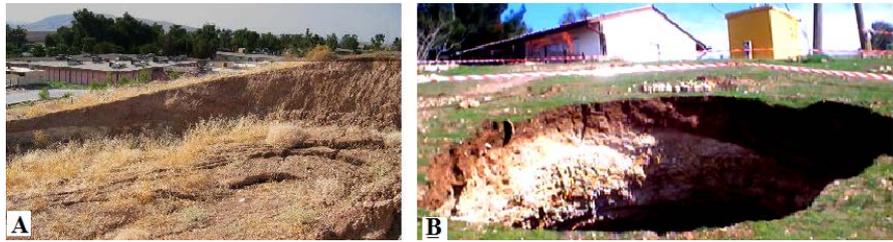
The presence of surface cracking and groundwater fluctuation give rise to the development of sinkholes. One sinkhole on the left flank of the reservoir appeared suddenly overnight in February 2003 and developed rapidly with 15 m of settlement and a 15 m diameter depression (**Figure 5**). Other sinkholes appeared on the right side downstream the dam (**Figure 6**). The rate of settlements of these sinkholes was 0.25 m when they appeared in 1992 and then reduced to 50% in 1998. The maximum cumulative settlement was recorded to be 5 m in a sinkhole SD4. It is believed that the formation of these sinkholes is due to the dissolution of surface gypsum beds, which led to the formation of conduits under the surface. This took place due to the groundwater flow from Wadi Malleh aquifer toward the River Tigris, and the recharge of this aquifer increased tremendously when the reservoir was impounded. The conduit has developed in size due to the fluctuation of the water level in the pond downstream the main dam caused by the operation of the regulating dam. Once the size of these caves increased and became closer to the surface they collapsed after heavy rainfall. Recent bathymetric survey conducted in 2011 showed the presence of a large number of sinkholes within the reservoir area (**Figure 7**). This is a dangerous phenomenon, especially if they are connected to Wadi Malleh aquifer, then they can cause numerous problems for the safety of the dam.

Figure 5. The left bank sinkhole (A) early stage (B) full development stage.

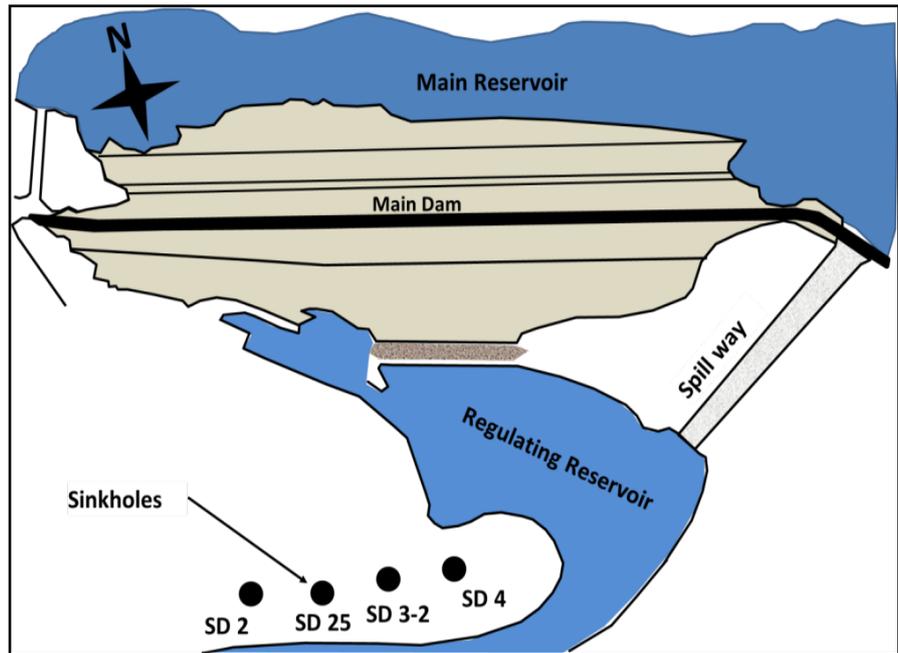
Figure 6. Sinkholes downstream Mosul Dam-Right Bank.

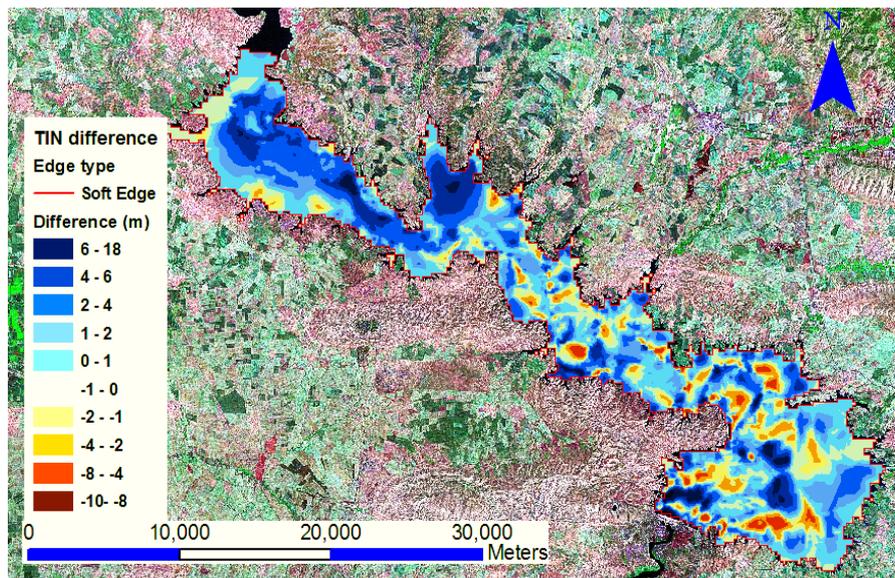
Figure 7. Holes noticed at the bed of Mosul reservoir [29].

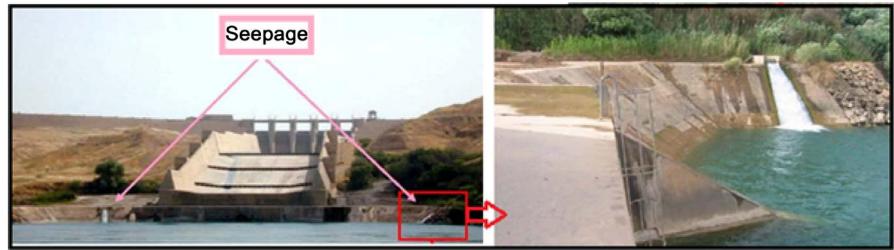
In addition, springs also appeared downstream the dam located on the same line of the sinkholes. The flow from the spring reached 360 l/s (**Figure 8**). The water had high concentration of sulphate indicating its origin from Wadi Malleh aquifer [30]. It should be mentioned, however, the amount of seepage flow from the Wadi Malleh aquifer was very high in the pumping storage scheme and the tailrace tunnel and its intake structure. The excavation of the caverns was only possible after performing extensive grouting works all around these caverns. The importance of the Wadi Malih aquifer is not only due to the great difficulties it caused during the construction of the pump storage scheme; but also that it shapes the ground water flow regime in and around the right abutment of the dam in addition to the fact that it contributed to the formation of a series of sinkholes at the right bank downstream of the main dam. The high concentration of sulphate in the water of this aquifer clearly indicates the dissolution of

Figure 8. Example of seepage.

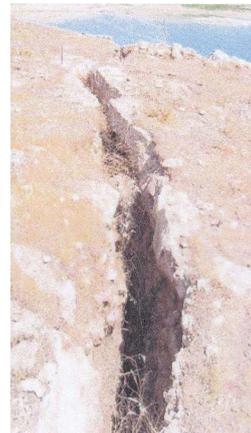
Figure 9. Fissure on the right slope side of the dam.

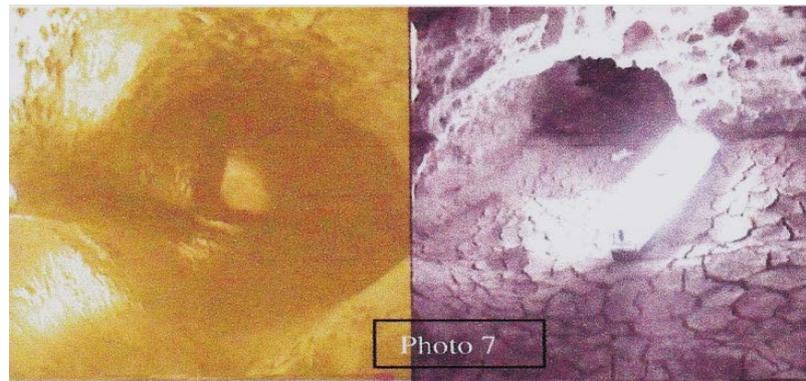
Figure 10. Large conduit found in March 2022 in the upper right rim of the reservoir.

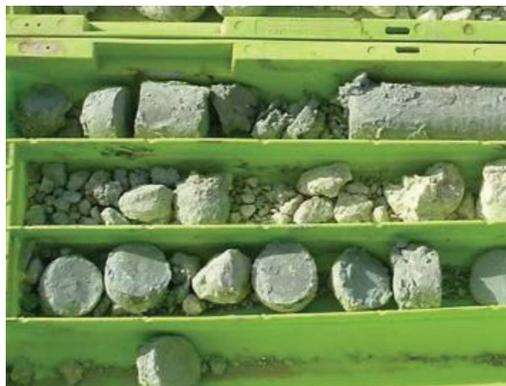
To evaluate the status of the geological conditions in the dam area, the Engineer's and Environmental center of research of the US Army Corps of Engineers [22] used the rock quality designation (RQD) [31] as an index for the description of rock mass fractured state. The comparison performed was on samples taken in 1989 and 2006. The results showed that RQD was 45% - 65% and 0% - 20% for the two years respectively. The deterioration of the samples is due to the dissolution of gypsum (**Figure 11**).

Figure 11. Samples recovered from well drilled near SD5 ([20]).

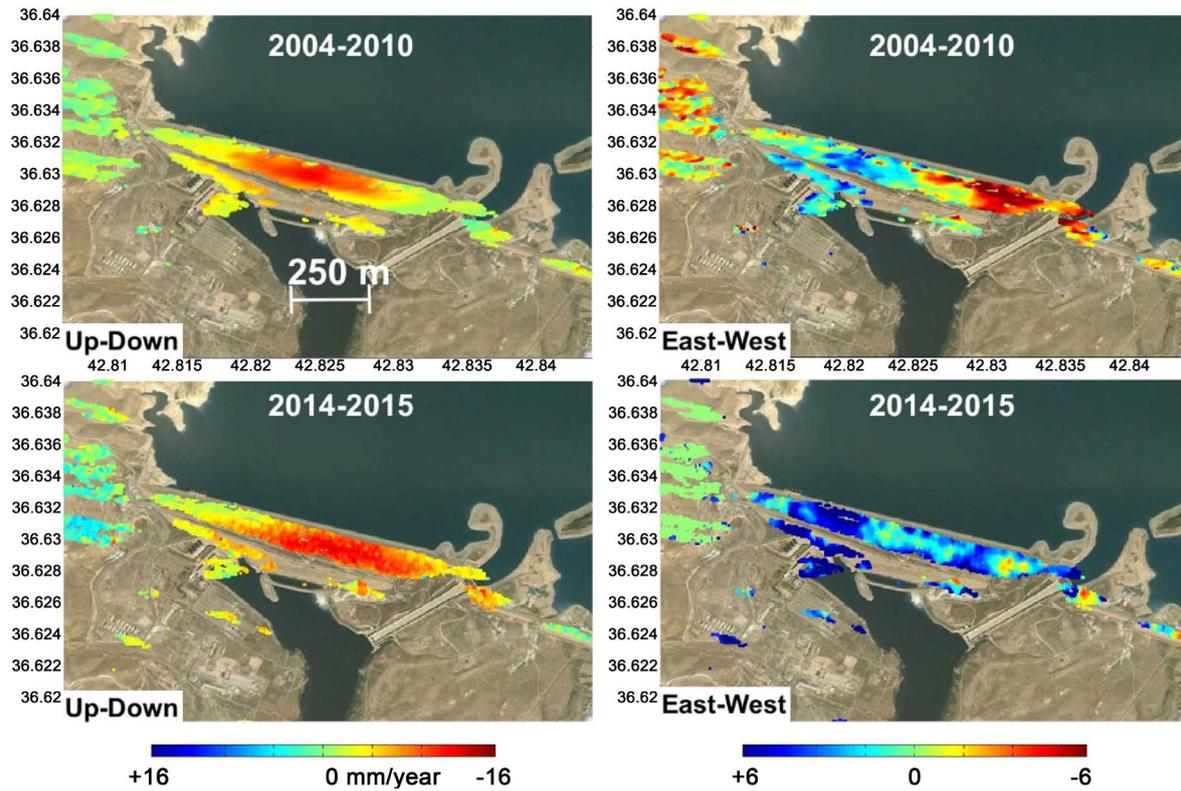
c) Increased monolith movement in the grouting gallery and cracks' opening were noticed ([32] p. 12). The movements are believed to be caused by settlement and not resulting from onsite activity. Cumulative settlement in the grouting gallery from 1986 to the end of 2015 records showed a sharp increase in settlement in 2015 which indicates a worsening situation in the dam foundations ([32] p. 13). Satellite based information also indicated that there is local differential settlement in the body of Mosul Dam averaging from 5 to 10 mm/year [33] [34]. In December 2016, Milillo *et al.* [37] published their findings from space geodetic monitoring of Mosul Dam. They found that the rate of subsidence of Mosul Dam for the period 2004-2010 was 12.5 mm/year has increased to 15 mm/year after 2013 after re-grouting operations stopped (Figure 12). This subsidence is related to the dissolution of gypsum and the reservoir-induced pressure which is the main cause of an increase in the dissolution rates. They also added that any annual increase of water levels in the reservoir in the future could lead to an increase of water pressure in the dam foundation, which combined with the absence of re-grouting could speed up the dissolution of the dam substrate and promote its destabilization.

Figure 12. Up-down (left) and east-west (right) displacement at the Mosul dam, Iraq. Negative values indicate downward and westward motion respectively ([32]).

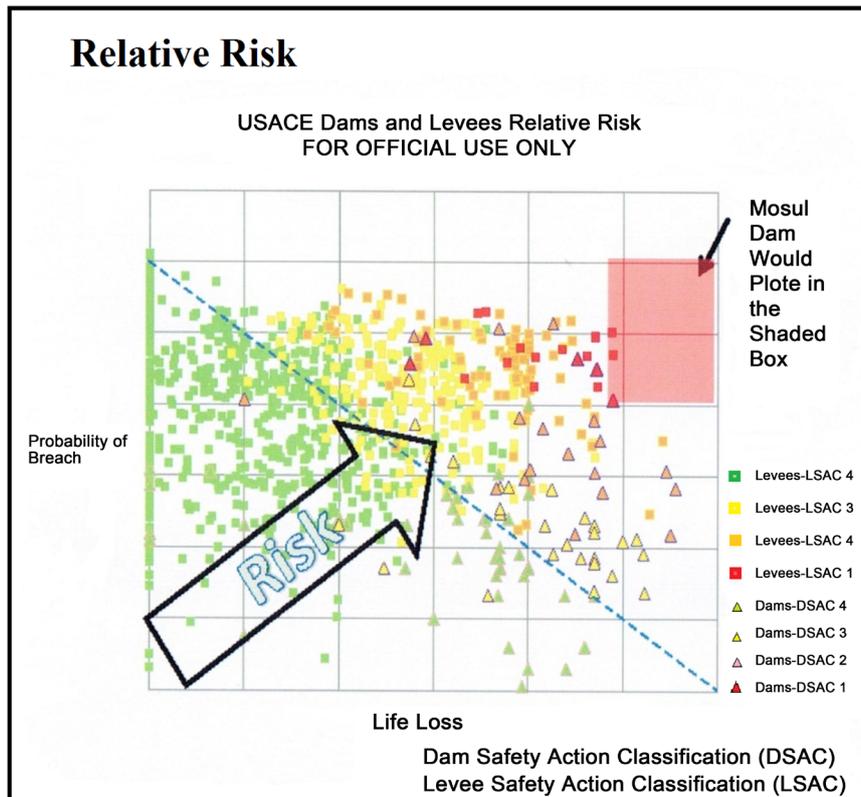
The plot of the data for Mosul Dam on the screening Portfolio Risk Analysis (SPRA) process for Dam Safety is shown in Figure 13. This plot considers loading frequency, an engineering rating to estimate a relative probability of failure,

Figure 13. Screening Portfolio Risk Analysis (SPRA) for Mosul Dam [32].

and both human life loss and economic consequences of failure [35] [36]. This procedure shows that Mosul Dam is in a state of extreme relative risk (Figure 13). For more details, see ([5]-[19]).
