Effect of Zinc Galvanization on the Microstructure and Fracture Behavior of Low and Medium Carbon Structural Steels

Microstructure and fracture behavior of ASTM 572 Grade 65 steels used for wind tower applications have been studied. Steels of two carbon level chemistries designed for this grade were used in the study. Fracture toughness of the steels was studied using 3-point bend test on samples coated with zinc and not coated with zinc. Lower carbon steel showed higher resistance to fracture than medium carbon steel after zinc galvanization. SEM study suggests that zinc and zinc bath additives that migrated to crack tips are responsible for the loss in ductility. The phenomenon of Liquid Metal Embrittlement (LME) is suggested to have taken place. Zinc bath additives traced at crack zones are suggested to have migrated at the zinc galvanizing temperatures.

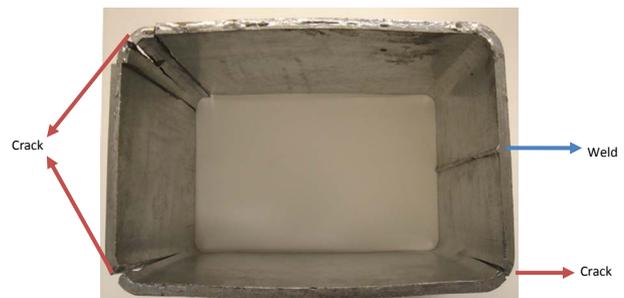
Our interest in this work derived from two cases; in one a customer reported severe cracking in A572 Grade 65 material used for wind tower applications; and in the other, an ultra high strength steel (HSS) hollow tubing (**Figure 1**) used for structural applications cracked, after the material had been zinc galvanized. Material from the same heat of both materials had been sold to a second customer, but no such problems were detected after identical treatment. In consequence a second steel chemistry was designed to counter this phenomenon. This paper reviews only one material (A572 Grade 65 steel) for the

Figure 1. Cracks seen in the galvanized ultra high strength hollow structural steel (HSS) tubing.

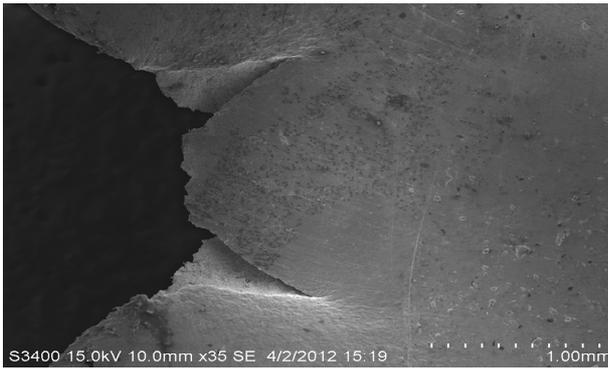
Figure 5. Shows cracked zones of the “V” notch studied for LME cracking.

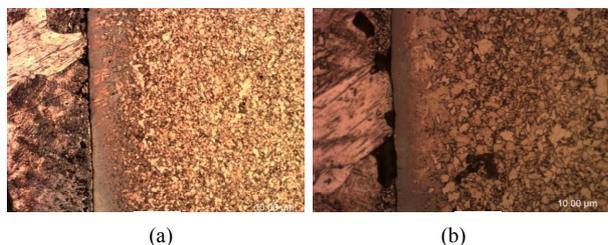
The micrographs of galvanized low carbon steels A and B taken at the notched location are shown in **Figure 10**. These micrographs show that both steels had dull grey appearance in the middle where the fusion of zinc into the steel occurred. Yeomans [23] explained the dull gray appearance as the result of zeta crystals having grown to the outside of the zinc coating and consuming the pure zinc layer. The coating is non-uniform, poorly adherent and also brittle in nature, as previously reported by Kinstler [13].

Figure 10. Optical micrographs of the galvanized low carbon steels (a) A and (b) B taken near the notch location at 20× magnification.

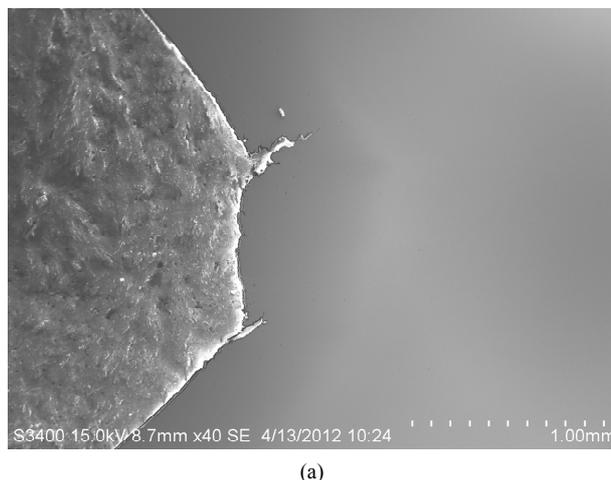
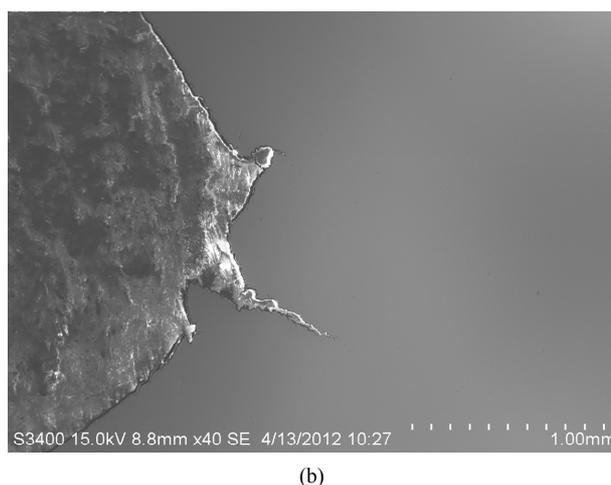
SEM micrographs of the crack regions from the 3-point bend testing for both parent and galvanized low carbon steels are shown in **Figure 11**. The fracture behavior of the parent sample is shown in **Figure 11(a)**. It shows little crack tip propagation. **Figure 11(b)**, however, obtained for the zinc coated piece, shows a longer crack tip travel on the lower right hand corner and a broader crack opening for the top right hand side. This might be due to the zinc galvanization.

Figure 11. SEM micrographs of low carbon (a) parent and (b) galvanized steels showing the cracked region as a result of 3-point bend mechanical test.

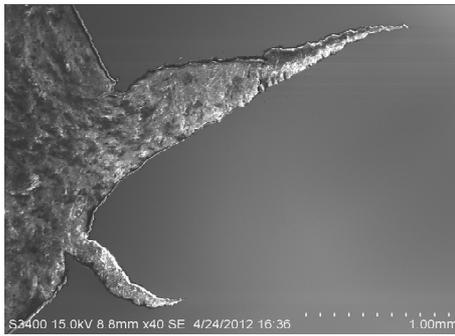
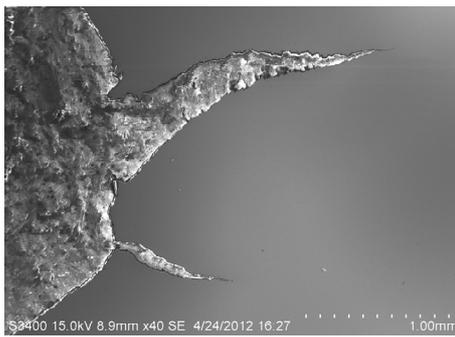
Figure 12 shows micrographs of similar crack region for parent and galvanized medium carbon steel. The galvanized steel micrograph from **Figure 12(b)** shows more of a contracted crack, or compressed crack, behavior than the parent sample from **Figure 12(a)**. The crack from the parent sample, however, is more relaxed and open. This might be due to the aging response on the surface of the material, where the material behavior is brittle in nature at the surface as the bulk of the steel is not embrittled.

Figure 12. SEM micrographs of medium carbon (a) parent and (b) galvanized steels showing the cracked region as a result of 3-point bend mechanical test.
