Metallography of an Underground Oil Pipeline

Francisco Casanova-del-Angel, Alejandra Córdova-Castillo

How to cite this paper: Casanova-del-Angel, F. and Córdova-Castillo, A. (2018) Metallography of an Underground Oil Pipeline. *Open Journal of Metal*, 8, 35-54.

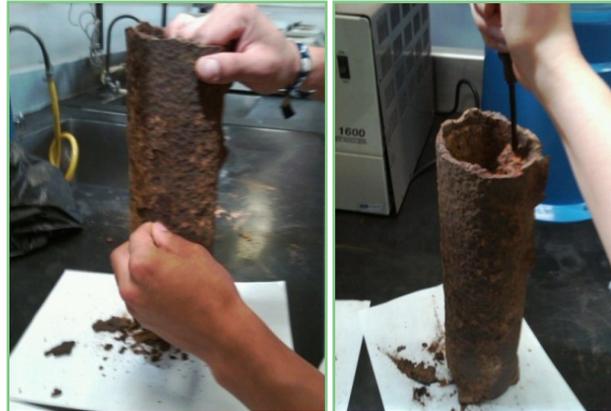
In order to clean it, first, the ground adhered on the outer side of the sample was removed using a chisel, since samples of the soil in which the pipe was buried were needed (Figure 1). The same procedure was used to remove the ground adhered inside the pipeline (Figure 2), where stones and dry sludge were found.

Figure 1. External cleaning of pipe.

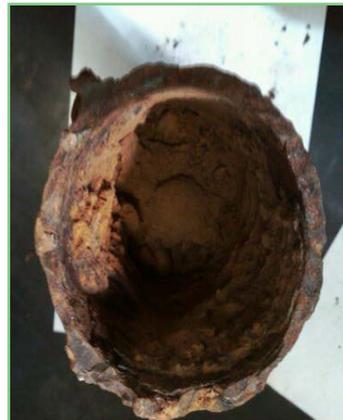
Figure 2. Internal cleaning of pipe.

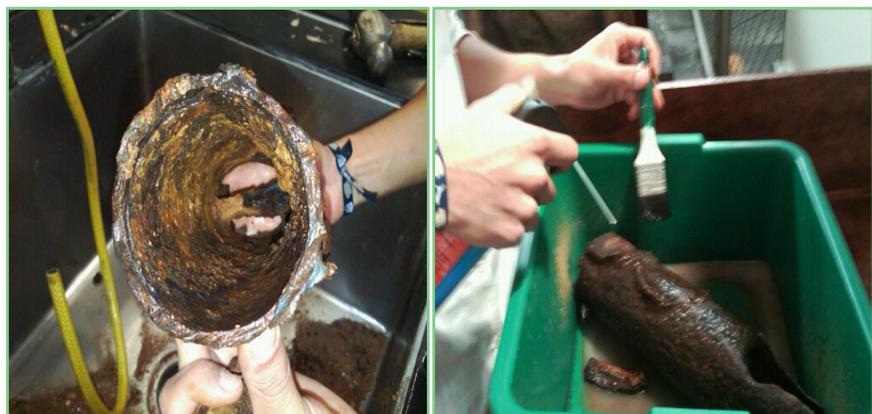
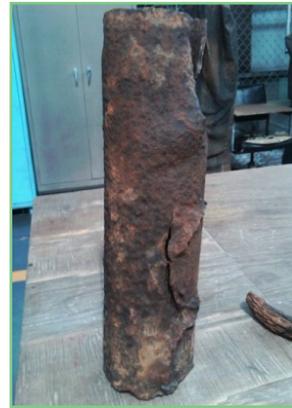
Upon completion of cleaning, the ends of the sample had varied thickness. This may have been due to the advanced corrosion in the entire structure. Some longitudinal deformations such as dents and small cracks were observed (Figure 3). After examining the sample, proper areas for cutting the probes that would be used in the metallographic analysis were chosen. Such cut was divided in two stages (*A* and *B*) in order to properly manage the samples.

Figure 3. (a) Sample after washing it in water; (b) Cleaning based on thinner; and (c) Upon completing cleaning.

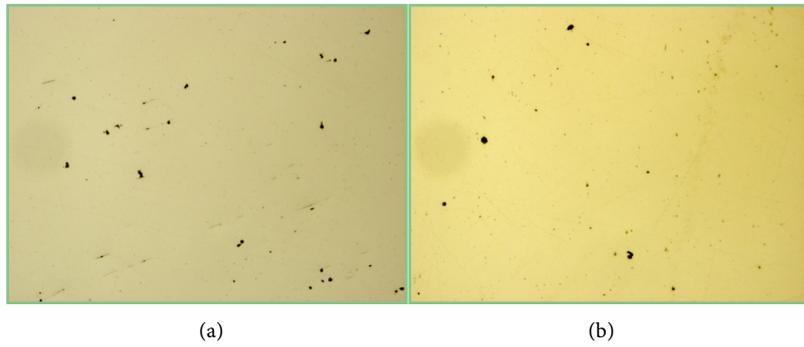
Figure 5 shows the polished longitudinal sample observed at 10x of *Stage A*, where pitting may be observed as black dots of various sizes, which was due to the state of corrosion of the sample. **Figure 5(b)** shows the polished transversal sample observed at 20x of *Stage A*, also with pitting.

Figure 5. (a) Polished longitudinal sample observed at 10×; (b) Polished transversal sample observed at 20×.

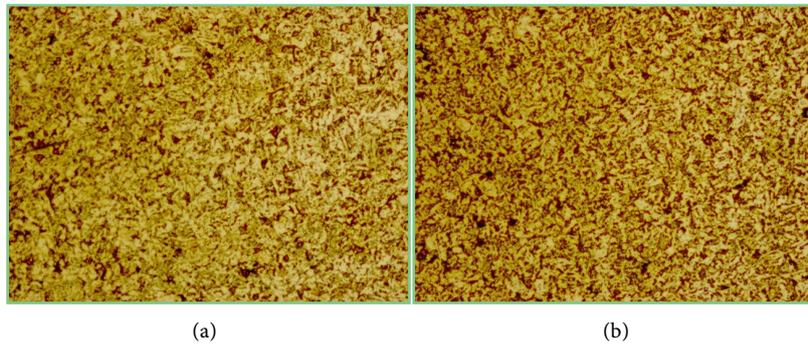
Figure 6(a) and **Figure 6(b)** show the probes after the chemical test, showing the microstructure of steel. It may be observed that the metal base is ferrite (light shades). On the other hand, dark areas are colonies of perlites, carbon particles uniformly distributed on the Fe base.

Figure 6. Samples observed after chemical test. (a) Longitudinal sample at 50×, with a 45° inclination, approx; and (b) Transversal sample at 50×.

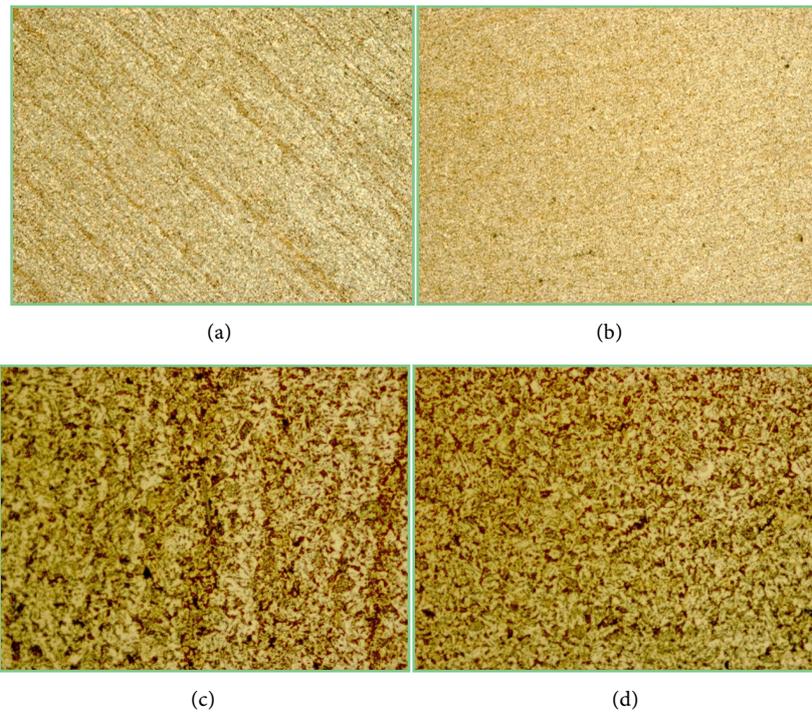
Figure 7 shows four pictures of probes observed with magnification up to 50x. In **Figure 7(a)**, the longitudinal probe was observed at a 10x magnification. It clearly shows a ferrite layer followed by a perlite layer, which shows relationship with flow lines or lamination of steel. **Figure 7(b)**, on the contrary, shows transversal probe with the same magnification, and its distribution shows no order whatsoever. Its grains seem to form a homogeneous layer of both components, while **Figure 7(c)** and **Figure 7(d)** are shown at a 50x magnification on both faces. This may be more clearly observed at small magnification.

Figure 7. Samples observed with the optical microscope after chemical test: (a) Longitudinal sample at 10×; (b) Transversal sample at 10×; (c) Longitudinal sample at 50×; and (d) Transversal sample at 50×.

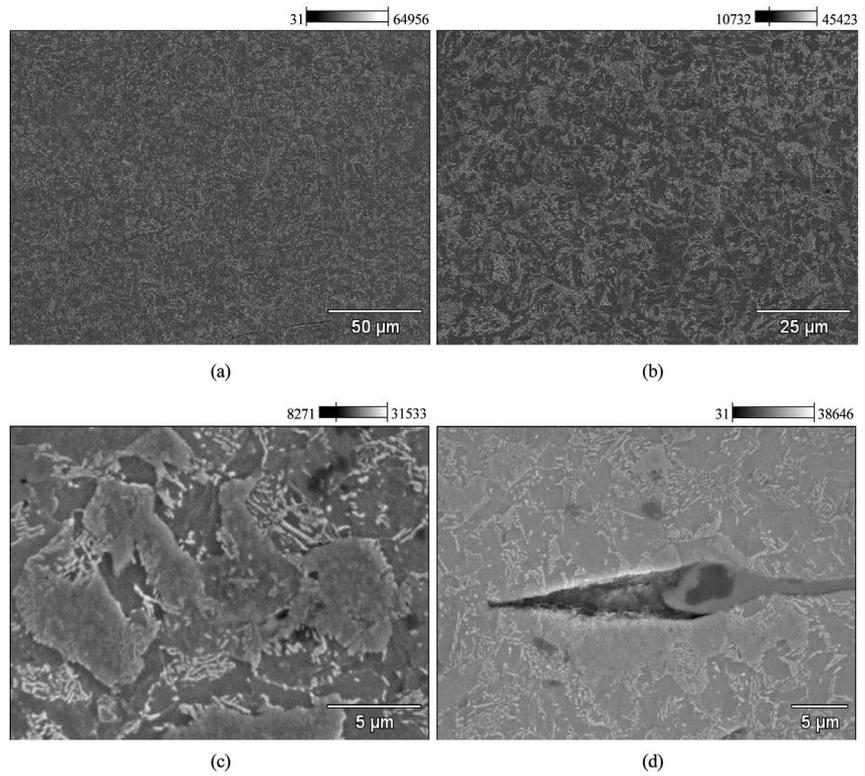
Figure 8 shows 4 pictures with various magnifications, higher than those obtained with the optical microscope. The first 2 pictures clearly reflect the perlite colonies and ferrite base. The granular structure and location of steel components under study may be gradually observed. Based on previous observations using the two microscopes, perlite is in a degradation stage, as small spherical particles. **Figure 9** shows an inclusion in various magnifications. Inclusions are impurities resulting from waste created by combining chemical components of steel manufacturing. Inclusions adhere as small vacuum capsules from manufacturing up to the laminating process.

Figure 8. (a) Magnification: 500×; (b) Magnification: 1000×; (c) Magnification: 5000×; and (d) Magnification 3000×.

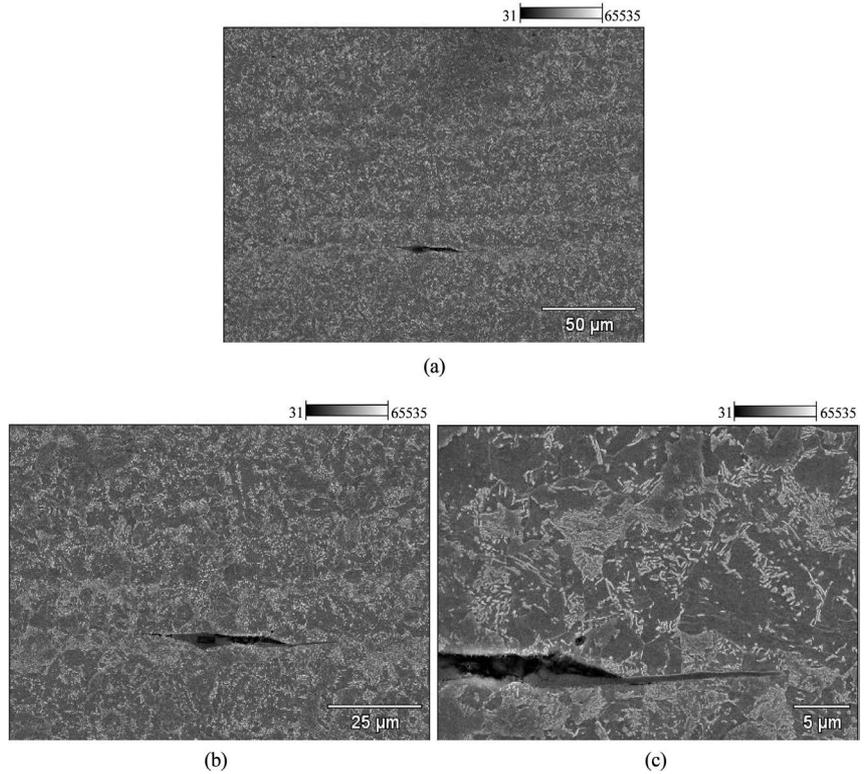
Pictures in **Figure 9** were taken close to the external wall of the pipe and clearly show the flow lines of the material and, as has already been mentioned, it is an inclusion following the same flow pattern.

For other magnifications, despite the same lamination process throughout, no delimitations were observed in the lamination flow of material or in the layers between ferrite and perlite shown in **Figure 9**. This means that degradation of steel was from the inside to the outside. Even though there are still some inclusions, in the middle of the probe, lamination lines are more visible, with more inclusions than those observed in the inner wall, but less than those in the external wall.

Figure 9. Picture taken close to the external wall of pipe. (a) Magnification: 500×; (b) Magnification: 1000×; and (c) Magnification: 3000×.

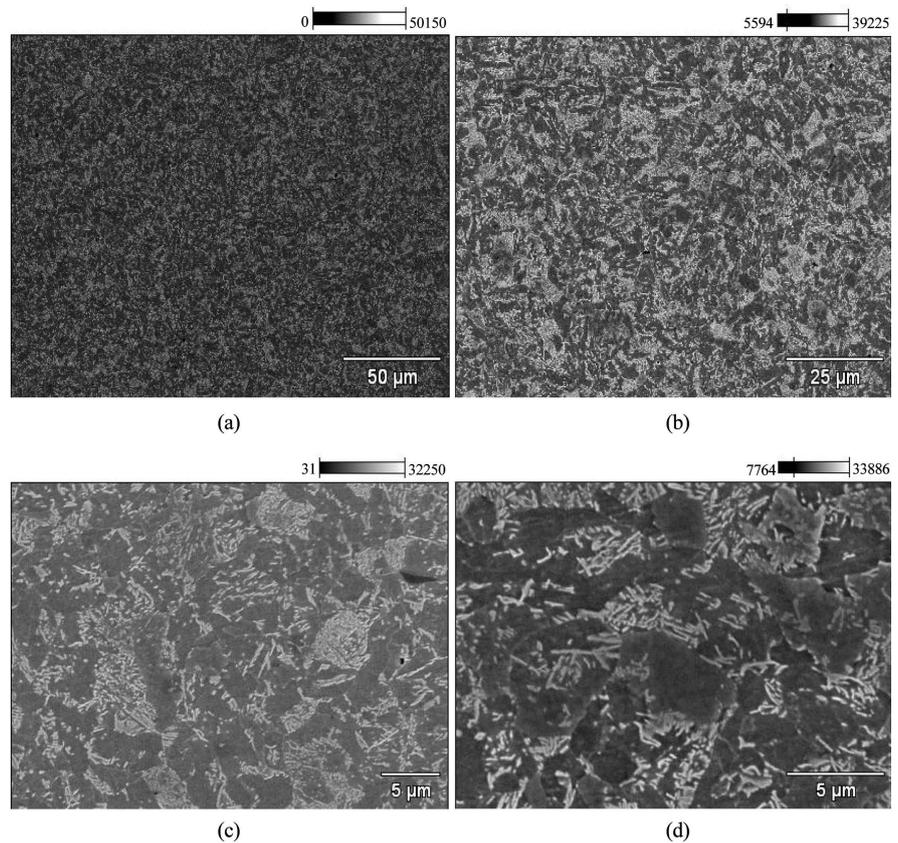
In pictures of **Figure 10**, the microstructure of the transversal probe is shown. The distribution of its ferrite grains and perlite colonies are not aligned. The latter delimit or cut the boundaries of the ferrite groups. At a 5000× magnification, perlites are more visible and delimited, distributed over the ferrite base.

Figure 10. (a) Magnification: 500×; (b) Magnification: 1000×; (c) Magnification: 3000×; (d) Magnification: 5000×.

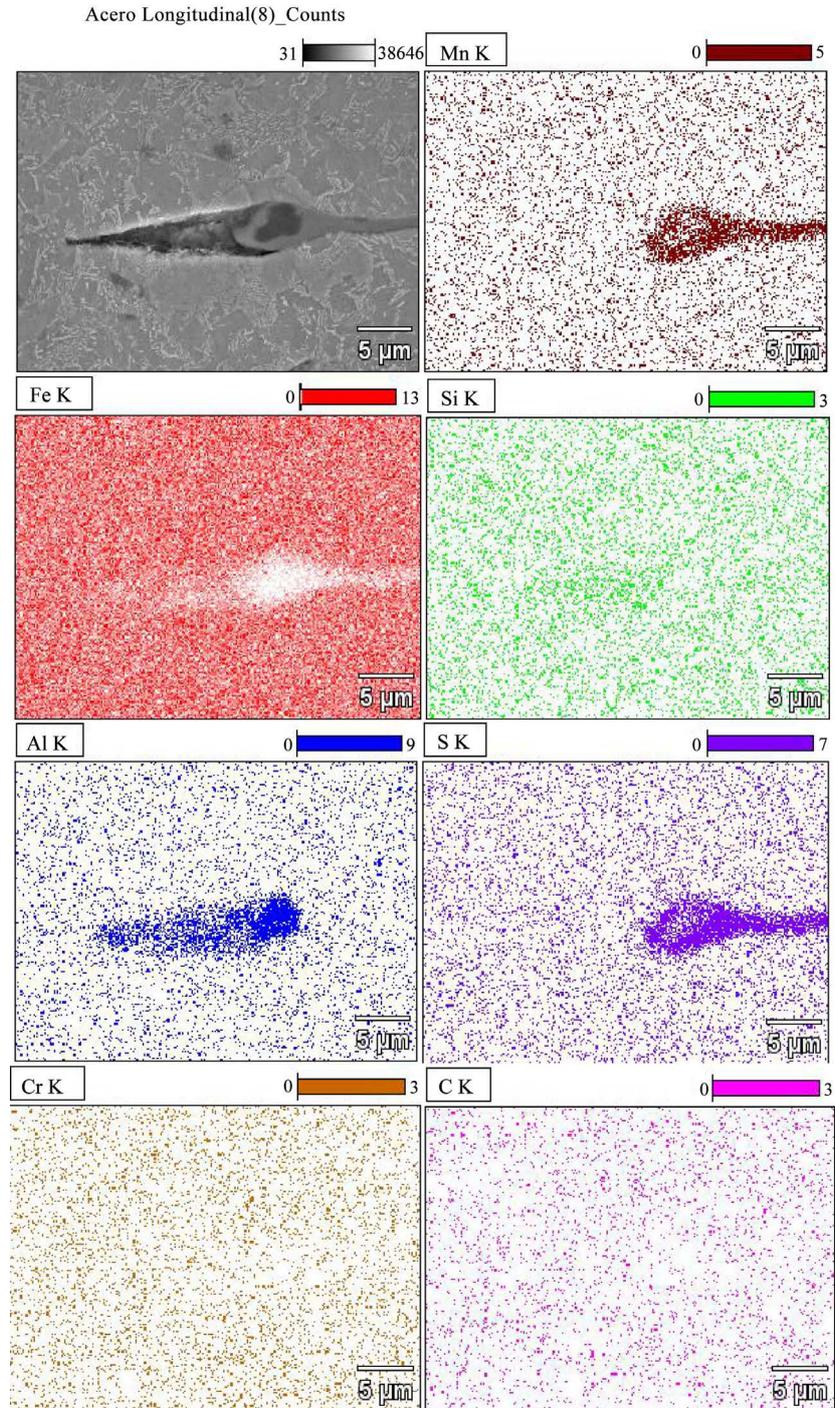
Figure 16 shows pictures of each chemical element of the longitudinal sample with an inclusion. It is clear that the inclusion is mainly composed by sulphur and aluminum, as well as some manganese. On the other hand, there is the highest content of iron, while the remaining elements are present almost in the same proportion, except carbon, which is the one with the lowest content. Since the Figure makes reference to an impurity, it makes all the surrounding space become polluted by its elements. Components may also be seen aligned in a uniform manner and, without inclusions, there are no sulphur and aluminum.

Figure 16. Mapping of a longitudinal sample section. Magnification: 3000×.

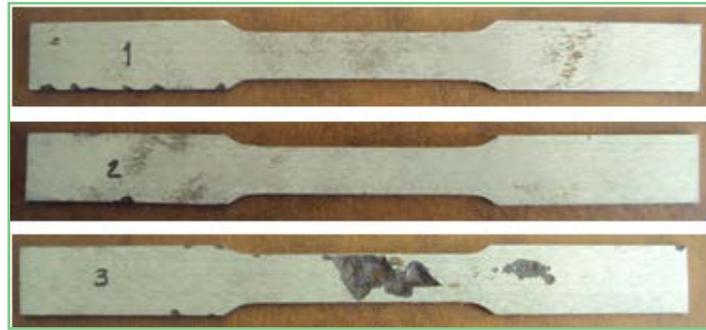
Probes 1 and 2 were in good conditions on the neck, that is, they did not have pitting or cracks rendering them less resistant compared to Probe 3, which showed pitting due to corrosion and, by sight, it was concluded that it would be the less resistant to the test.

Probe 3 collapsed in less than half a second, which shows that, since it was entirely corroded, the sample could not bear the loads to which it was subject. Therefore, it may be said that corrosion greatly contributed to failure. However, its fluency and ultimate tensile strength results were between the parameters of

Figure 17. Probes for tensile test.
