Quantitative Analysis Method for Corrosion and Patina Progression on Plumbing Components during Long-Term Connection Leaks from Potable Water Supply Systems

Abel Crean

Geo Hazards, Inc., Gainesville, FL, United States of America

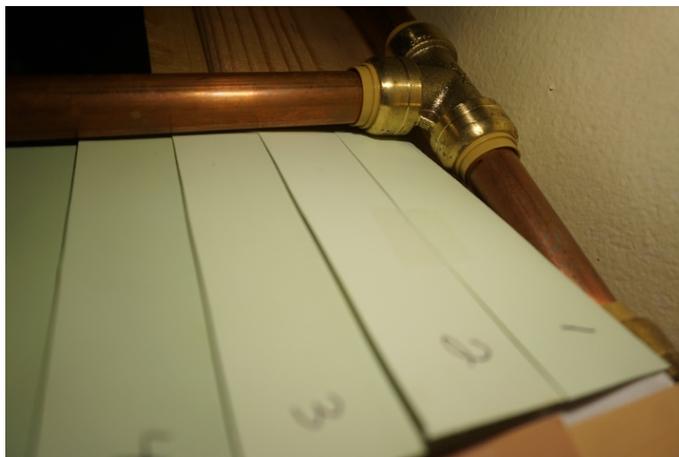
Minute, faint patina spots of color depth 2 (Figure 5) were first observed on week 2 and increased to depth 3 by week 7. Minute spots further increased to depth 4 on week 11 and depth 5 by week 15. Spots remained at depth 5 for the duration of the study at week 15 (Figure 6). The observed minute spots were

Figure 5. Control—Minute faint patina spots on week 2 [19].

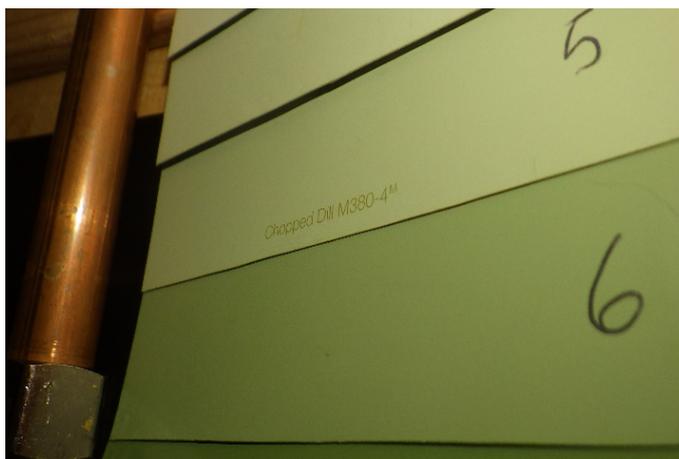
Figure 6. Control—Small spots with a color depth #5 on week 15 (end of study) [19].

located randomly over the pipe surface and were not concentrated in a local area. Consequently, the widespread minute spots represented the patina induced by atmospheric humidity and general usage.

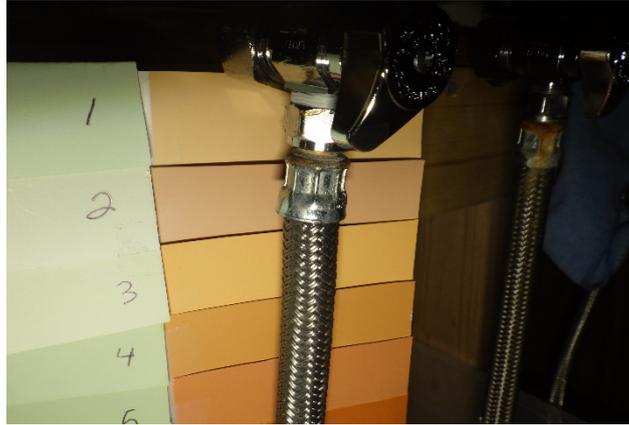
Very light corrosion with a color depth #1 was first observed on week 2 around the base of the upper supply line nut (**Figure 7**). The color depth increased to depth 2 by week 3. On week 8, corrosion finally increased to depth 4 with no appreciable increase in area and remained a similar color through the end of the study on week 15 (**Figure 8**).

Figure 7. Control—Very light corrosion of color depth #2 on week 2 at supply line nut [19].

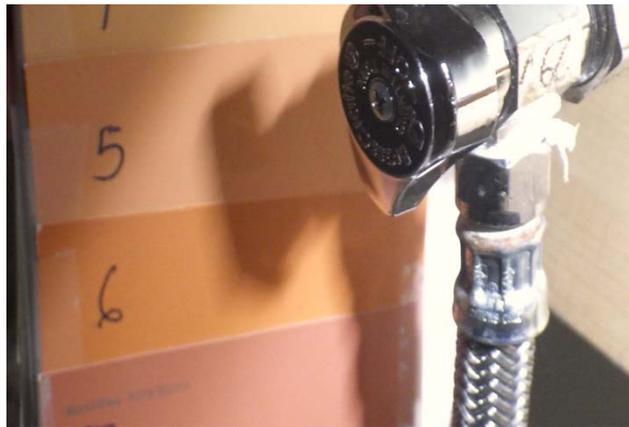
The corrosion orientation followed a tool mark or mating surface where the surface layer was absent and did not extend past the area of absent surface layer. Consequently, the observed corrosion may have represented the initial oxidative reaction during which the outer metal layer slightly corrodes and served to inhibit further corrosion and protect the underlying metal layer. The fact that the corrosion color depth remained steady and did not increase after week 8 supported this interpretation.

Figure 8. Control—Corrosion with color depth #4 on week 15 (end of study) [19].

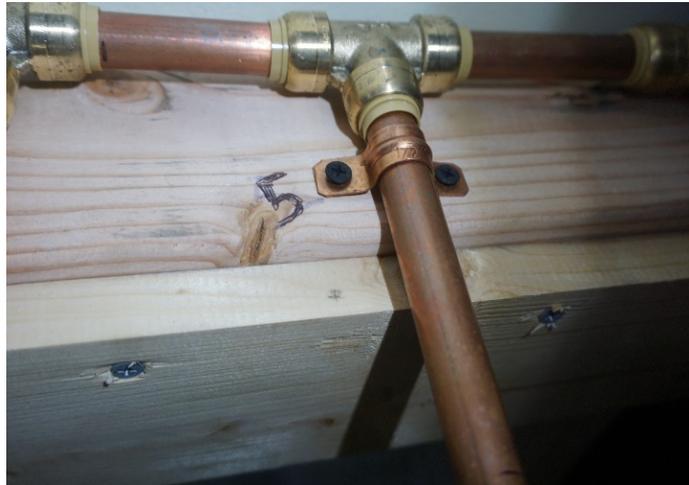
By week 3, all specimens exhibited light widespread patina spots with an average of color depth 3.25 (**Figure 9**). Specimens 1 and 3 first exhibited minute specks of patina on the pipe adjacent to the supply valve connection leak on week 8, with color depths of 6 and 4, respectively (**Figure 10**). By week 16, the widespread, minute spots circularly increased slightly in area and deepened in color. Patina at the leaking connections progressed to an average of 6.25 by the end of the study on week 15 and remained locally concentrated around the leaks (**Figure 11** & **Figure 12**).

Widespread patina spots represented atmospheric and usage induced patina and were also observed on the control specimen. This is a vital observation, as detailed observations distinguished patina caused by a leak from that which is caused by general service conditions.

Figure 9. Patina—Widespread spots on week 3 [19].

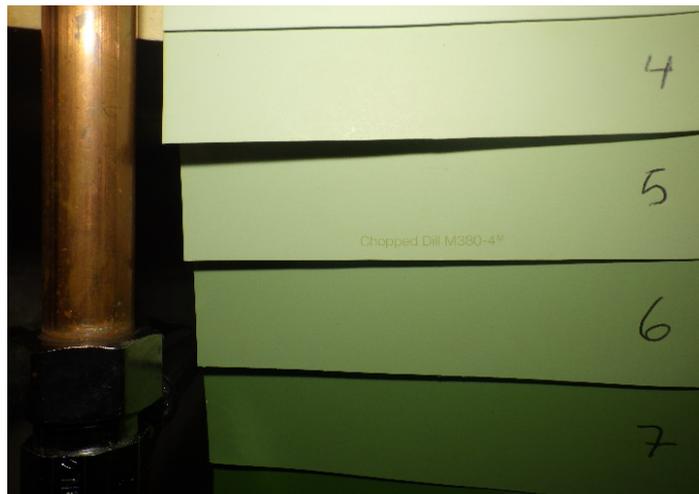
Figure 10. Patina—Specimen 3 first exhibited minute specks (color depth 4) at a leak on week 8 [19].

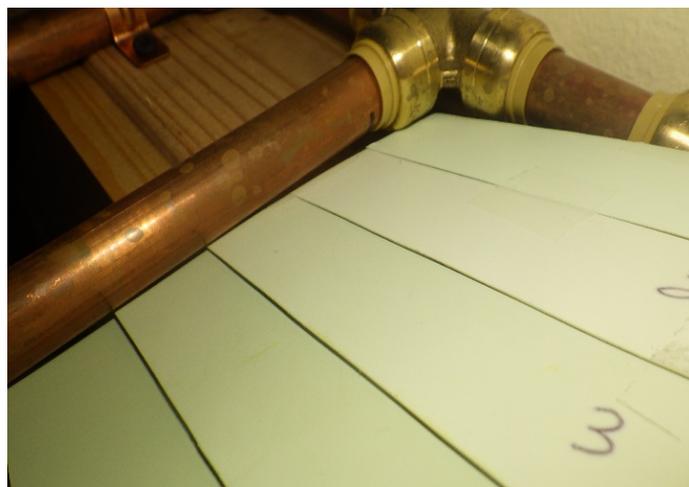
Figure 11. Patina—By week 16, the minute spots increased slightly in area and deepened in color [19].

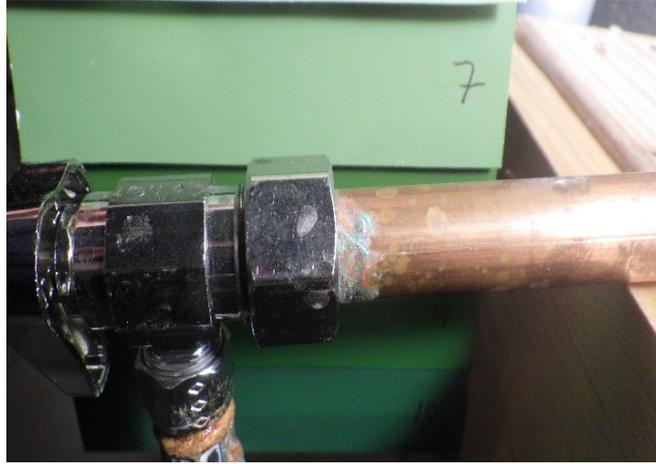
The localized patina on the supply pipe was largely concentrated adjacent to the engineered leak from the angle stop compression fitting. The concentrated area represented the surface which was directly wetted by the leak and did not greatly expand outside of this limited area.

Figure 12. Patina at the engineered leak Specimen 1 on week 15, concentrated around the leak [19].

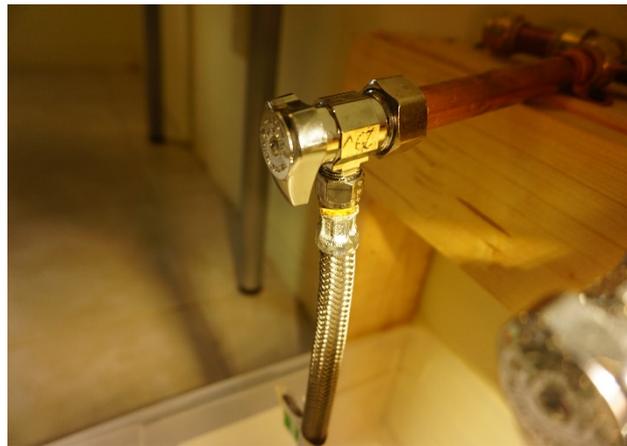
Notable corrosion of average color depth 2.25 first appeared on the copper pipe adjacent to the supply valve connection on week 2 (**Figure 14**). Corrosion gradually advanced to an average color depth of 6.75 by the end of the study, remaining concentrated around the supply line connection, while streaking downward onto the supply line on one specimen (**Figure 15**). The area of downward streaking denoted the surface of the supply line wetted by the engineered leak.

Figure 14. Corrosion—Average color depth 2.25 first appeared at the supply line connection on week 2 [19].

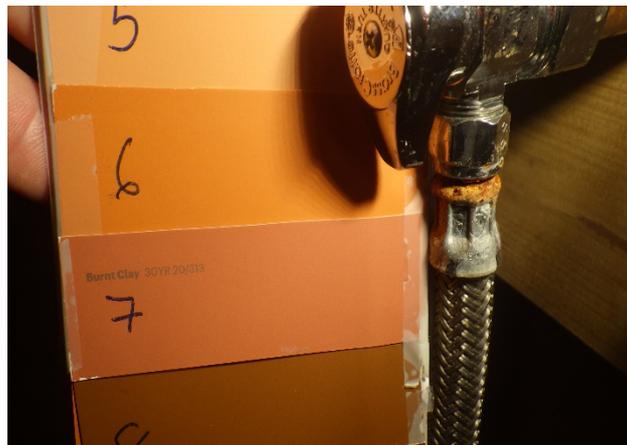
Figure 15. Corrosion—Average color depth of 6.75 at the end of the study, concentrated around the supply line connection [19].
