# Slope Instability at Nablus-Al Bathan Road, Palestinian Territories (Causes, Analysis and Remedy Measurements)

**How to cite this paper:** Jardaneh, I., Hijjawi, S. and Odeh, G. (2021) Slope Instability at Nablus-Al Bathan Road, Palestinian Territories (Causes, Analysis and Remedy Measurements). *World Journal of Engineering and Technology*, 9, 538-547.  
<https://doi.org/10.4236/wjet.2021.93036>

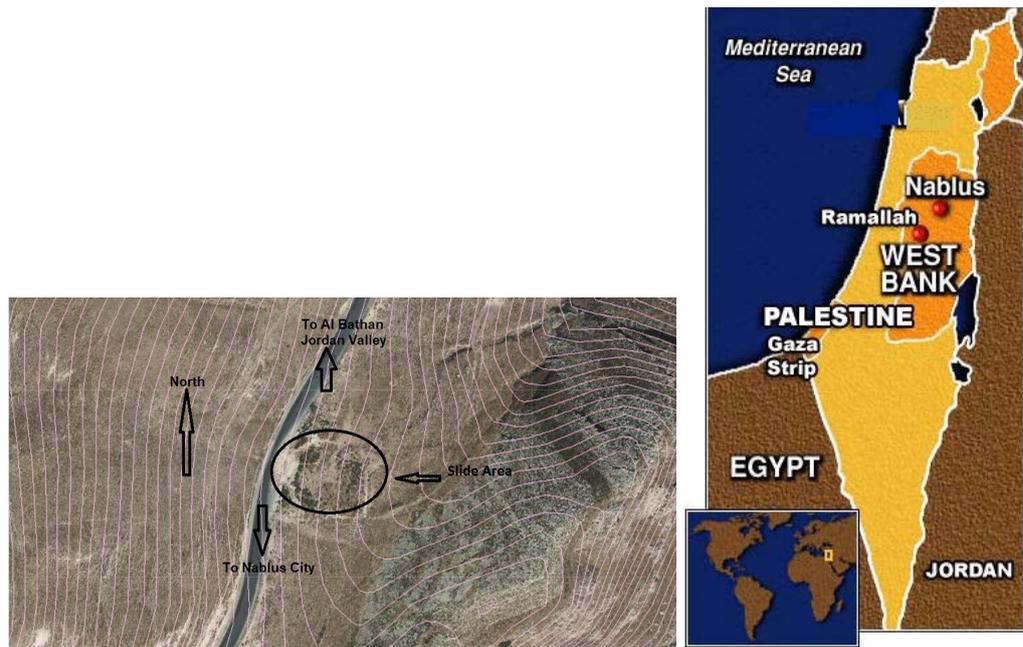
Nablus Al Bathan site location that suffers instability problems is shown in **Figure 1**. Typical longitudinal cracks in several locations along the eastern side of the road were noticed yearly, as shown in **Figure 2**. In 2009 PWHD-Nablus did major rehabilitation to the road, such as widening and reconstruction the road. In March 2012, large longitudinal cracks along the eastern side of the road at

**Figure 1.** Landslide in eastern side of the road and extended down to the bottom of the valley.

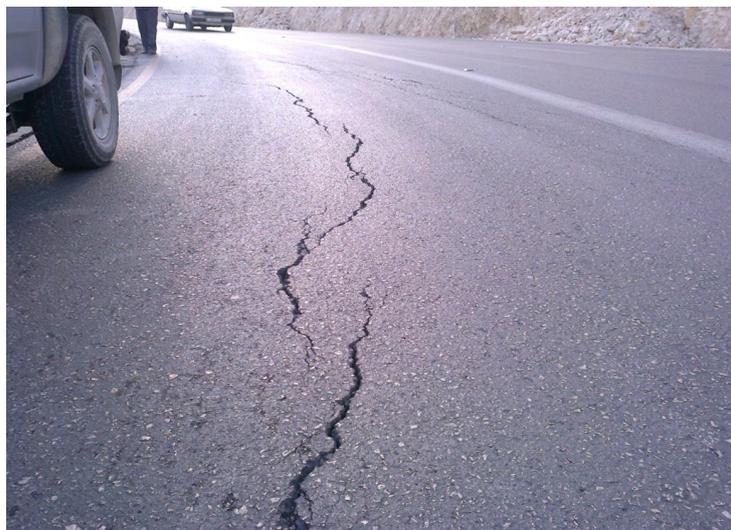
**Figure 2.** Typical cracks that occurs yearly along Nablus-Al Bathan Road.

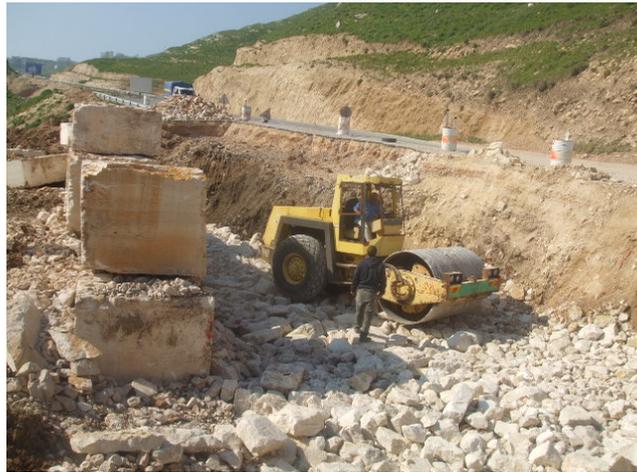
The rehabilitation conducted by PWHD-Nablus at station 2 + 100 was replacing the body of the road to a depth of about 4 m by several layers of boulders and base course and supporting the eastern side of the road by big boulders to a depth of about 6 m below the ground surface. This is shown in **Figure 3**. During the construction of the remedial measures large settlement and sliding occurred in the eastern part of the road next to the big boulders and extended down to the bottom of the valley, as shown in **Figure 4**.

**Figure 3.** Remedial measures to fix the problem at station 2 + 100 in March 2012.

Remedy measurements in 2012 by inserting big boulders at the eastern edge of the main street increased the driving force and hence reducing the factor of safety. This is the main reason that sliding was recognized clear at that time. The solution to this problem is to insert piles below the soft semi-liquid layer in or-

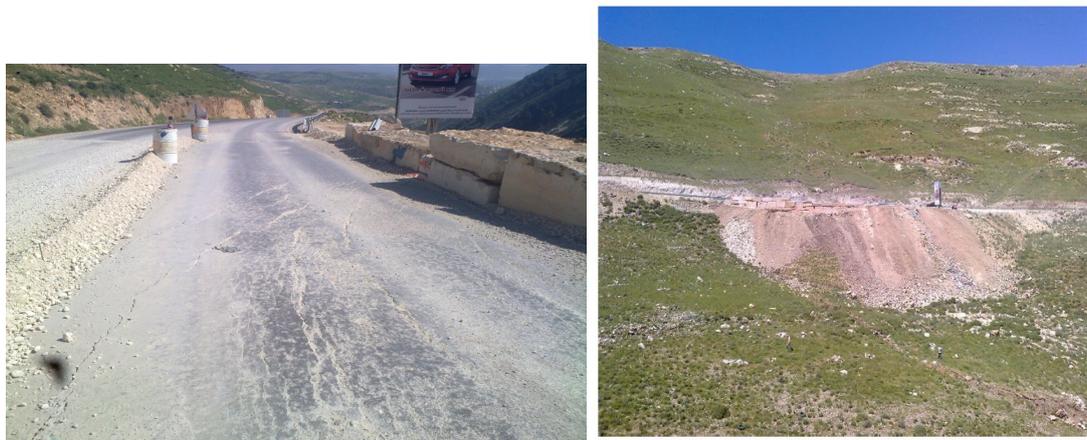
**Figure 4.** Large settlements occurred in eastern side next to big boulders (left picture) and large landslide occurred and extended to bottom of the valley (right picture) in 2012 during the construction of remedial measures.

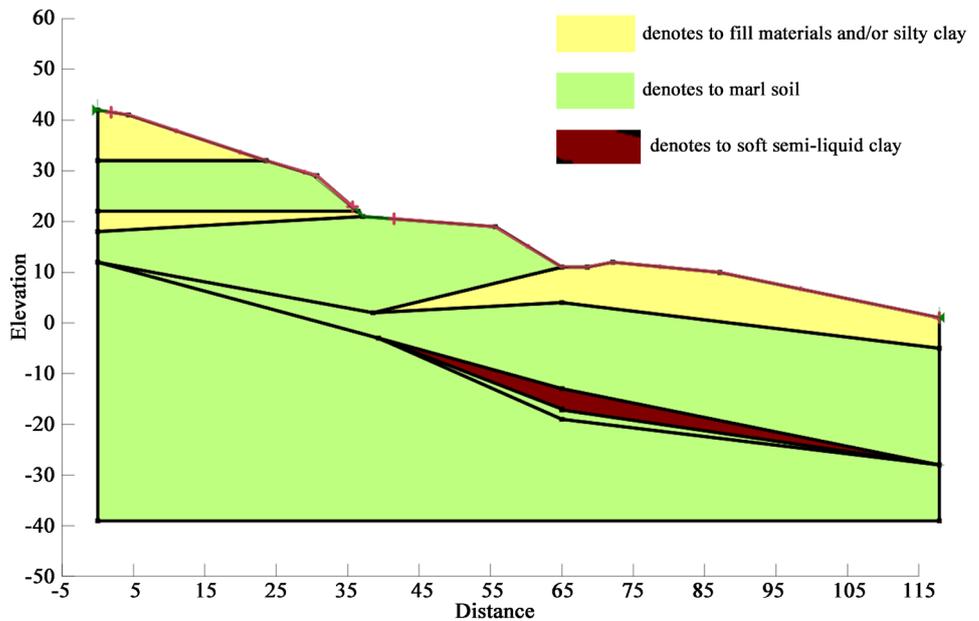
Detailed soil properties and parameters within the depth of each borehole were obtained from soil mechanics laboratory tests. However, these properties were reduced to minimum soil properties and in this case the soil layers were reduced to three layers with minimum soil values as shown in colors as in **Figure 6** for section 7-6-10-8 as an example. **Table 1** shows the values of soil parameters

**Figure 6.** Soil strata as reduced to critical soil properties as in Section 7-6-10-8.

that used in slope stability analysis. It is important to note that a soft saturated semi-liquid clay layer was found at a depth of about 20 to 23 m from the ground surface.

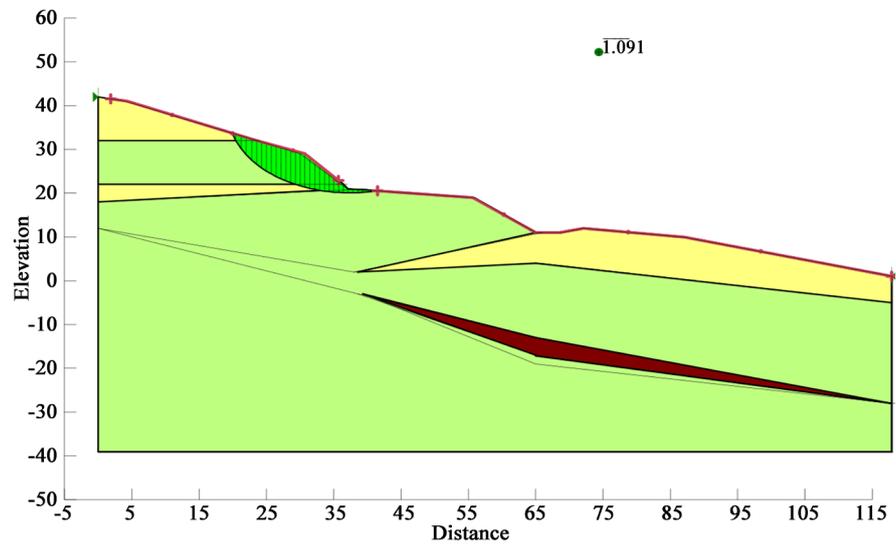
In general, the factor of safety required for stable slope is 1.5 [11]. It is clear that the site in general suffers slope instability and hence, landslides may occur at any moment above and below the main street alignment. The factor of safety

**Figure 7.** Slope stability analysis for section 7-6-10-8 with Soft Semi-Liquid layer as found during drilling (minimum factor of safety = 1.091).

above the as well as below the main street is well below 1.5. The case becomes worst as the soft semi-liquid layer extends to other layers as expected during winter season.

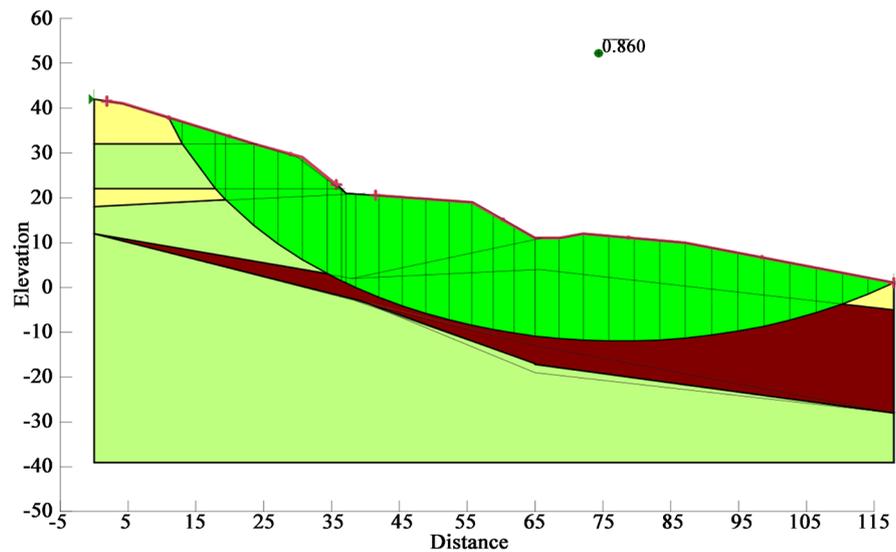
**Figure 8.** Slope stability analysis for section 7-6-10-8 with Soft Semi-Liquid layer extends to close layer (minimum factor of safety = 0.860).

The results show the resisting force due to shear strength properties of the soil and the driving or activating slope failure due to the soil mass. The difference with appropriate factor of safety should be carried out by a set of piles that will resist this shear force.
