# Evaluation of Stress Corrosion Cracking Damage to an API 5L X52 Pipeline Transporting Ammonia: A Case Study

José Luis Mora-Mendoza<sup>1</sup>, Mónica Jazmín Hernández-Gayosso<sup>2</sup>, Daniel Antonio Morales-Serrat<sup>1</sup>, Octaviano Roque-Oms<sup>1</sup>, Digna Alejandra Del Angel<sup>1</sup>, Gerardo Zavala-Olivares<sup>2</sup>

<sup>1</sup>Petróleos Mexicanos, Marina Nacional 329, Col. Petróleos Mexicanos, CDMX, Ciudad de México, México

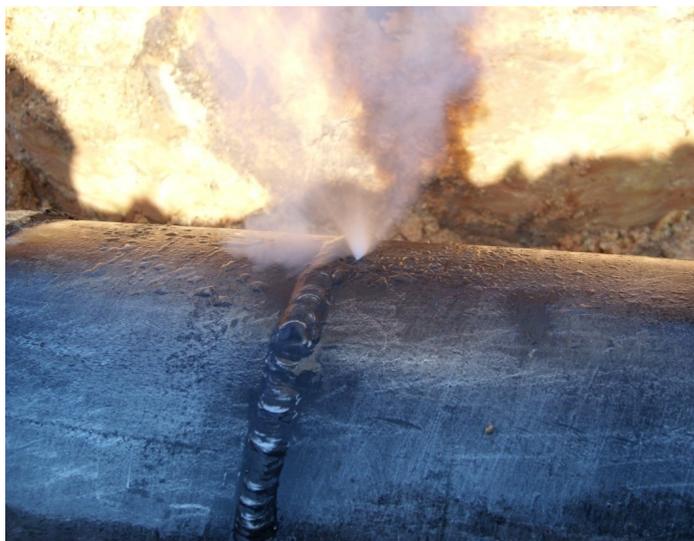
In most failure points, circumferential fractures were identified which were close to the field welds, and generally located at 12 technical hours from the pipeline (**Figure 1**). In general, these types of circumferential fractures tend to be favored in their formation and propagation by axial stress and pipeline flexion. In five leaks, it was not possible to identify the type of damage caused to the pipeline, due to the priority assigned to repair and eliminate the leak to reestablish the product transportation.

**Figure 1.** Ammonia leak located close to a circumferential weld, at 12 technical hours from the pipeline.

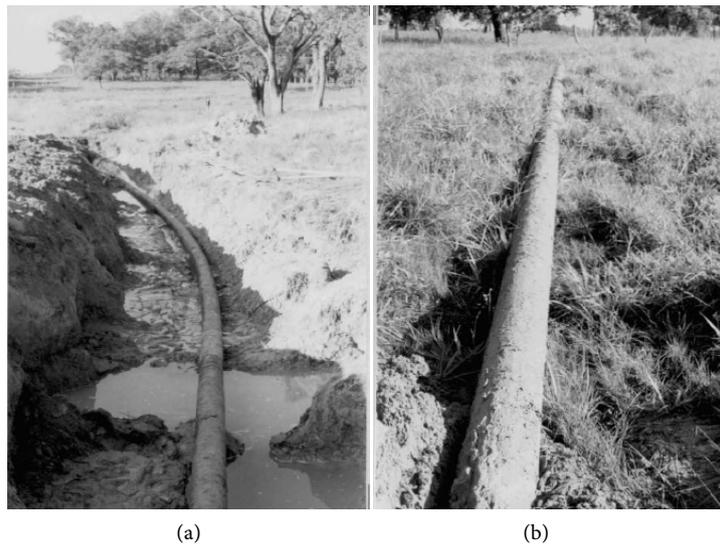
1) During the direct evaluation at 17 sites, there were pipeline segments with displacements between the original plane and the cut section, of more than 90 cm, which recovered their linearity after removing them from the ditches (**Figure 2**).

2) The laboratory results reported cracks in the analyzed segments, which were associated to the stress corrosion cracking (SCC) mechanism. The origin of the strains was attributed to the inadequate field conformation of the pipeline by forcing the pipes to adjust to the terrain topographic profile.

**Figure 2.** (a) Curved pipeline; (b) Withdrawn section with linearity recovery.

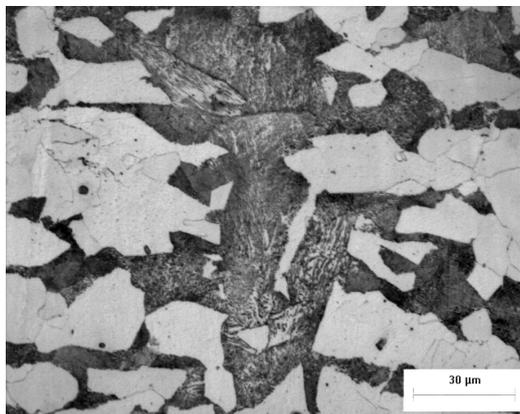
The microstructure of the base metal showed abnormal carbon segregation and pearlite acicular morphology, characteristic of a fragile microstructure [16] (Figure 3). The presence of fractures with fragile aspect and multiple cracking was also identified. Neither metal loss nor pitting corrosion occurred (Figure 4). The cracks, being of the transgranular type, displayed trajectories going from the interior to the exterior part of the pipeline wall (Figure 5).

**Figure 3.** Base metal microstructure.

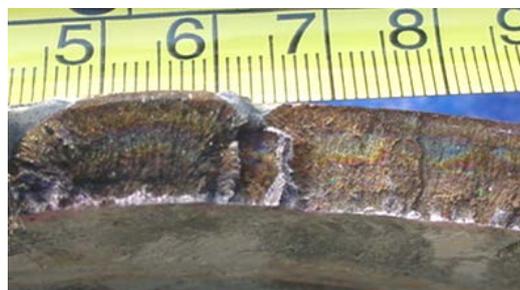
**Figure 4.** Brittle fracture.

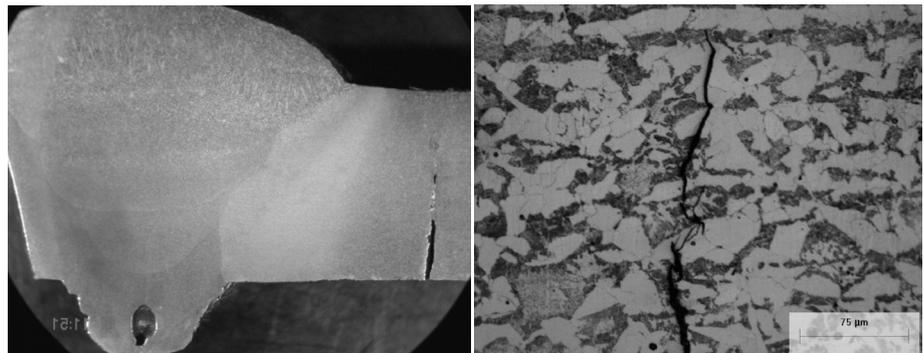
Based on the results of these metallographic analyses, it was concluded that the failures obeyed to a stress corrosion cracking (SCC) mechanism, which was originated by various factors: high stress resistance, high hardness, a brittleness-susceptible microstructure and the presence of residual stress that was probably originated from the pipeline construction and lying.

**Figure 5.** Microscopy fractography analysis and transgranular cracks.

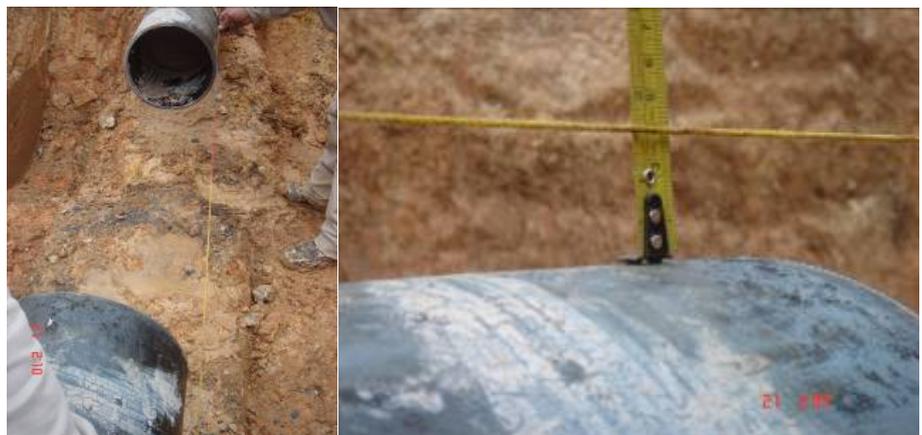
**Figure 6.** Pipeline cut at the 3 + 300 kilometer.

1) At the 3 + 300 kilometer, once the pipeline cut was finished, a linear displacement of approximately 4 cm was observed (**Figure 6**), which made necessary further digging, in order to match correctly the pipe and release the present stress.

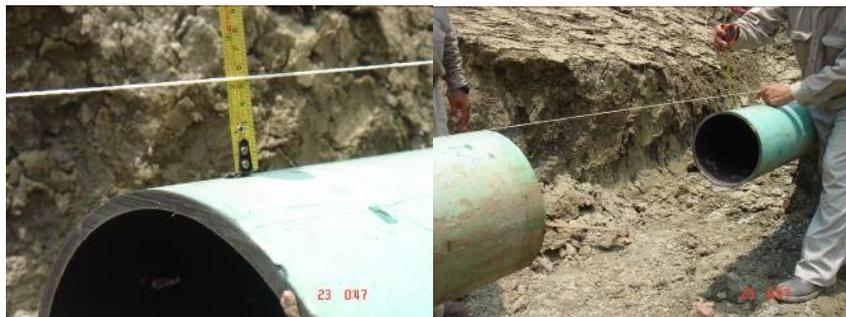
**Figure 7.** Pipeline cut at the 8 + 025 kilometer.

2) At the 8 + 025 kilometer, the pipeline cut was finished and a linear displacement of approximately 5 cm was also observed, as shown in **Figure 7**. It was necessary to continue digging to match correctly the pipe and release the present stress.

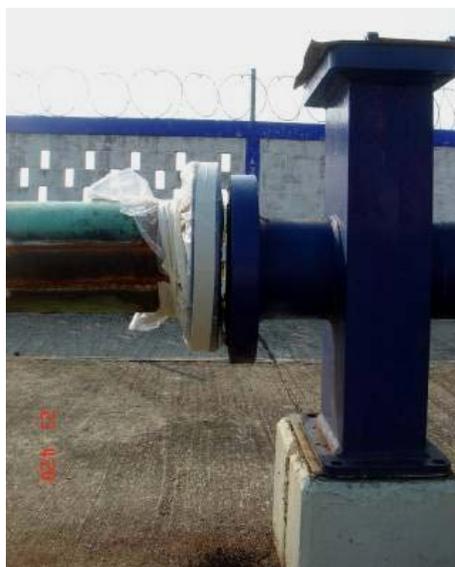
3) At the 15 + 137 kilometer, which is close to a sectional valve, a pipe vertical displacement of approximately 4 cm was observed when the valve flange was unscrewed, **Figure 8**. In order to perform the total repair, it was necessary to modify the valve supports to match the flanges and release the present stress.

**Figure 8.** Pipeline vertical displacement at the sectional valve.

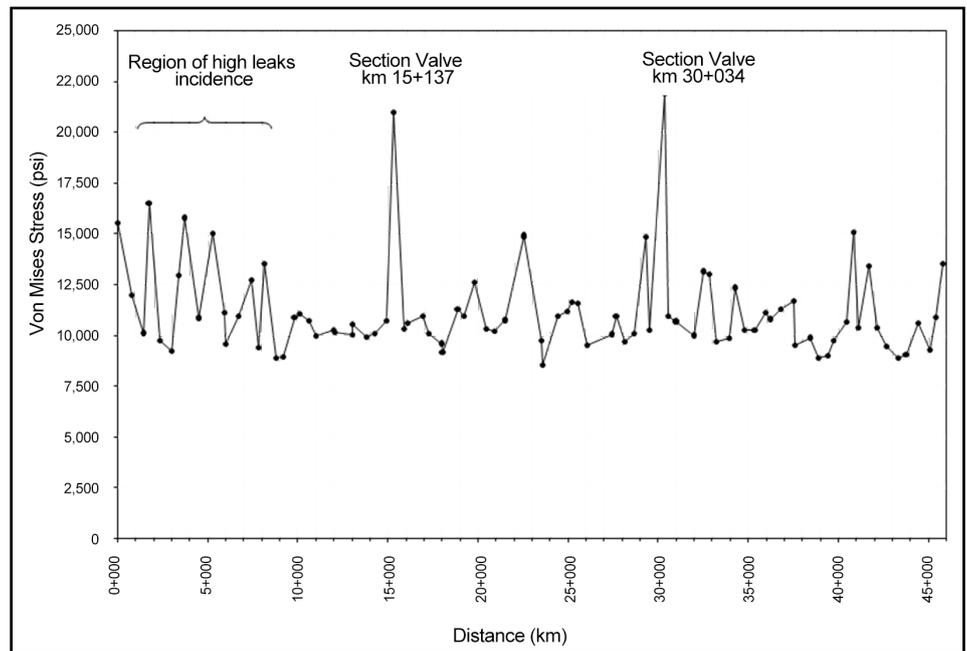
By considering the pipeline loads and operative conditions, along with the topographic profile of the terrain reported by the GPS of the last ILI inspection [23], a pipeline flexibility analysis was performed to identify the zones or sites with higher stress levels and/or displacement probability. The results showed (Figure 9 and Figure 10) that the pipeline is submitted to stress conditions that don't surpasses 35% of the allowed limits established by ASME B31.4 2009 [24]. There are displacement points and relatively high stress levels (peaks) in the zones where failures occurred in the pipeline. The highest displacements and stress levels were located at two sectional valves (15 + 161 and 30 + 034 kilometers). In addition, there is a region with stress fluctuations that are in accordance with the highest occurrence of pipeline failures.

Figure 9. Pipeline stress profile.

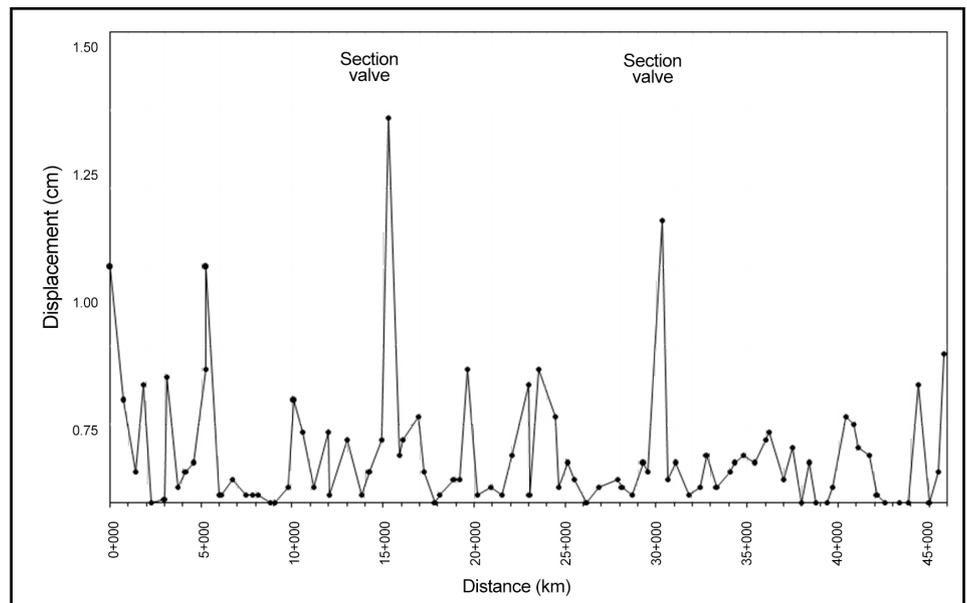
Figure 10. Pipeline displacement profile.

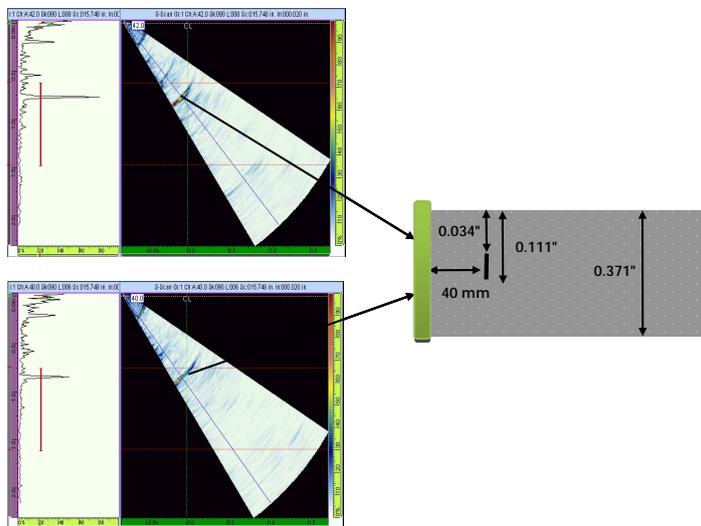
<b>Type</b>	Crack confined inside the pipe body.
<b>Location</b>	12 technical hours from the pipe, at 40 mm of field weld.
<b>Dimensions</b>	11.43 mm of circumferential length and 0.077” of radial length, <b>Figure 11</b> .
<b>Evaluation</b>	Crack mechanics: Crack located at the “no failure zone”. The failure stress is 47% of the applied stress.
<b>Recommendation</b>	Repair with a type B sleeve, designed to contain the pipeline operation pressure in the case of a leak or the possible replacement of the pipe.
<b>Performed action</b>	Pipe replacement.

**Figure 11.** Dimensioning and location of a crack at the 3 + 371 km.

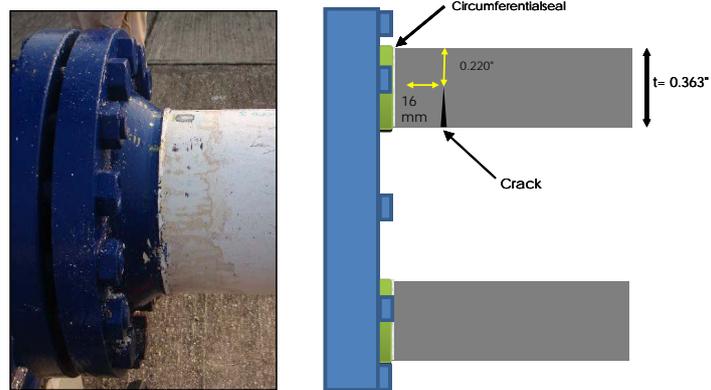
<b>Type</b>	Crack confined inside the pipe body.
<b>Location</b>	12 technical hours from the pipe, at 16 mm of field weld and at 0.220” of the external pipe surface.
<b>Dimensions</b>	23.36 mm of circumferential length and 0.143” of radial length, <b>Figure 12</b> .
<b>Evaluation</b>	Crack mechanics: Crack located at the “no failure zone”. The failure stress is 74% of the applied stress.
<b>Recommendation</b>	Pipe replacement.
<b>Performed action</b>	Pipe replacement.

**Figure 12.** Location of the crack at the 15 + 161 km.
