The Monitoring Mast of the WWII German W/T Station Be-2

Giancarlo T. Tomezzoli

Abstract

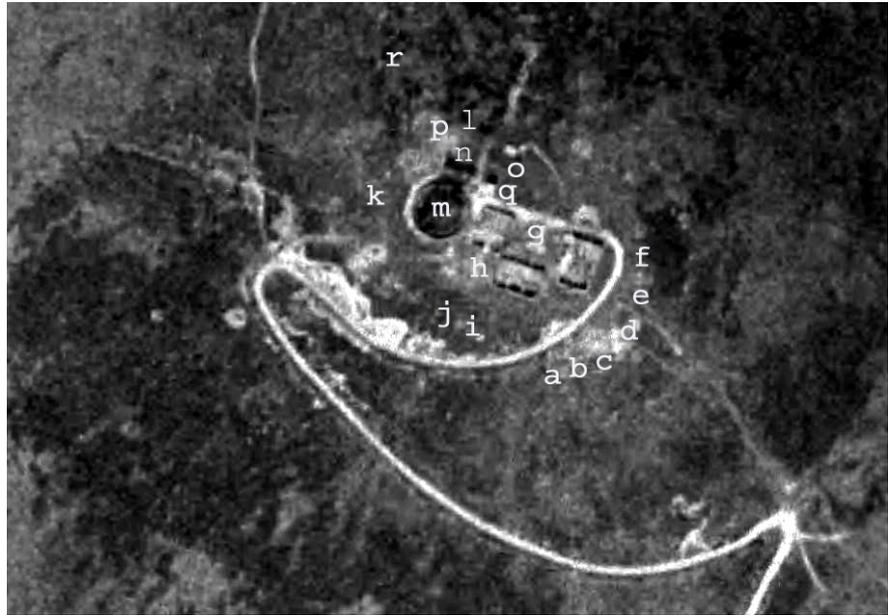
Figure 1. Be-2 site: (a) Concrete niches; (b) Emplacement for machine or *Flak* guns; (c) Possible stone bunker; (d) Emplacement for machine or *Flak* guns; (e) Emplacement for machine or *Flak* guns; (f) Emplacement for machine or *Flak* guns; (g) Barrack emplacement; (h) Cisterns; (i) Bunker; (j) Trench; (k) Bunker; (l) Two antenna cable anchorages; (m) *FuSan* 724/725 circular support; (n) 17th century Saint Michel chapel; (o) Ruins of a small construction; (p) Two antenna supports; (q) Transformer cabin; (r) Possible *Flak* emplacement.

Two well preserved concrete niches (a), about $1.5 \times 1.0 \times 0.6$ m, one above the other on a side of the mount for storing ammunitions and/or materials for the nearby machine or *Flak* guns. On their vertical sides the joints for two closing wood doors were still visible.

A ground emplacement (b) in the terrain, probably for machine or *Flak* guns. Built by local stones, it was in a degraded preservation state and completely invaded by the vegetation.

A possible 5×3 m stone bunker (c), near the ground emplacement. Built by local stones, it was in a degraded preservation state. It cannot be excluded that originally it was an old country construction probably reused during the WWII as guardhouse or commandment place for the nearby machine or *Flak* guns.

A 2×2 m emplacement (d) for machine or *Flak* guns. Built by local stones it was in a degraded preservation state and completely invaded by the vegetation.

Two emplacement (e)-(f) for machine or *Flak* guns. Excavated directly in the terrain, they were in a degraded preservation state.

A barrack emplacement (g) for three barracks. The barracks were gone and only their traces and their concrete foundations were visible on the terrain.

Two well preserved 3×2 m open cisterns (h).

A possible bunker (i) buried in the terrain, having four 60×30 cm rectangular apertures on one side of its well preserved coverage, in correspondence with an aperture on one of its side walls. Probably it hosted an emergency electrical ge-

nerator and the apertures ensured its cooling. According to another interpretation (Tomezzoli & Dupont, 2011), it was the basis of a disappeared latrine barrack.

A degraded trench (j) still visible on the terrain, connecting the bunkers (i) and (k).

A bunker (k) ($48^{\circ}21'00\text{N}$, $003^{\circ}56'41\text{W}$) about 9×4 m, buried in the terrain. The descending entrance, oriented toward the *FuSan* 724/725, was filled by terrain; therefore the inspection of the interior was not possible. It was probably a protection bunker for the personnel or for Be-2 instrumentation in case of attack.

Two antenna cable anchorage supports (l) at their places on the terrain.

The *FuSan* 724/725 support (m) formed by a concrete, circular ring about 20 m in diameter and 1.5 m in width, with a circular, concrete construction about 4 m in diameter at its centre, slightly emerging from the terrain. The internal room of the construction was completely filled by terrain; therefore the inspection of the interior was not possible. The circular rail on the ring for the rotation of the *FuSan* 724/725 disappeared and only its fixation joints emerged from a light concrete layer covering the ring.

The well preserved 17th cen. Saint Michel chapel (n) having a short bell tower superimposed on its front facade. One of its doors was open, but surprisingly its interior was not vandalized or disfigured by modern graffiti. The chapel and its bell tower evidently have not interfered with the *FuSan* 724/725 radio emissions.

The ruins of a small construction (o), still intact in the year 1991, probably hosting a transmission centre.

Two antenna supports (p) at their places on the terrain.

A possible emplacement (r) for a *Flak* gun, excavated on a mount side.

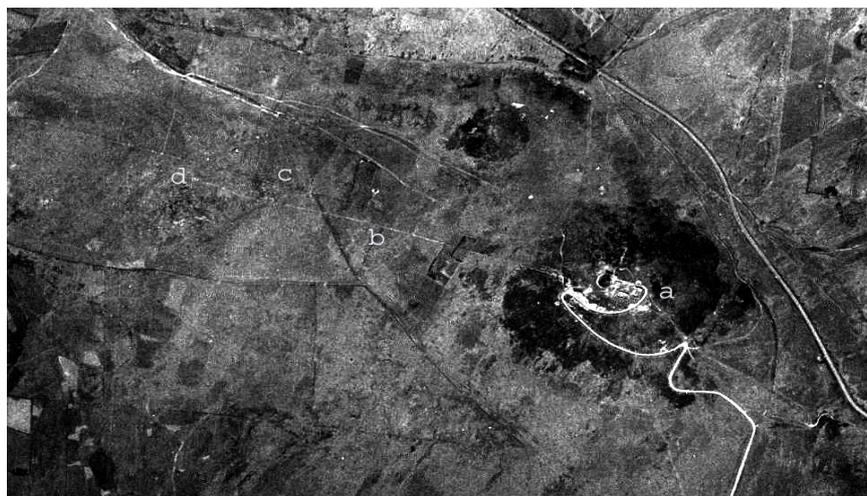
At that time, the vestiges of the transformer cabin (q) (Figure 1) were not recognized and because of the lack of information, the vestiges of the cable trench (b) and the monitoring mast (d) (Figure 2) were not searched at all.

Figure 2. Be-2 site—(a) Mont Saint-Michel de Brasparts; (b) Cable trench; (c) Stone straight alignment; (d) Monitoring mast concrete support.

The third Be-2 visit took place on 14th May 2017 with good weather. It was possible to recognize on the terrain the traces of the foundations of the transformer cabin (q) close to the chapel (n) and to ascertain that the cable trench (b)

(Figure 2) was no longer identifiable.

disappeared either because both it was covered by terrain and vegetation, in which case the cable, probably an Erdkabel RLM with external insulation and four conductors (Dörenberg, 2019a), would be still in place, or was filled up by terrain after the cable removal.

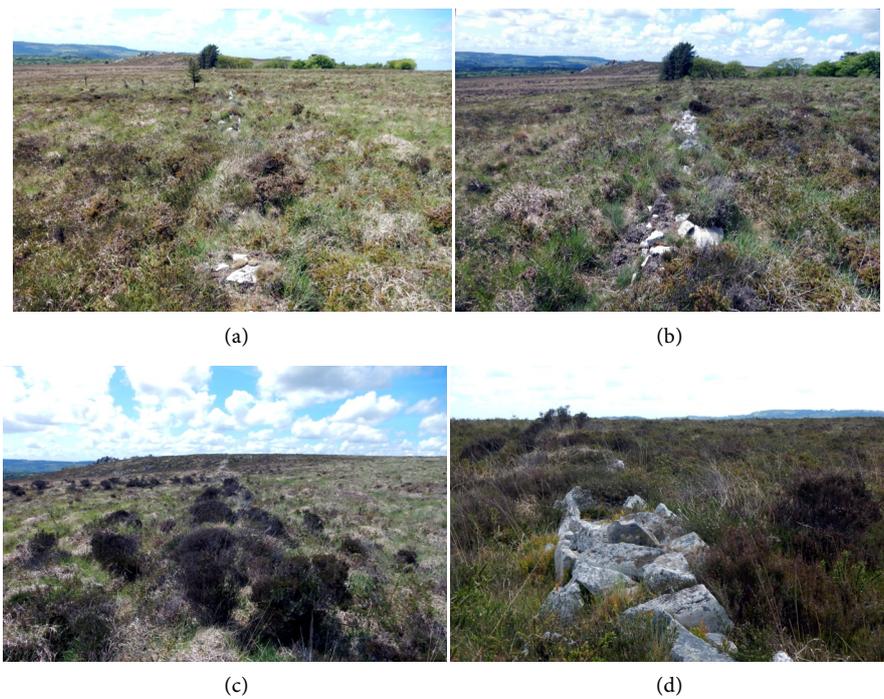
To arrive to the mast vestiges (d), I followed a stone straight alignment (c) visible on the terrain, which passed in proximity of their position (Figure 2 & Figure 3). The stones were posed directly on the terrain with no trace of excavation. Search for possible rests of cables or other military devices between or under the stones gave no result.

Figure 3. Third Be-2 visit—(a)-(d) stone straight alignment.

The absence of rests of cables or other military devices along the stone straight alignment indicates that it was simply a stone border between two adjacent pri-

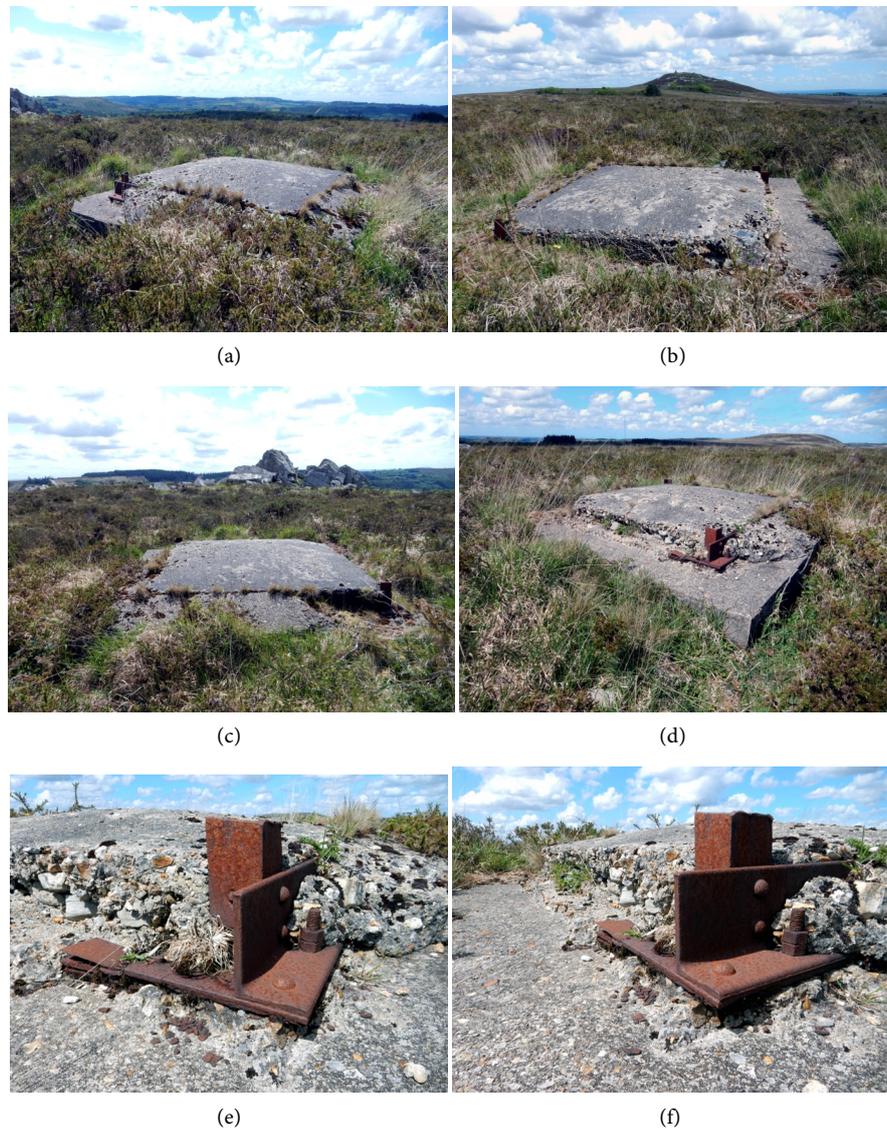
The mast concrete support ($48^{\circ}21'7.86''\text{N}$, $3^{\circ}57'28.14''\text{W}$) (Figure 4) was at about 915 m from the chapel along the stones straight alignment, displaced about 43 m south from it. The support was formed by a square concrete foundation about 3×3 meters just emerging from the terrain and a square mast metallic fixing frame. A thick concrete layer covered the foundation surface and the fixing frame. A failure on two sides of the concrete layer let visible part of the fixing frame. Originally, it was formed by four 2 m long, 20 cm high, L-shaped riveted metal beams fixed by bolts to the foundation. Only two beams were actually in place on the foundation, buried in the concrete layer. Three mast leg rests were in place on the fixing frame and emerged from the concrete layer. Two leg rests, along a fixing frame diagonal, appeared sawn. In particular, one of them (Figure 4(e) & Figure 4(f)), free from the concrete layer, showed the rivets securing it to the fixing frame near a bolt securing the fixing frame to the foundation. The third leg rest (Figure 4(a)), at a corner of the fixing structure, appeared not only sawn, but also broken along a vertical line and curved toward the exterior of the foundation. The pebbles of the EroVili (Tomezzoli & Marzin, 2015) mixed to the foundation concrete and the concrete layer were clearly visible.

Figure 4. Mast vestiges—(a) Mast support, north vision; (b) Mast support, east vision, on the background the 17th cen. Saint Michel chapel (n) on Mont Saint Michel de Brasparts; (c) Mast support, south vision, on the background group of basaltic blocks emerging from the terrain; (d) Mast support, west vision; (e) Mast fixing structure, thick concrete layer with EroVili pebbles; (f) Mast fixing structure, rivets and fixing bolt.

The concrete foundation was similar in dimensions to the foundations of Be-0, Be-9, Be-10, Be-11 and Be-13 at Buke (Germany), but it was the only one in which the foundation surface and the mast fixing structure were covered by a concrete layer. The purpose of this layer was to insulate the mast fixing structure from corrosion due to the weather. Differences in the construction technics indicate that the foundations were manufactured by local companies or artisans under the supervision of personnel of the *Organization Todt*.

The failure of the concrete layer on two sides, the absence of the corresponding two fixing frame beams and the third mast leg rest sawn but also broken and curved toward the exterior of the foundation, indicate that during the mast removal, at least three legs were sawn and the mast fall in the direction of the third leg. The fall of the mast on the terrain broken and curved the third leg rest. During the fall, the fourth leg tore up the two missing fixing frame beams which caused the observed failure of the thick concrete layer. The mast, and may be the cable, was removed between the 1946, when the antenna *FuSan 724/725* was sold for demolition, and the 16th April 1948 date to which it is no longer visible in the air reconnaissance image C3639-0431_1948_MISSIONBETAGNE9_0168 (Figure 2).
