Characteristic Analysis and Comprehensive Control for the Horizontal Stripes of High-Grade Automotive Panels in Continuous Annealing*

Abstract

As to the horizontal stripes defect which exist on the surface of the high-grade automotive panels in continuous annealing process, an effective comprehensive control method is proposed on the basis of full consideration of the equipment and technological features of continuous annealing line. With five field tests as basis, the generation mechanism of the defect was analysed in detail and the comprehensive control measures were put forward. According to actual situation, a detailed technical plan was worked out. Then the relevant technologies were applied to a 1850 continuous annealing line. The statistics shows that this program acquired good effects. The incidence of horizontal stripes defect decreased from 100% to 2.78%. Meanwhile, the surface quality of strip also improved effectively, which created a larger economic benefit.

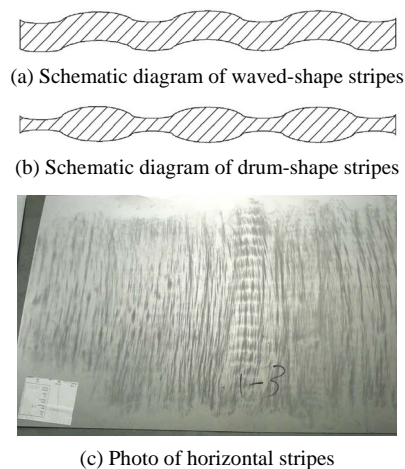
To the panels after continuous annealing process, the horizontal stripes defect is refer to the light and dark, drum-shaped or wave-shaped stripes which appear on the strip surface and only can be seen after grind by oilstone (Figure 1). These stripes arise from the continuous annealing furnace. They are vaguely visible before temper rolling, and then they will become serious. At the same time, the spacing of the stripes and the severity of them have nothing with the speed of temper rolling. This is different from vibration fringes which come from temper rolling process.

Figure 1. Photo of horizontal stripes defect in continuous annealing.

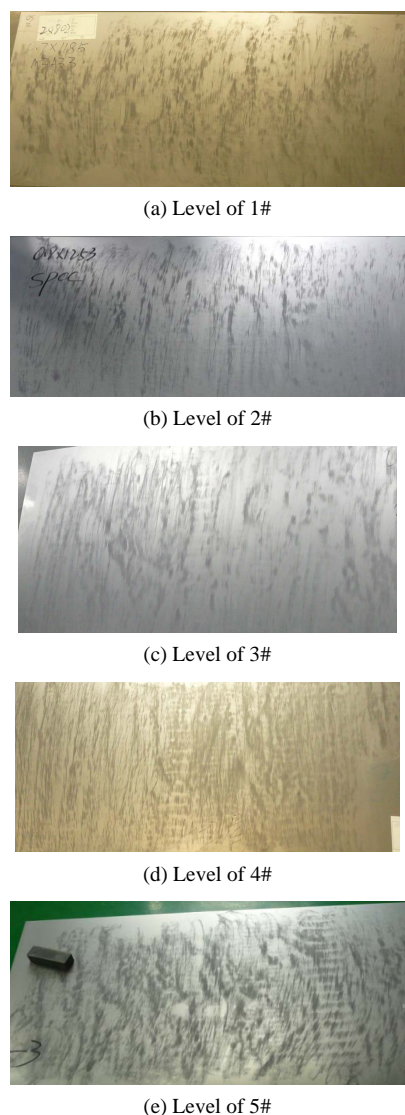
For convenient and qualitative to describe the horizontal stripes defect, the severity of the defect is divided into five grades (1, 2, 3, 4 and 5). The related definitions are described in Table 1. Typical photos of all grades are illustrated in Figure 2.

Figure 2. Photos of various grades of production.

Description	Grade	Can meet user need	Treatment
1	The stripes can't be seen in side light.	1 (Nothing)	Meet	Qualified
2	The stripes can be seen in side light, but can't be seen when face to them.	2 (Very slight)	Meet	Qualified
3	The stripes can be seen in side light and when face to them, but they are vague.	3 (Slight)	Meet	Qualified
4	The stripes can be seen in side light and when face to them, a clear boundary existed between stripes.	4 (Serious)	Cannot be used for automobile outer panel, but can satisfy the request of inner panel.	Conditional pass
5	The stripes can be seen before grind and there is a slight hand feeling when grind.	5 (More serious)	Not meet	Seal

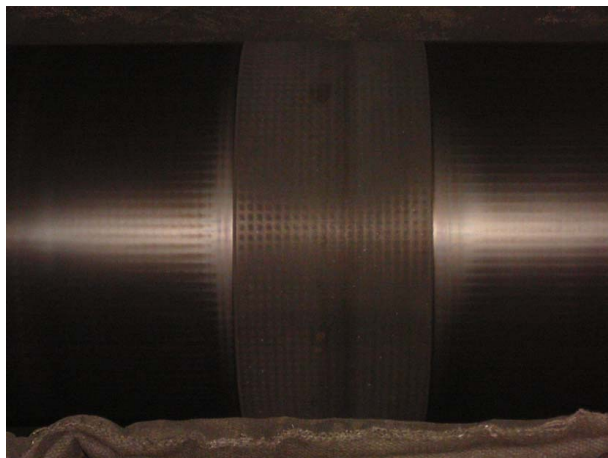
According to the test result of 3.1.3, if the generation of horizontal stripes has relation with the furnace factors, while has little to do with the speed of strip in furnace, then those stripes may be associated with the surface conditions of furnace rollers. For this reason, the engineers and technicians took advantage of the overhaul gap to open the furnace lid and had a detailed investigation to the morphology of furnace rollers' surface. Through checking, the evident horizontal stripes were found in the 1# bottom roller of heating section 1(HS1), as shown in **Figure 3**.

Figure 3. The horizontal stripes on surface of the furnace roller.

4) Strengthen the checking for the surface of the furnace roller, once finding stripes appeared in the furnace roller's surface, replacing the furnace roller timely.

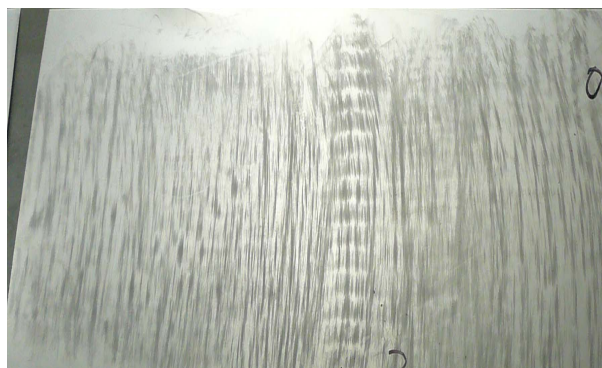
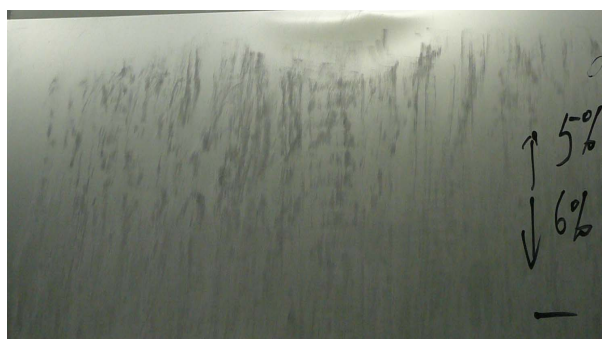
1) The optimization of tension system can effectively reduce the horizontal stripes defect (As shown in **Figure 4**, the conditions of horizontal stripes on typical specification products are given separately).

(a) The original tension system

(b) The optimized tension system

Figure 4. The horizontal stripes before or after the tension system was optimized.

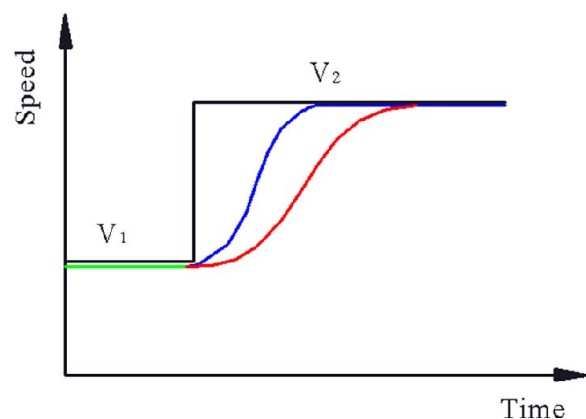
Figure 5. The reducing of the response speed.

2) If the response speed of transmission system in furnace is too high, it may exacerbate the fluctuations of actual tension in acceleration and deceleration phase, which is not conducive to suppress the vibration. As shown in **Figure 5**, the response speed of all transmission system in furnace was reduced properly on the original basis and the vibration of strip was suppressed maximally.

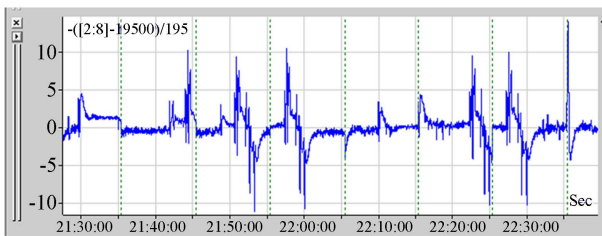
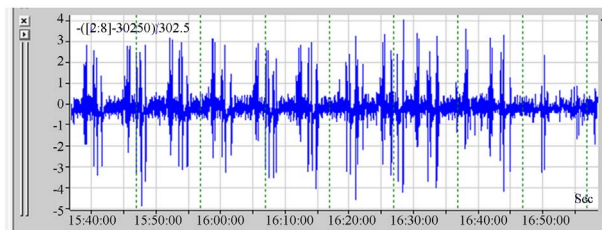
3) The mechanism for the tension detection in entry and exit looper was established. Once the operator finds the unusual fluctuation of tension, the reasons should be found out timely. The tension controller is analysed to see whether it is appropriate or not. According to the field tracking and troubleshooting, an error that the operator mistakenly selected the looper tension controller was found. This mistake led to long-term and wide-range fluctuation of the tension in furnace's entrance, which is a source of vibration. **Figure 6** shows that the range of tension fluctuation changed from $\pm 15\%$ to $\pm 3\%$ after the modification.

(a) Before modification

(b) After modification

Figure 6. Chart of the looper tension fluctuation.

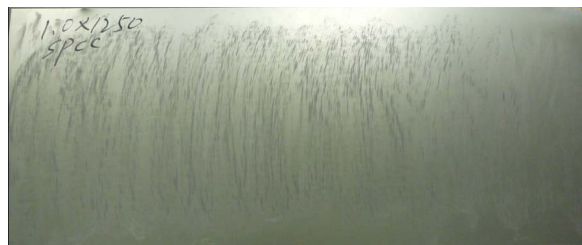
Figure 8. The photo of typical specification product when after management for the horizontal stripes.

According to statistical data of six-month, the incidence of horizontal stripes defect decreased from 100% to 2.78% and the severity of it greatly reduced after the implementation of measures above (the typical strip steel that after grind is shown in **Figure 8**). The surface quality of strip improved effectively, which created a larger economic benefit for field.
