# Karstification Effect on the Stability of Mosul Dam and Its Assessment, North Iraq

Varoujan K. Sissakian<sup>1</sup>, Nadhir Al-Ansari<sup>2\*</sup>, Sven Knutsson<sup>2</sup>

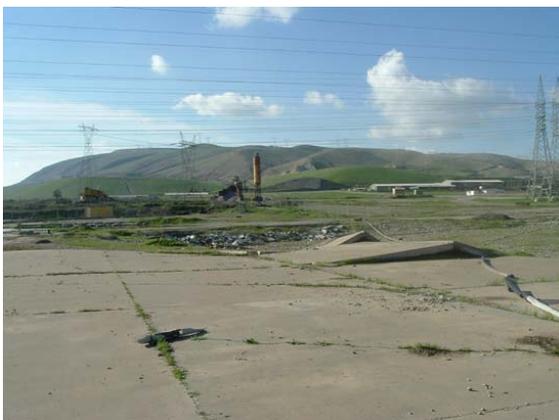
**Figure 2.** A sinkhole under a concrete pavement.

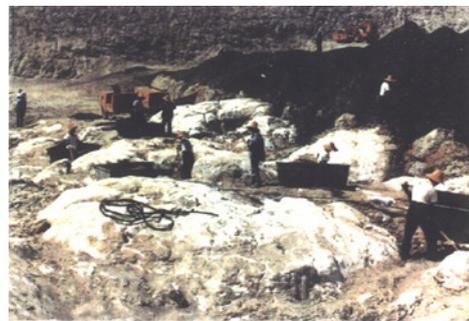
Dissolution intensity at Mosul Dam ranged from 42 to 80 tons per day. This process coupled with the karstified limestone, dolomite, and calcareous marls as well as the evaporate rocks present the unfavorable foundation conditions under Mosul Dam. The karst line also denotes the transition from the interbedded limestone-anhydrite/gypsum beds to the less permeable Jeribe limestone [14]. Examples of the types of karst conditions encountered during the excavation of the foundation are shown in **Figures 3-5**.

**Figure 3.** Karstified gypsum in the foundations of the dam.

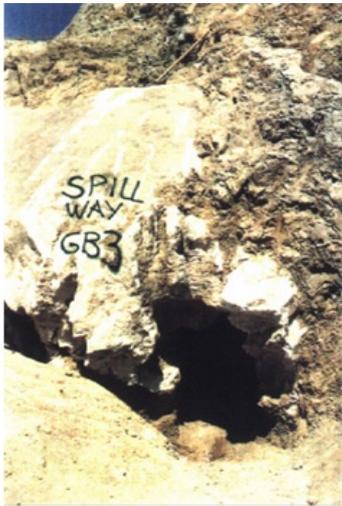
**Figure 4.** Karstified gypsum in the foundations of the dam.

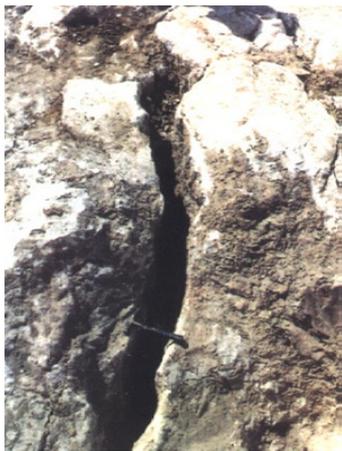
**Figure 5.** Solution crack.

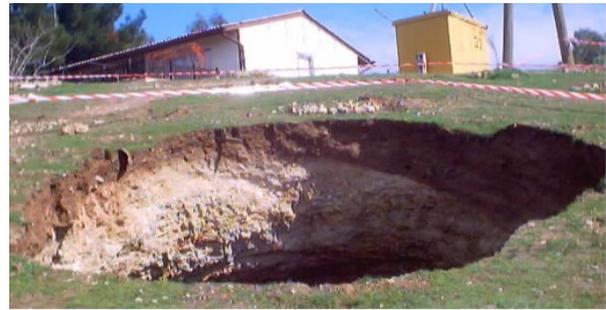
Sinkholes on the right abutment have developed progressively with initial manifestation by surface cracking and ground settlement. By contrast, a sinkhole on the left flank of the reservoir in the local tourist village appeared without warning and developed rapidly with 15 m of settlement and a 15 m diameter depression overnight in February 2003 (Figure 6). The sinkhole was dry, located on a slope on the north side of a valley feature. The deposits at the surface standing vertically appear to be superficial silty soils, with perhaps bedded marls below. Although the initial sinkhole was filled with 1200 m<sup>3</sup> of loose sandy gravel material and fenced off, the settlement continued. A further 3000 m<sup>3</sup> of material was required to fill the settled surface of the sinkhole in two separate filling operations in May 2003 and October 2004. By March 2005 there were been a smaller settlement of the ground surface of about 0.5 m.

It was reported that during the drilling of a piezometer hole near the sinkhole, a rod drop occurred. There was no water encountered in the hole so the piezometer was not

**Figure 6.** Sinkhole near the tourist village.

installed, and the hole was grouted, taking 250 tons of grout. The suggestion was made that the sudden appearance of the sinkhole is related to seepage water passing through the left abutment of the reservoir and the sinkhole lies close to the end of the left extension of the original grout curtain. Though possible, an increase in infiltration of surface water, perhaps from heavy rain, could cause a collapse into an existing void by destabilizing the ground [13].

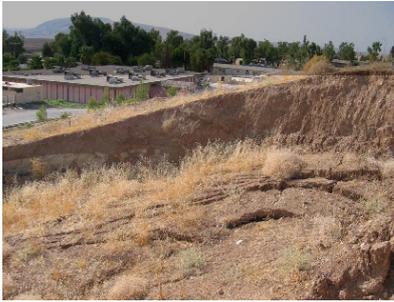
**Figure 7.** Soil failure in a village on left abutment.

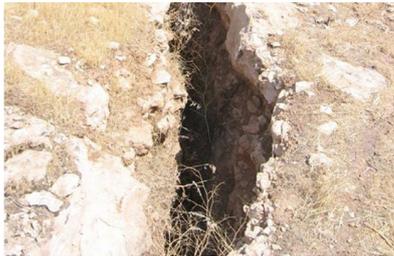
On the right abutment of the reservoir, about 100 m upstream from the dam, the ground surface on the slope formed on limestone on the margin of the reservoir had settled. This movement could be partly related to sloping failure and translation of the rock beds as a result of fluctuating reservoir levels and residual high pore pressures in the slope. However, a sinkhole feature seems more likely (Figures 7 and 8). Although tested for, no connection has been established between this upstream sinkhole and those downstream [14]. It is believed that, Figure 7 it is not a sinkhole, but a soil failure, which could be initiated due to over saturation of the soil by rain water and that of Figure 8 is slab failure, most probably due to fluctuation of the water level in the reservoir.

**Figure 8.** Upstream right abutment, open fissure resulting from slab slide.
