# The Suitability of Typhoon Disaster Reconstruction Work Planning—A Case of Meizuolyu Stream in Taitung County

Shu-Tzu Chen<sup>1</sup>, Hung-Ming Shu<sup>1</sup>, Shin-Yi Dai<sup>1</sup>, Jie-Ming Huang<sup>2</sup>, Chung-Li Hsu<sup>2\*</sup>

## Abstract

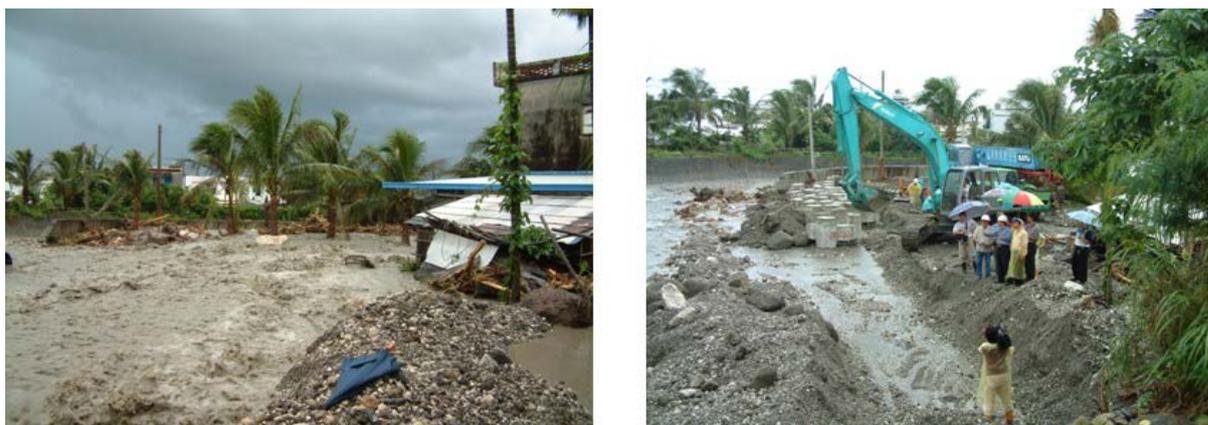
in **Figure 5**. The rainfall initiated debris flow that washed off the existing embankment and crashed into Meishan community. The Meizuolyu Bridge was damaged, and many farms were destroyed, as shown in **Photo 1**. Flood smuggle a large number of sediments and debris into houses. Emergency placement blocks to construct the damaged embankment and prevent flood further inflow villages.

**Photo 1.** Meizuolyu stream disaster in 2002.

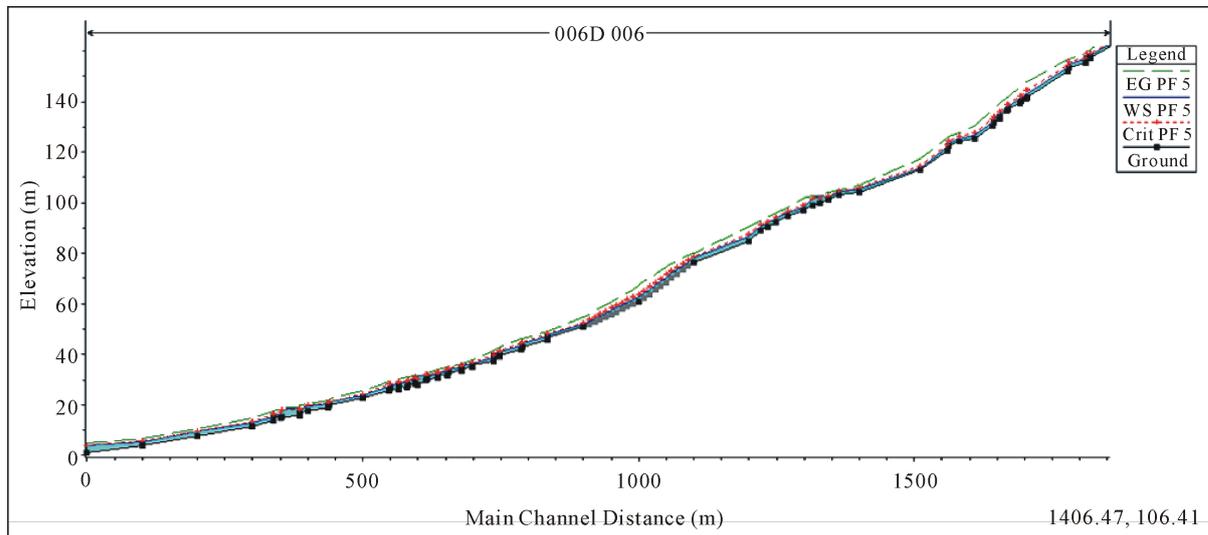
Comb-type dam, submerged dam, ground sill and stream regulation were constructed on the upper reach and lower reach of this stream. The result of hydrologic analysis is shown in **Figure 7**. According to the analysis of various profiles, at right bank of 0k+100 is sustainable to only 10-year recurrence interval flood peak, this part is located in the lower reach of Meizuolyu bridge. There would be no influence on the highways and settlements, protective measures are not required. Although at 0k+600 is sustainable to only 5-year recurrence interval flood peak, both sides are high bottom phases, there is no influence yet, and at 1k+299 reach with steep banks, an over 25-year recurrence interval flood peak may overflow the flood land. Only this flood land has no protected object, the reaches other than the above ones can sustain 50-year recurrence interval flood peak.

**Figure 7.** Riverbed longitudinal profile hydrology analysis.
