Mosul Dam: A Catastrophe Yet to Unfold

Nasrat Adamo¹, Nadhir Al-Ansari¹, Sven Knutsson¹, Jan Laue¹, Varoujan Sissakian²

Abstract

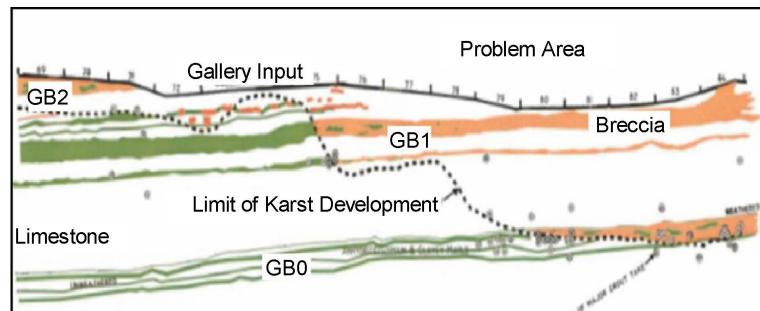
The deep grout curtain had a depth of 80 - 100 meters in the deep section of the river where the worst karstified rock formations existed. Under the main dam a karst level line was defined during investigations which showed the extent to which weathering and Karstification process worked its way down. The most affected bed formations above this line were the gypsum/Anhydrite beds and the transitional gypsum breccia (GB) in addition to brecciated marls (marls with gypsiferous cement). The four gypsum breccia layers had varying thicknesses between 8 and 18 meters and were designated from downwards up as (GB0), (GB1), (GB2), (GB3) [2]. The importance of these layers stems from being very difficult to grout and if they happen to be somehow grouted they soon lose the grout material and start to erode and dissolve under the effect of seepage water. **Figure 2** shows geological section on the dam axis extending from east at the top left corner to west at the bottom right corner. It is constructed based on geologist's field notes and inspection of rock cores recovered from the previous investigation works in addition to water permeability tests executed using the Lugeon method. Employing the same procedure and methods a line which was called the karsts line marking the boundary between the highly karstified layers above it from the less karstified and less permeable layers below it. This is shown in **Figure 3** and it was used as a guideline to establish the depth of the grout curtain [3] [4].

Figure 3. Karst line location under the dam.

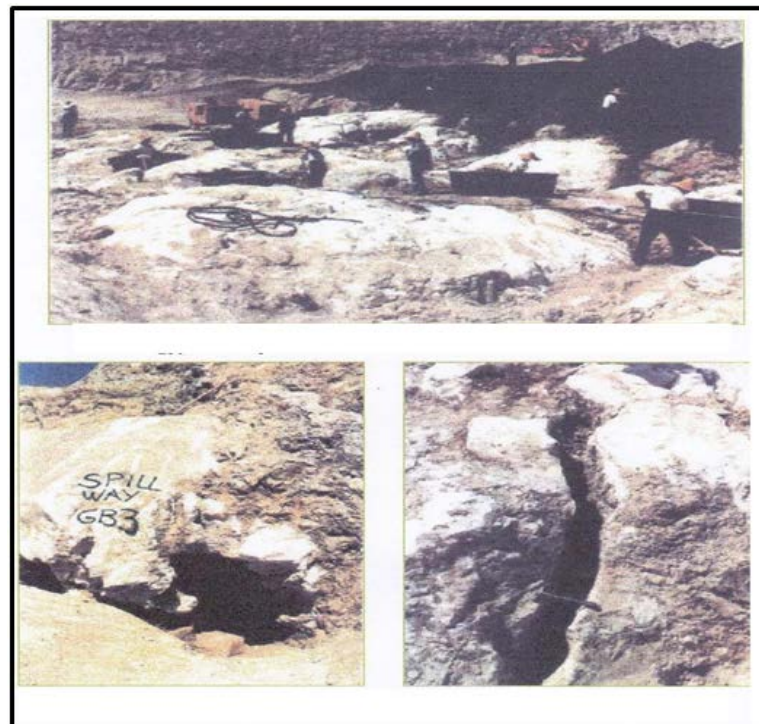
In the left bank and under the saddle dam, the foundation was not any better than the main dam described above (**Figure 4**). Although it did not suffer much karstification, the (F-Bed) limestone layer dominating the upper 30 meters was very much cracked and fissured and it formed open conduits to seepage water down to the river bank and to the more solid (GB3) layer below it. This layer was uncovered during the excavation of spillway chute and bucket's foundations and represented a dissolution hazard as it contained very wide cracks and joints as shown in **Figure 4**.

Figure 4. The badly jointed and fissured (GB3) layer found in the left bank in the foundation of the spillway chute and bucket [7].

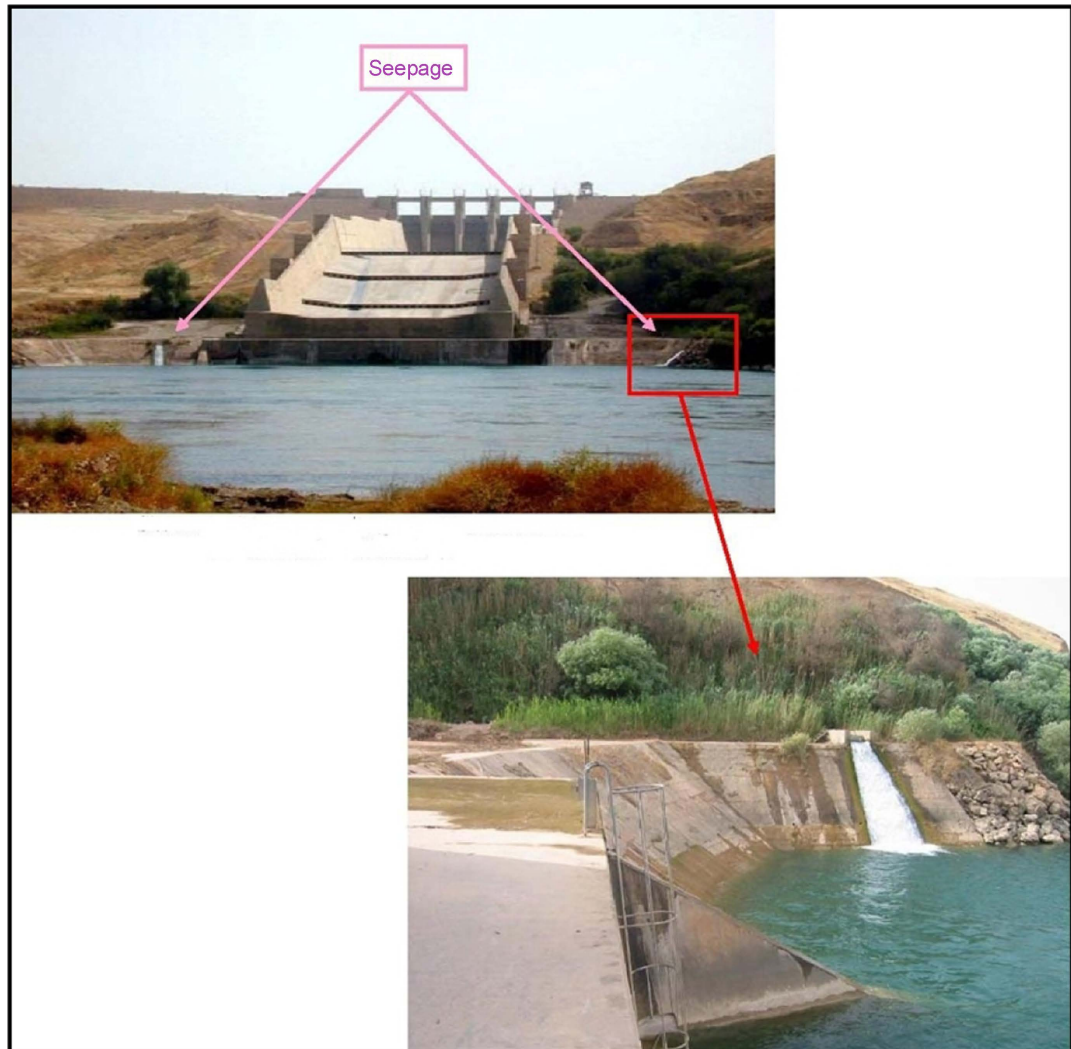
In the left bank, heavy seepage and dissolution of gypsum were observed during the filling of the reservoir, and similar thing was occurring from under the main dam. Field measurements and calculations showed that a quantity of (13,000) tons of salts had been dissolved and washed away during the period February-March 1986. Dissolution was progressing at a rate of 42 - 80 tons per day. Remedial actions were taken to reduce the deterioration of rock formations in the left bank by strengthening the grout curtain under the saddle dam and adding another curtain parallel to the spillway chute to protect its foundation. These measures reduced seepage and dissolution but they could not stop them altogether. The photographs in **Figure 6** show present day seepage outflows on both sides of the spillway [3] [6].

Figure 6. Outflow points of left bank seepage water [3] [6].

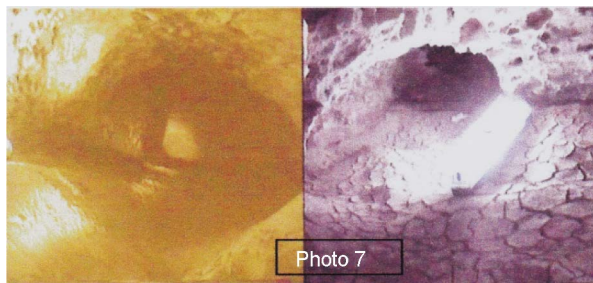
around and close to the dam, there was clear evidence of the deterioration of the whole site. **Figure 7** shows 1.3 meter high dissolution tunnel at the right rim of the reservoir which was formed in September 1986 close to a group of sinkholes in the same area after one year of starting impounding. **Figure 8** shows a ground crack which appeared in 2002 very close to the right abutment resulting from the dissolution of gypsum layer beneath it. This was kept under observation and it

Figure 7. Dissolution tunnel observed in the right bank close to dam abutment [3].

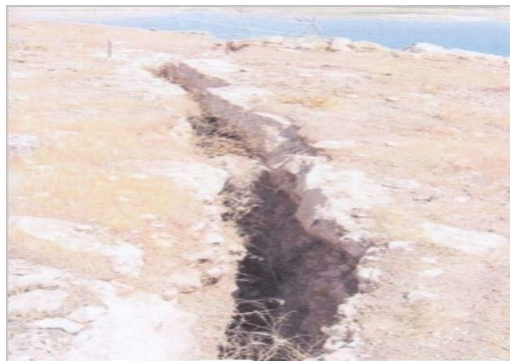
stopped enlarging in 2004. Our interpretation of its opening is that it had resulted from the dissolution of a thin under layer of gypsum which was open to the reservoir. These and other observations indicate active dissolution at this side of the dam and very close it.

Figure 8. Ground fissure which appeared in the right abutment close to dam abutment [3].

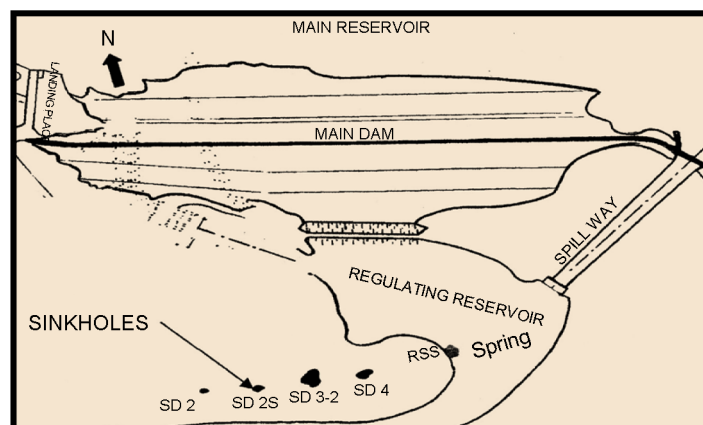
Sinkholes had also formed in both right and left banks downstream and close to the dam. **Figure 9** shows the location of four very large sinkholes which had appeared in 1992 and continued to develop till 1998. After much research work, it was concluded that they have resulted from water inflow coming from Wadi Malih aquifer which was being fed from the reservoir and outflanking the dam. This seepage water had caused the dissolution of a gypsum bed below the sinkholes location. On the left bank and very close to the toe of the dam another sinkhole appeared suddenly in 2002. **Figure 10** shows this sinkhole when it first appeared and after it was cleaned and measured. It took 4200 cubic meters of filling materials to fill it but continued to settle for another 0.5 meter in 2005. The cause for this sinkhole was established after boring piezometers around it and conducting tracers dye tests. Seepage water coming from under the far end of the dam was responsible for dissolving a gypsum bed of (GB3) in this location leading to its formation.

Figure 9. Location of sinkholes (1992-1998) [3].

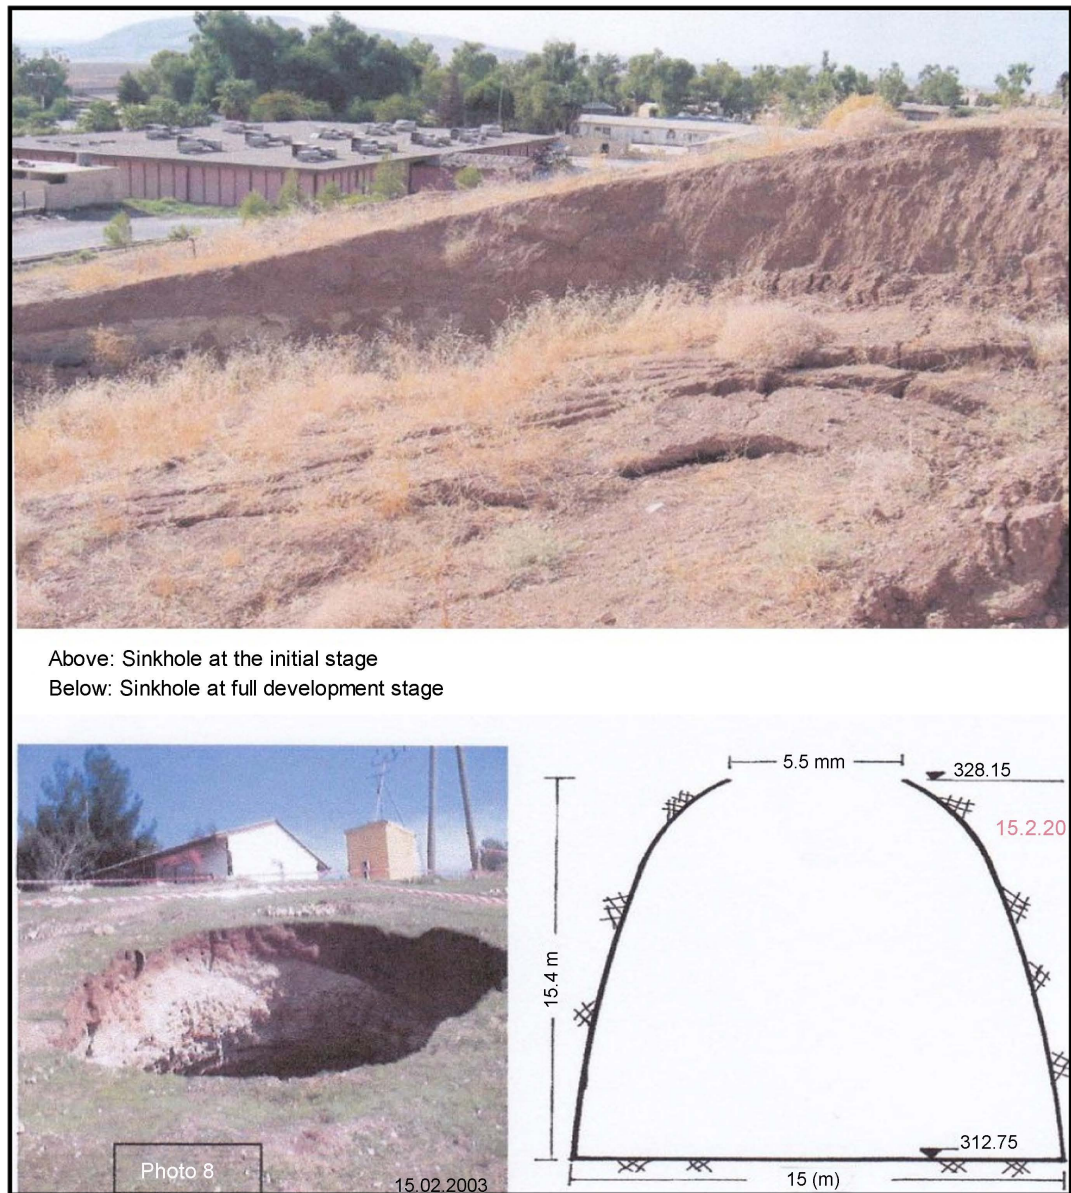
Figure 10. Sinkhole at left bank [4].

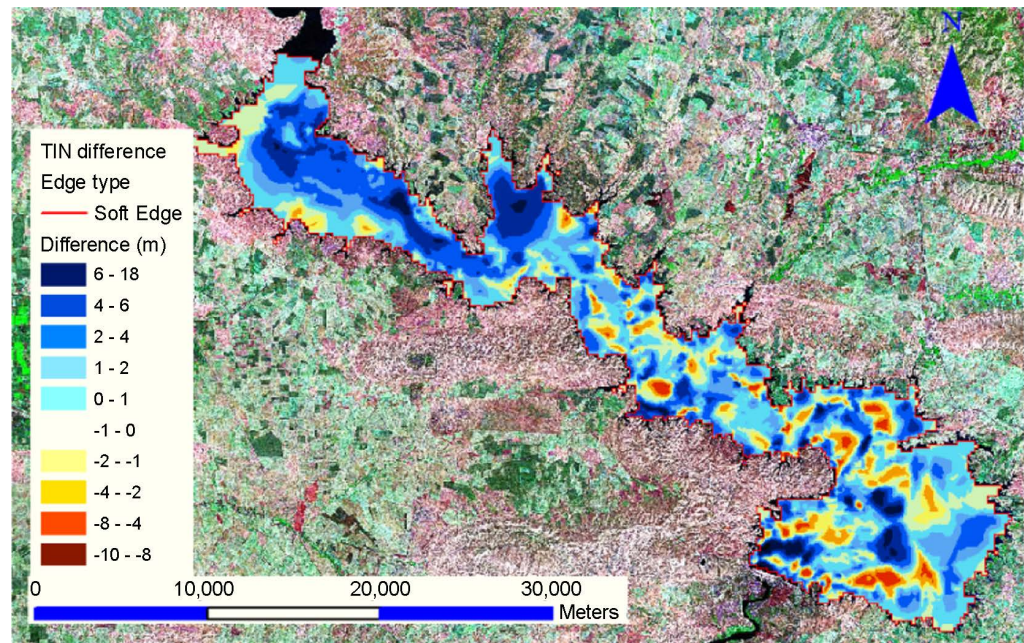
In 2010 a bathymetric survey of the reservoir was conducted by a PhD student of Lulea University (Sweden). This survey showed a great number of sinkholes

which had formed there (**Figure 11**). Some of these were as deep as 10 meters and were very close to the dam [9]. Such sinkholes pose a great threat to the dam if they are formed at the dam u/s toes. This is due to the dissolution of gypsum and limestone beds forming the sinkholes and other karst forms within the reservoir, these forms will increase in size with time and exert hazards to the dam.

Figure 11. Sinkholes in Mosul Dam Reservoir mapped in (2011) [9].

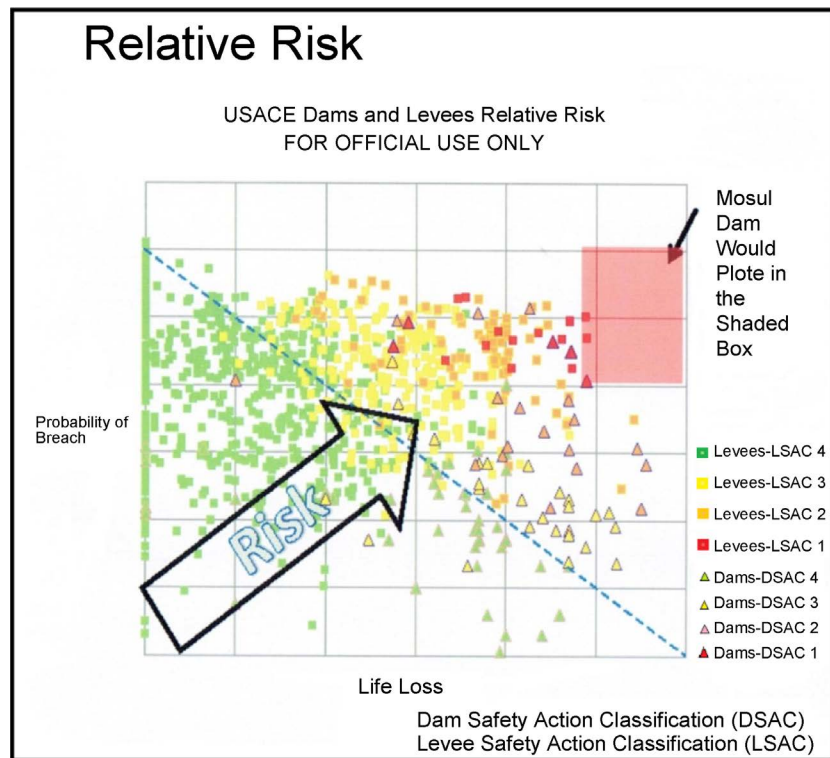
The team installed instruments and cameras to monitor movements of the dam structures and measured seepage and check gypsum concentrations in seepage water. The displacements were abnormally high, checking seepage flows and the dissolution of gypsum gave also alarmingly large quantities of both. At the end of (2015) the team accumulated enough evidence to prove that the dam was progressing rapidly to failure conditions. In their report completed by the end of that year they considered the dam as being on the verge of failure. **Figure 12** gives the position of Mosul Dam on The USACE relative risk chart. Their Conclusion is shown in **Figure 13** which is copied from their report.

Figure 12. Mosul Dam on the USACE chart of relative risk.

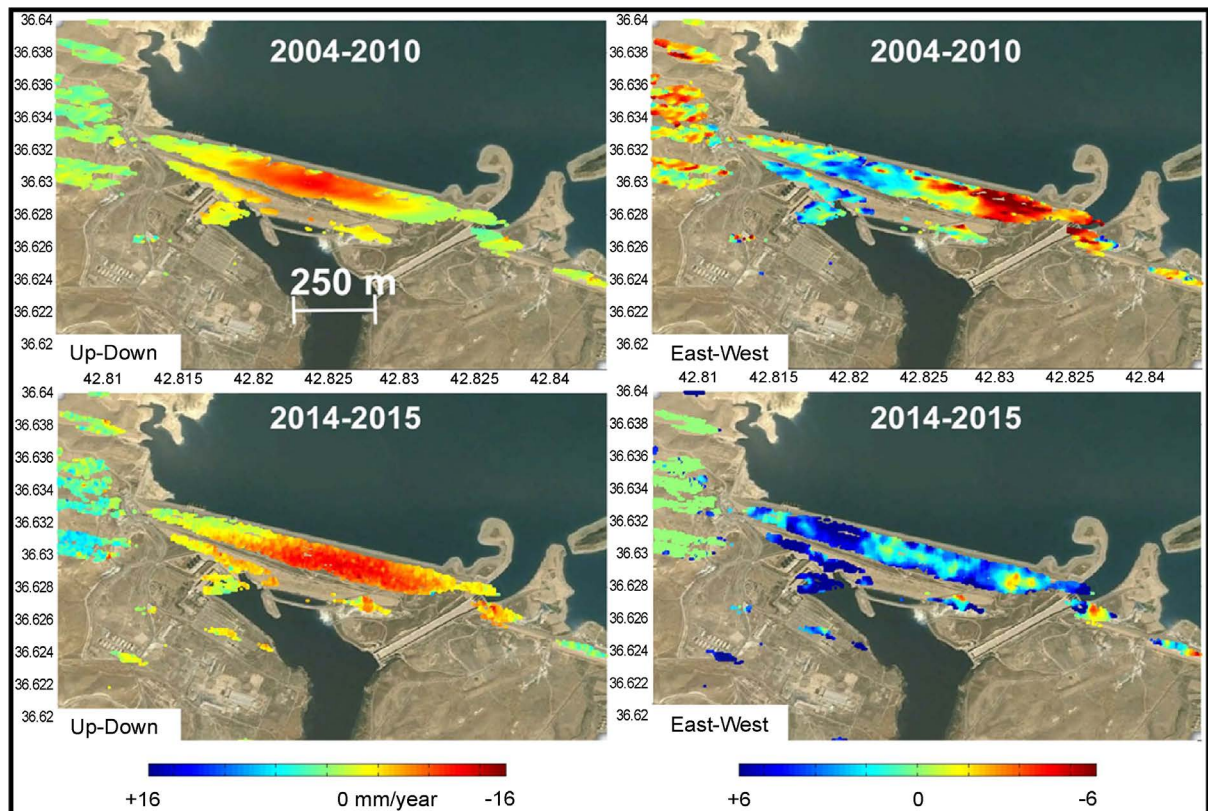
In a scientific report published in the magazine (Nature) on 6th December 2016 [15]. It proved from space geodetic monitoring that Mosul dam is suffering from an accelerated rate of vertical displacements and lateral movement since the stopping of maintenance grouting. The vertical displacement rate for the period 2004-2010 was 12.5 mm/year compared to 1.5 mm/year in 2014-2015 as shown in space monitoring images given in **Figure 14**. This study confirms the results of a previous study which was presented in a lecture given by Frano Cernin from GLOBASAR AS, Norway, to a Workshop on Mosul dam which was held

Figure 14. Photographs on the left indicate vertical movement. Photographs on the right show horizontal displacements. All in (2004-2010) and (2014-2014) [15].
