Study of Alkali Metal Corrosion on Heating Surfaces and Bed Material Agglomerate in Biomass-fired Fluidized Bed Boiler

ABSTRACT

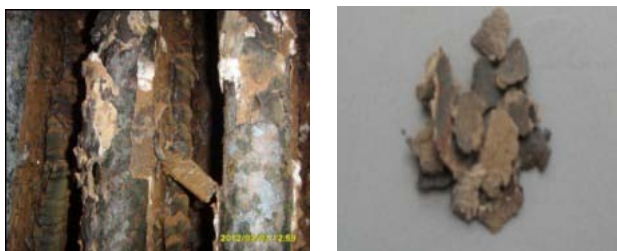
After put into operation for more than 140 days, the furnace heating surface pipe corrosion was occurred in large area, especially on the platen super-heater tube. The corrosion rate was much higher than the normal design value, reaching the magnitude of mm/thousands of hours. The corrosive thin was more than 2 mm after two months operation, being 10 times higher than the normal amount of corrosion.

Observing the sediments taken from the platen super-heater positioning tube (as shown in **Figure 1**), it could be found that the outer side of the sediments was loose, while the inner side was hard and brittle with metal material. In order to determine the composition of corrosion scale sample, the corrosion sample at the outer side of the tubes and the fly ash in horizontal flue pipe were tested by scanning electron microscope and energy spectrum analysis (HitachiS-3700 scanning electron microscope).

Figure 1. Corrosion schmutzband of the tube.

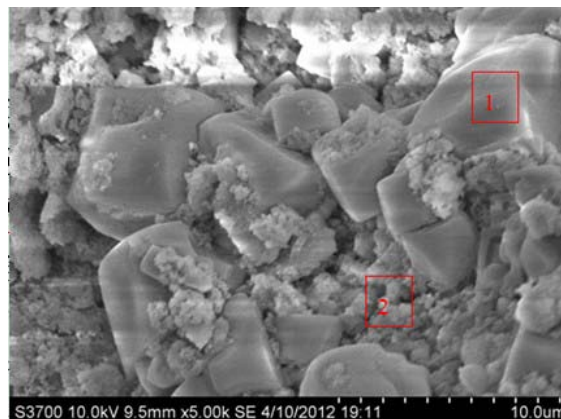
As shown in **Figure 2(a)**, at the outer side of corrosion samples, some large crystals were mixed up with the tiny crystals. The energy spectrum results of both the large crystal and fine crystal were shown in **Table 2**. It can be seen that the main elements are K, Cl, O and S, also contains a certain amount of Ca, Si, Mg, Al. There are less component content of metal material and very low content of Fe, Ni, Cr. Judging from the elements content, it could be roughly estimated that the outside wall mainly composes of alkali metal chloride, sulfide/sulfuric acid compound and a small amount of oxide of Ca, Si, Mg oxide.

Mole ratio $R = (K + Na)/(Cl + 2SO_4)$ was used to judge the existed form of alkali metals in the corrosion. According to the calculation, the R value of larger particles was close to 1, suggesting that the alkali metal was mainly existed in the form of chloride and sulfide (K_2SO_4 , Na_2SO_4 , KCl, NaCl). In addition, only the quality content of K and Cl could reach 60%, showing that large particles were mainly made up of alkali chloride, which was volatilized from biomass materials and move with smoke then deposition as ash on the heating surface.

Figure 2. (a) SEM photograph of the outer side of corrosion; (b) SEM photograph of the inner side of corrosion; (c) SEM photograph of fly ash.

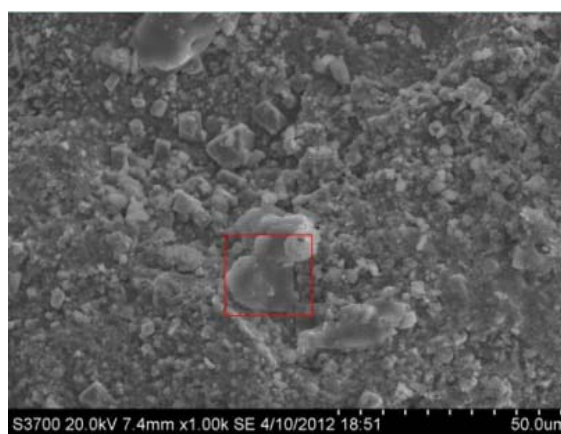
(b)

Figure 2(b) was SEM photograph of the inner side of corrosion sample. Different sizes of crystal structure can be seen in the picture. The box area in the figure was tested by energy spectrum analysis. The results showed that the main ingredients of the inner side of corrosion sample were Fe, Cr, Ni and O elements. Chemical component analysis of non-corrosion sampling section was carried out on Shimadzu PDA-7000 spark photoelectric direct reading spectrometer. The results were shown in **Table 3**. Comparing **Table 2** with **Table 3**, it can be seen that the inner side of the corrosion mainly remained SUS316 substance, but adding alkali, oxygen, chlorine and sulfur. Among them, the content of S was greater than that in the pipe. It shows that the sulphur content of the biomass material involved in the corrosion of metal surfaces.

Table 2 shows that the content of alkali metal (K and Na) was much less than chlorine, and the mole ratio of (K+Na)/Cl was only about 0.52. The increasing equivalence ratio of Chloride ions indicated that Chloride ions exist in some other forms besides alkali metal chlorides, such as iron chloride.

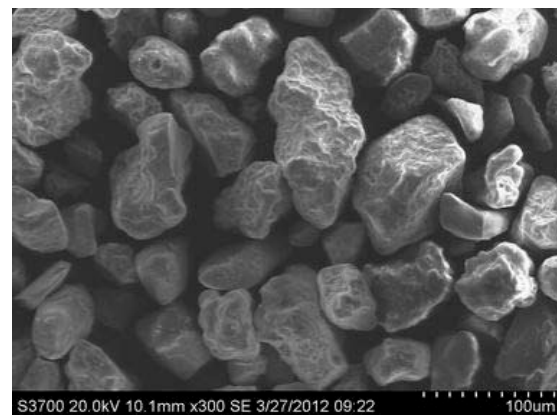
(c)

The element distribution of horizontal flue fly ash was quite different from that of the corrosion. They were mainly O and Ca, Si, Mg, AL, but few alkali metal and chlorine content. According to the content, it could be

roughly estimated that the fly ash mainly composes of calcium oxide, silicon oxide, magnesium oxide, alumina and silicate minerals with high melting point.

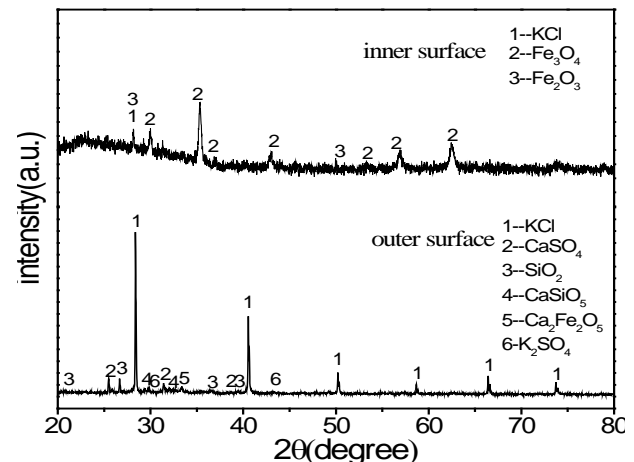
Results show that the main chemical composition of the inner side of platen superheater pipe corrosion was KCl, Fe_2O_3 , Fe_3O_4 (the corrosion products). There were some impurity peaks on the internal surface, especially at the diffraction Angle 2θ between $10^\circ\sim 20^\circ$, mounts of amorphous substance that cannot occur X ray diffraction appeared, forming a large piece of "hills" baseline. Combined with the results of SEM/EDX scans, the hills may be iron eutectoid mixture melt with alkali metal and fly ash.

XRD analysis about the outer side of the corrosion show that the main chemical compositions of the corrosion were KCl, $CaSO_4$, SiO_2 , K_2SO_4 , $CaSiO_5$ and $Ca_2Fe_2O_5$ These ingredients were mainly burning ash, the test results are gree well with spectrometry detected speculation.

Figure 3. Result of XRD analysis of the inner and outer sides of corrosion schmutzbands.

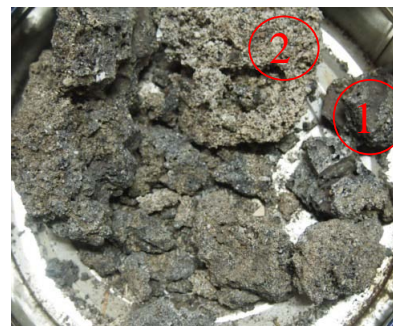
The slag at the rated operation load was sampled. The agglomerates were found in the fluidized bed layer with diameter mainly from 20 mm to 100 mm (Figure 4). Agglomerates are mainly divided into two categories. One was hard structure with compact form, and it formed the caesious block that marked as point 1. The other was

pore structure slag which was adhered with a large number of tiny particles on the surface and thus formed interspace. But after scraping down the particles or cutting the slag, it was found that its internal structure was the same as the first type. For the convenience of Sample preparation of spectrum detection, the scraped particles were marked as point 2.

Figure 4. The slag samples from CFB.

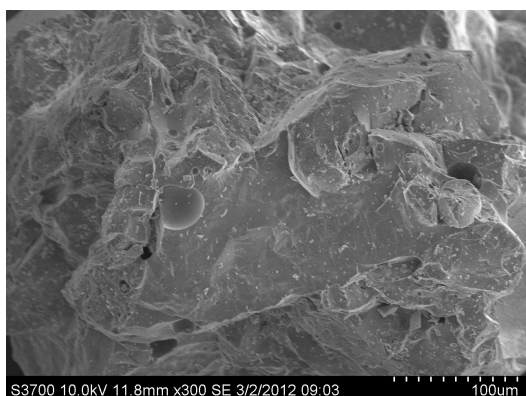
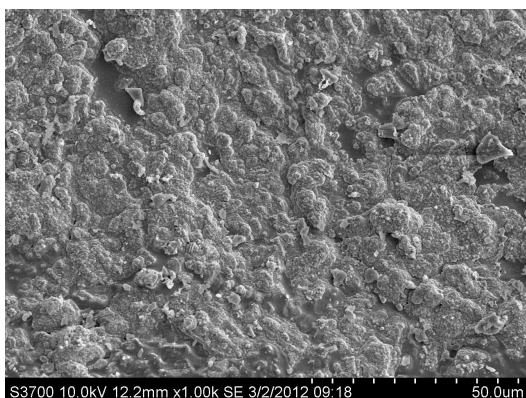
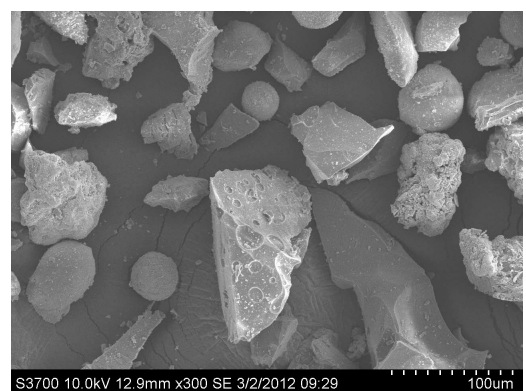
The above two samples were tested by scanning electron microscopy (sem) respectively (Figure 5). It could be found that the morphological structure of slag 1 was compact and there were some small circular hole on the surface. But after further amplification, we can see that the surface was uneven and it was like slag condensing together. The form of Slag 2 was fine grain structure and it was angular.

Figure 5. SEM photographs of slags.

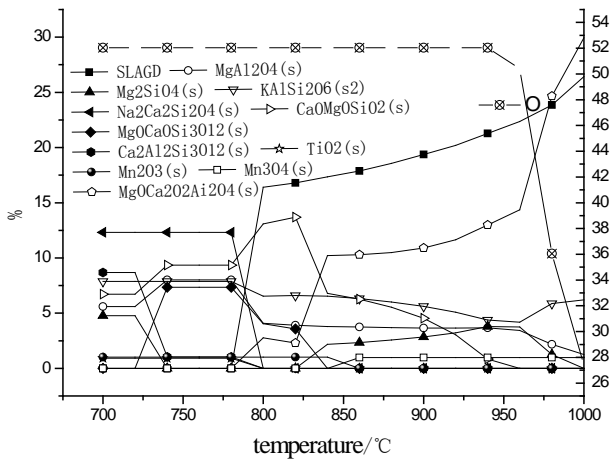
It could be found that the main solid phase composition of slag 1 was Silicate and aluminate, silicon aluminium acid salt ($\text{Ca}_3\text{Al}_2\text{Si}_2\text{O}_4(\text{s})$, $\text{MgOCaOSiO}_2(\text{s})$, $\text{MgO-CaOSi}_2\text{O}_4(\text{s})$, $\text{Ca}_2\text{Al}_2\text{SiO}_7(\text{s})$, $\text{MgAl}_2\text{O}_4(\text{s})$, $\text{MgOCa}_2\text{O}_2\text{-Si}_2\text{O}_4(\text{s})$). At the same time there was a small amount of alkali metal existing in the form of silicon aluminium acid salt or forming complex Solid phase material with calcium silicate ($\text{Na}_2\text{Ca}_2\text{Si}_3\text{O}_9(\text{s})$, $\text{KAlSi}_2\text{O}_6(\text{s}2)$). But these parts of Alkali metal solid product reduced with the temperature increasing gradually, for example, $\text{Na}_2\text{Ca}_2\text{-Si}_3\text{O}_9(\text{s})$ disappeared after the temperature was higher than 760°C . At this temperature $\text{KAlSi}_2\text{O}_6(\text{s}2)$ is only 6 ~ 7% quality content. The content of molten compounds increased with the temperature increasing substantially. The rapid growth occurs on 760°C was relative to the sudden drop of $\text{Na}_2\text{Ca}_2\text{Si}_3\text{O}_9(\text{s})$. These phenomena show that with the increase of temperature, alkali metal solid product starts further reaction and transformed into the molten oxide.

Figure 6. Material distribution of Slag 1.

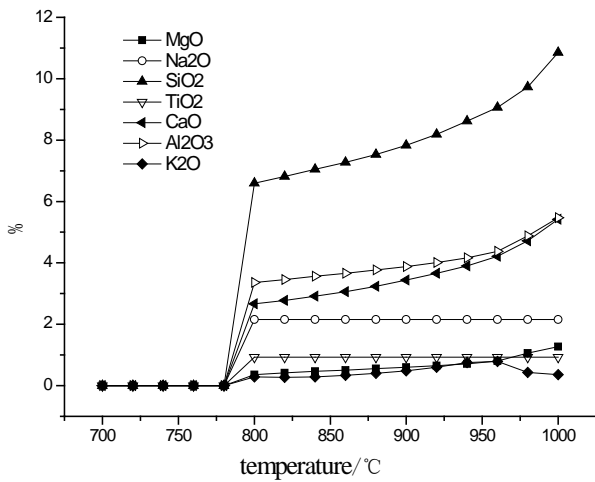
The molten oxide mainly includes $\text{K}_2\text{O}(\text{SLAGD})$, $\text{Na}_2\text{O}(\text{SLAGD})$, $\text{SiO}_2(\text{SLAGD})$, $\text{Al}_2\text{O}_3(\text{SLAGD})$, $\text{CaO}(\text{SLAGD})$, $\text{MgO}(\text{SLAGD})$ (**Figure 7**). The bonding characteristics of the molten oxide bonded the high melting point solid compound together and resulted in bed agglomeration. Research shows that the low melting point compounds, which bonds the alkali metals and quartz sand or ceramic material, came from the following reaction between gaseous KCl/NaCl and the silicon oxide on the surface of the material[12].

Figure 7. Molten Material distribution of Slag 1.

As the temperatures rising, the quality content of SiO₂(SLAGD), Al₂O₃(SLAGD), CaO(SLAGD) rise gradually, indicating that the physical stability of the silicon, aluminum, calcium oxide and the melt start multiple phase reaction, which was reflected in the n (coefficient of silica of K₂O·nSiO₂, etc)rise.

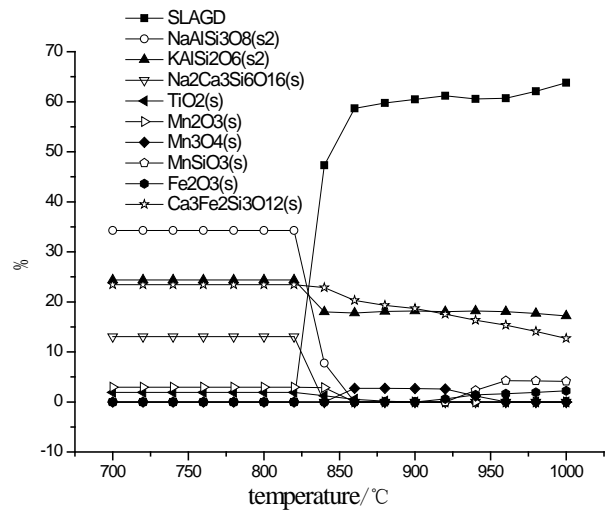
The composition of fine particles adhered on the surface of slag 2 was analyzed by applying the thermodynamic calculation. It can be seen from Figure 8 that molten material did not appear in the particles below 840°C. This kind of material existed in the form of stable compounds in the reaction process. Molten oxide materials began to appear when the temperature was higher than 840°C. Judging from the reduction of solid material, the main solid materials, which change into the molten

state, were NaAlSi₃O₈(s2) and KAlSi₂O₆(s2). With the temperature was up to 1000°C, the content of the melt was about 40%.

Figure 8. Material distribution of slag 2.

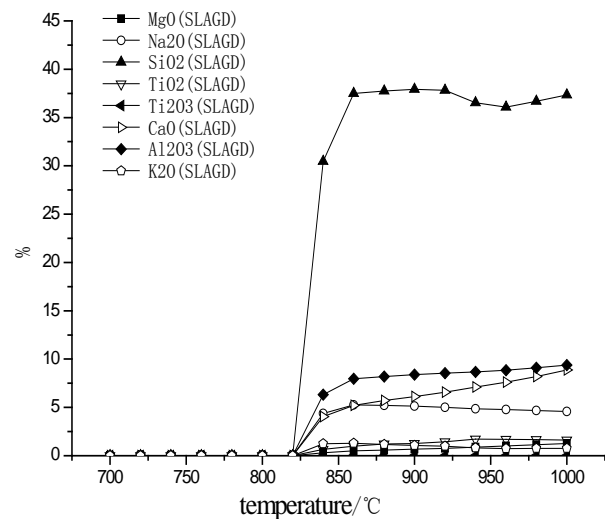
The composition of the molten oxide material formed under the high temperature were the same as slag1, mainly includes K₂O(SLAGD), Na₂O(SLAGD), SiO₂(SLAGD), Al₂O₃(SLAGD), CaO(SLAGD), MgO(SLAGD). Obviously, as temperatures rising, eutectic reaction happened between the stable compounds and alkali substances, leading to the growth of the slag.

Figure 9. Molten Material distribution Of slag 2.

Judging from the slag formation process, a small amount of the melt could be accumulated to form larger slags, which led to the deterioration of bed Fluidization effect. On the other hand, the formation of the melt mainly depended on the content of alkali metal and silicon. Therefore the reasonable control of the content of silicon in the bed material, and operating temperature of fluidized bed would make a great contribution to the control of the bed material agglomeration. Due to the low precipitation temperature of alkali metal, bed temperature control could relieve the heating surface corrosion problems which were caused by volatile alkali metal transferring into the gas phase.
