# Analysis for the Defect of Chromatogram in 35kv Oil-immersed Electric Reactor

Yongdong Li, Qingda Meng, Zheyuan Zhao, Po Yang, Yuzheng Wang

Maintenance of northern Hebei Province Electric Power Co. Ltd, Substation maintenance center, Beijing, China  
Email: zhaozy447525200@126.com

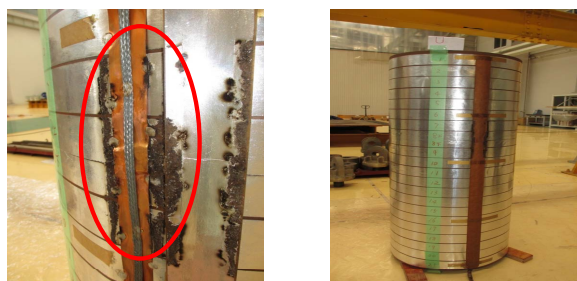
**Figure 3. Photo of discharge trace of magnet shield layer.**

When testing the A core magnetic shielding, we find out that around the Aluminum foil stickers, it appeared

the discharge stains on the top of the seventh layer and the eighth layer, the bottom of the eighth layer and the ninth layer of A core magnetic shielding. The flowchart of dismantling the reactor is shown below as **Figure 2**.

The aluminum foil and the grounding potential separation of copper is shown as below in **Figure 3**.

1) The shape of shielding copper in the core magnetic shielding is banding, both sides of it is fixed on the aluminum foil. In the long running process, as the repeating operation of reactor, the winding vibration results in the contact area of aluminum foil and copper board endures the stress. The contact area of aluminum foil and copper board adopts the manual welding, affecting by the human factors. When the stress is applied to this area, the contact of aluminum foil and copper board will be broken and produce the floating electrode.

The potential difference between floating electrode and grounding copper plate will discharge, results in a large number of characteristic gas(H<sub>2</sub>, acetylene).[7]

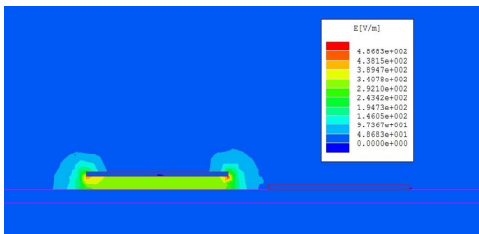
Figure 4. Suspension electric field strength of aluminum foil.

2) According to the site situation, we use the simulated calculation to describe the electric field distribution of this area. (Figure 4) as we can see from the Figure 4, the electric field intensity of the broken area between the aluminum foil and copper board is the highest. So the characteristic gas is produced by the electric discharge.
