Stability Analysis of Cliff Face around Kego Falls in Nikko, Eastern Japan: An Implication to Its Erosional Mechanisms

Yuichi S. Hayakawa

Center for Spatial Information Science, The University of Tokyo, Chiba, Japan

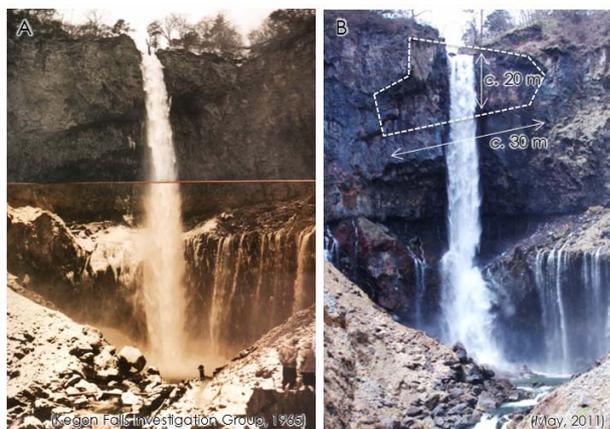
Figure 2. Photographs of Kegon Falls prior to and following the 1986 collapse. (A) Kegon Falls in 1965; (B) Kegon Falls in 2011 (photograph taken by the author). Approximate extent of the 1986 rockfall is indicated by the white dashed line.

Kegon Falls was formed during the early stages of activities of an adjacent stratovolcano, Mt. Nantai, the mountain body of which was built by repeated eruptions during c. 22,000 - 13,000 ka [33,34]. The formation of Mt. Nantai caused a southward shift in rivers that originally drained northward, forming an east-facing valley of the Daiya River [34]. The andesite lava flow (Kegon lava) in 20 ka filled the valley to form a dammed lake known as Lake Chuzenji, and Kegon Falls was formed at the end cliff of the lava flow [34]. Since that time, the waterfall has receded approximately 350 m at a long-term rate of 0.018 m/y [23]. As noted, the uppermost portion of the cliff near the crest of the waterfall (approximately 30 m in width and 20 m in height) collapsed in 1986, causing actual recession of the waterfall of 4 - 5 m (**Figure 2**).

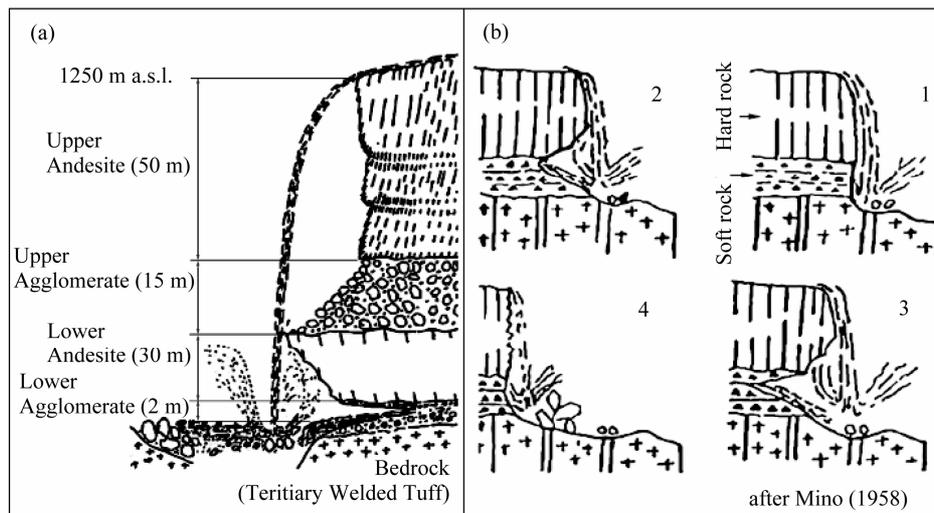
site lava (upper andesite), 15 m of agglomerate (upper agglomerate), 30 m of andesite lava (lower andesite), and 2 m of agglomerate (lower agglomerate) (**Figure 3(a)**). Some silty lacustrine sediments are partly interbedded between the upper agglomerate layer and the lower andesite layer [24]. The total height of Kegon Falls is 97 m. The surface water ($3.5 \times 10^7 \text{ m}^3/\text{y}$), which had formerly dropped from the top (1250 m a.s.l.) to bottom directly, has hit the upper agglomerate layer in the middle portion of the cliff since the 1986 rockfall. The upper and lower andesite layers exhibit overhanging profiles, whereas the agglomerate layers are relatively weak and appear to have been eroded by groundwater outflow beneath the andesite layers. The abundant groundwater outflow ($6.5 \times 10^7 \text{ m}^3/\text{y}$) at the boundary of the upper andesite and upper agglomerate layers is supplied from the upstream Lake Chuzenji. Hayakawa and Matsukura [23] showed that stream power by both the surface and groundwater flow is responsible for the recession of Kegon Falls. Moreover, Mino [34] reported the presence of a cave-like depression beneath the lower agglomerate layer with a width of 51 m, height of 5 m, and depth of 26 m. In addition, a 1.5-m-high water drop of the groundwater outflow from the upper Lake Chuzenji was observed at the innermost part of the cave.

Figure 3. Sketches of Kegon Falls by Mino (1958). (a) Longitudinal profile of the waterfall with lithological structures; (b) Schematic model of the waterfall retreat showing catastrophic collapse.

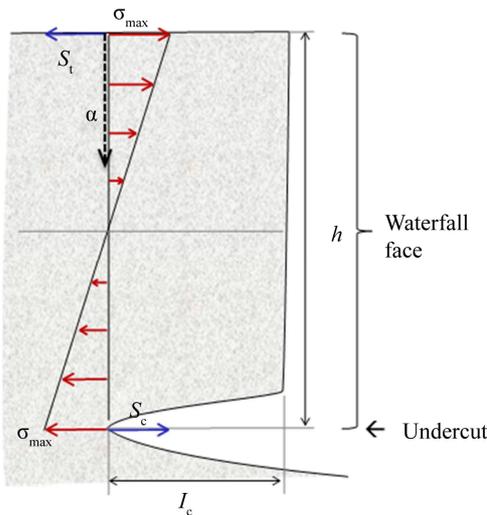
Figure 4. Cantilever beam model for the cliff face of a waterfall describing undercut notch, vertical crack, and stress distributions.

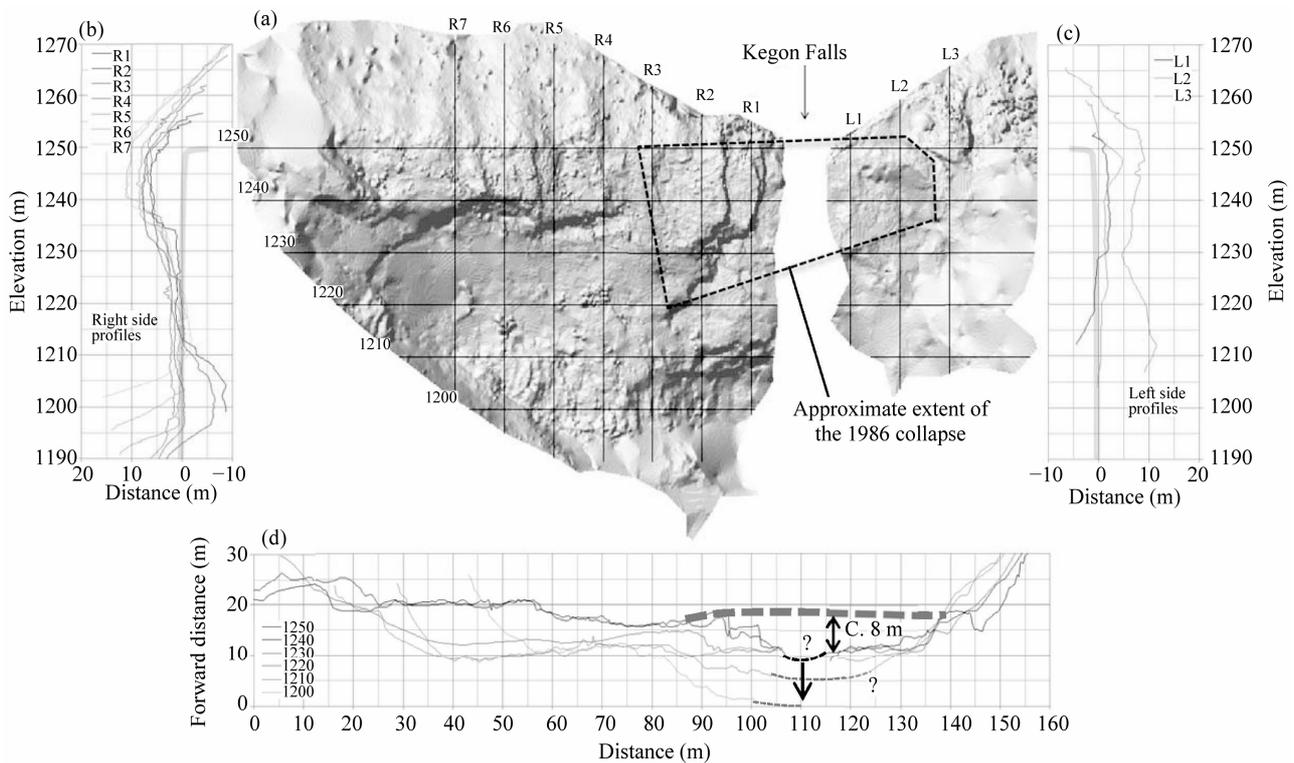
Figure 5. Detailed morphology of the Kegon Falls cliff face. (a) Hillshade image of the vertical DEM at a 20-cm resolution; (b) Seven longitudinal profiles of the cliff face on the right side of the waterfall. Numbers R1-R7 correspond to those on the hillshade image; (c) Three longitudinal profiles, L1-L3, of the cliff face on the left side of the waterfall; (d) Six horizontal cross-sectional profiles of the cliff face at elevations of 1200 - 1250. The view is from the bottom. The thick dashed line in gray indicates the probable surface of the cliff face prior to the 1986 collapse.

Seven longitudinal profiles on the cliff face of the right-side bank and three longitudinal profiles on that of the left-side bank were then extracted from the DEM at a spacing of 10 m (**Figures 5(b)** and **(c)**). Six horizontal cross-sectional profiles were also extracted at a spacing of 10 m, which correspond to elevation levels of 1200 - 1250 m a.s.l. (**Figure 5(d)**). The profiles near the waterfall exhibit an overhanging trend of the upper andesite lava layer. The uppermost portion of the upper lava layer, at a height of 10 - 15 m, exhibits several vertical planar surfaces, likely representing platy joint planes formed within the lava. Spacing of the major joint planes is approximately 5 m, which indicates that major rockfalls tend to occur for block units bounded by the joints. Several minor joint planes are apparent in the lower part of the upper lava layer, where columnar joints dominate. An approximate surface before the collapse in 1986 (**Figure 2(A)**) can be reconstructed by connecting the foremost surfaces in the uppermost portion of the upper lava layer, which gives a rough estimation of missing rock volume at more than 8000 m³. The location of the reconstructed surface plane is approximately 8 m from the current waterfall lip (**Figure 5**), which is consistent with and slightly larger than the reported length of the waterfall

recession created by the collapse (4 - 5 m). This discrepancy can be either by the uncertainties in the unknown method by which the reported recession distance was measured, or insufficient accuracy in the approximate surface reconstruction.

Although the measurement data is missing in the DEM at water surfaces with widths of approximately 8 m (**Figure 5**), the location of the waterfall lip can be estimated in the original point cloud because several exposed rock surfaces near the water indicate several points. The lip location appears to be depressed farther than the upper and middle parts of the surrounding cliff face, indicating that the surface water flow has been eroding the lip to some extent (**Figure 5(d)**). The lower part near the bottom of the upper lava layer exhibits a distinct depression, 8 m of which is more depressed than the lip. This depression has not been previously identified. The depth of the depression, compared to the adjacent horizontal profile 10 m above the measured cross section, is approximately 5 m. The approximate width and height of the depression are 40 m and 10 m, respectively. This depression behind the water drop likely developed after the collapse in 1986, because no such depression could be visually identified in photographs of the waterfall

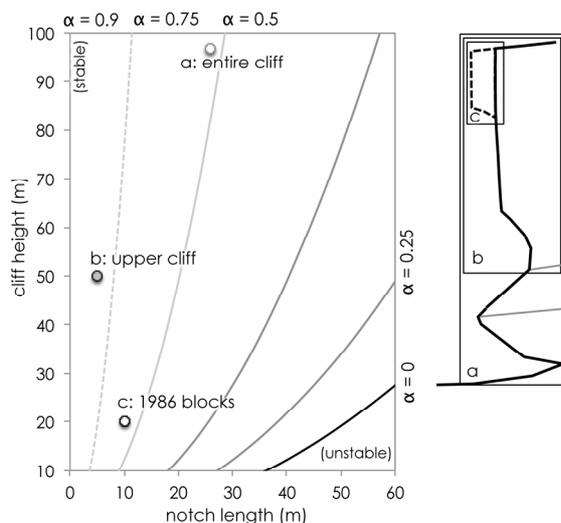
Figure 6 shows the relationships between the height of the cliff face and the critical notch length for various depths of vertical cracks (α) computed from Equation (5) by substituting the reported rock unit weight (γ) of 0.0026 kgf/cm³ and tensile rock strength (S_t) of 102 - 510 kgf/cm², which is 1/5 - 1/25 of the andesite's compressive strength (S_c) of 2550 kgf/cm² [23]. The weaker value (102 kgf/cm²) of the tensile strength is applied here to examine the minimum notch length to cause collapse.

Stability analysis reveals a critical notch length (l_c) of 112.6 - 251.8 m for the entire 97-m high cliff of Kegon Falls. At more than 100 m, this estimated critical notch length is considerably longer than the 26-m observed notch length beneath the lower agglomerate layer [34]; such a long notch length is not likely to be formed solely by underground outflow. The entire cliff face is stable until the vertical crack depth (α) reaches nearly 80% (Figure 6); however, such a long vertical crack is also unrealistic. Moreover, the critical notch length for the upper andesite layer with an h of 50 m is calculated to be $l_c = 80.8$ to 180.8 m without vertical cracks, which also appears implausible. With an observed depression of 5 m at the bottom of the upper andesite layer, more than 90% of the vertical crack is necessary for collapse. However, as shown in the upper portion of the upper andesite layer, dense joints likely prevent development of such a long vertical crack in the cliff. For these reasons, a catastrophic collapse of the entire cliff face as described in the schematic model by Mino [34] unlikely occurs.

Figure 6. Stability of the entire cliff (a); upper andesite cliff (b); and uppermost andesite blocks (c) at Kegon Falls that collapsed in 1986 with regard to the notch length, cliff height, and the ratio of vertical crack depth to height (α).

blocks in 1986, stability analysis indicates a critical notch length for the collapse of the rock blocks of 51.1 - 114.3 m if no vertical crack exists. Compared with the actual depth of the fallen blocks of approximately 10 m, this estimated critical notch length is again excessively long to have caused the collapse; a vertical crack (α) of nearly 80% is necessary. Unlike that for the entire cliff or andesite layer, such a vertical crack could have developed along the platy joint planes, which is observed in the present surface morphology of the cliff face at the upper portion of the upper andesite layer.

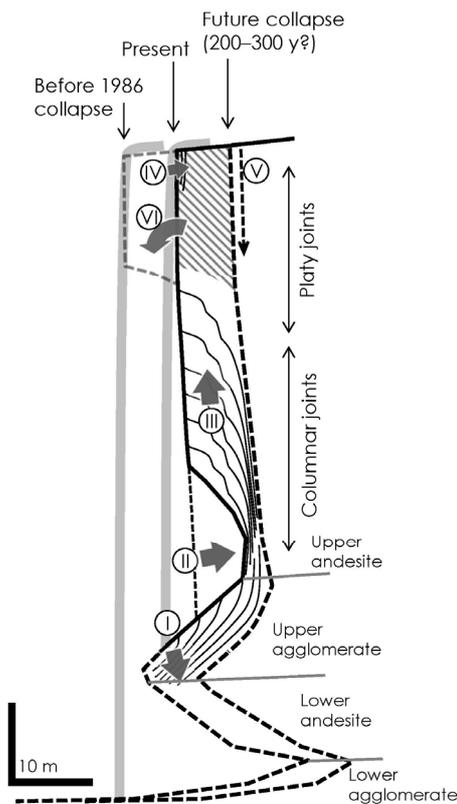
Figure 7 shows a schematic model of morphological development of the waterfall cliff. After the collapse of the uppermost andesite rock block, the surface water began to drop onto the upper agglomerate layer (I), which caused scouring and upslope propagation of erosion of the upper agglomerate layer. The protruding portion, supported by the lower andesite layer, is being destroyed in part.

Figure 7. Schematic illustration of the development of the Kegon Falls cliff face.

Water splash from the dropping water on the upper agglomerate layer then caused freeze-thaw and wet-dry weathering in the base of the upper andesite layer where dense columnar joints dominate (II), and the depression was formed at the bottom of the andesite cliff. The rapid formation of the depression will be stabilized when the water drop completed scouring through the slope of the upper agglomerate layer, ending the supply of splash water. Erosion of the slope of the upper agglomerate layer and the bottom depression of the upper andesite cliff is also supported by the groundwater outflow from the boundary of the upper andesite and upper agglomerate layers.

The formation of the depression will be followed by its upward propagation due to gravitational minor rockfalls in the lower part of the upper andesite cliff containing columnar joints (III). This process may last significantly longer—at least not as fast as the formation of the depression—because the weathering of the andesite rock depends on freeze-thaw or wet-dry weathering with fewer water supplies. Concurrently, the lip of the waterfall can also be eroded to some extent by surface water flow, although little evidence has been obtained (IV). Cavitation may be responsible for this process because the maximum discharge at the waterfall is 94 m³/s, which appears sufficiently high to cause cavitation at the 8-m-wide waterfall lip. It should be noted that this discharge is presently controlled at the water gate between the waterfall and the upstream lake; the natural maximum discharge could have been higher depending on lake level.

After the upward propagation of the minor rockfalls (III) and the development of a vertical crack within the andesite layer (V), the uppermost blocks of the andesite layer will finally collapse along the platy joints (VI). Thus, the processes of the erosion of Kegon Falls are variable in time and space, and both surface water and underground outflow are responsible for direct erosion and indirect effects on weathering of the rocks.
