Rockfall Hazard in an Old Abandoned Aggregate Quarry in the City of Tétouan, Morocco

Hatim Delloero*, Younes El Kharim

Department of Geology, Faculty of Sciences of Tétouan, Abdelmalek Essaadi University, Tétouan, Morocco

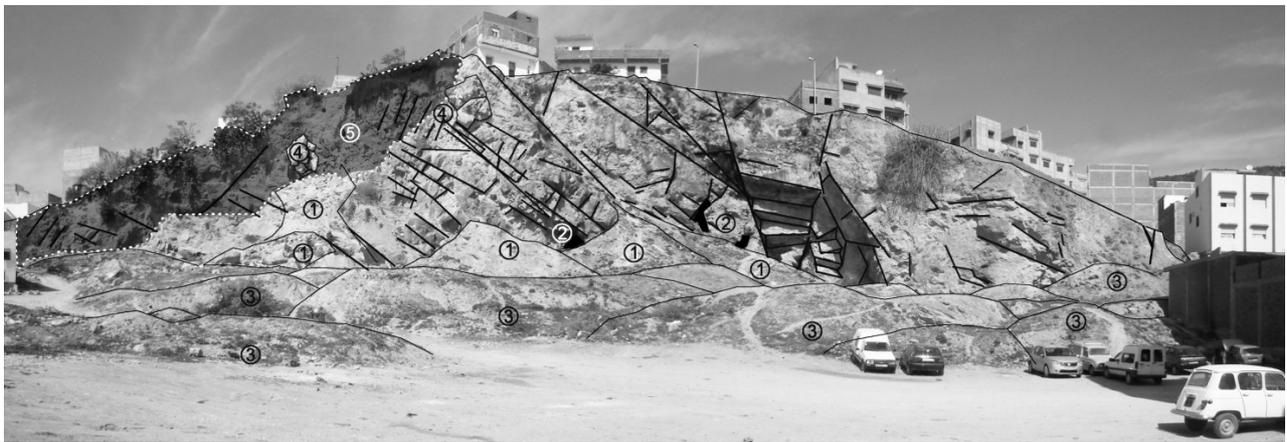
The face of the quarry is heavily fractured due to both tectonics and to the use of explosives during its active years. The joints in the rock mass vary from small scale fractures to decametric faults that run vertically through the whole rock mass; the fracturing becomes denser towards the east as the rock benches narrow (**Figure 2**).

Figure 2. Fracturing and instability components showing on the face of the quarry. (1) Talus; (2) Caves; (3) Overburden; (4) Unstable rocks attached to the face of the quarry; (5) Highly fractured area.

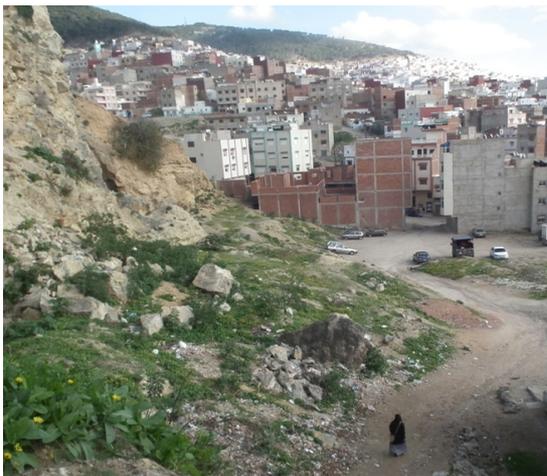
There is no official registry of the previous incidents but according to local residents in the neighborhood, they are frequent and can happen every year with some major ones that occurred in 1969, 1972 and 1977 during the rainy season, resulting the fall of big blocks of rock (Figure 3).

In recent years, a major rockfall incident happened January the 29th and the 31st of 2010, which followed a week of rain (208 mm) and two days after the rainiest day of the year (88 mm). Another one of a lesser scale happened in mid-January 2012 resulting screes and rockfalls, these two incidences have affected mostly the eastern area of the quarry where it is most fractured and caused it to recede noticeably.

Figure 3. Photo of the eastern part of the quarry showing different blocks that have fallen off the slope during different incidences.

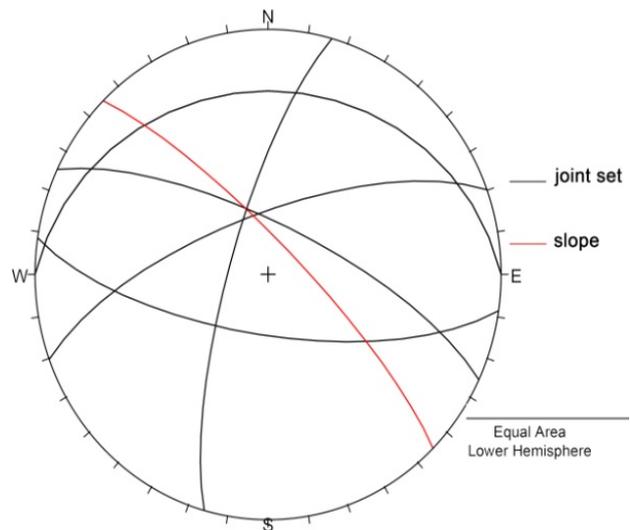
The stereographic representation of the join sets with the slope (Figure 5) allows the realization of a kinematic analysis on the walls of the quarry divided in five domains, following the variations of slope to identify the different failure mechanisms that occur in the quarry [7,8].

Figure 5. Stereographic representations of the joint set and slope in one of the positions.

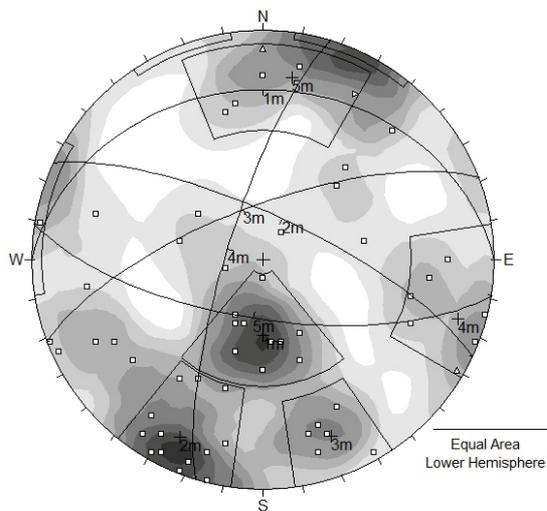
The measurements were then reported on the canvas of Schmidt (Figure 4) with the help of DIPS (5.1) (Roc-Sciences) [4] in which we were able to determine five different join sets represented in Table 1 with their different parameters.

Figure 4. Stereographic representation of joints and joint sets in the quarry.

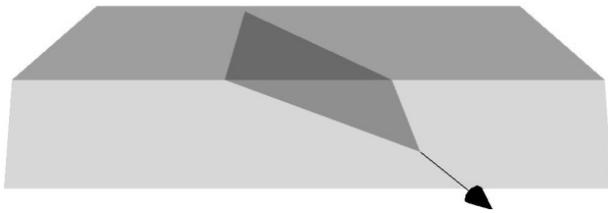
The stability analysis was done using specialized programs like Swedge (4.0) [4] (Figures 6 and 7) for wedge analysis and Roc-Plane [4] (2.0) for planar failures, these two programs allow to estimate the probability of failure (PF) for each case, taking into consideration the different variables like orientation of the joints, orientation and height of the slope, the rock's specific weight, cohesion, friction angle, water pressure in the joints and seismic coefficient.

The results show that in the actual orientation of the quarry's face, many wedges exist along its wall, and while they are totally stable in dry conditions, they are at risk of falling when the joints get filled with water.

Figure 6. Virtual modeling of a wedge type failure in the quarry done by sledge.

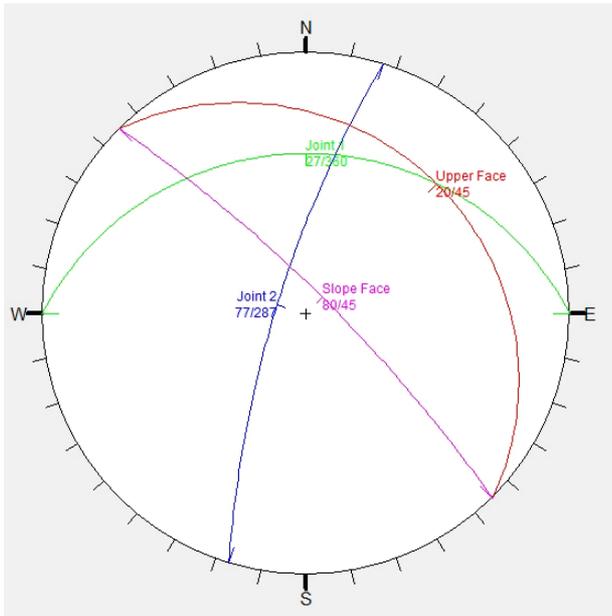
Figure 7. Stereographic representation of the same failure.

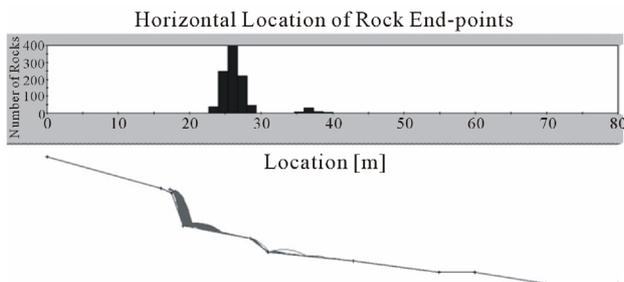
Figure 8. Rock simulation and its vertical distribution in one of the profiles done by Rocfall (4.0).

The results of rockfall simulations show that in most location within the quarry 80% - 99% of the rocks fall only few meters away from its wall, which is due to those levels of overburden that work as a catch bench, still there is a risk that rocks can reach distances as far as 40 m from the wall in some places with a bounce level that can reach over 1 m in height.

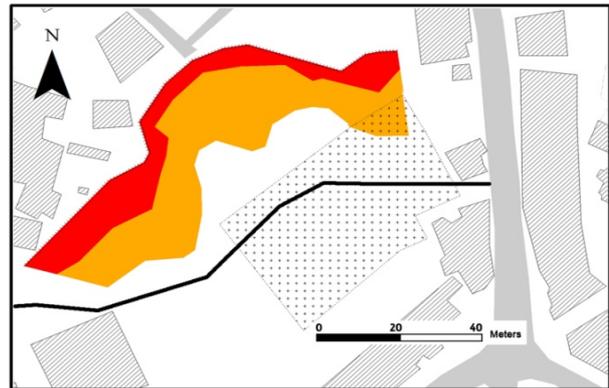
These results enabled the determination of the distance from the quarries wall where most rockfalls could occur. Reporting these distances on the quarry's plan allows to draw a high risk area and determinate a safe distance from the wall of the quarry (Figure 9).

Figure 9. Rockfall risk areas in the quarry.

have left the Carian quarry at a genuine risk of rockfall that can cause serious physical and/or propriety damages, to the population of the area, passengers, and the houses on top and cars at the ground. On the other hand these instabilities cause a noticeable recede of face of the quarry in some of its areas, which puts the houses on top at a great risk. As these risks get even higher during the raining season, it is advisable to keep a safe distance as mentioned and get into rehabilitating the area as soon as possible.
