Shoreline Instability Study on Fun Island Resorts, Maldives

E. W. K. Loh, Thoufeeg Usamath, T. J. Deepak

School of Civil Engineering, Linton University College, Mantin, Malaysia.

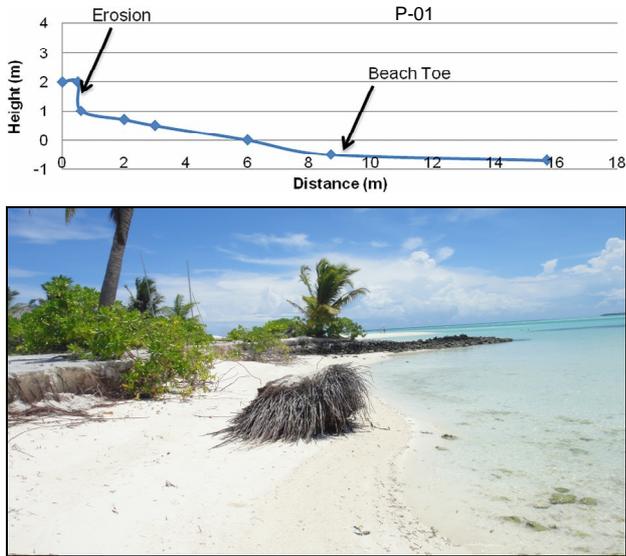
Figure 10. Beach profile P-01.

Figure 10, shows the north eastern side of Fun Island. It can be observed here that this area has a major problem of erosion. The erosion could be a result of the strong currents between Fun Island and Medhufinolhu and tidal fluctuations. This area of the island is also exposed directly to the winds during both the monsoons and does have erosion effects during both the monsoons.

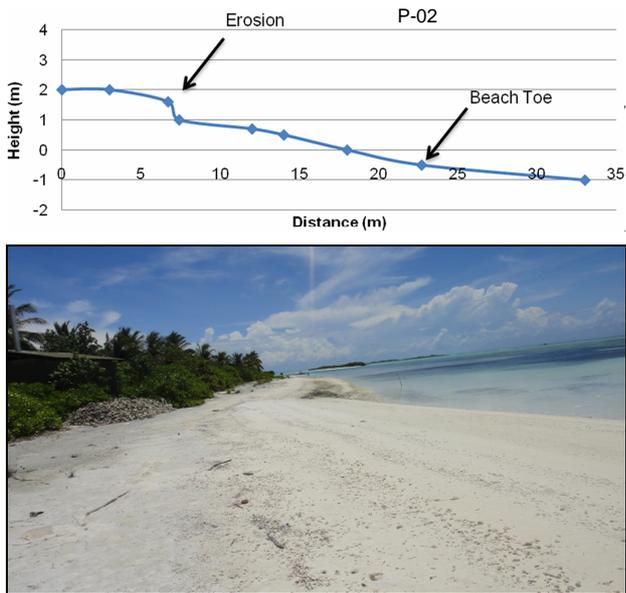
Figure 11. Beach profile P-02.

Figure 11, shows the profile for the eastern side of the island. Erosion can be observed on this part of the island as well. However the erosion in this part of the island is not as savvier as on the northeastern side of the island. It was noted during the survey that this area is protected from the northeast monsoon winds by the vegetation of the island. Thus this area does not have much of an erosion problem during the northeast monsoon though it is affected by the winds and waves of the southwest monsoon.

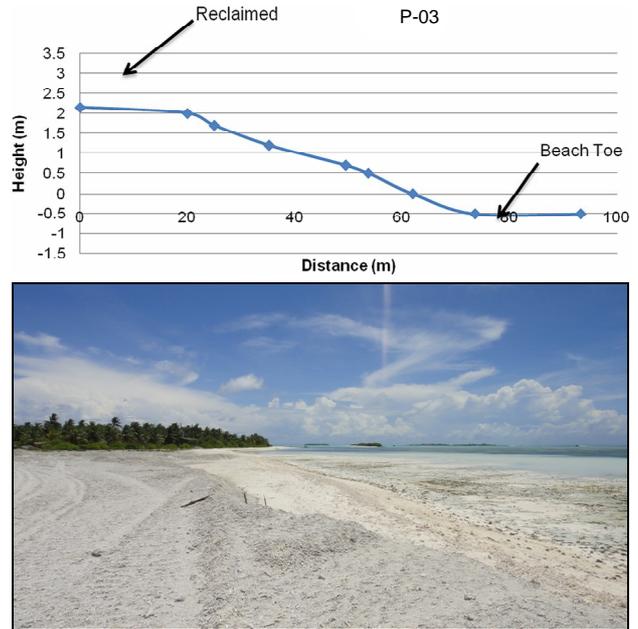
Figure 12. Beach profile P-03.

Figure 12, shows the beach profile of the southwestern side of the island. The height on this part of the island is slightly increased than the rest of the island due to the excess soil obtained from the dredging of the harbor. Thus the natural processes along the beach have been altered by the modification of the surroundings and yet the impact of this is not fully known. However it was observed that there are slight signs of erosion along this area as well. It was also observed that during the low tide the beach extends about 20 m unlike the rest of the island.

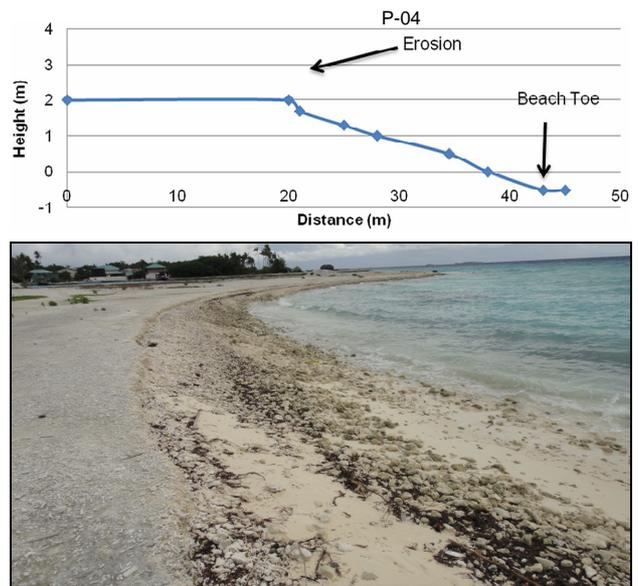
Figure 13. Beach profile P-04.

Figure 13, shows the southwestern side of the island. It was observed that this area has a major problem of erosion. The reason for erosion within this area could be due to the strong currents between Fun Island and Olhuveli

Island. It was also noted that the lagoon is deeper in this area than the rest of the island. This side of the island is directly exposed to the winds of both northeast monsoon and southwest monsoon. Thus the effect of erosion occurs during both the monsoon.

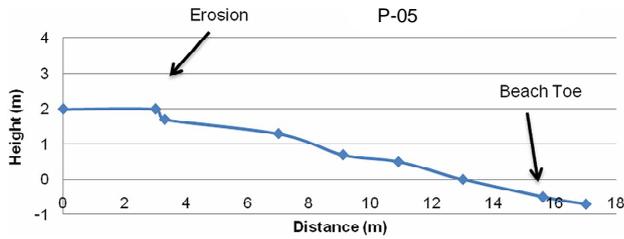
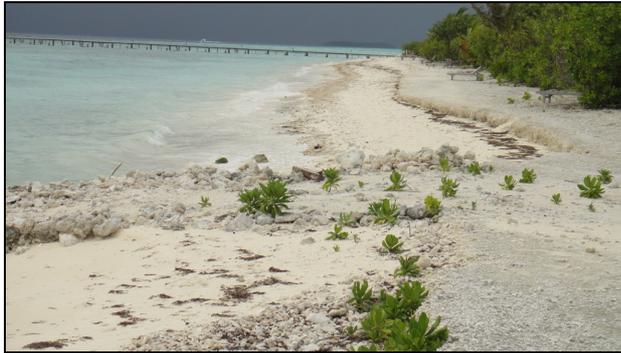
Figure 14. Beach profile P-05.

Figure 14, shows the profile for the western side of the island. Erosion can be observed on this part of the island as well. It was noted during the survey that this area is directly exposed to both northeast and southwest monsoon winds. Thus the effect of erosion occurs during both the monsoon. The groyne constructed on this side of the island to protect it against erosion has been damaged

during the 2004 Tsunami and this could also be one of the reasons for the increased erosion in this part of the island.

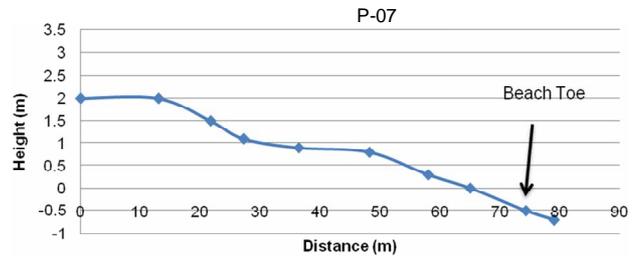
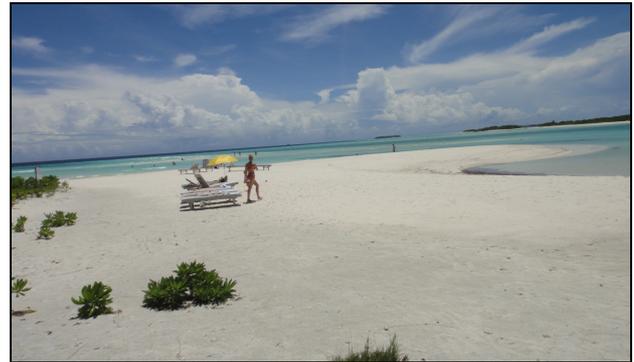
Figure 16. Beach profile P-07.

Figure 16, shows the northern side of the island. According to Mr. Abdulla Kamil, Resident Manager, Fun Island Resort, the beach here moves noticeably to the east during the northeast monsoon and to the west during

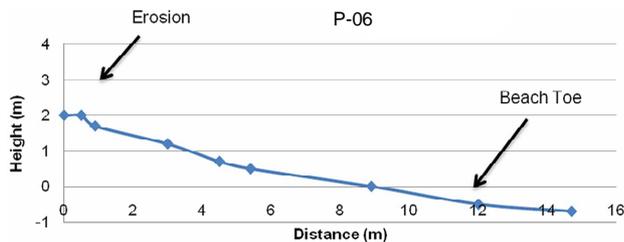
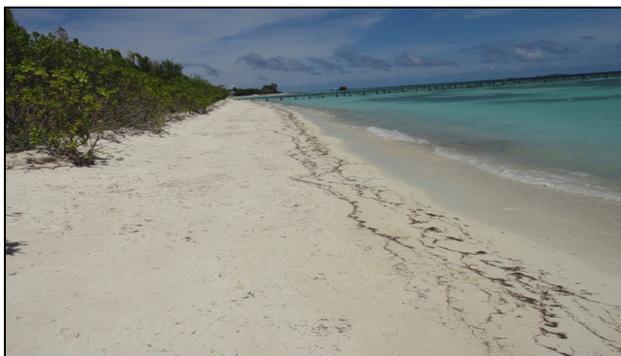
Figure 15. Beach profile P-06.

Figure 15, shows the northwestern side of the island. Slight evidence of erosion can be found on this part of the island. It was observed that the erosion of this area is minimized by the damaged groyne on the northeastern side of the island.

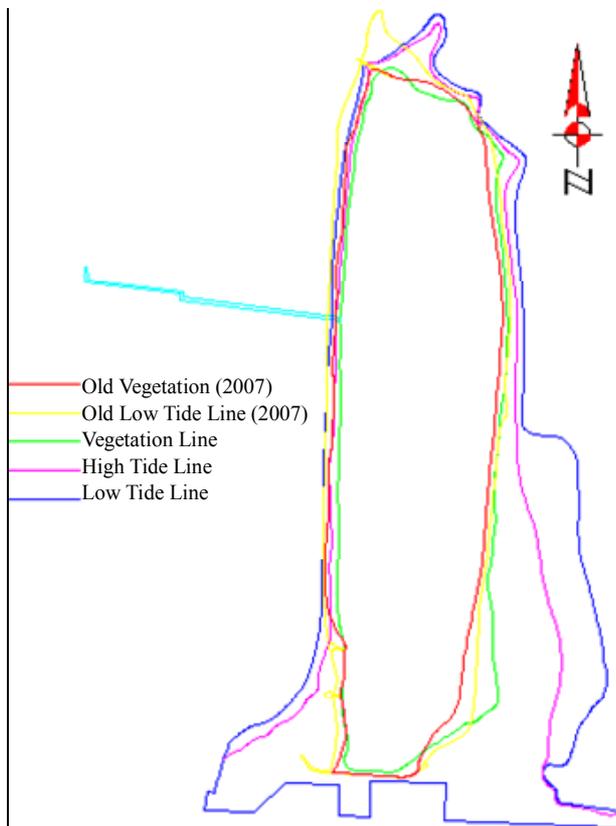
the southwest monsoon. The movement of the beach can be seen in the Figure 17 which shows the merged map of 2007 and 2011 of Fun Island Resort.

The merged map (Figure 17) shows that the shoreline of the island has changed within the three years. The southern end is changed due to the sheet-piling and dredging of the harbor. The southeast side of the island has been reclaimed to some extent with the excess soil obtained from the deepening of the harbor. However on the northern end it can be seen in the Figures 4-15 that the sand bank at the northern end of the island has changed shape and moved towards east. We can see sign of abrasion along the north eastern end of the island.

Figure 17. Merged map of 2007 and 2011 of Fun Island Resort.
