Lengthening, Cracking and Weldability Problems of Fe–Ni–Cr Alloy Tube

Ali Babakr* and Fakhruddin Habiby

*SABIC Technology Center
P.O. Box 11669
Jubail, Saudi Arabia 31961*

ABSTRACT

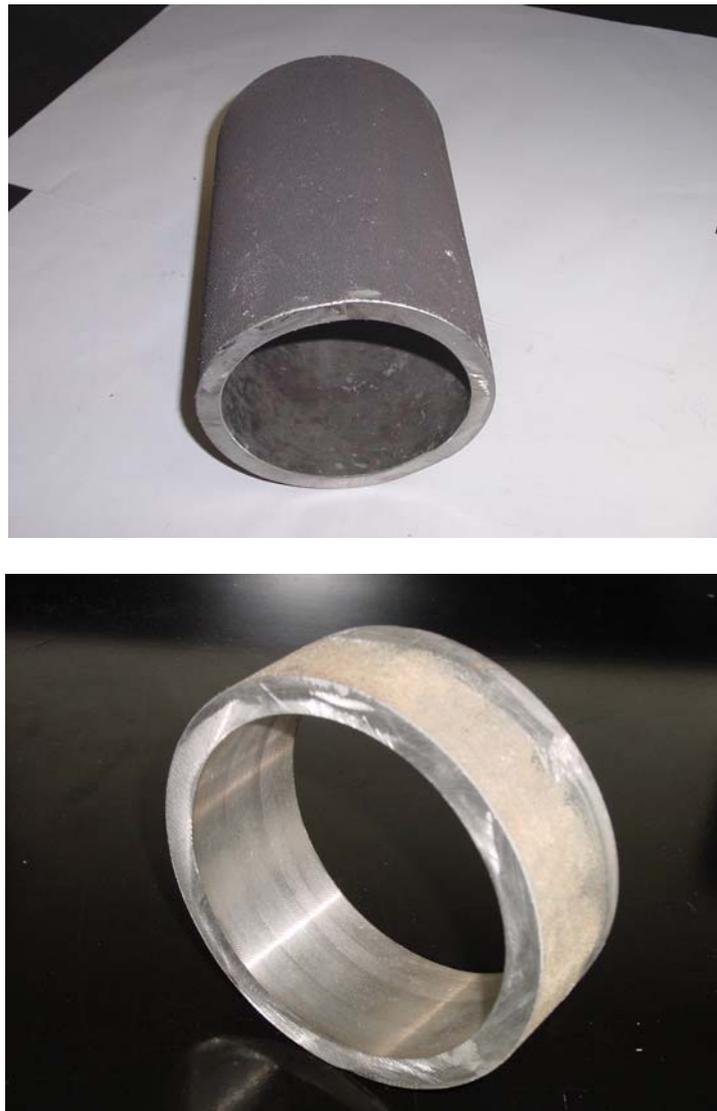
An initial visual observation of the samples removed from the elongated tubes indicated no visible creep damage resulting from the elongation (Figure 1). In addition, the sample showed no significant damage internally or externally. There were no visible pits, deposit, signs of carburization. Generally, it looked in good condition.

Figure 1: Photographs showing as received used tube sample (above) and new tube sample.

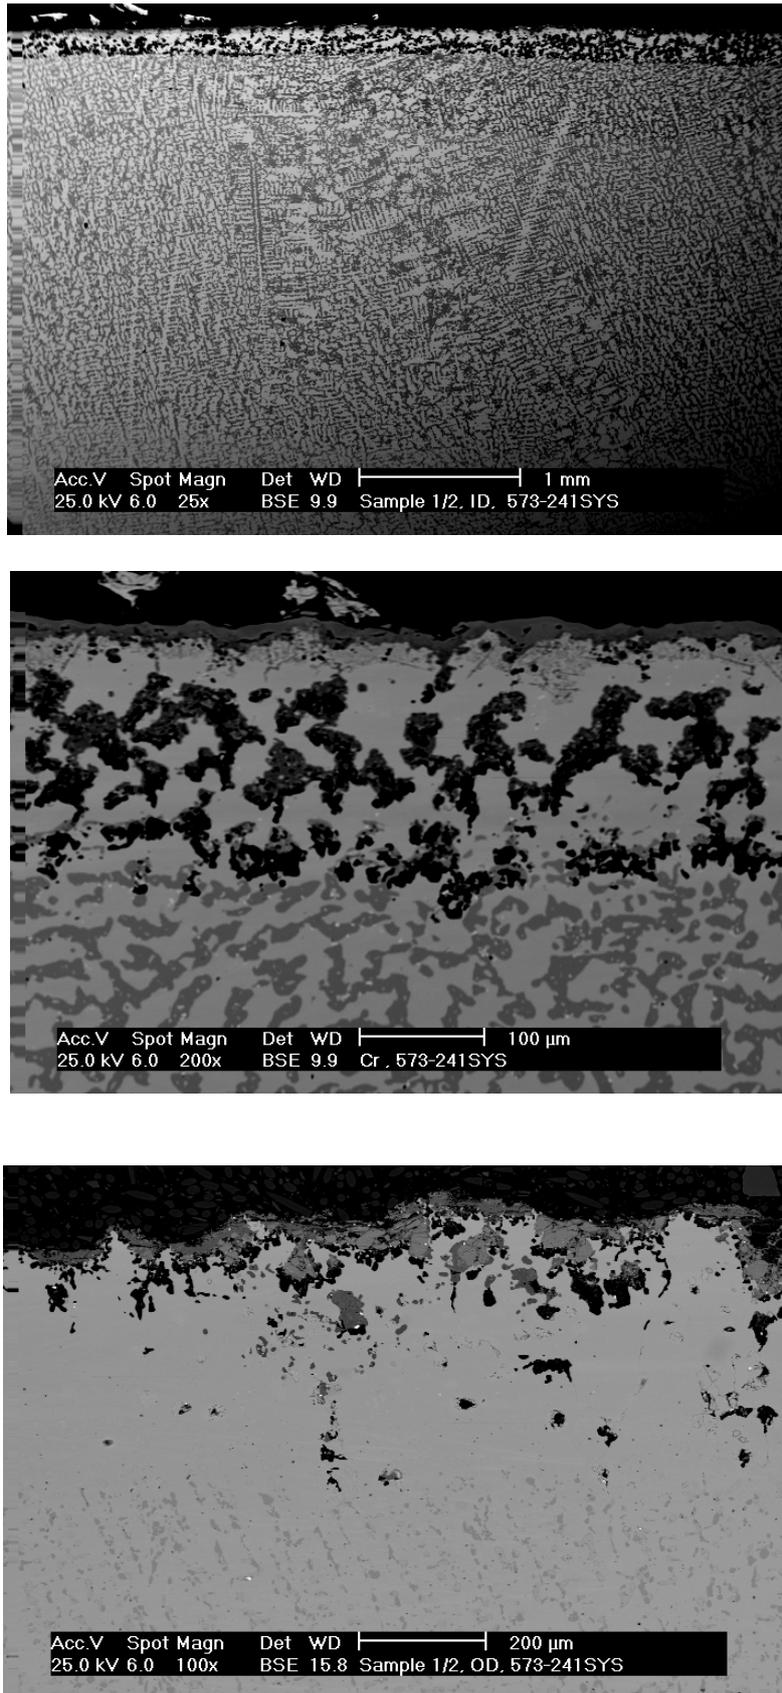
Microstructural analysis of samples taken from the tube section indicated that it underwent carburization. The samples exhibited slight surface roughness with the presence of a thin carburized layer. Figure 2 show three SEM photomicrographs of a representative samples to view carburization, ID surface, and OD surface.

Figure 2: SEM micrographs showing carburized layer (above X25), carburized layer ID at higher magnification (middle X200), and oxide layer at the opposite side (OD X100).

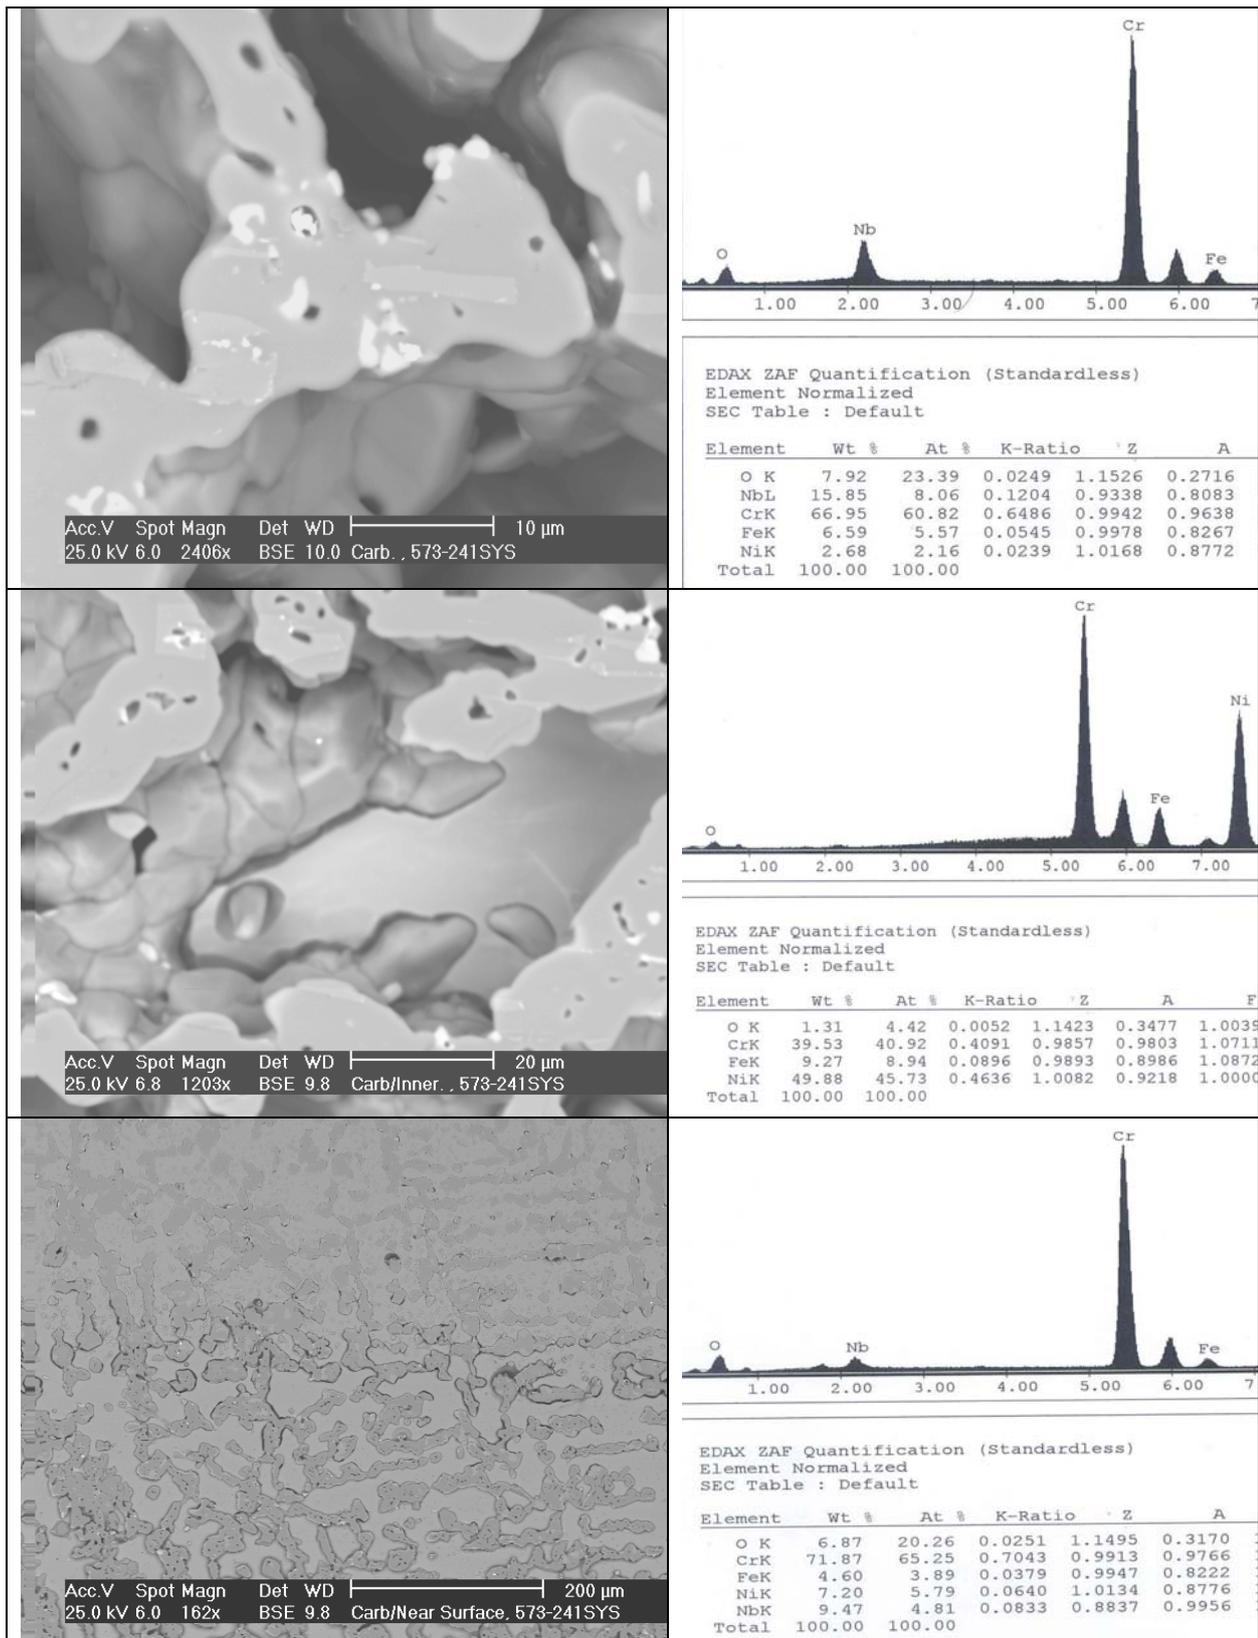
Figure 3 shows three SEM photomicrographs comparing carburization of the top photo in figure 2, from surface (ID), slightly lower toward middle, and at the interface from where carburization starts (bottom) with their corresponding EDS results. The lighter area within the top photo was analyzed by EDS and found to consist of mainly Nb. It appears as if the grains have leached out leaving dendrites behind. Analysis of the carburized layer (figure 3 top photo) indicated that the major element was Cr, next is Nb, followed by oxygen. Elemental composition indicates that the make up of carburized layer can be metal carbides and oxides.

Within the dendrites, basically Ni and Cr are the major elements in addition to iron. At the interface line (figure 3 bottom photo) Cr again was the major element.

Figure 3: SEM photomicrographs with their corresponding EDS results of the outer part of the carburization layer in the ID (top), slightly below location of the top photo (middle), and at the interface of carburization and tube material.

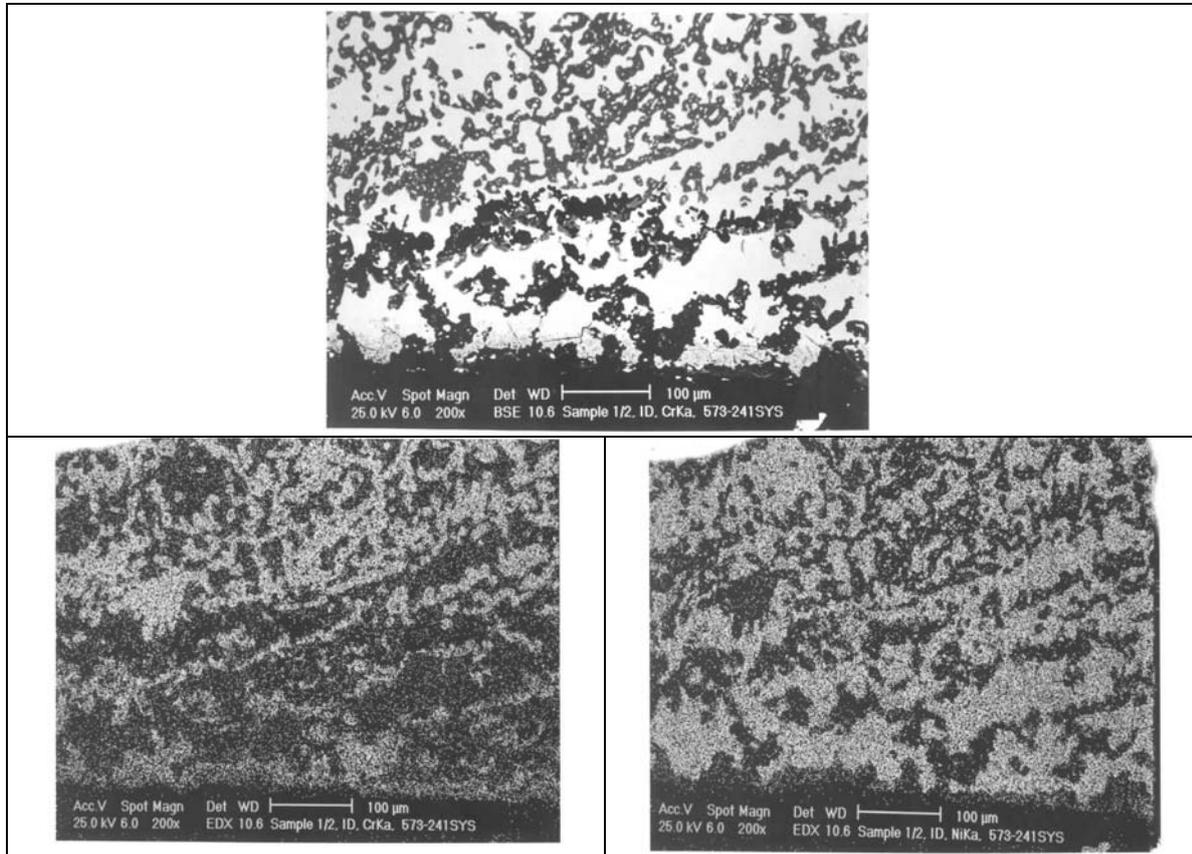
Figure 4 shows SEM photomicrographs elemental mapping of the ID surface region. Figures 5 to 7 are SEM photomicrographs (all at X1000) showing the microstructure of the new tube sample, and comparing three different views from OD, middle, to ID along with their EDS analysis results. Figure 8 shows the elemental analysis of the different phases of oxides within the OD side. There were no pitting, cracks or intergranular attack, and no evidence of sigma-phase.

Figure 4: SEM photomicrograph elemental mapping of major elements distribution in the carburized layer, Cr (left photo) and (Ni-right photo).

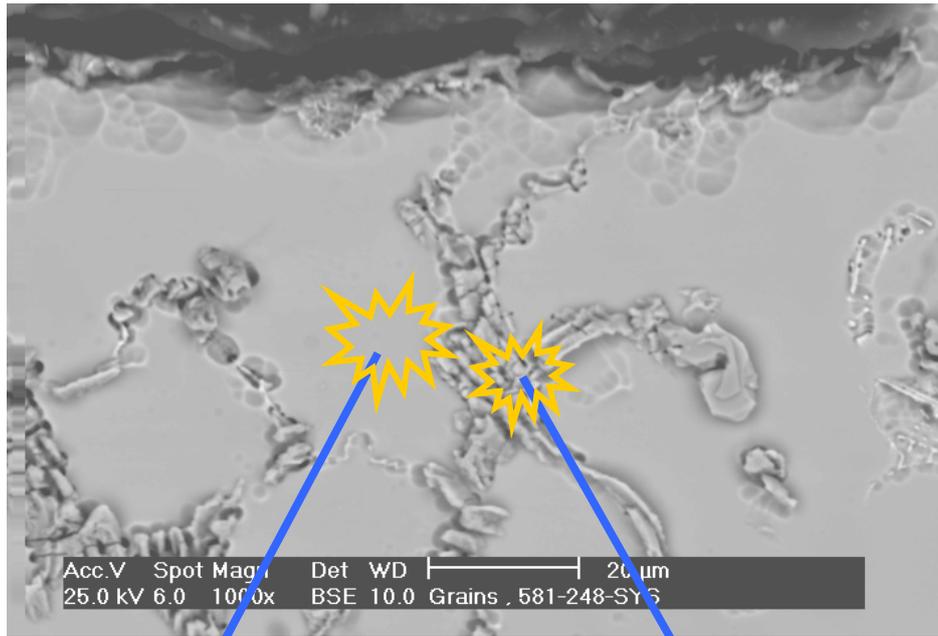
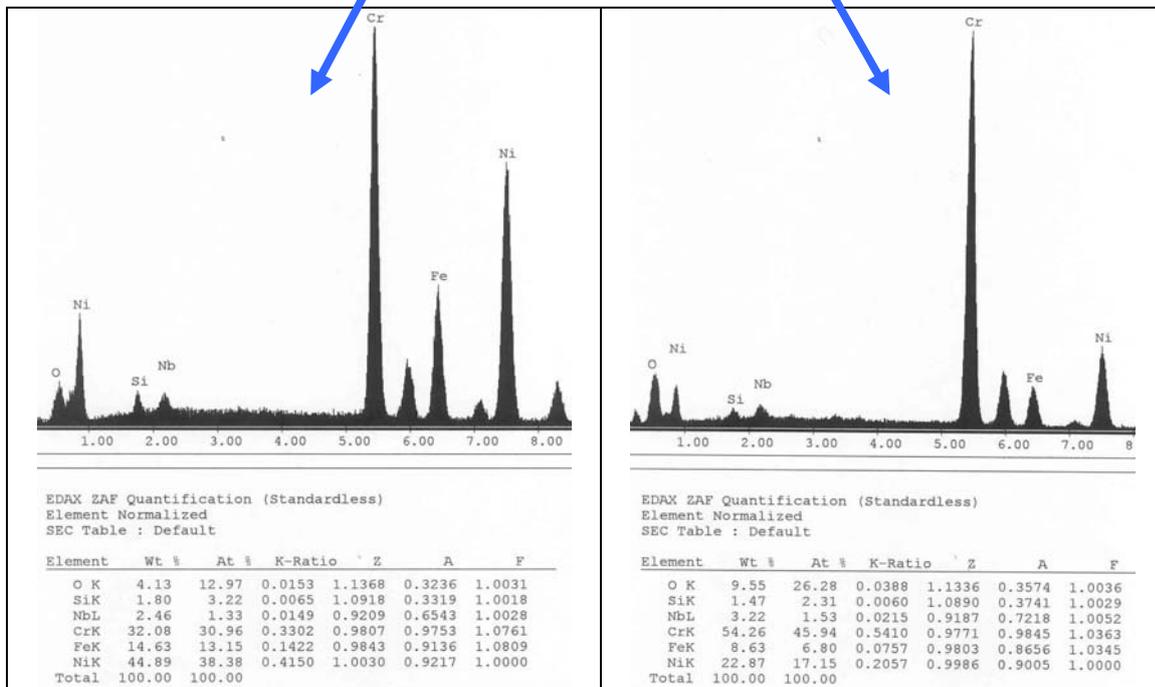
Figure 5: SEM photomicrograph showing grain structure at the OD surface. Accompanying EDS shows elements make up of grain (bottom-left) and at the grain boundaries (bottom-right).

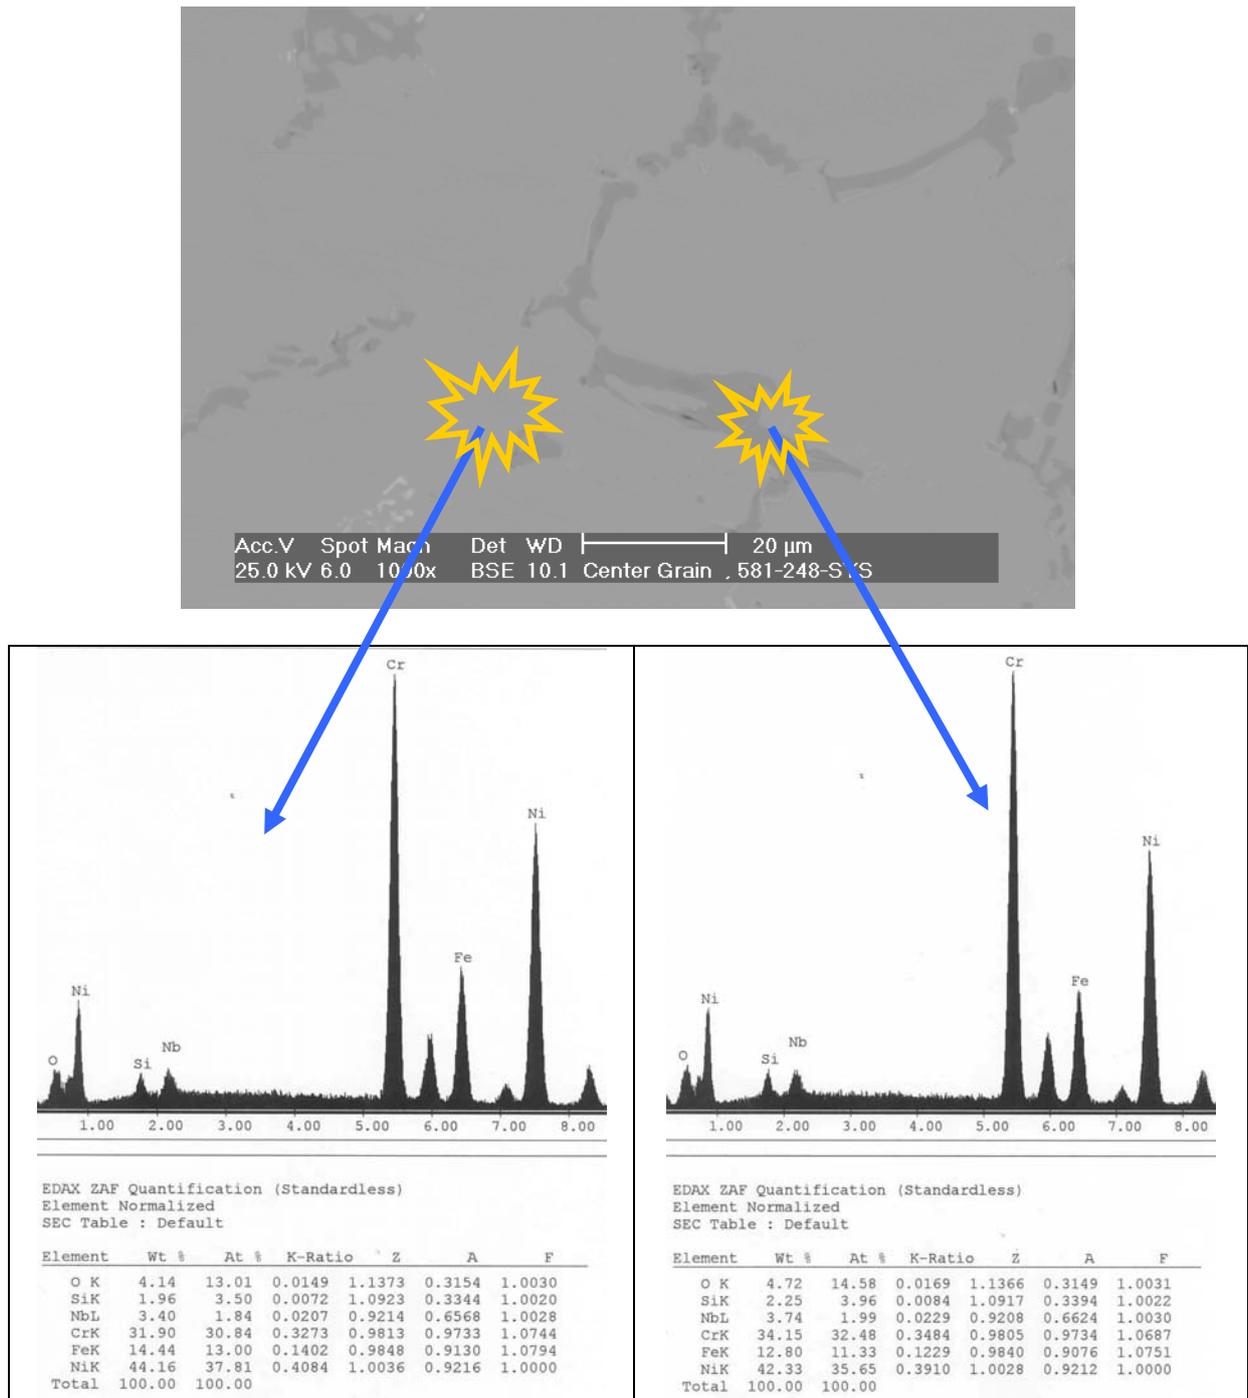
Figure 6: SEM photomicrograph showing grain structure at the middle area of the sample. Accompanying EDS shows elements make up of grain (bottom-left) and at the grain boundaries (bottom-right).

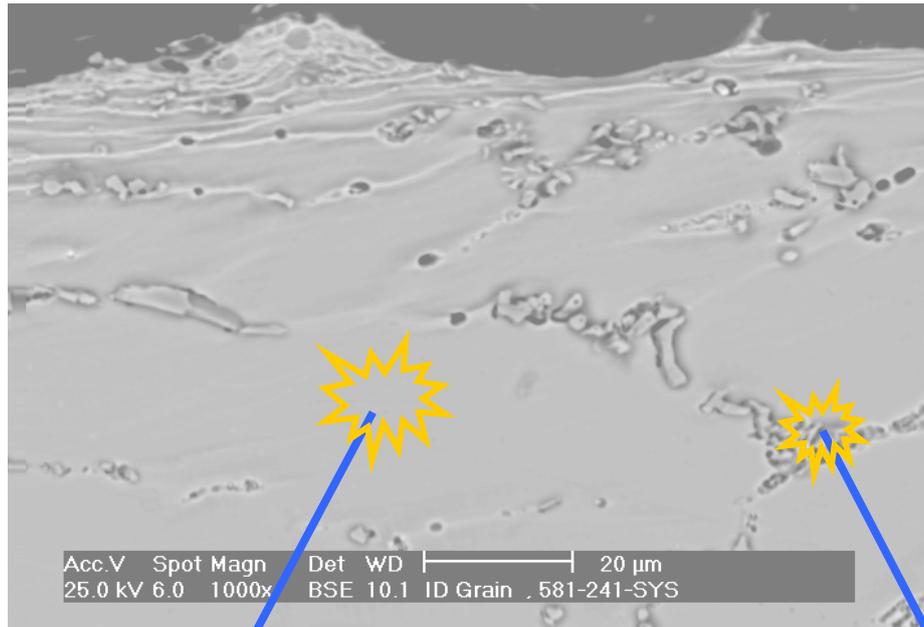
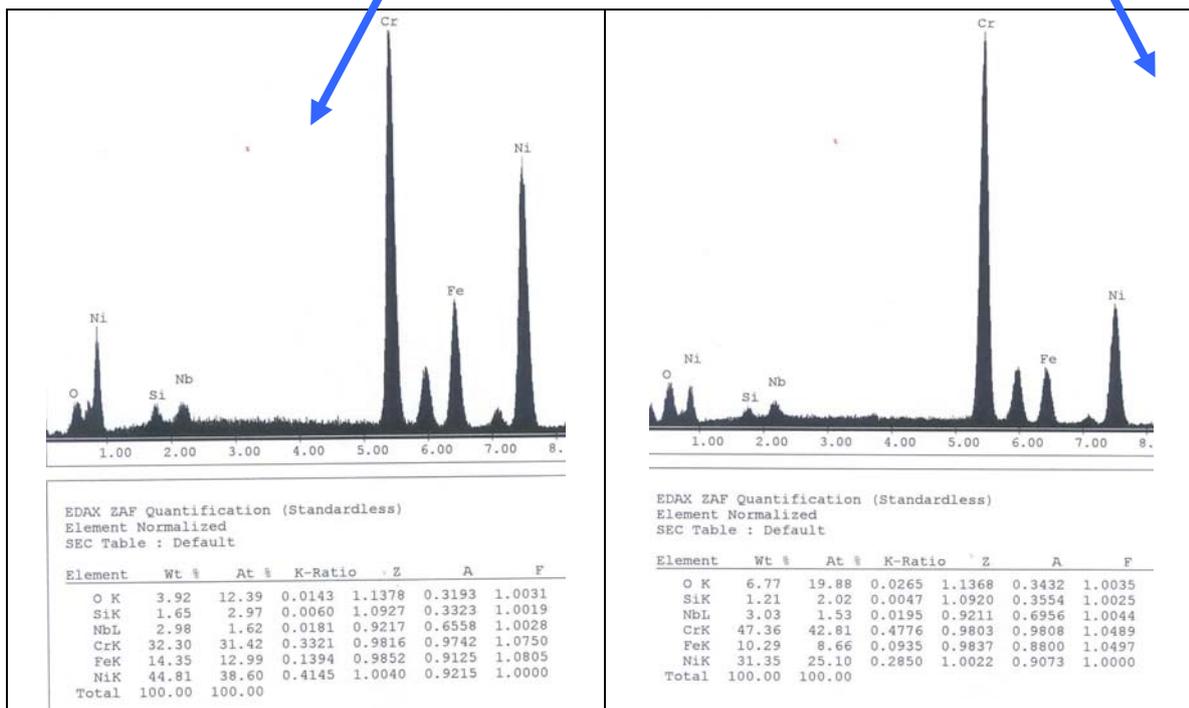
Figure 7: SEM photomicrograph showing grain structure at the ID surface. Accompanying EDS shows elements make up of grain (bottom-left) and at the grain boundaries (bottom-right).

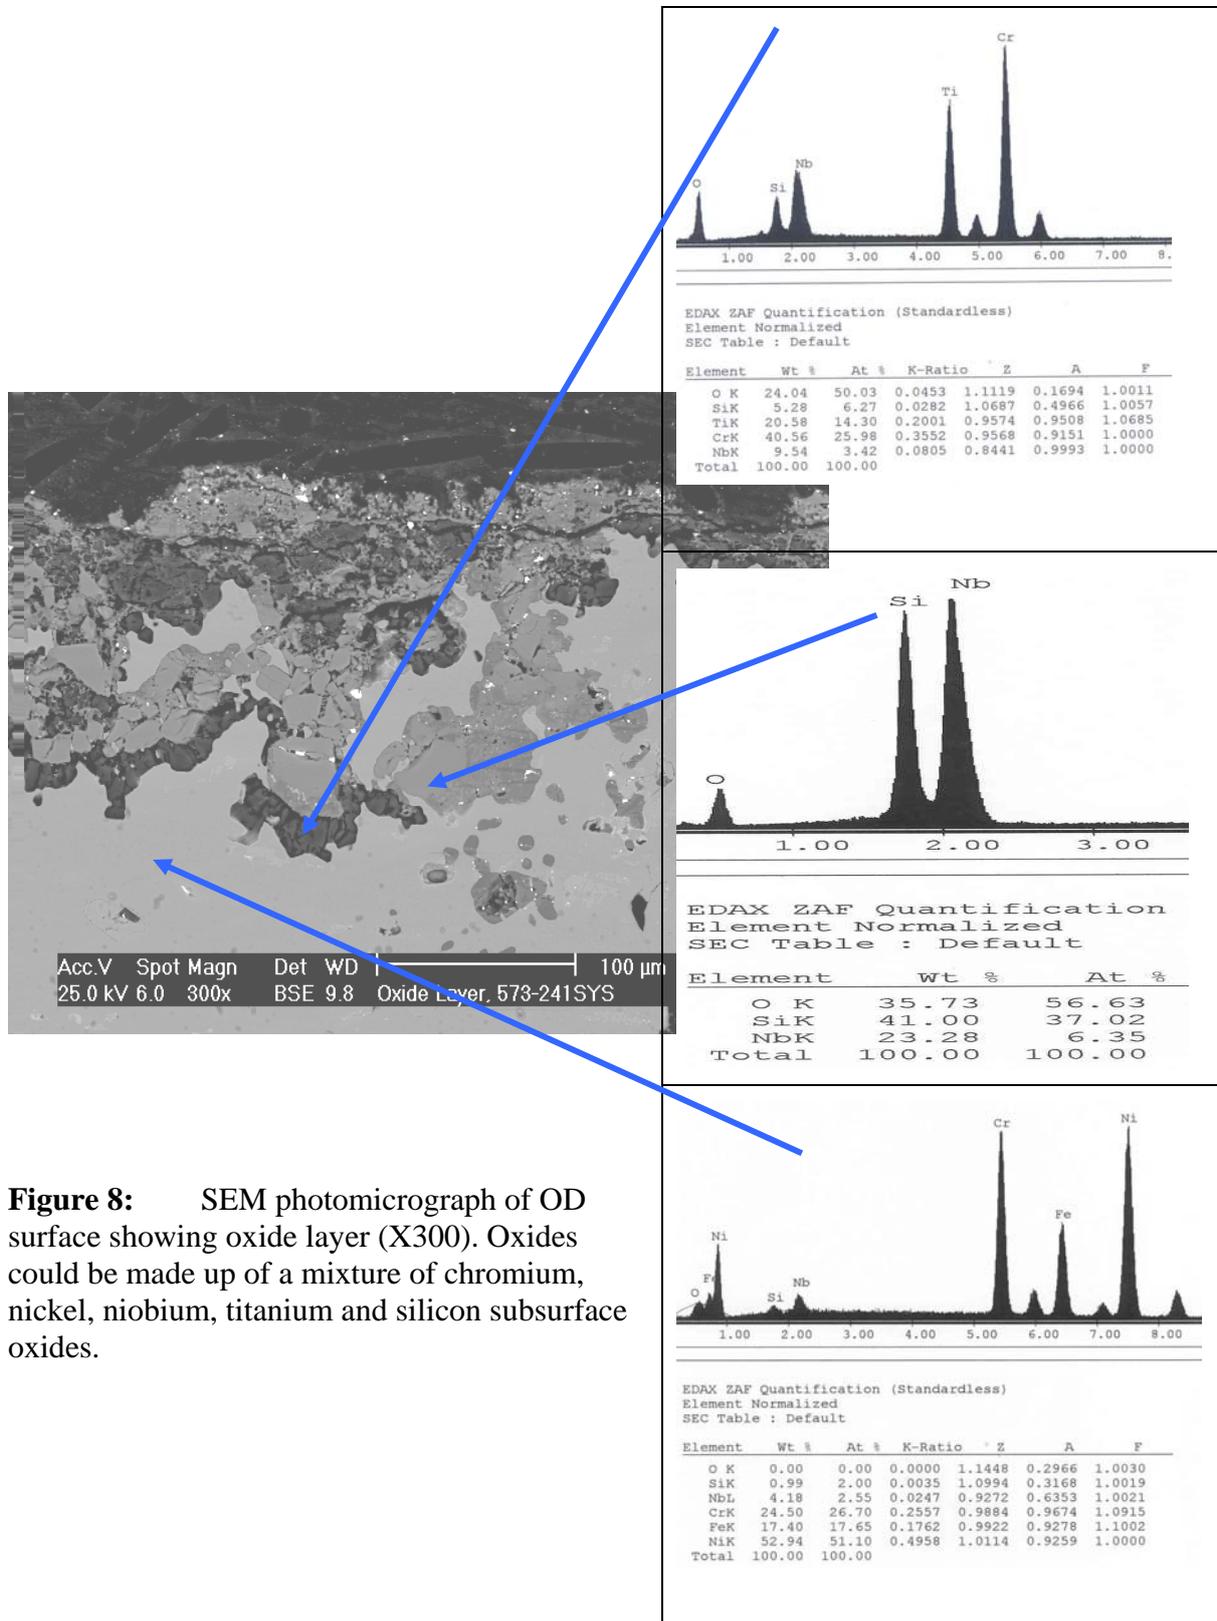
Figure 8: SEM photomicrograph of OD surface showing oxide layer (X300). Oxides could be made up of a mixture of chromium, nickel, niobium, titanium and silicon subsurface oxides.

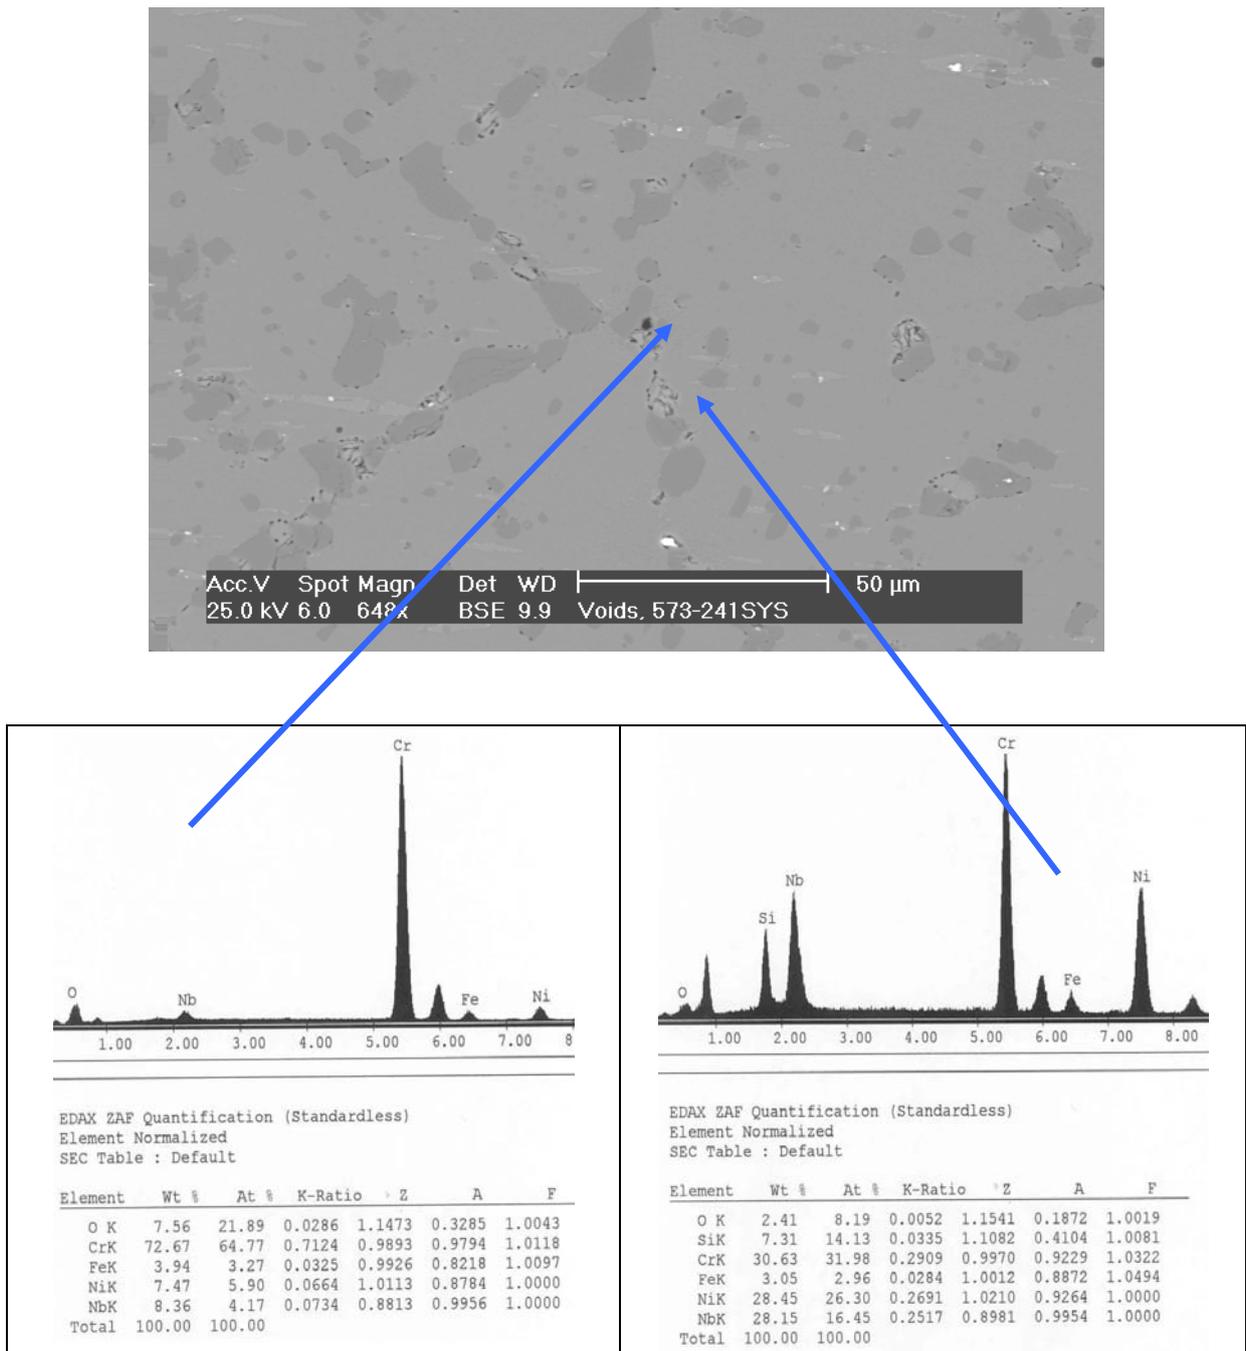
Figure 9: SEM photomicrograph of old tube sample showing what seemed to be creep voids (X684) with their corresponding EDS.
