Corrosion of Steel Pipelines Transporting Hydrocarbon Condensed Products, Obtained from a High Pressure Separator System: A Failure Analysis Study

Gerardo Zavala Olivares*, Mónica Jazmín Hernández Gayosso

Instituto Mexicano Del Petróleo. Eje Central Lázaro Cárdenas Norte, Col. San Bartolo Atepehuacan, C.P., México D.F., México
Email: *gzavala@imp.mx

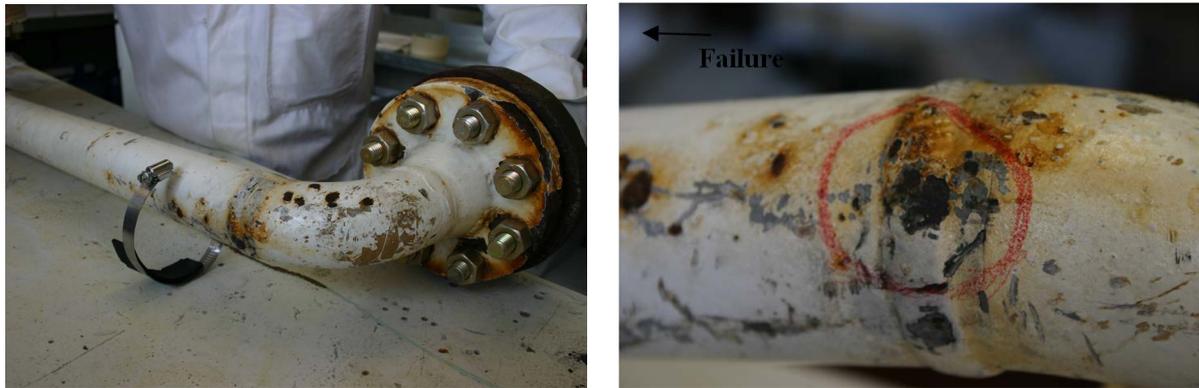
The failure was located at the welding joint with the first elbow, according to the fluid flow and at the 6 technical hours position, as shown in **Figure 9**.

Figure 9. Location of the site where failure occurs.

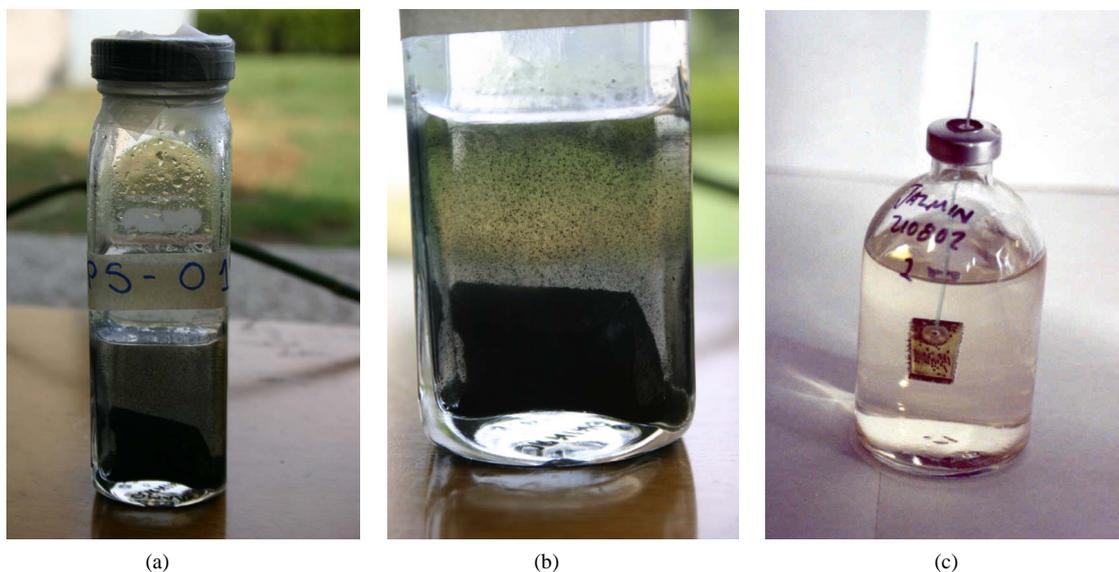
When SRB are present in the samples, they reduce the sulfate of the media to sulfide, which reacts with iron to produce a black precipitate of iron sulfide. This is an indicative of SRB presence. When there is no presence of SRB, the culture media remains transparent with no change (Figure 10).

The formation of FeS deposits at the metal surface is one of the main characteristics of this type of corrosion. These results are in good agreement with those obtained in Stage 1, where the presence of SRB in water was indicated.

Figure 10. Presence of sulfate reducing bacteria, indicated by the formation of FeS deposits. a) Presence of SRB; b) Presence of SRB; c) Absence of SRB (Blank).

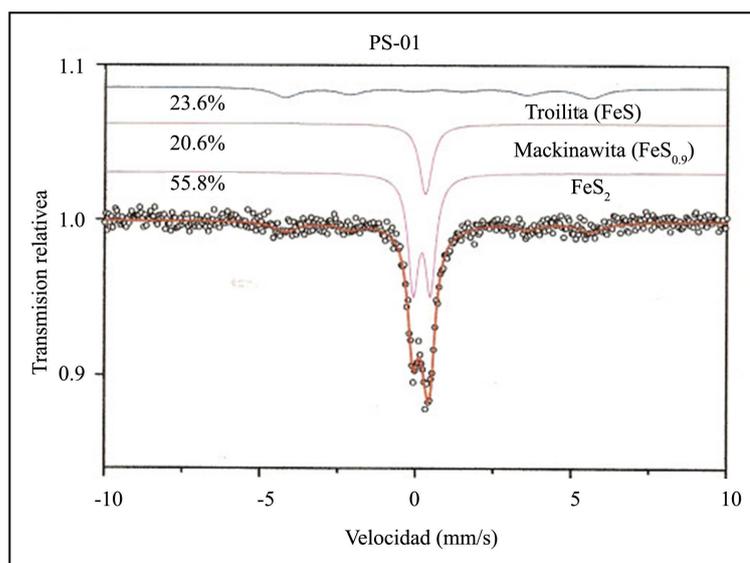
Mössbauer Spectroscopy: This analysis is specific to determine iron compounds. The spectrum obtained is shown in Figure 11. The compounds found mainly correspond to iron sulfides: Troilite (FeS), Mackinawite (FeS_{0.9}) and FeS₂.

Figure 11. Spectrum obtained from Mössbauer spectroscopy.

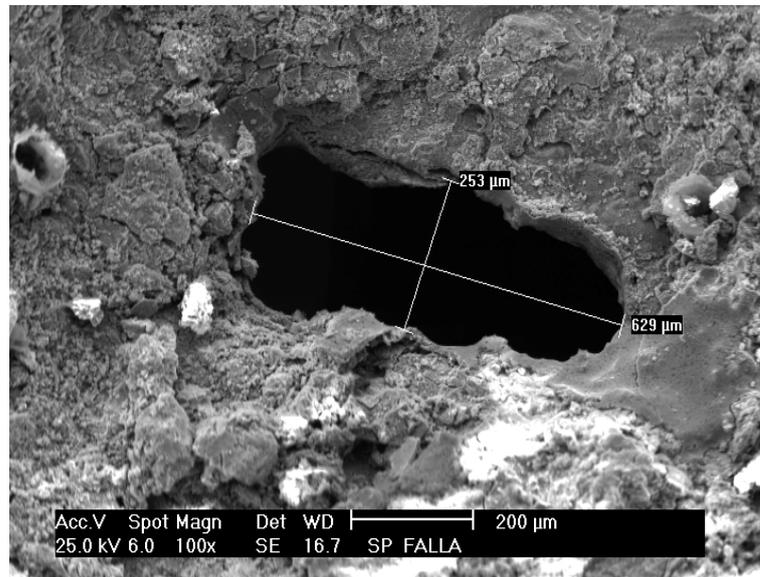
occurred, before and after the corrosion products were removed from the metal surface [16]. The results corresponding to the analysis with corrosion products at the surface, exhibited a rectangular failure, with side dimensions of 253 μm and 629 μm , located at the welding joint (Figure 12). An elemental analysis indicated a typical mild steel composition, including Fe, C, Ni, Cr, Si, and Mn.

Moreover, S and O were observed. These elements are associated to the steel composition, but also could be related to the corrosion products formed at the metal surface. Once the corrosion products were removed, a surface analysis was carried out. A uniform corrosion process was observed in the entire metal surface, with a type of localized corrosion in specific sites (Figure 13).

Figure 12. Micrograph of failure. Corrosion products at the metal surface.

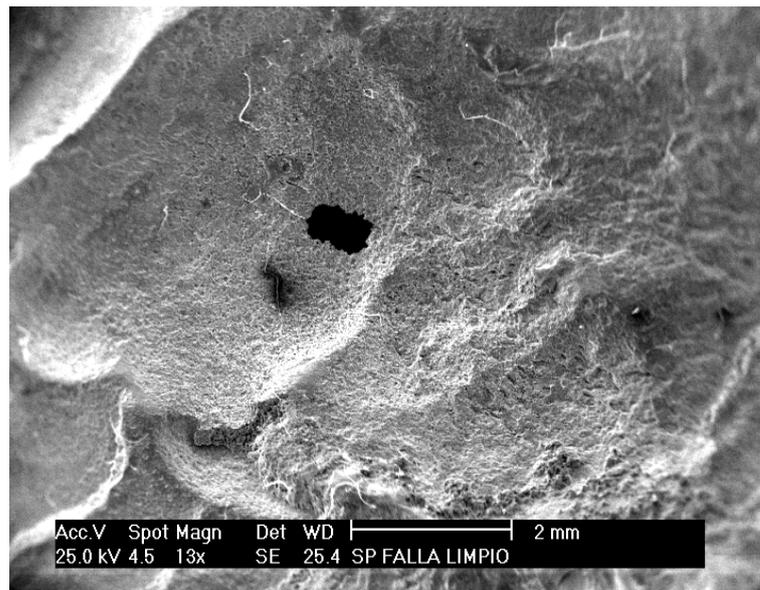
In this case, the characteristic elements for carbon steel are still observed. However, there is lower oxygen content and the presence of sulfur was detected. These results corroborate the fact that the corrosion products are mainly formed by sulfides and oxides. Additionally, as the failure occurred in a welding joint, a galvanic corrosion effect was considered and a metallographic analysis was suggested.

Figure 13. Micrograph of failure. Metal surface free of corrosion products.

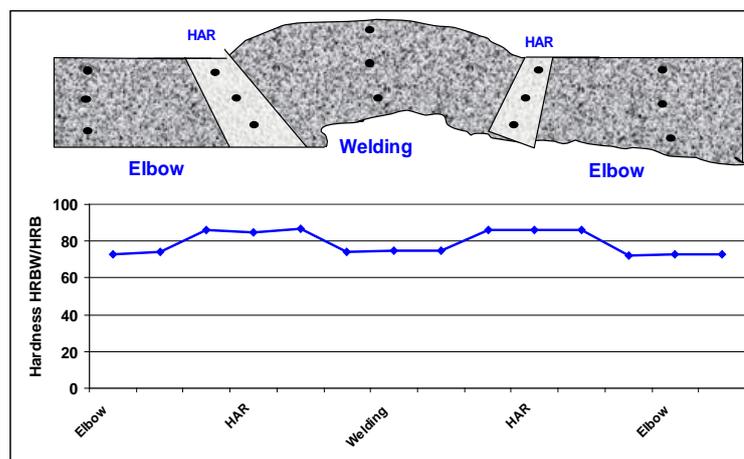
A metallographic analysis and a hardness profile were carried out at the site where the failure occurred, considering the tube, the welding joint and the elbow. During the sample preparation, inclusions at the metal surface were evaluated. Sulfides and oxides were observed in the tube and oxides were noticed at the elbow surface. These results corroborate previous analysis, where the presence of these two compounds was reported. Regarding the hardness profile, the results indicate similar behavior for the three regions analyzed: tube, welding joint and elbow. Values around 74 Rockwell units (HRBW) were measured. However, the heat affected regions (HAR) exhibited higher hardness values, around 86 HRB, as shown in **Figure 14**.

Figure 14. Hardness profile for the metal sample.

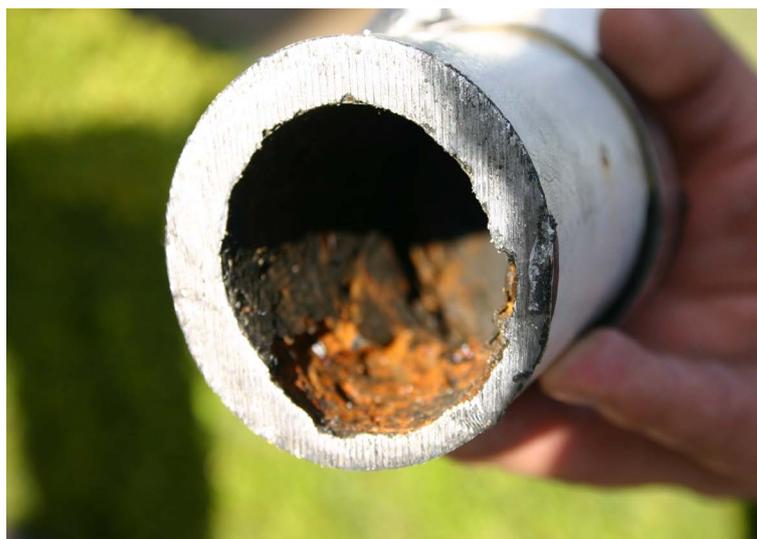
1) The first visual inspection of the pipeline inner wall, after the first metal cut and before any metal cleaning, indicated a severe uniform corrosion, identified by a reduction of the pipeline thickness in specific sites, mainly located at the 6 hours position (**Figure 15**).

This type of corrosion was generally observed at the elbows and “T” joints, where the fluid changes its flow direction. It is expected that during the hydrocarbon transport, heavier fluids are located at the bottom of the pipeline. For this specific case, water phase is in this position, generating aggressive conditions for the metal.

Figure 15. Pipeline transverse cutting. First elbow after the high pressure separator.

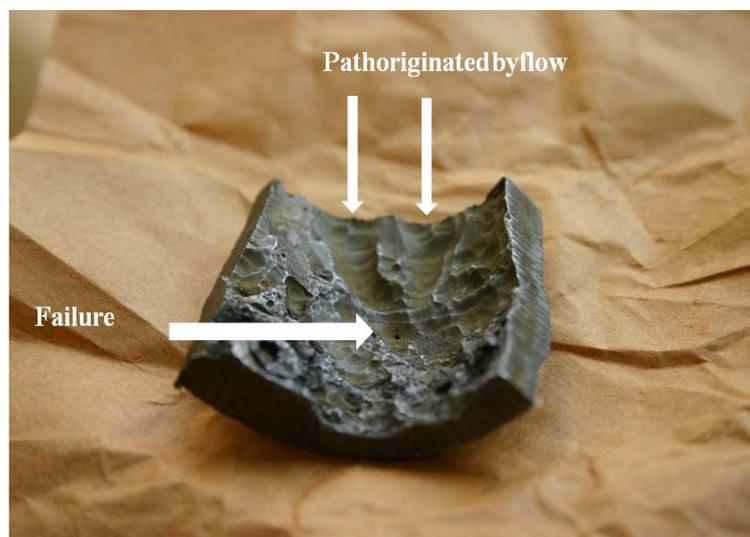
Due to the morphology, location and distribution of this type of uniform corrosion, an erosion corrosion effect is considered. In this type of corrosion, the hydrocarbon flow is enough to remove corrosion products from the metal surface, decreasing their protective effect and increasing the corrosion rate. Corrosion processes due to fluids flow usually induced a localized impact pattern. The failure was located at the welding joint, in a site where an erosion corrosion effect was also observed, as shown in **Figure 16**.

Figure 16. Site where failure occurs. Erosion corrosion goes in flow direction.

In this way, it is very important to verify the fluid velocity, as it should not exceed the recommended material limits. From a corrosion point of view, a smooth flow is always preferable to a turbulent flow. At the same time, gases and solid particles must be eliminated from the fluid as possible.

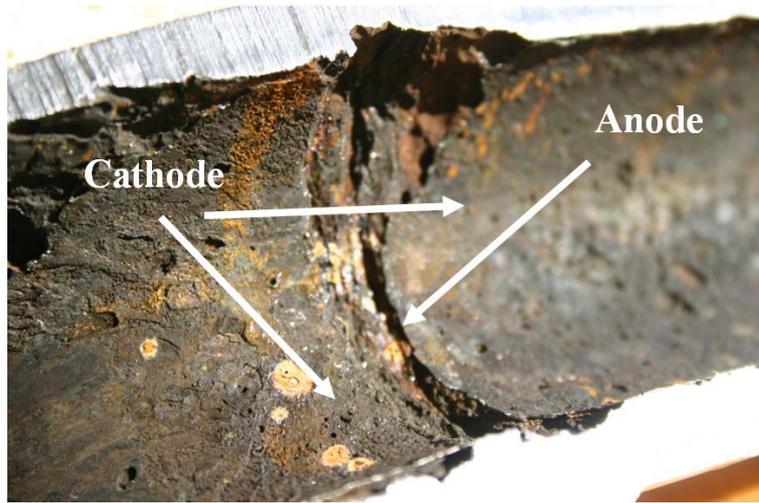
A galvanic effect could be explained by these differences and the different microstructures observed in the metals. It seems that the welding joint material acts as an anode and the adjacent regions as a cathode.

2) A galvanic corrosion process may be considered at the welding joints regions. This type of corrosion occurs because of potential differences between metallic materials, when in contact and in presence of an electrolyte. The material with more negative potential acts as an anode and exhibited a corrosion process. For this specific case, apparently the welding joint acted as anode in the corrosion reaction. However, the galvanic corrosion was less evident in the site where the failure occurred, because of the effect of the erosion corrosion. At the 12 technical hours position, the erosion corrosion effect is less evident and the galvanic corrosion is clearly observed (**Figure 17**).

Figure 17. Corrosion process at the interface tube-elbow.

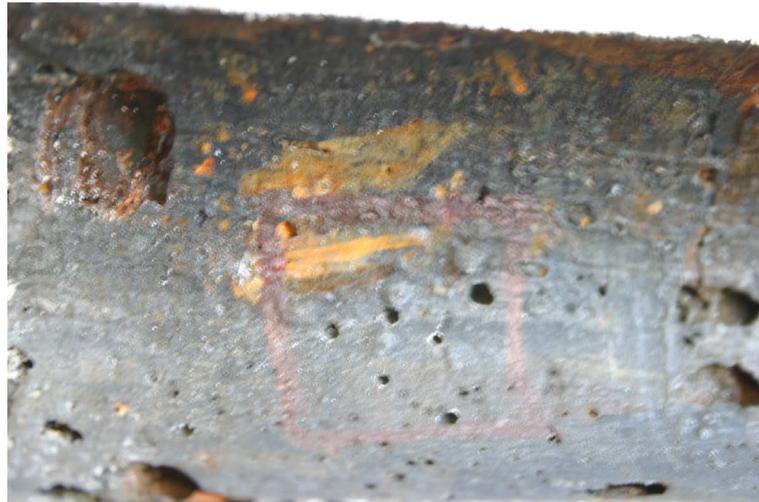
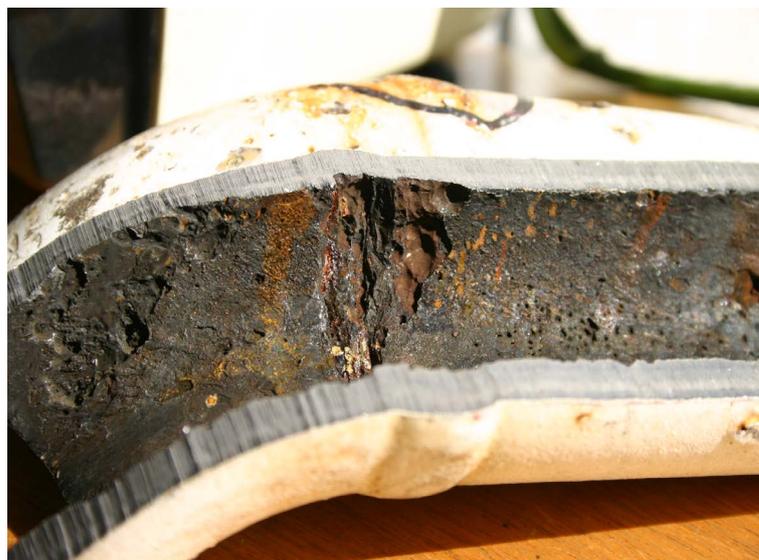
3) Microbiological induced corrosion, which can be associated to localized corrosion processes, was observed along the metal sample. It was more evident at longitudinal regions, between 5 and 7 technical hours positions, although this type of corrosion was also detected in most of the pipeline inner metal surface, as shown in **Figure 18**. Corrosion products were removed from some pits and SRB populations were detected inside the cavities.

Figure 18. Localized corrosion at the elbow inner wall.
