Adverse Wear in MOM Hip-Arthroplasty Related to the Production of Metal Fragments at Impingement Sites

T. K. Donaldson¹, E. J. Smith², A. Koutalos³, A. John⁴, J. Y. Lazennec⁵, I. C. Clarke^{6*}

How to cite this paper: Donaldson, T.K., Smith, E.J., Koutalos, A., John, A., Lazennec, J.Y. and Clarke, I.C. (2018) Adverse Wear in MOM Hip-Arthroplasty Related to the Production of Metal Fragments at Impingement Sites. *Open Journal of Orthopedics*, 8, 381-412.

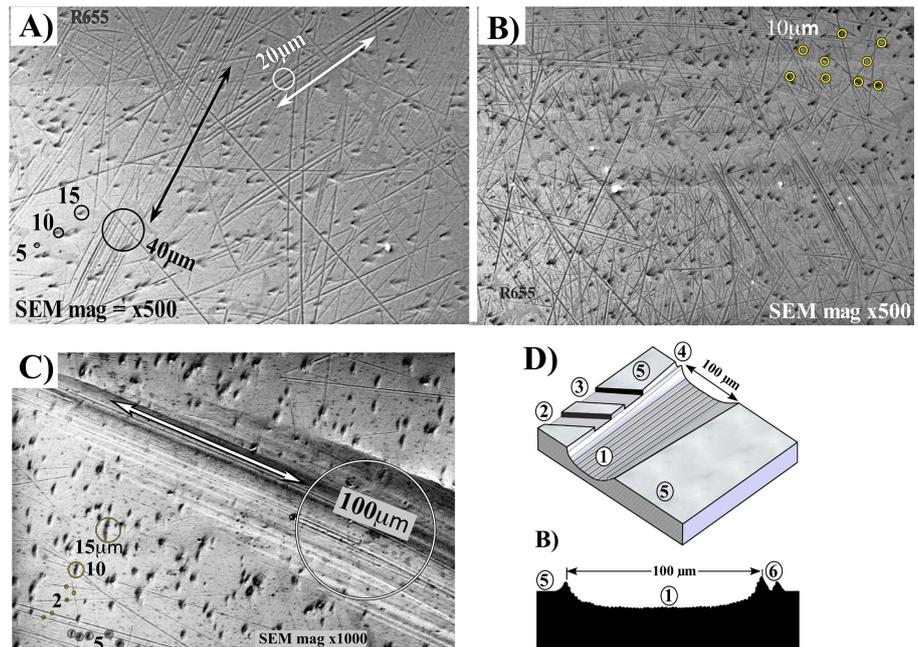
In our THA study [54], pitting and microgrooves were detectable on all retrieved components (**Figure 1**), being more than 10-fold larger than typical background CoCr scratches and carbides. Microgrooves were identifiable by extreme lengths, raised lips and ranging 40 - 160 μm with conspicuous longitudinal striations (**Figure 1(C)**, **Figure 2**). These appeared very similar to type-IV scratches reported in the McKee-Farrar study (**Figure 1(D)**) [40]. Our assumption was that 100 μm wide scratches had been created by CoCr particles 100 μm or larger. However, we found no evidence to support the presence of large CoCr fragments. It is therefore significant that 96% of particles found embedded in the plastic liners of metal-on-polyethylene (MPE) retrievals were metallic, averaging 126 μm in size (ECD: equivalent circle diameter), and some even larger than 2.5

Figure 1. SEM image of Cor scratches and carbide inclusions (46 mm BHR head): (A) Type I-II wear, 5 - 15 μm scale markers indicate fine scratches, carbides and 20 - 40 μm parallel scratch formation: (B) Type-III wear, 10 μm scale markers; (C) Type-IV wear, “micro-groove” with striations (100 μm scale marker); (D) Type-IV scratch modeled on SEM image showing small scratches (#2-4) on CoCr surface (5) intersecting 100 μm microgroove (as in Howie *et al.*, **Figure 5**) [40].

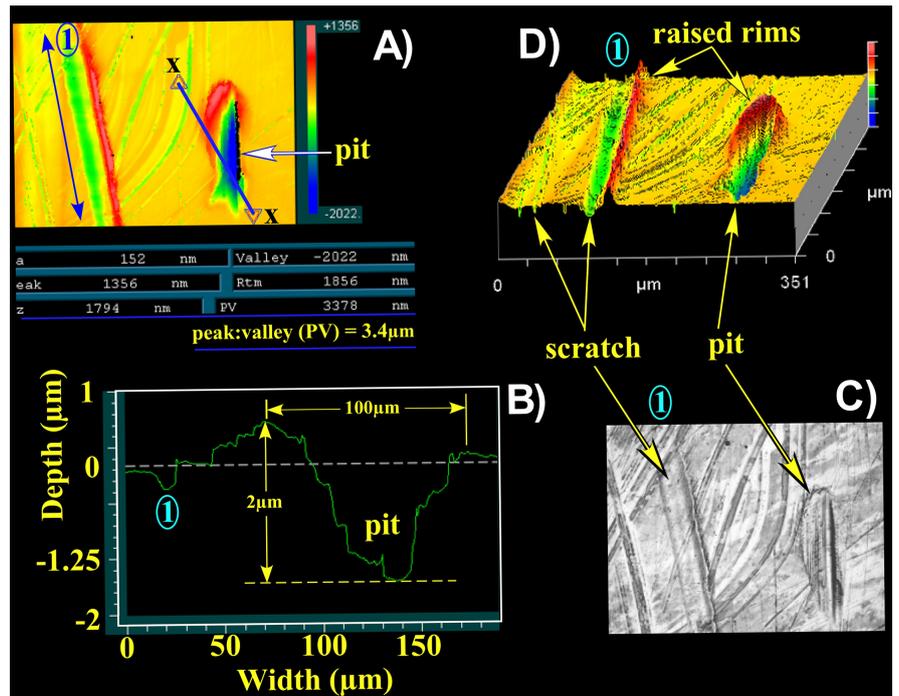
Figure 2. White light interferometer (WLI) images: fine scratches adjacent to large pit: (A) View of scratch (1) and profile trace (xx) crossing pit; (B) Cross-section of pit (xx) as traced in image-A; (C) Light-microscopy image (in image-A); (D) 3D-oblique view: raised lips around scratch and pit.

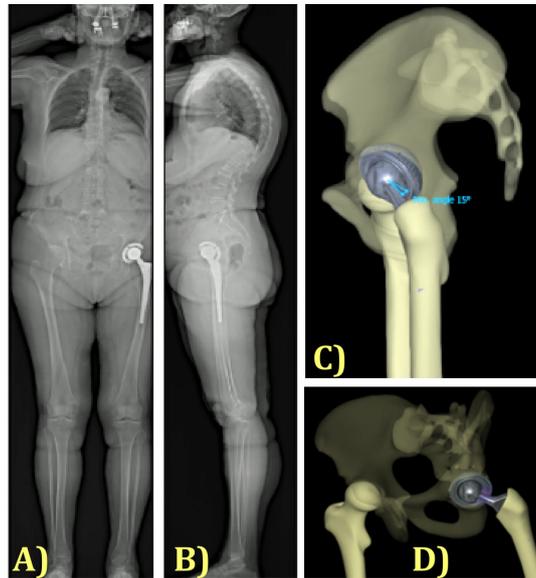
Figure 3. Standing EOS-radiographs with 3D-reconstructions showing 28 mm THA with anterior subluxation (left-hip, female patient): (A) EOS anterior view; (B) EOS lateral view; (C) femoral-neck on cup rim in lateral view; (D) Oblique view of femoral-neck impinging cup rim.

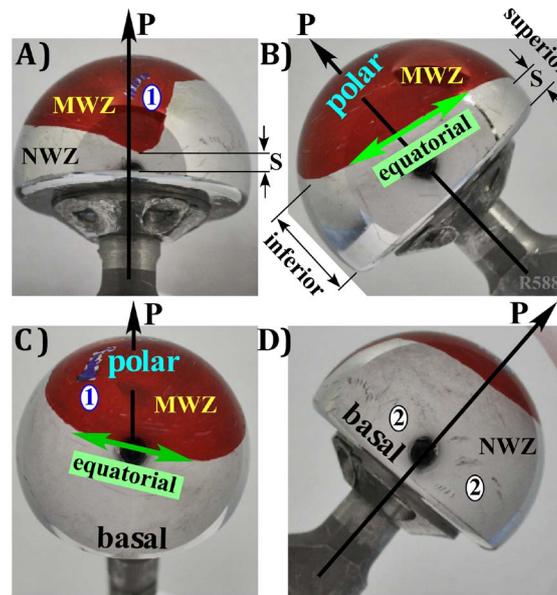
Femoral heads were photographed in four orthogonal views and one polar view whereas cups were simply photographed en-face. Positioning of the narrow NWZ-margin (**Figure 5(A)**, B: S) defined the superior aspect of the femoral head and position of the habitual wear area (MWZ) in vivo. This we validated on THA received with heads fused to their femoral trunnions (**Figure 6**). To define the cup's in-vivo position, the typically eccentric position of its MWZ area was matched to that of the femoral MWZ. The sites of microgrooves visible to the naked eye on head and cup components were colored for photography (**Figure 5**, **Figure 6**: polar as blue, equatorial as green, basal as black).

Figure 5. Main-wear zone (MWZ) on THA retrieval with head fused to trunnion (left hip, 50 mm Magnum THA) [65]. (A) View-1 superior region: narrow non-wear zone (S) and polar microgroove (1); (B) View-2 anterior: equatorial and polar landmarks; (C) View-3: basal, equatorial, and polar site with microgroove (1); (D) View-4 posterior: basal microgrooves.

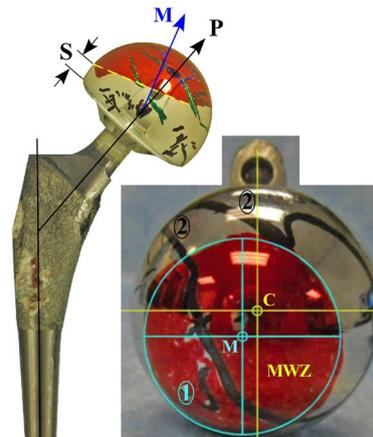
Figure 6. Wear pattern on fused-head (50 mm Magnum THA) illustrating position of NWZ narrow region (S) [65]. Inset shows polar axis (P), MWZ centroidal axis (M) and microgrooves, polar (1) and basal (2). MWZ area 2200 mm² represented 56% of hemispherical area (50 mm MOM).

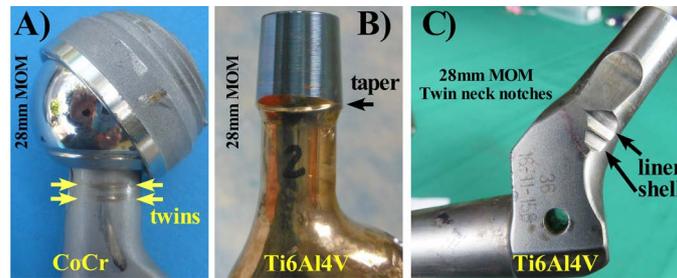
Figure 7. Cup rim impingement indicated by circumferential neck scratches, (A) twin defects on CoCr neck; (B) notch on Ti6Al4V trunion, and (C) two notches on Ti6Al4V neck.

our SROM case (**Figure 7(C)**) had two notches that exactly matched the rim profiles of the Pinnacle shell and CoCr liner [71]. This resembled a precision-machining process, unequivocal retrieval evidence that such neck-notching required millions of wear cycles to acquire. Some femoral necks demonstrated two and sometimes three notches (**Figure 7(A)**). Using geometric THA models, [43] we have shown that the proximal notch indicated the 1st impingement site (**Figure 7(A)**). For the more distal notch, the femoral head had to sublux to a more vertical position, relative to the polar axis (**Figure 8(B)**, **Figure 8(D)**). Such a mechanism, whereby the femoral neck was worn by repetitive oscillations of the cup rim, we defined by the acronym “NAR-damage” (**Table 2**). This was variable, from cosmetic scratches more typical on CoCr necks (**Figure 7(A)**) to deep notches found on Ti6Al4V necks (**Figure 7(B)**, **Figure 7(C)**). In this regard, it is notable that the majority of mating CoCr cups showed no comparable rim damage.

circulating Ti6Al4V fragments, which in turn implicated Ti6Al4V-component impingement (Figure 7(B), Figure 7(C)). This SEM evidence was a significant finding because we could not prove the existence of circulating CoCr fragments or CoCr-transfer. The quandary here was in deducing did the Ti6Al4V particles actually damage the CoCr surface *i.e.* created microgrooves, or did they just form a transfer layer that coated pre-existing microgrooves? For discussion purposes, microgrooves produced by abrading Ti6Al4V particles will be termed 3TI-damage and titanium transfer will be termed TTL-damage (Table 2).

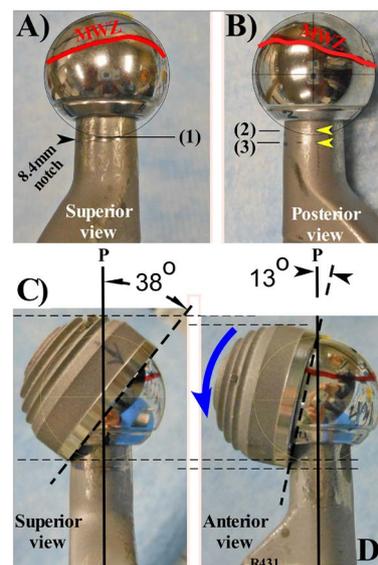
Figure 8. Impingement indicated by circumferential notches on femoral neck (28 mm Metasul THA): (A) notch (1) in superior femoral neck (female gymnast, squatting exercises); (B) twin notches (2, 3) in posterior neck; (C) cup rim contacting notch-3, posterior neck; (D) head subluxed, rim contacting notch-1 on superior neck.

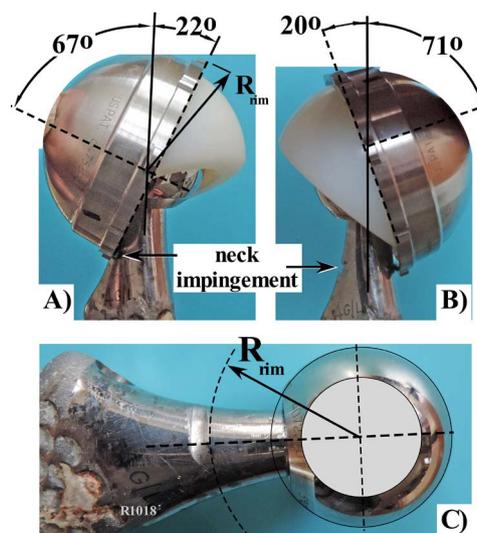
Figure 9. Metal-on-polyethylene THA with neck notch at impingement site.

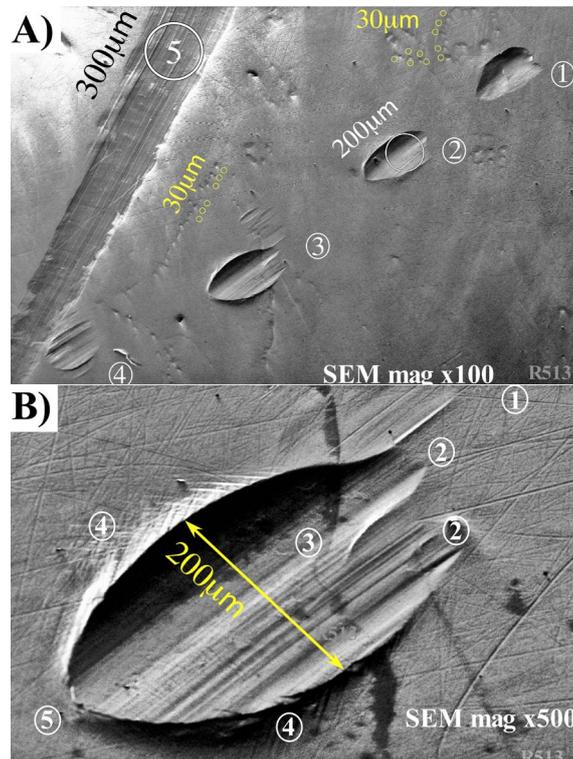
There was unequivocal evidence of large pits in all retrieved MOM bearings (**Figure 10(A)**). The basal head areas (non-wear zone) in particular provided the most dramatic evidence. This was likely because basal regions represent the first sites of ingress for circulating metal particles [49] [58] and such damage was not mitigated by habitual wear during patient’s normal activities (**Figure 5**, **Figure 6**: non-wear zone). Strings of surface pits were characterized by 100 - 300 µm width, smooth entry points, longitudinal striations indicating direction of travel, and lips raised towards the point of egress (**Figure 10(B)**). WLI imaging showed that pits typically varied 3 - 10 µm in depth (**Figure 11**, **Figure 12**). The pits presented partly as a ploughing action that raised scratch lips above the surface (plastic deformation) and partly abrasive action (releasing CoCr debris). For

Figure 10. SEM image of string of pits in basal head (38 mm M2a): (A) 200 µm pits (#1-4) juxtaposed to 300 µm microgroove (5), 30 µm circles indicate carbides; (B) SEM image of pit defect, (1) fine CoCr scratches, (2) entry point of particle, (3) longitudinal striations, (4) plastic deformation in defect lips/shoulders, and (5) exit terminus.

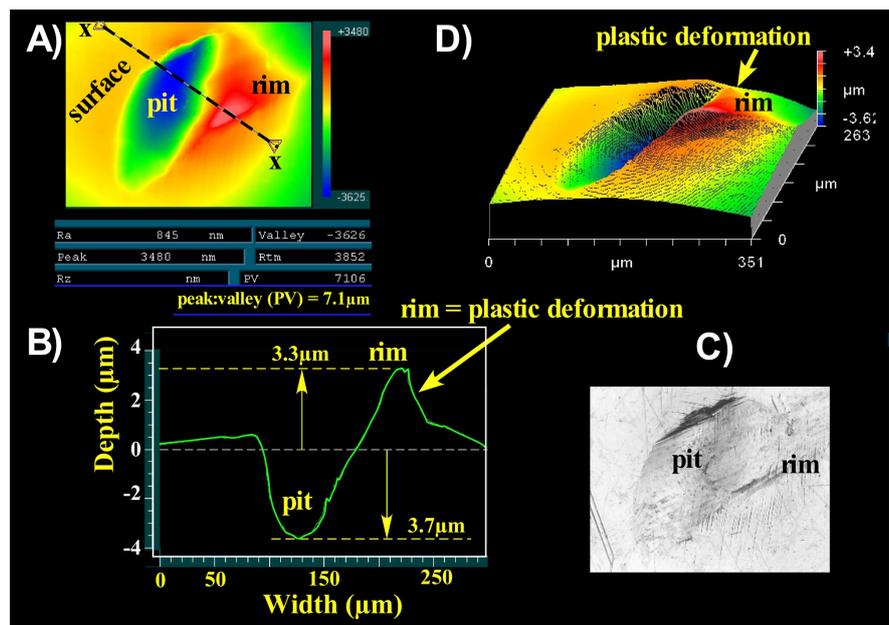
Figure 11. Imaging of pit in basal head area following repetitive sub-clinical subluxations (RSS) and 2 dislocations (complex case, 65-year old rheumatoid patient, 44 mm Magnum) [72] [73]. (A) profile line across pit and elevated lip; (B) Cross-sectional view 100µm defect (valley 3.7 µm, plastically-deformed lip 3.3 µm); (C) Light microscopy image (in image-A); (D) WLI oblique view of plastically-deformed lip and shoulder.

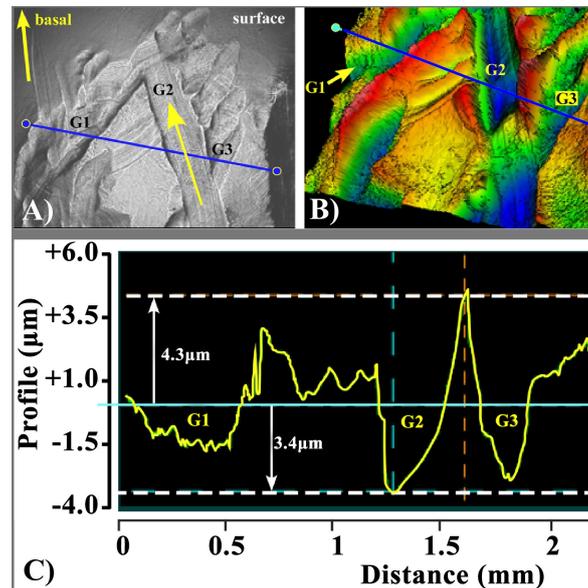
Figure 12. Extensive damage in basal head (dislocating case, **Figure 11**): (A) SEM image of multiple pits and microgrooves (G1-3) oriented in polar direction; (B) Corresponding WLI image showing profile trace.

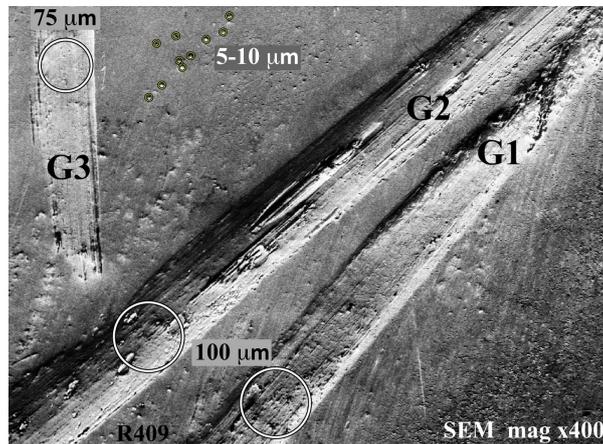
All retrieved MOM bearings revealed microgrooves from 40 to over 100 µm wide with raised lips and linearly-striated sidewalls (**Figure 13**) [54]. Depending on location, these were defined as basal, polar or equatorial microgrooves (**Figure 5**). Our retrieval study may be the 1st to confirm such “type IV” wear as described in the McKee-Farrar study [40]. In addition, the microgroove characteristics, *i.e.* 100 µm width, longitudinal striations, and plastically-deformed lips (**Figure 13**, **Figure 14**) appeared very similar to the large pits (**Figure 10**, **Figure 11**) and both will also be considered representative of 3rd-body abrasive wear by large CoCr particles (**Table 2**: 3CO).

Figure 13. SEM image of twin 100 μm microgrooves (G1, 2) intersected by 70 μm microgroove (G3). Note 5 - 10 μm carbides dwarfed by microgroove size.

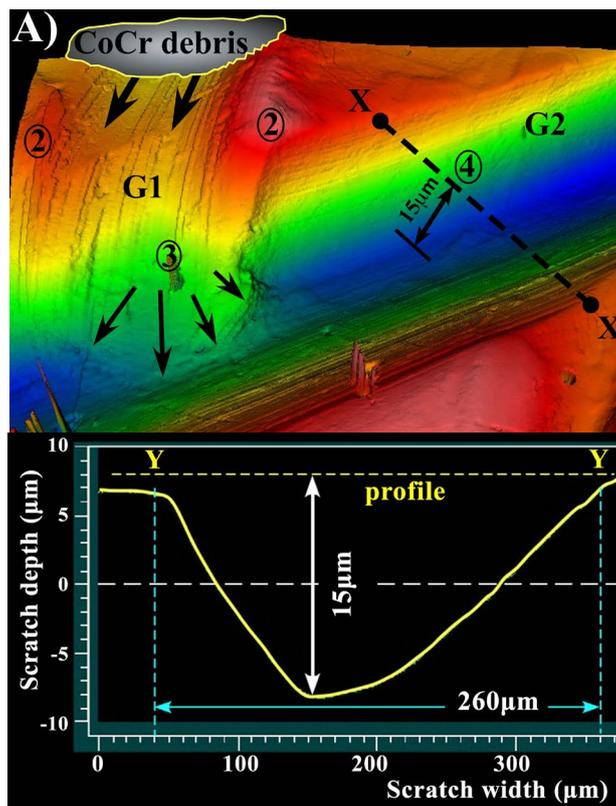
Figure 14. WLI image of 100 μm microgroove (G1) intersecting microgroove (G2) with profile track (xx): (A) Hypothetical metal fragment sketched on microgroove-G1 indicating ploughing direction (arrows) and longitudinal striations, plastic deformation of side-walls (2) and avalanche-like flow of CoCr matrix (3); (B) Cross-sectional profile (xx) of microgroove (G2: 260 μm wide, 15 μm deep).

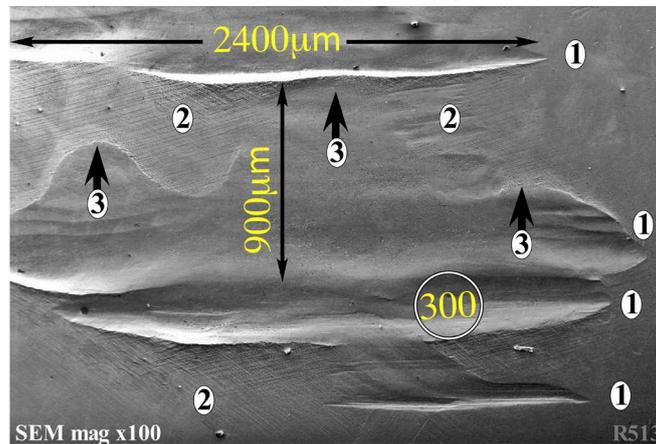
Figure 15. Gouges formed by plastic deformation in basal head (38 mm M2a): (1) parallel surface defects; (2) slip planes; (3) plastic-deformation.

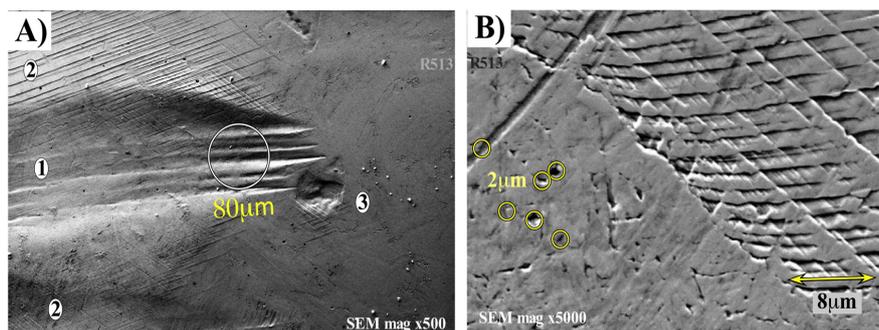
Figure 16. Damaged basal head (38 mm M2a). (A) Large defect (1) and pit (3) surrounded by slip bands (2); (B) Higher magnification of slip bands.

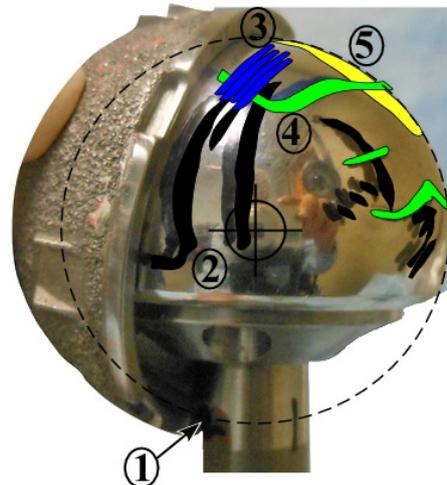
Figure 17. Retrieved head (44mm Magnum) positioned on surrogate femoral stem with impingement on cup rim (1), rim juxtaposed to basal (2: black) and polar (3: blue) microgrooves. Equatorial microgrooves (4: green) and degraded protein layer (5: yellow) as indicated.

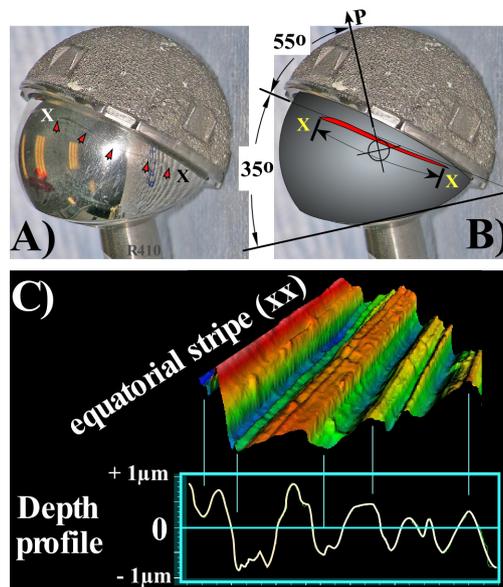
were less predictable, could vary from short to considerable length, and were generally not at locations associated with prosthetic impingement (**Figure 18**).

Figure 18. Same worked example (Figure 17) showing cup rim juxtaposed to equatorial microgroove: (A) Visual of long microgroove (red arrowhead track-xx); (B) Cartoon depicting microgroove > 40 mm length oriented 55° to polar axis (P); (C) WLI profile showing longitudinal striations (2 μm peak-to-valley).

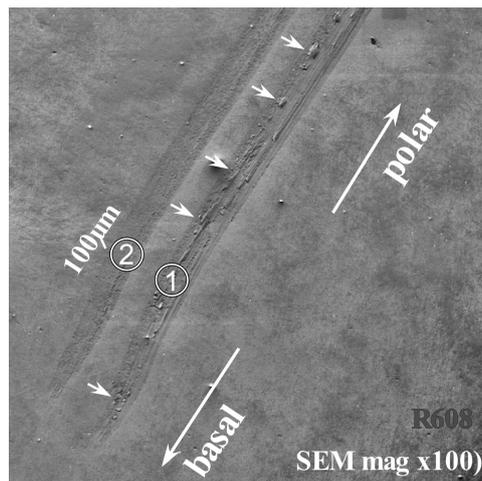
SEM analysis demonstrated basal scratches that resembled 100 μm wide microgrooves, except they lacked typical longitudinal striations (**Figure 19**). WLI imaging frequently revealed multiple parallel tracks that represented metal transfer of 1 μm thickness with 3 - 5 μm peak heights (**Figure 20**). SEM analysis (**Figure 21(A)**) and energy dispersive spectroscopy imaging revealed predominantly elemental titanium (Ti) tracking along CoCr surfaces (**Figure 21**). SEM analysis also revealed longitudinal surface striations exiting some transfer layers. These tracks were therefore considered microgrooves coated by a layer of titanium transfer. Clinical studies of MOM THA have demonstrated that high concentrations of Ti-ions correlated with femoral-neck notching noted in revised Ti6Al4V stems [77]. This unequivocal evidence of metal transfer proved existence of large

Figure 19. SEM image of twin 100 μm microgrooves extending from base of head in polar direction (47 mm ASR XL). Metal transfer (arrows) shown obscuring any longitudinal striations.

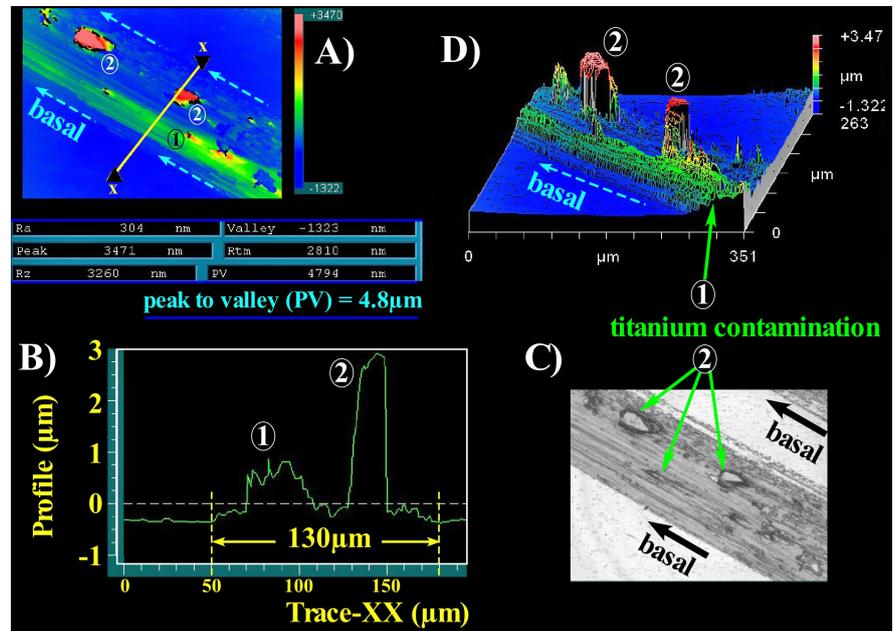
Figure 20. WLI images of twin 100 μm tracks with metal transfer (36 mm Pinnacle): (A) Profile trace indicated across transfer peak; (B) Profile of metal transfer, 1 - 4.8 μm thick; (C) Light microscopy (in image-A); (D) 3D oblique view of metal transfer (presumed titanium).

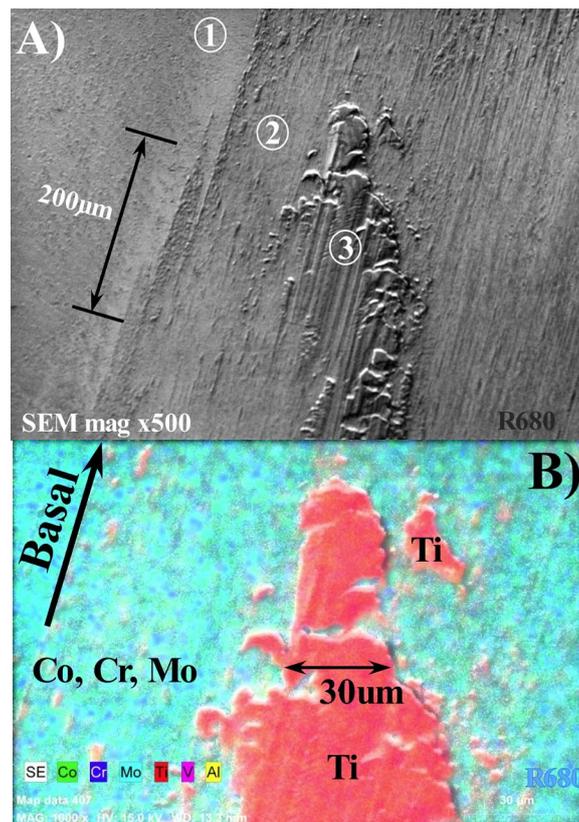
Figure 21. Images of basal microgroove in Figure 20 showing metal transfer: (A) CoCr surface (1) with exposed carbides, (2) metal transfer layer, and (3) metal peaks; (B) Energy dispersive spectroscopy (EDS): titanium smear track crossing CoCr surface.

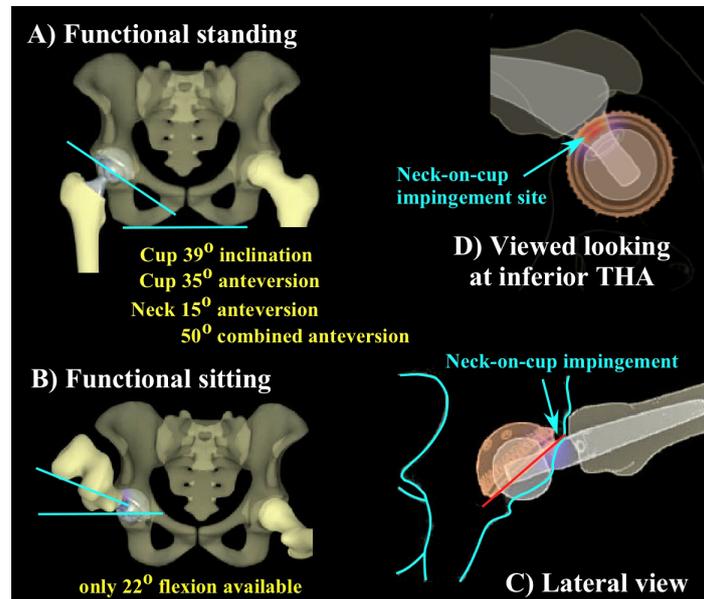
EOS images in the functional-standing position of the 2nd example showed a cup with 40° inclination and 35° anteversion (**Figure 23(A)**). Including 15° of femoral anteversion, this hip demonstrated 50° of combined anteversion. This patient's standing posture showed 37° motion available before neck-on-cup posterior impingement for extension testing. Thus, EOS imaging demonstrated no significant limitation in functional-standing. However, in functional-sitting position (**Figure 23(B)**), this patient had only 22° of flexion arc. This hip impinged

Figure 23. EOS-reconstructions with cup-impingement site in functional-standing: (A) frontal and lateral images in functional-standing posture; (B) functional standing (1) and impingement revealed in extension-test (2); (C) Oblique 3D-reconstruction, femoral neck close to posterior cup rim; (D) Lateral reconstruction, 15° arc before neck impinged posteriorly.

and subluxed, as demonstrated in the corresponding lateral (**Figure 23(C)**) and inferior views (**Figure 23(D)**).

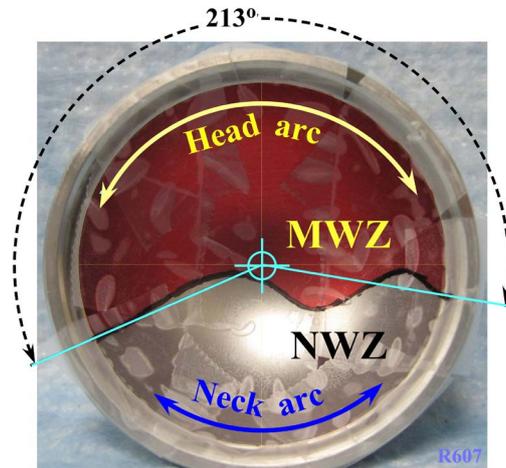
- 6) The circular shape of femoral wear-patterns (**Figure 6**) was not duplicated in cups. The cup wear-patterns were mostly eccentrically positioned around arcs of cup rim (**Figure 24**).

Figure 24. Position of main-wear zone (MWZ) representative of superior quadrant in retrieved cup (46.5 mm ASR). Cup rim-wear produced by subluxing head extends around large arc (213°) while femoral neck rotated against contra-rim (neck arc).
