# Aspects of Transformer Fires in Brazil

Dayse Duarte

Departamento de Engenharia de Mecânica, Universidade Federal de Pernambuco, Recife, Brazil

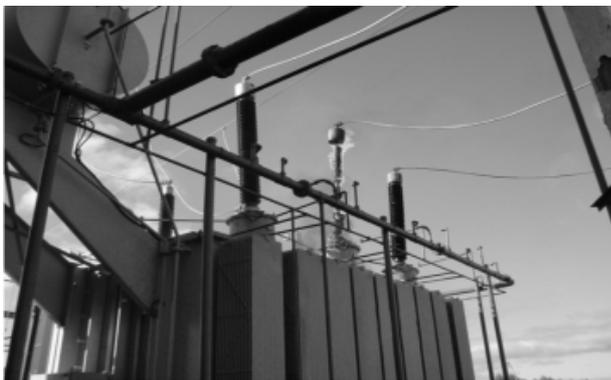
It is not difficult to identify substations or hydroelectric power plants in which, despite both active and passive fire protection barriers, a fire has caused extensive destruction. In **Figure 1**, an autotransformer of 150 MVA protected by a spray system caught fire as a result of a bushing failure. The spray system did not operate when the fire began. Due to the oil leakage through the base of the bushing, this delay caused the fire to spread. NFPA 15 describes water spray design for transformers. Even if suppression systems are available, there are many uncertainties concerning their success or failure in controlling the fire. The questions that arise include: Can water be discharged from the spray system? Can water extinguish the fire? Water will be discharged from the spray system if all water supply valves are open, but when the sensor fuses, will enough water reach the spray head? Moreover, the violent nature of a transformer fire could render an automatic spray system useless. Although this has happened on a number of occasions, the automatic spray system survived the explosion and was credited with controlling the fire, limiting damage and minimizing system downtime. As the system in which the transformer is inserted has a dynamic behavior, the various fire scenarios are subject to many uncertainties.

**Figure 1.** Escalation of a transformer fire.

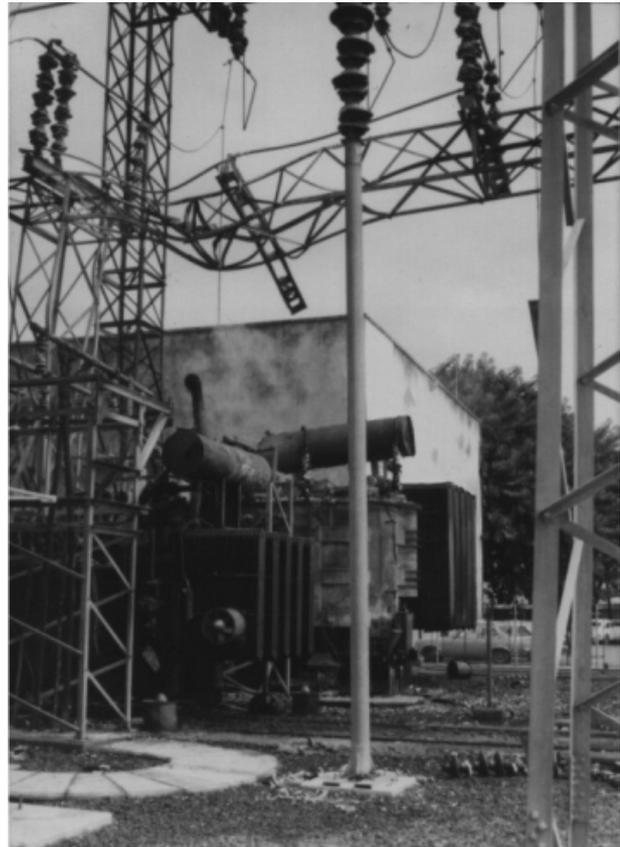
**Figure 2** shows the result of a transformer fire which rendered the substation unavailable and left about one million people without energy, because the structures that supported the overhead bus collapsed.

**Figure 2.** Collapse of overhead bus due to a fire.

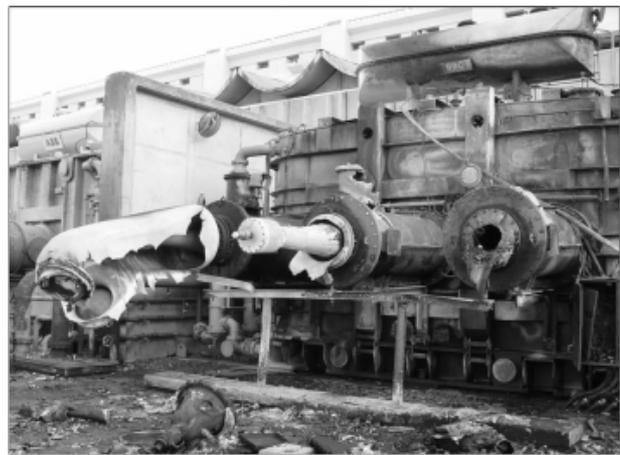
**Figure 3**, a fire in a generator step-up transformer spread to other units due to poor design of the fire wall

and the rock-filled pits. Rock-filled pits are a passive control measure against soil contamination in the event of a major transformer oil leak and fire. As well as a flowing liquid fire, it is also important to prevent a Boiling Liquid Expanding Vapor Explosion (BLEVE). A rock-filled pit should use clean rocks of a certain size and extend to a defined depth in order to ensure that the flow of burning oil through the rock layer is sufficiently fast to cool the oil and extinguish the pool fire.

**Figure 3.** A transformer fire caused by bushing failure.

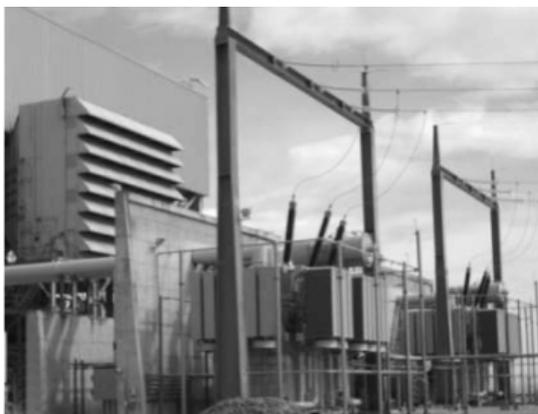
**Figure 4.** Detail of a power plant layout.

(**Figures 4 and 6**) can spread the impact to other parts of the substation. The time necessary to re-integrate the substation into the network will thus increase, even without considering the other costs involved. The compatibility of the substation layout with fire behavior is important to understanding the substation's post-fire operational continuity.

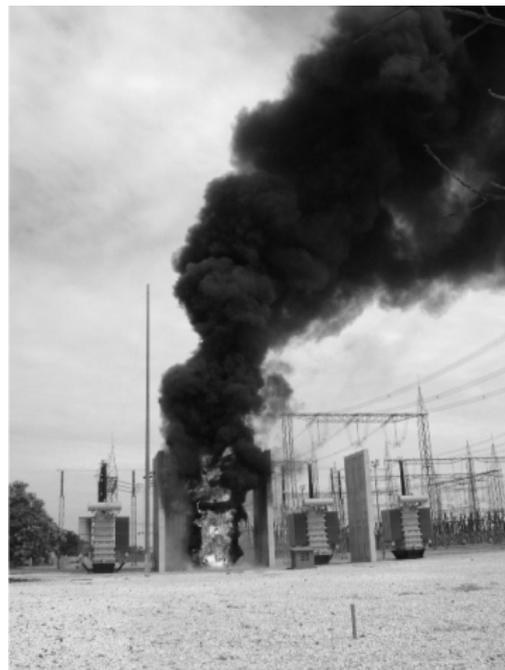
5.3) An insulating oil pool fire created a very large fire plume. Due to high wind speeds, the fire plume tilted significantly and exposed adjacent equipment, buildings and other structures, as well as causing significant soot deposits in the downwind plume area (**Figure 5**).

**Figure 5.** Fire plume from a reactor fire.

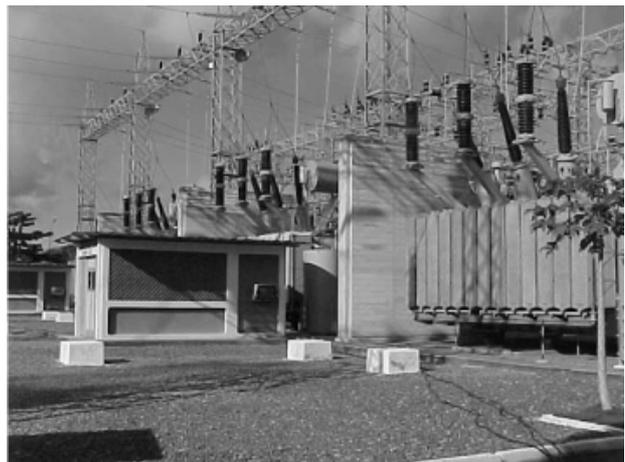
tion, its effectiveness is questionable, because it was introduced in isolation from the rest of the system (as will be shown in the following paragraphs). **Figure 6** shows details of the layout of a 230/69 kV substation. This substation was initially designed, constructed and operated for some years without firewalls. Firewalls were constructed at a later stage, probably because a transformer fire in another substation without firewalls destroyed the transformer adjacent to the one on fire. As firewalls exist to protect adjacent transformers in the event of one catching fire or exploding, firewall failure may result in the loss of additional transformers. Although the firewalls were designed to resist fire for 4 hours, studies conducted by Duarte *et al.* [1] showed that they can start to collapse after just one hour. In **Figure 7**, the grey area shows that the structural integrity of the firewall was compromised, since compressive and tensile stress exceeded the values of  $150 \text{ kg/cm}^2$  and  $15 \text{ kg/cm}^2$  respectively.

Figure 6. Detail of substation layout.

For the substation shown in **Figure 6**, it is also important to note the relay houses. Some of the protection, bypass and control circuits that control the transformers and other substation equipment are installed in the relay house. In this particular substation there are two relay houses whose structure is masonry with glass windows. A structural thermal performance simulation of one of the relay houses during a transformer pool-fire was carried out using the finite elements method. The distance between the transformer and the relay house was 3.50 meters. Ninety minutes after the fire started, the wall temperature distribution showed some wall temperatures to be above 300°C. Although such high temperatures can cause wall failure, the structural integrity of the walls, pillars and beams was maintained for 117 minutes after the fire started. 45 minutes after the fire started, the glass windows would break, so there would be a rapid increase in the gas temperature inside the relay house. The heat impact would cause irreversible damage to the electronic panels. Analysis of gas temperature distribution inside the house showed that temperatures higher than 70°C would be reached in approximately 30 minutes.

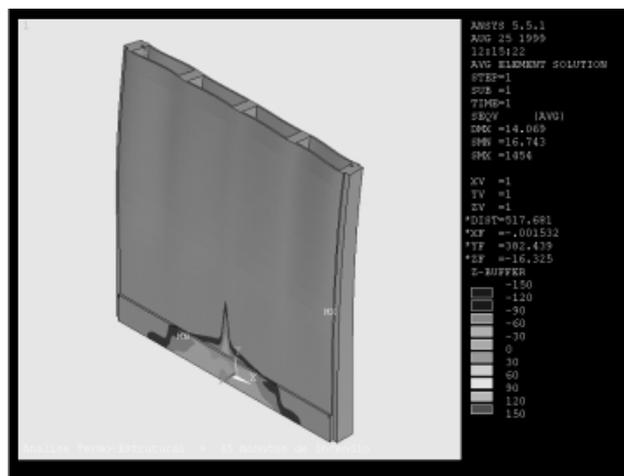
Figure 7. Von Mises tension test on firewall after 60 minutes.

Why did the engineers who designed the firewall believe it had a fire resistance of more than 4 hours? They did not take into account the energy released by a fire or explosion. They did not ask the following question: what will the energy release be if a fire or explosion occurs in one of the transformers? The answer involves the quantification of the physical phenomena involved in a fire or explosion. What is surprising is that the design team thought that all the transmission transformers were protected against a possible fire. About a hundred firewalls of the same design were constructed in other substations of the transmission network managed by this company. However, since the transmission transformer specifications are not the same for the entire network, the energy released during a fire or explosion differs among transformers in operation. The energy release depends on such things as the transformer capacity, distance between the transformer and the firewall, type of fire resulting from the transformer failure, oil characteristics, wind velocity and direction. As a result, some of the firewalls of this particular transmission network are over-dimensioned and others under-dimensioned.

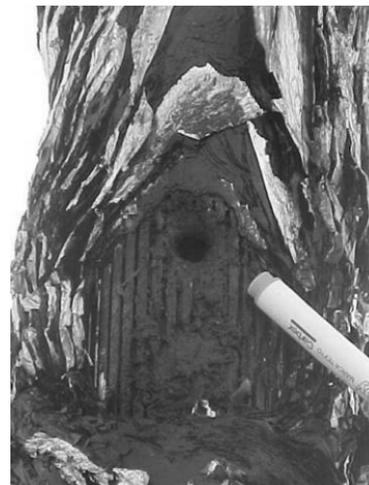
The main causes for bushing failures are extremely difficult to determine. The basic obstacle lies in the fact that the explosion leaves little to trace the origin of the fault and provide a reliable diagnosis. The main cause of bushing failure is poor sealing and the resulting reduction of supportability due to contamination by oxygen (oxidation) and humidity (hydrolysis). Sealing failure occurs due to degradation of seals or corrosion. Other causes that should be considered are the bad connection of a capacitive tap, storage in the horizontal position for a long period, pollution effects on porcelain, overheating and very fast transient overvoltages [7]. **Figure 13** shows bushing failure due to insulation degradation resulting from manufacturing defects. If a bushing fails, oil is expelled. If there is a rupture at the oil end of the bushing housing, oil from the transformer will feed a fire and the fire will spread to the main tank. Some bushing failure causes are represented in detail in **Figure 14**. **Figure 15** shows how a bushing failure can result in a transformer fire.

**Figure 13. Bushing failure caused by degradation of its insulation.**

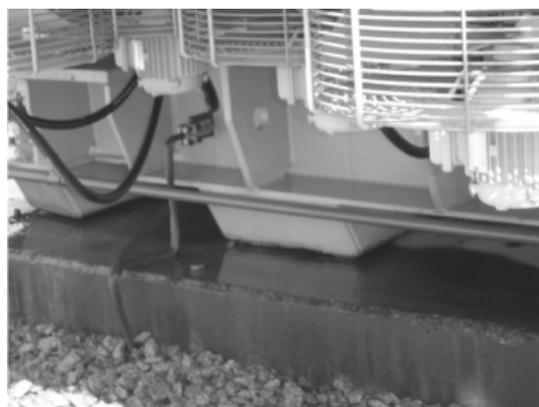
Poor mechanical design of the transformer could cause oil leakage (**Figure 16**), leading to oil contamination and thus to transformer fire. Additionally, a failure in the maintenance of an oil-filled transformer could result in a pool fire, spray fire or Boiling Liquid Expanding Vapor Explosion (BLEVE). The principal environmental impact would probably be the discharge of oil into the soil, which could affect the water table. In order to prevent soil contamination in the event of a major leak, rock-filled pits should collect the oil.

Since 1995 FURNAS has been observing an increase in the failure rate of new transformers and reactors, either during acceptance tests or in the first year of operation. Although these failures have not been catastrophic, they have resulted in equipment becoming unavailable [8]. The failure analysis pointed out deficiencies in the manufacturing process and dielectric design. For example, oil leakage from the main tank was observed to be a result of poor welding leading to the contamination of the mineral oil (**Figure 16**). This could have caused a transformer fire or explosion.

**Figure 16.** Oil leakage will probably cause oil contamination.
