Characteristics of Seismic Hazard in a V-Shaped Valley and Hazard Mitigation Methods

Yan-Ling Qiu¹, Ling-Kan Yao^{1,2*}, Quan Yuan³

How to cite this paper: Qiu, Y.-L., Yao, L.-K. and Yuan, Q. (2015) Characteristics of Seismic Hazard in a V-Shaped Valley and Hazard Mitigation Methods. *Open Journal of Safety Science and Technology*, 5, 27-36.

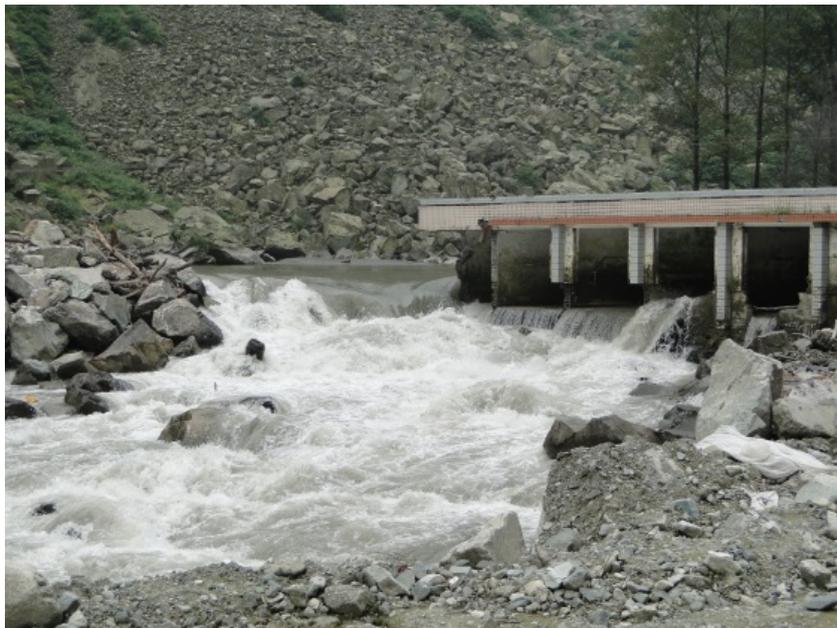
Figure 3. A quake lake formed by rock avalanche deposits submerged a hydropower station.

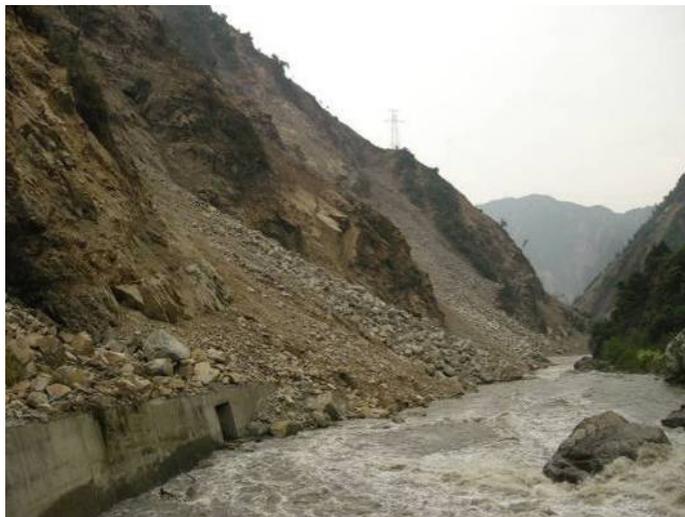
Figure 4. Rock avalanche buried the embankments.

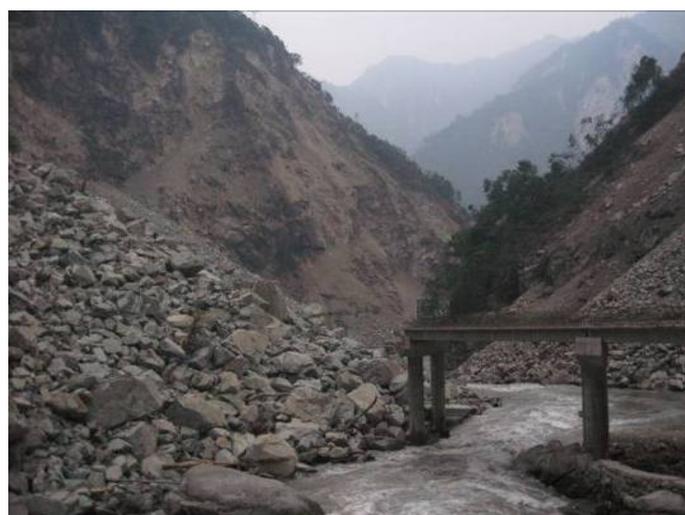
Figure 5. Rock avalanche destroyed the bridge.

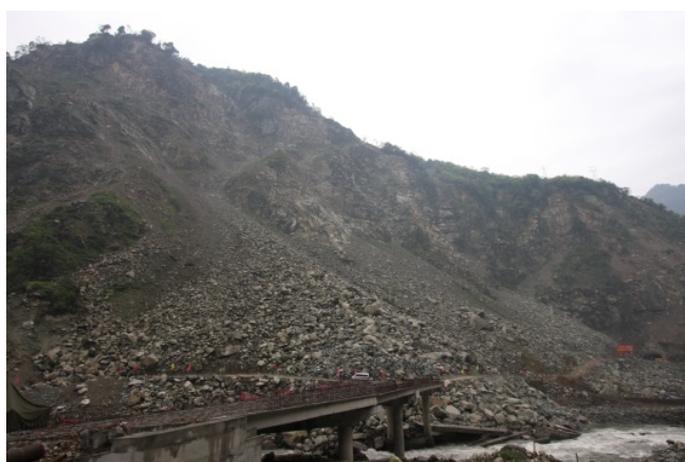
Figure 6. Rock avalanche fell from the steep slopes continuously, destroyed the bridge and buried a large section of road.

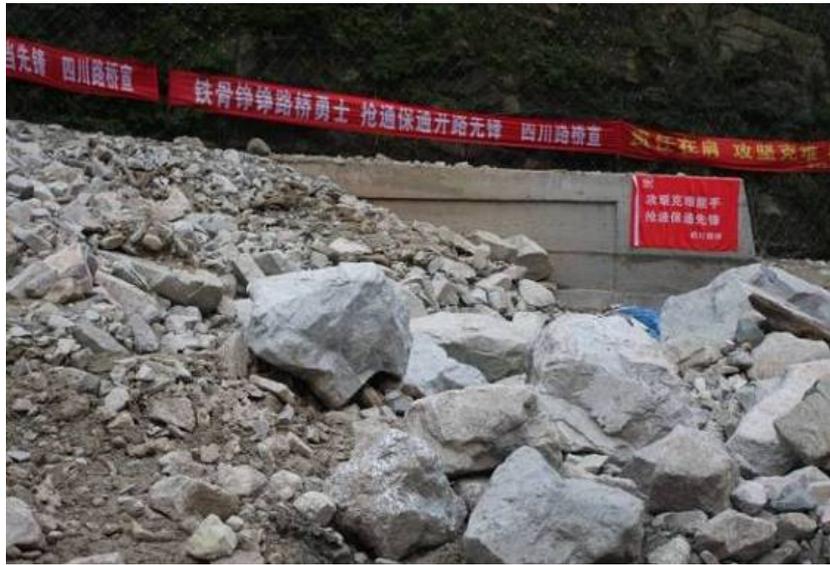
The Xiaojiagou gully is very close to the portal of newly-built Nanhua Tunnel. An excessive large-scale debris flow of 0.5 million-m³ outbreak in the gully, accumulating together with the slope debris flow near tunnel portal. The deposits buried the entire tunnel portal and stuffed the whole tunnel. The river silted up and the riverbed uplifted 30 m high. The water level rose above the route elevation more than 20 m and reached the roof of the tunnel. More than 1km length of roadbed was buried and submerged. It was one of the most affected sections by debris flow hazard. Figure 7 and Figure 8 show the portal before and after the event. The Xiaojiagou

Figure 8. The portal of Nanhua tunnel was buried by debris flow deposits after August 13, 2010.

gully is an old debris flow with a watershed area of 0.24 km², and there has a debris flow drainage canal before the earthquake. According to a survey, loose or non-consolidated materials for originating were estimated to be up to 3.57 million·m³ after Wenchuan earthquake. The huge material threatened the road continuously.

V-shaped valley need pay attention to post-seismic debris flow hazard, which may form dammed lake and rise the water level substantially. The design of the basic line elevation needs a series of study on the hazard: A survey on the amount of material source, a calculation of the deposit in recovery period, an estimate of the rising water level. Earthquake shaking generates a lot of fresh discontinuities and expands the pre-existing discontinuities in inner hard rock. These discontinuities expand in the weathering process, and finally disintegrate into blocks and fall down. Rock fall is the most common and the longest duration hazard after an earthquake. Structures stabilization or protection against rock fall shall be considered in design to mitigate the damage, and tunnels are proposed to avoid areas of rock fall.
