Geo-Electric Assessment of Kali Failed Dam Project Aliero, North Western Nigeria

Abstract

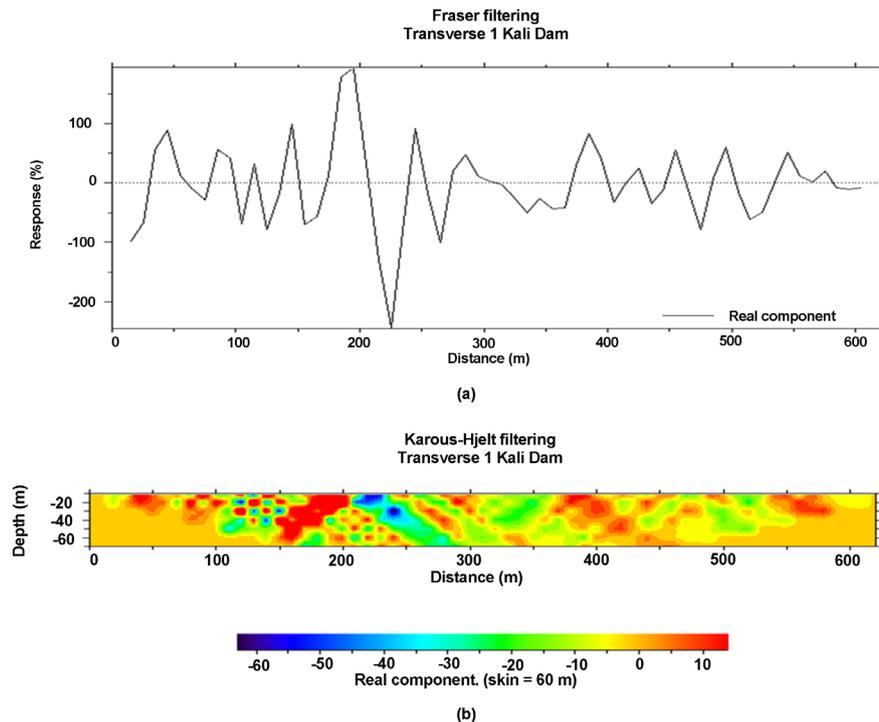
Transverse 1 (620 m long) is in the vicinity of the main reservoir of kali, Aliero dam Prominent cross-over point that depict the exact location of the subsurface fractures appear within 50 m, 200 m and 400 m from the starting point of the profile (**Figure 2(a)**). The fracture zone appears as a positive peak, indicating a conductive characteristic, compared with the surrounding rocks. The inferred pseudo section (**Figure 2(b)**) shows that the fracture content is resistive with a response signal of around -50% and extends beyond a depth of 60 m, the model further shows that the area along this profile is generally underlain by a resistive rock, the most prominent identified homogeneously at 220 m. Thus, the pore there could indicate presence resistive bodies such as clay, sand or empty space.

Figure 2. Plot of VLF results along the Traverse 1, (a) unfiltered Real component of VLF-EM data, Fraser filtered real (in-phase) data against distance, (b) Karous and Hjelt pseudo-section of in-phase data (apparent current density pseudo-section) against distance.

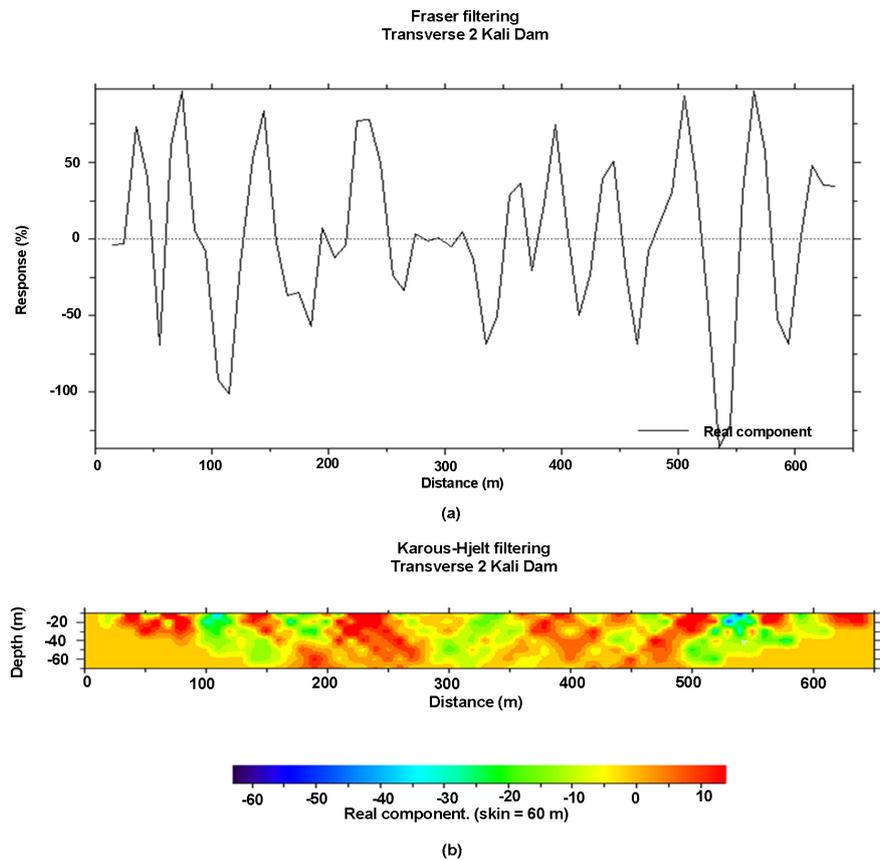
Transverse 2 is parallel to traverse 1 in the same location at the dam embankment with length of 640 m. A prominent fracture appears at subsurface at distance 40 - 80 m, 120 - 280 m and 380 - 500 m (**Figure 3(a)**). The minimum signal response is +50% upward and it extends beyond 40 m depth at some points. The fracture depicts a high conductive zone (**Figure 3(b)**). There is an evidence of low consolidation at the beginning of this profile but the consolidation increases towards its end with exception of some minor location *i.e.* 100 m and 520 m that indicate resistive zone.

Figure 3. Plot of VLF results along the Traverse 2, (a) unfiltered Real component of VLF-EM data, Fraser filtered real (in-phase) data against distance, (b) Karous and Hjelt pseudo-section of in-phase data (apparent current density pseudo-section) against distance.

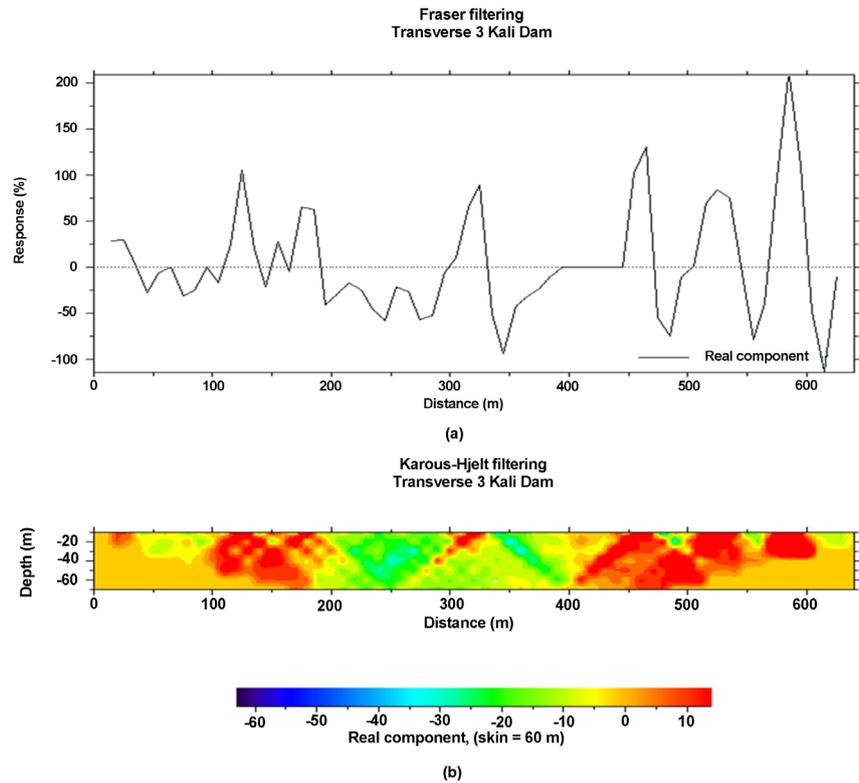
transverse 3 is at the dam canal with a total length of 620 m. Highly conductive fracture zones appear at a distance of 100 - 190 m and 400 - 600 m (**Figure 4(a)**) with a common signal response of +100% and above. The pore could be considered to contain conductive material such as water. At 230 - 250 m and 350 m on the profile, fractures whose content is less conductive appear. The fracture depths start at 20 m and extend as far as 50 m in most cases. The fracture system here could be inimical to the stability of the dam in question.

Figure 4. Plot of VLF results along the Traverse 3, (a) unfiltered Real component of VLF-EM data, Fraser filtered real (in-phase) data against distance, (b) Karous and Hjelt pseudo-section of in-phase data (apparent current density pseudo-section) against distance.

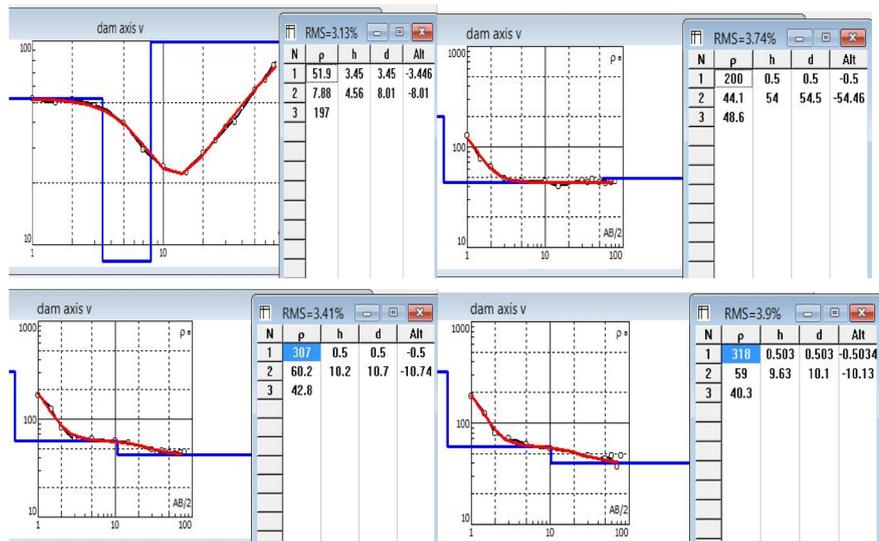
From the resistivity curves the geoelectric layers varies from 3 - 4 in all the traverses. The geoelectric layers delineated correspond to the upper sand and clay or top soil, confining clay and artisan aquifer. This is summarized in **Table 1**. The resistivity and thickness of the top soil (upper sand and clay) varies from $51.9 \Omega\text{m}$ - $318 \Omega\text{m}$ and from 0.5 m - 3.45 m respectively. The second layer has resistivity and thickness that ranging from $7.88 \Omega\text{m}$ - $60.2 \Omega\text{m}$ and 4.56 m - 54 m which is probably clay to confined clay. Its resistivity varies with degree of saturation. The third layer, artisan aquifer has resistivity range of $40.3 \Omega\text{m}$ - $197 \Omega\text{m}$ and thickness of 5.76 m - 73.9 m respectively as shown in **Table 2**. The Fracture seated in this layer can affect the stability of dam if it extends to the subsurface. In fact the resistivity values captured are almost low in all the 10 VES stations as highlighted by [17], in **Table 1**. At a depth of about 4 m to 35 m, a relatively weak zone with apparent resistivity value ranging as low as $<100 \Omega\text{m}$ is shown in pseudo section (**Figure A2**) at VES 1 and VES 2 at depth ranging from 5 to 30 m with low resistivity that are suspected to be clay portion, as compared with remaining 8 VES stations. This weak zone could be as a result of closeness of static water to the subsurface of the area or as the tip of a weathered rock of the sedimentary rock underlying the area.

Figure A1. Model result of VES curves at four location VES 1, VES 2, VES 3, and VES 4 respectively.

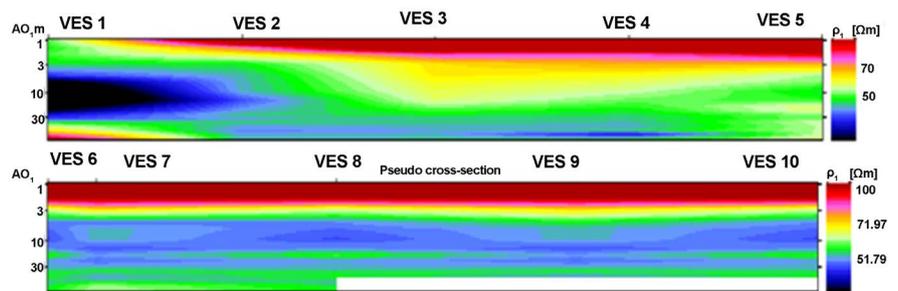
Figure A2. 2D geoelectric pseudo section equivalent of the geologic formation.

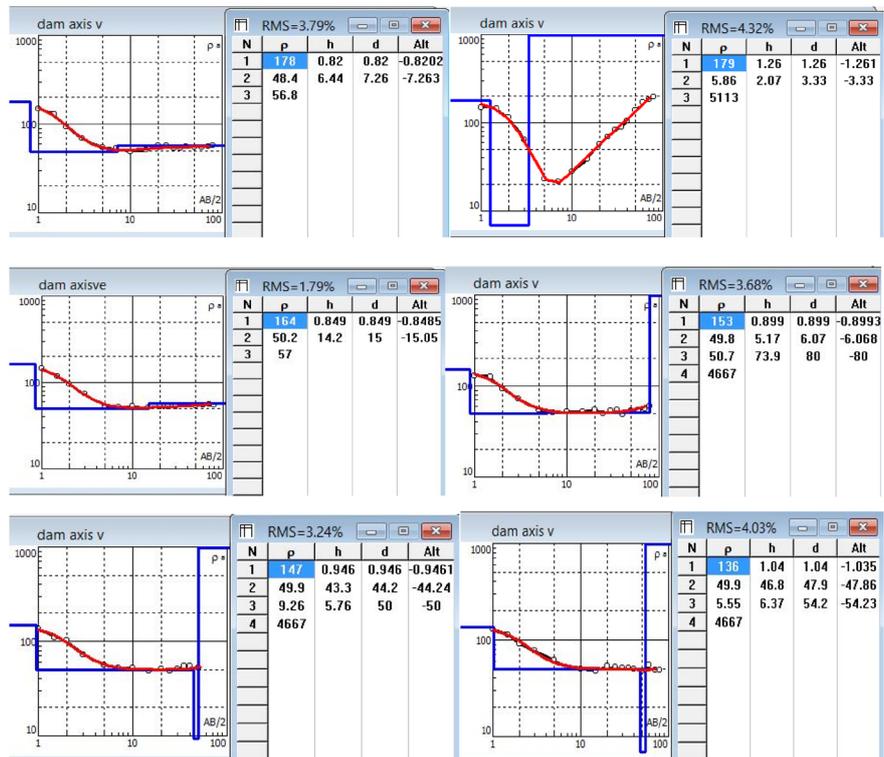
Figure A3. Model result of VES curves at four location VES 5 to VES 10 respectively.
