The Collapse of Culverts-Arch in Several Cities around the World, Technical Arguments for Their Maintenance and a Legal Proposal for Prohibiting Their Construction in Mexico

Martín D. Mundo Molina*, José L. Pérez Díaz, Daniel Hernández Cruz, Eber Godínez Domínguez

Academic Group Science and Engineering, Research Center of the Engineering Faculty, Chiapas State University, Chiapas, Mexico.

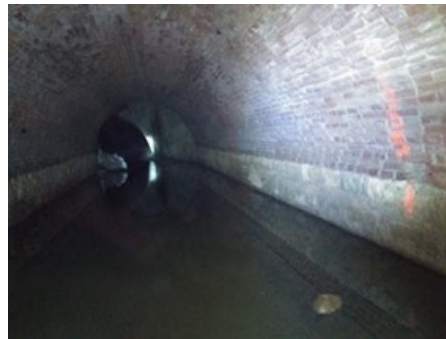
Figure 2. San Roque's UCA, Tuxtla Gutiérrez, Chiapas [3].

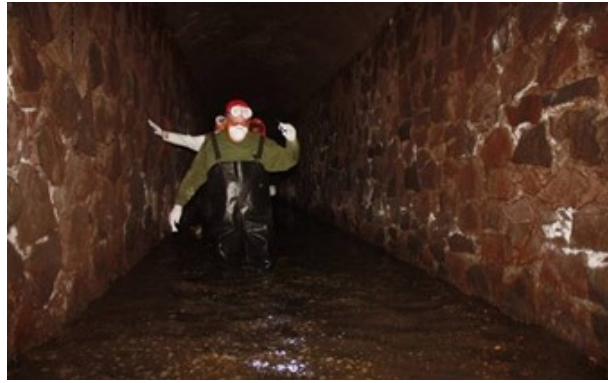
Toluca, Estado de Mexico, Mexico. Toluca is the capital of the Estado de Mexico, and the city has grown in a disorganized way with hundreds of people living in federal areas of the rivers that cross the city. According to the Water and Sanitation Organism of Toluca, families are at risk for the possible collapse of the UCA constructed above Verdiguél River (Figure 3). The federal area of the Verdiguél channel was invaded by citizens who built their houses over the UCA, and the risk grows every day due to the erosion of the structure's foundation, especially on the stretch between Morelos Street and Maestros avenue. Citizens and some concerned institutions have reported the situation to the authorities because there is a record of previous minor collapses of the structure. On February 10, 2015, a part of it caved in between the Lerdo and Quintana Roo streets [7].

Figure 3. Verdiguél river's UCA [7].

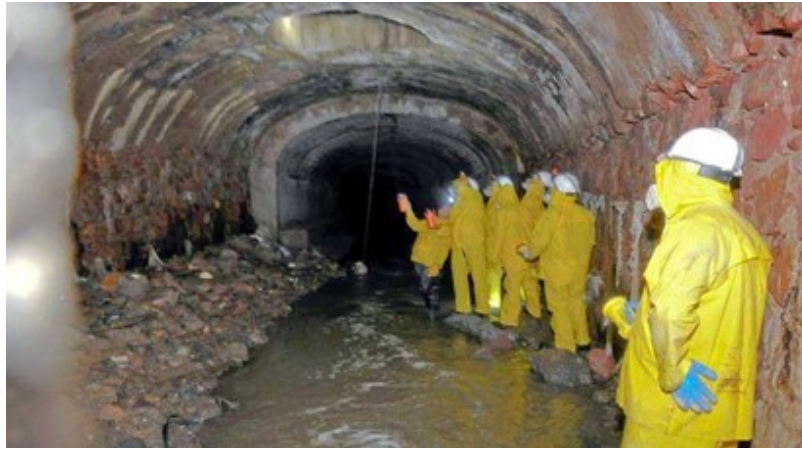
Zacatecas, Mexico. Each rainy season, the risk of collapse of the UCA in the historic center of Zacatecas resurfaces due to the undermining, erosion, and lack of maintenance of its structure. Some of the damaged sections are close to cavities in the subsoil, product of the mining activities of the XIX century, which have weakened the structure's foundation [16]. In the wake of the collapse of a section of the UCA, the Public Works Department (PWD) intervened to repair the damage and in 2014 the Protection Board for Monuments and Typical Areas elaborated a diagnosis of the physical state of the UCA, intending to study the structure's stability. The UCA was built in several stages from 1850 to 1900 approximately, during the colonial era [17].

In April 2019, the Department of Environment and Water (DEW) delivered another study that confirmed the need to give constant upkeep to the UCA (Figure 4). The DEW studied about 200 hectares of the principal UCA and

Figure 4. La Plata river's UCA, Zacatecas, Mexico [16].

seven secondary ones located in the area. The UCA begins in Bracho hills, goes all the way to Bicentenario Square, and continues in direction to the Guadalupe municipality. There, the UCA branches into secondary channels, which have also suffered several collapses. In the city's historic center, which was declared Cultural Heritage of Humanity, are several important buildings like the Government's Palace and the Cathedral which are among the hundreds of constructions built over the UCA, and are in danger due to the natural deterioration and lack of maintenance of the structure [16].

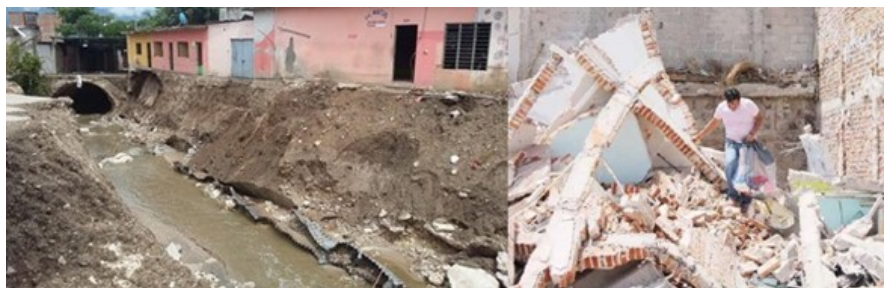
On September 2, 2016, a section of the San Roque UCA, located at 12th South and 3rd East street in Tuxtla Gutierrez, Chiapas, collapsed. That night, the rains lasted three hours with a 115 l/m² intensity, the out of control runoff overflowed the stream and damaged houses close to it and the water flow dragged a vehicle. Photo 3 shows the collapsed tunnel vault. The lack of maintenance and insufficient capacity of UCA, plus the hydraulic push and the flow's momentum caused the UCA to break and collapse, taking down a house built over it, and damaging six more houses (**Figure 5**).

Figure 5. UCA and house, collapsed [19].
