# Explanation of the Damage to the Royal Family's Cemetery in Historic Cairo and Examination of the Building Materials

Ahmed Elyamani<sup>1\*</sup>, Nabil A. Abd El-Tawab Bader<sup>2</sup>, Mahmoud Algohary<sup>1</sup>, Ragab Abou El Hassan<sup>3</sup>

<sup>1</sup>Department of Archaeological Conservation, Faculty of Archaeology, Cairo University, Cairo, Egypt

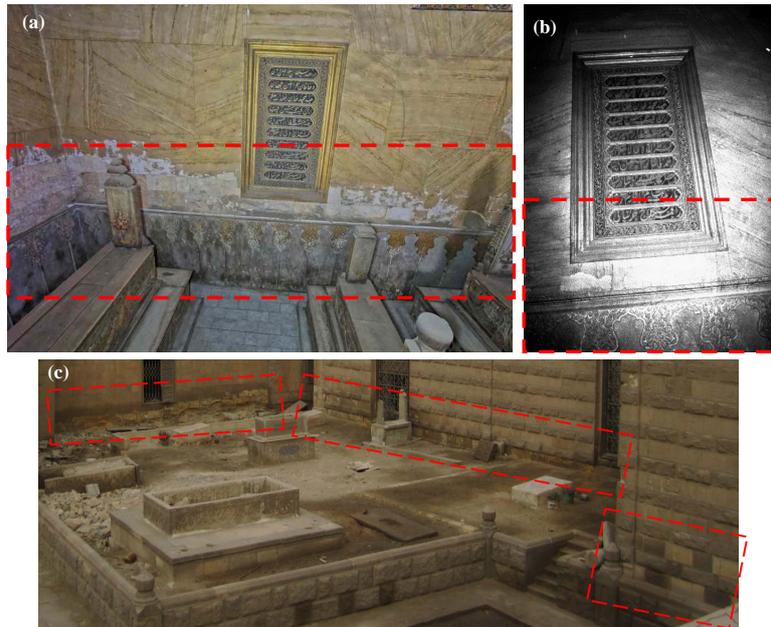
The rise of the groundwater by capillarity inside the walls of Hosh al-Basha is clearly noticed. In **Figure 12**, the comparison between an old photo and a recent one shows how the groundwater raised in the east wall of the room (7). Because of this rise, the salts penetrated with the groundwater inside the stone masonry wall. Afterward, the groundwater evaporated and the salts crystallized which led to internal stresses in the stone resulting in its deterioration and failing of its marble casing. Finally, the salts effloresced on the stone surface distorting its appearance (**Figure 12(a)**). In the same Figure, one can notice the groundwater rise in the walls from outside and the discoloration and the blackening of the stone as a result. Some other observations of the same phenomena of stone deterioration can be noticed in **Figure 13**.

**Figure 12.** (a) groundwater rise by capillarity in the east wall of the room (7), (b) old photo of the same wall showed lesser rise and damage, (c) groundwater rise by capillarity in the outside of the walls of the rooms (5), (6), (7) and the adjacent building. (photo “a” by [18], photo “b” after [17], explanations by the authors).

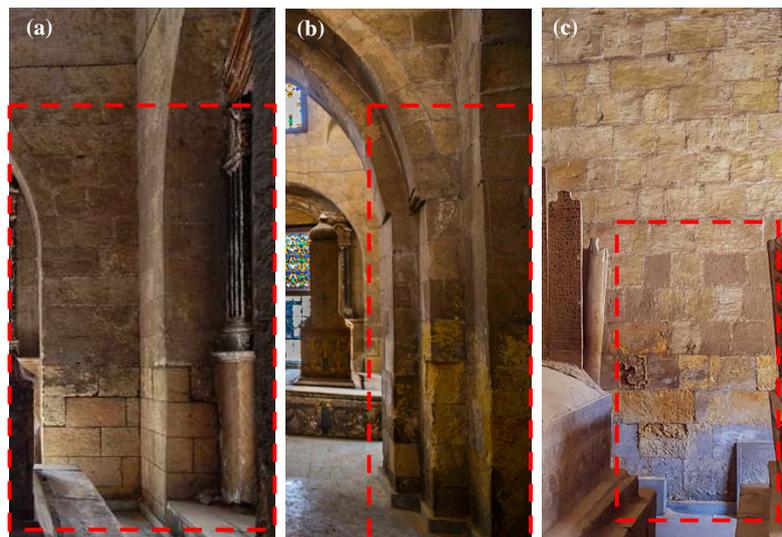
**Figure 13.** Evidences of the damage due to the groundwater rise inside the walls of Hosh al-Basha: (a) the west wall of the room (5), (b) the arch between the rooms (4) and (5), (c) the east wall of the room (1). (photos by the authors).

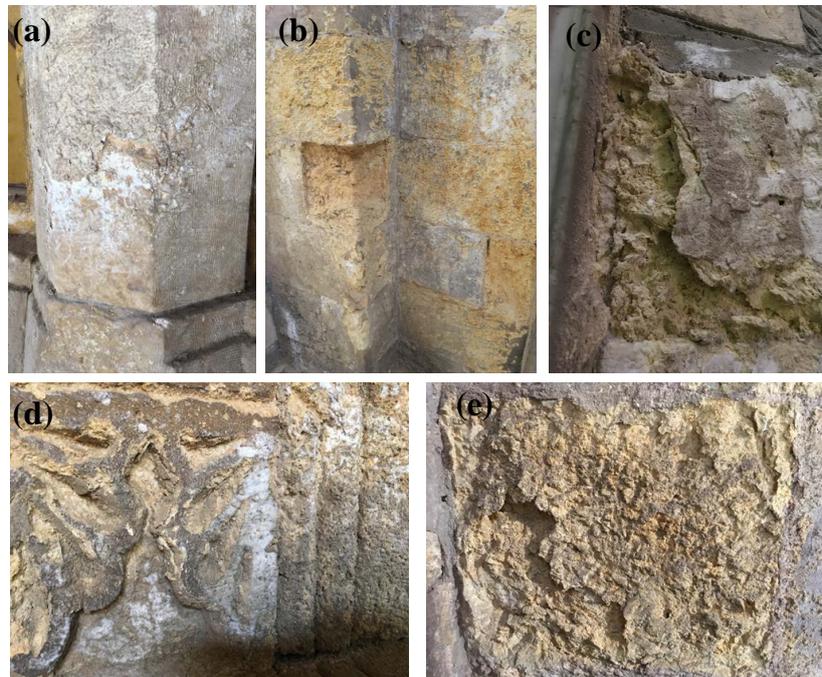
The stone was badly affected by the groundwater rise and different deterioration symptoms were noticed (**Figure 14**). Those included granular disintegration and losses of stone layers, losses of crusts and salt efflorescence, losses of scales, stone soiling by atmosphere particles, subflorescence.

**Figure 14.** Different groundwater-induced damage patterns of the limestone of Hosh al-Basha: (a) granular disintegration and losses of stone layer, (b) losses of crusts and salt efflorescence, (c) losses of scales, (d) subflorescence, (e) efflorescence and soiling by particles from the atmosphere. (photos by the authors).

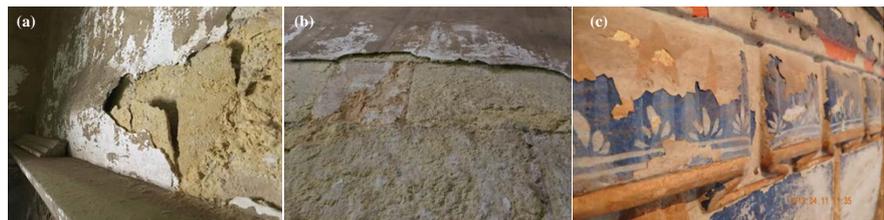
Hosh El-Basha tombs have many wall paintings whether directly applied at the stone masonry walls or at layers of plaster; both of them are in very bad conditions. Because of the groundwater rise in the walls, the paint layers suffer from severe deterioration such as discoloration, detachment, and loss of some pieces (**Figure 15**). Physiochemical factors and biological agents increase the effect of groundwater by causing a remarkable amount of aesthetical and chemical damage. Different types of dirt accumulate, such as dust, stains, insect's remains, and

house flyspecks are deposited on the painting surface. In addition to crumbling in some parts of paint and fine network of cracks is present through the paint and the ground layers. Some previous interventions were done by painting the walls with a lime layer that concealed the original drawings. This lime layer was deteriorated, peeled, and revealed these original drawings (**Figure 15(c)**).

**Figure 15.** Deterioration symptoms of the wall paintings of Hosh al-Basha in the form of: (a) detachment of the paint layer from the ground layer, (b) pieces of both layers were lost, (c) the lime layer deteriorated, peeled and revealed the original blue decorations.

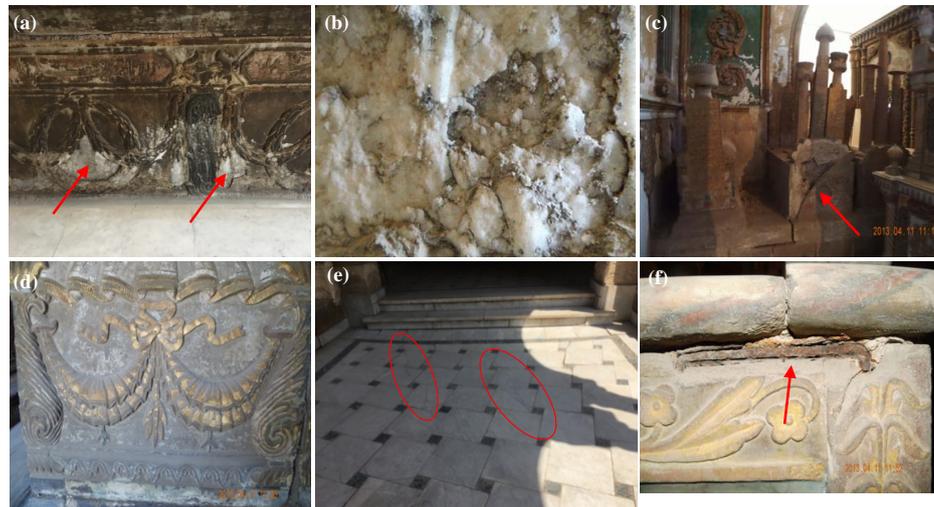
The groundwater-induced damage is clearly noticed in the marble elements. Distributed cracks of different depths and forms can be seen and are more obvious in the lower parts near the ground. The marble casing and slabs show massive efflorescence, due to the surface salt crystallization (**Figure 16(a)**). The detachment of smaller stone elements from large-sized elements, flaking on the edges, and granular disintegration is noticed clearly (**Figure 16(b)**). Large areas of the marble layer became very fragile and completely detached from the background of the stone masonry walls (**Figure 16(c)**). Different types of dirt accumulate are deposited on the marble surface which can cause the marble to deteriorate further and distorts the marble's decorations (**Figure 16(d)**). Due to the settlement of the foundation soil beneath the marble slabs at the corridor, it manifests cracking (**Figure 16(e)**).

**Figure 16.** Symptoms of the damage of the marble elements in Hosh al-Basha: (a) cracks and salt florescence, (b) loss of stone material, detachment, flaking and granular disintegration, (c) detachment of marble, (d) dirt accumulate, (e) cracking due to settlement, (f) previous restoration using iron bars.

Previous restoration using iron bars to connect cracked marble elements are noticed, however, due to surrounding conditions of air and humidity in conjunction with groundwater rise, the iron oxidized and converted to hydroxide with considerable volumetric increase and as a result, it cracked the marble around (**Figure 16(f)**).

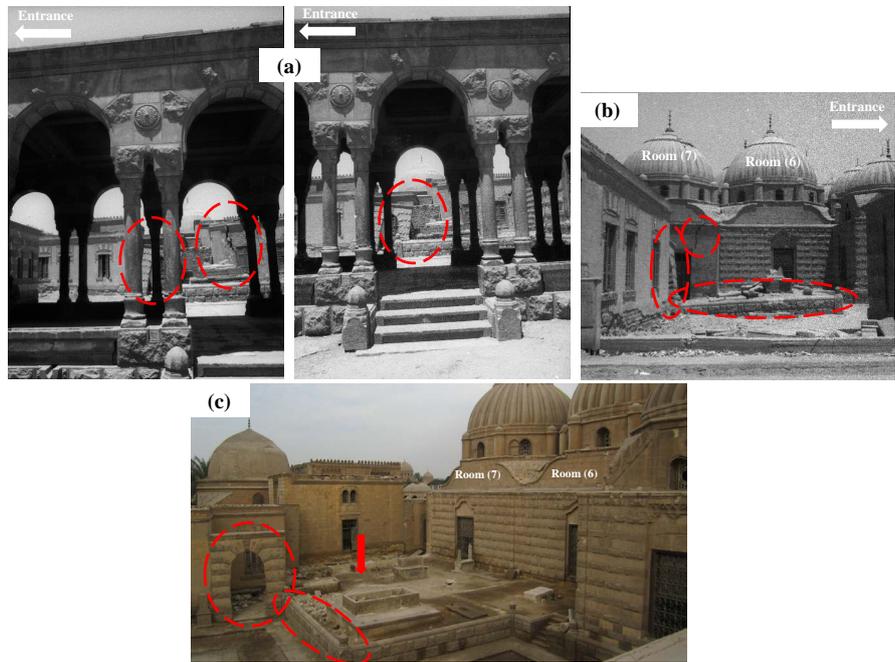
The damage manifested by Hosh al-Basha's structural elements due to the foundation decay and differential settlement was surveyed. In **Figure 17**, a comparison is made between old photos dating back to the last century and recent ones of the arch, the short wall, and a previous room existing in the courtyard.

As can be noticed the arch and the short wall manifested large deformations and the room's walls suffered from large cracks. It seems that the room collapsed; however, the arch and the short wall were restored by dismantling and re-constructing.

**Figure 17.** The effect of the differential settlement: (a) large deformations of the arch and large crack in the wall (looking north), (b) looking east at the arch, the wall and the short wall, (c) the current situation of the arch and the short wall and the disappearance of the room. (the old photos are after [17], explanations by the authors).

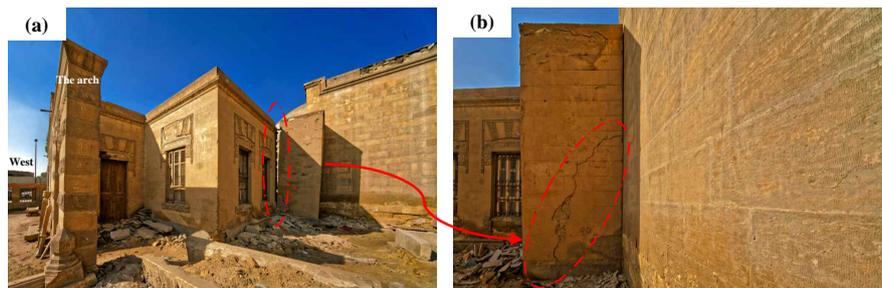
It appears that the foundation soil in this area is going large deformations affecting Hosh al-Basha and the adjacent buildings until today. In **Figure 18**, recent photos show the serious tilting of a wall behind the arch. The same wall has also serious diagonal cracking.

**Figure 18.** Serious deformations and cracking in the existing walls at the collapsed room area: (a) serious tilting, (b) diagonal cracking. (photos by [18], explanations by the authors).

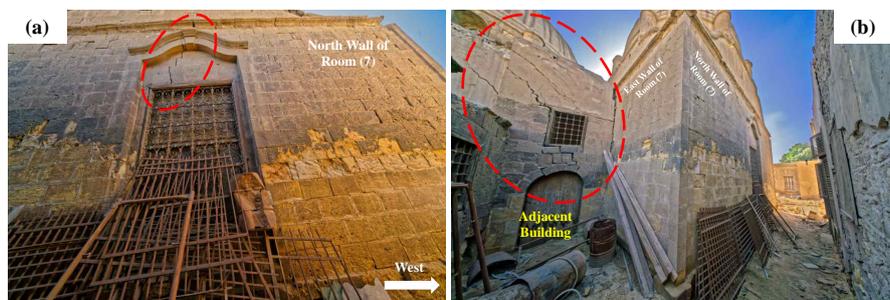
In **Figure 19**, it can be noticed the north wall of the room (7) suffers from diagonal cracking above its window. The adjacent building as well suffers from serious diagonal cracking above its door and window. For the same room, the east wall is diagonally cracked (**Figure 20(a)**). Besides, the west wall is cracked from outside (**Figure 20(b)**) and inside (**Figure 20(c)**), it seems that the crack is recent as an old photo did not show it (**Figure 20(d)**).

**Figure 19.** The differential settlement cracking at the room (7) and the adjacent building: (a) diagonal cracking, (b) adjacent building diagonal cracks. (photos by [18], explanations by the authors).

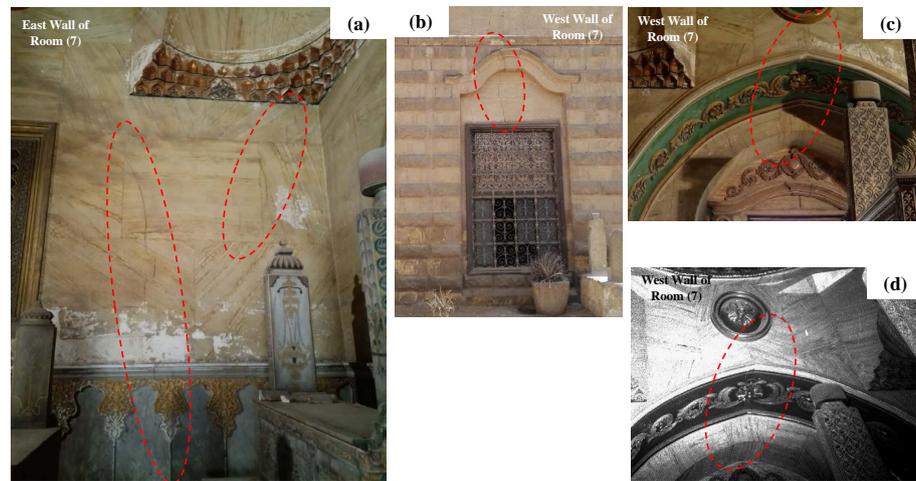
**Figure 20.** Cracking of room 7 walls: (a) cracking of the east wall, (b) cracking of the west wall from outside, (c) cracking of the west wall from inside, (d) old photo shows no cracking. (the old photo is after [17]).

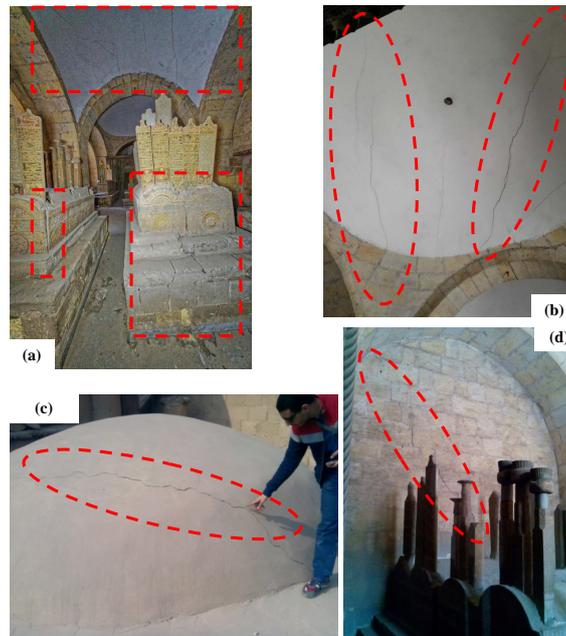
One can notice the visible wide cracks in the dome of the room (1) and the tombs (**Figure 21(a)**). In the room (2), the dome is also cracked and the crack is extended and visible from the intrados and the extrados (**Figure 21(b)** and **Figure 21(c)**), as well, the north wall has a typical long diagonal crack due to the differential settlement (**Figure 21(d)**).

**Figure 21.** (a) The observed damage in the room (1); (b), (c) and (d) the observed damage in the room (2). (photo “a” by [18]).

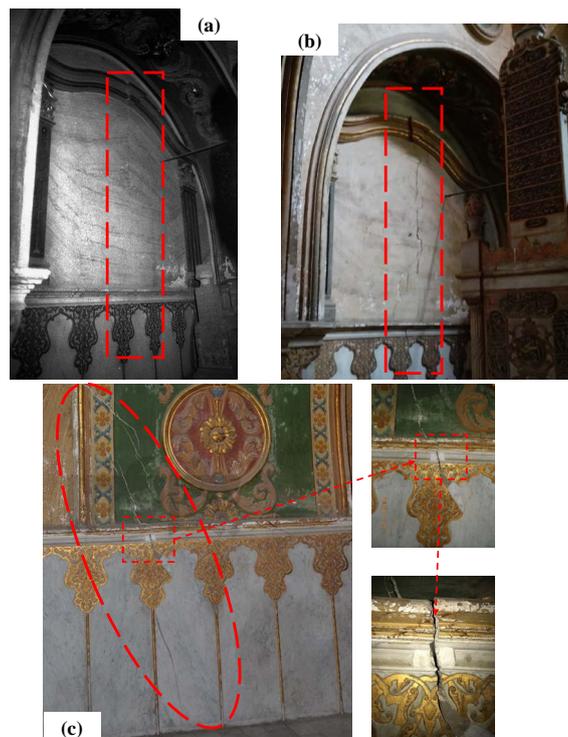
The north wall of the room (3) has a long vertical wide crack (**Figure 22(b)**) that starts from the arch middle and extends to the wall. This crack did not exist before as can be observed from an old photo dates back to the last century (**Figure 22(a)**). At the back of this wall, the arch between the two rooms (6) and (8) exist (refer to the plan in **Figure 8(a)**). The arch is heavily damaged from the ground to above the springing with multiple diagonal cracks (**Figure 22(c)**). The gypsum telltale mounted on the crack to monitor its movement was found broken indicating its on-going movement and widening (**Figure 22(c)**) due to the differential settlement. It is interesting to confirm the on-going damage by looking to **Figure 23** in which the dome of the room (3) has an old photo and a recent one. The recent cracks can be easily identified. The south wall of the room (8) has a diagonal crack (**Figure 24(a)**) and the two south squinches as well are cracked, **Figure 24(b)** & **Figure 24(c)**.

**Figure 22.** The observed damage in the room (3) and the arch between the rooms (6) and (8): (a) old photo before cracking, (b) cracking in the north wall of the room (3), (c) cracking in the arch between the rooms (6) and (8). (the old photo is after [17]).

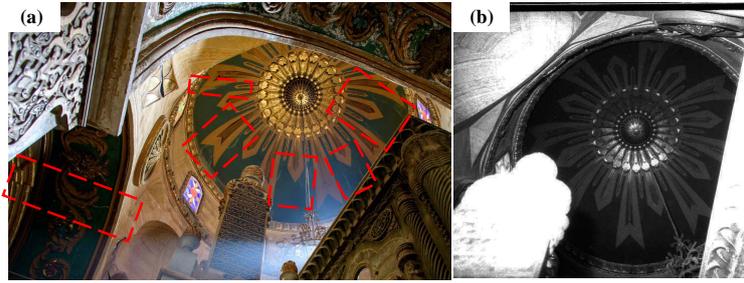
**Figure 23.** Recent damage of the dome of the room (3): (a) cracking in the dome, (b) old photo of the dome showed no cracks. (the old photo is after [17]).

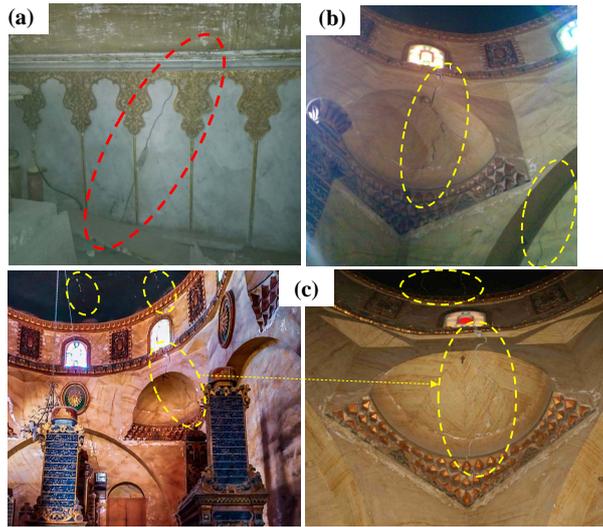
**Figure 24.** The observed damage of the room (8): (a) cracking in the south wall, (b) cracking in the south west squinch, (c) cracking in the south east squinch. (explanations by the authors).

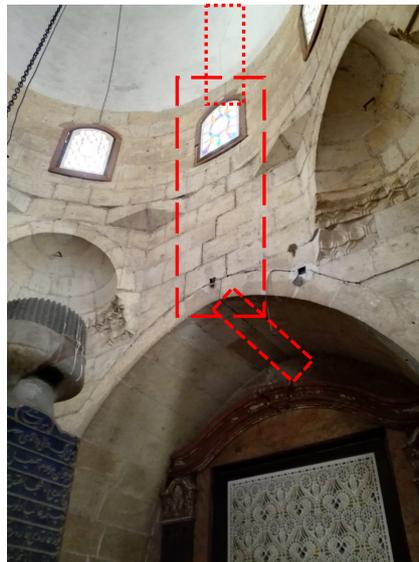
The differential settlement damage is affecting the dome of the room (4) and the supporting drum and arch as indicated in **Figure 25**. The typical diagonal cracking is noticed passing through the weak plane of the mortar joints affecting both of the arch intrados and the dome drum.

**Figure 25.** Structural damage of the dome and its supporting drum and arch in the room (4). (explanations by the authors).

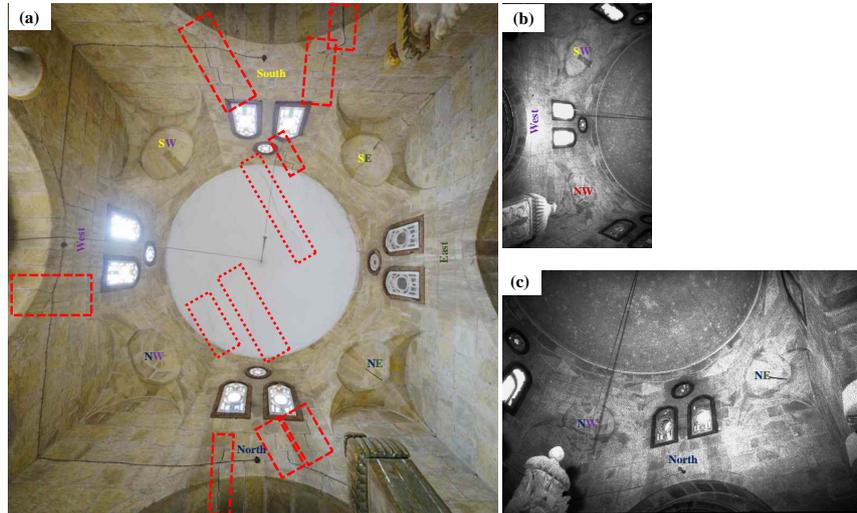
The cracking of the structural elements of the room (5) seems to be also in progress as can be noticed from the comparison shown in **Figure 26**. The old photos did not show the observed damage nowadays. A More detailed focus on the cracking of the south and north parts of the room is shown in **Figure 27**. The differential settlement affected tomb number 2 that was cracked as indicated in **Figure 28(a)** and **Figure 28(b)** as observed in the year 2018. Fine restoration

**Figure 26.** Structural damage of the room (5): (a) cracking of the dome, the drum and the arches, (b) old photo of the west side showed no cracking, (c) old photo of the north side showed no cracking. (photo “a” by [18] and the old photos are after [17], explanations by the authors).

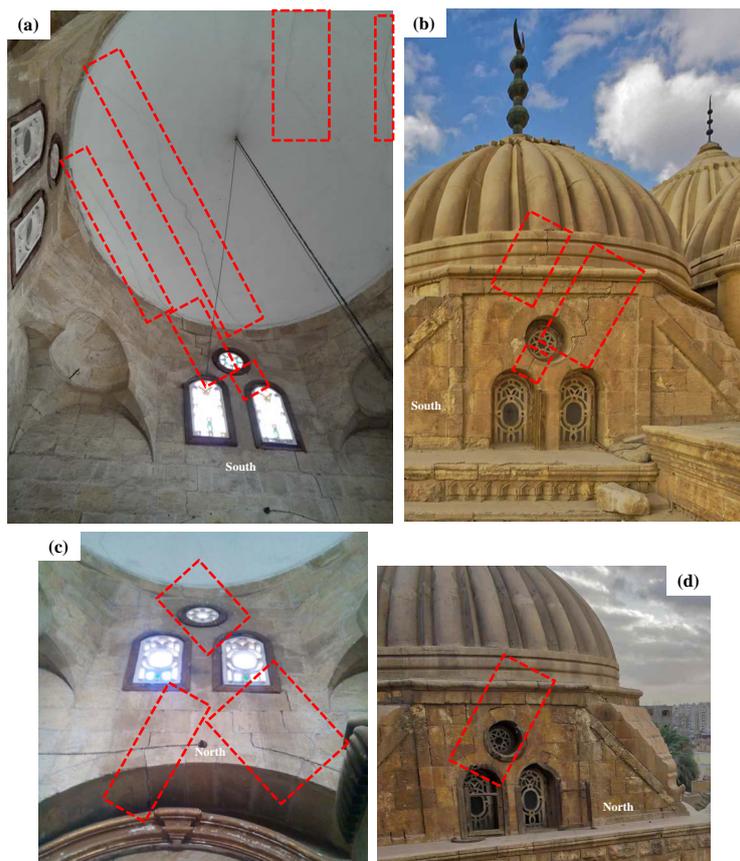
**Figure 27.** The damage of the room (5): (a) cracking of the dome and the drum from the intrados (south part), (b) cracking of the dome and the drum from the extrados (south part), (c) cracking of the dome and the drum from the intrados (north part), (d) cracking of the dome and the drum from the extrados (north part). (explanations by the authors).

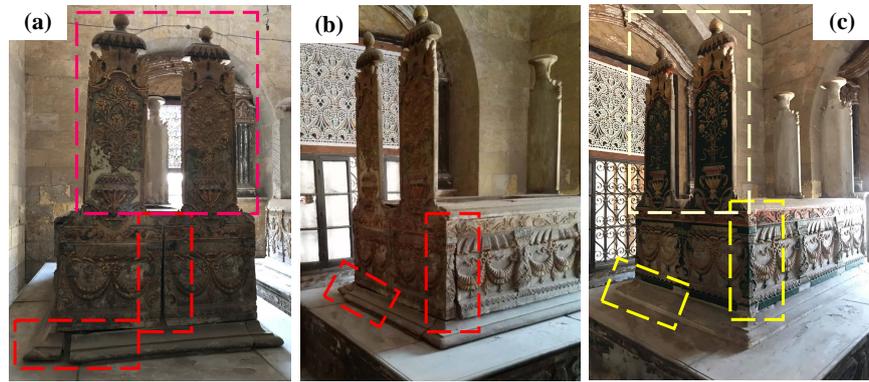
**Figure 28.** The cracking and the discoloration of the tomb number 2 in the room (5): (a) and (b) before restoration in 2018, (c) after restoration in 2020. (explanations by the authors).

works were carried out after 2018 and recovered the original integrity and colors as can be noticed in **Figure 28(c)**.

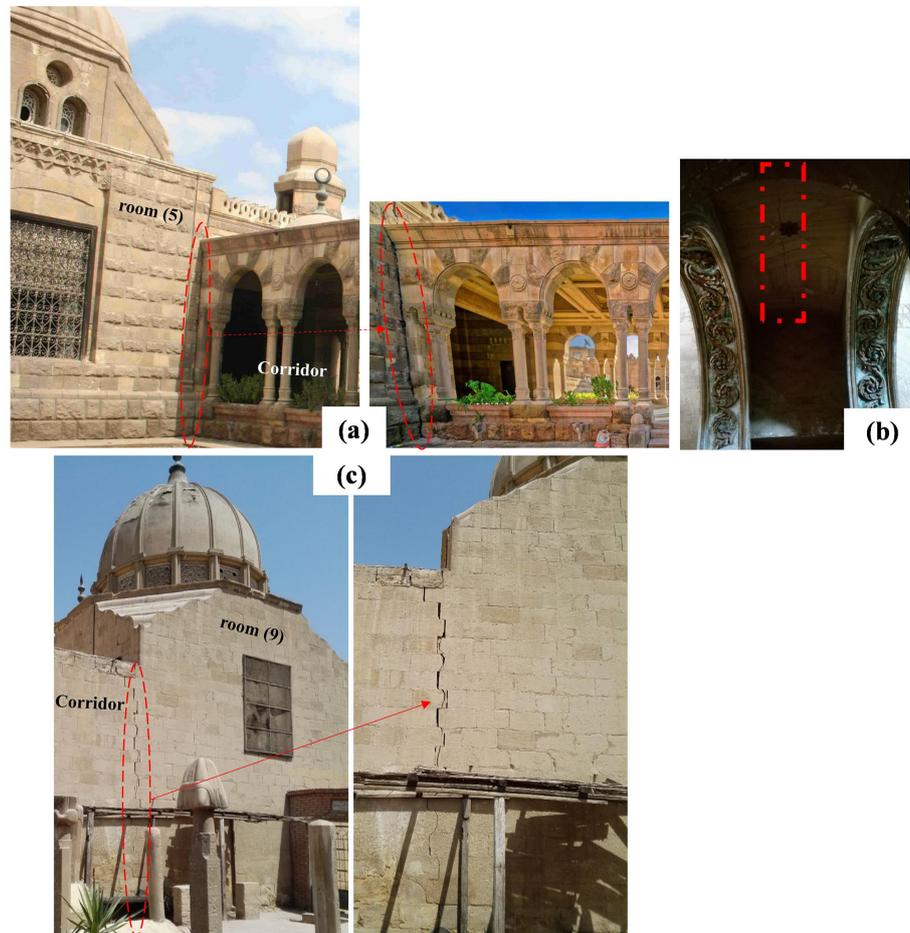
The construction sequence of the cemetery is one of the reasons for the observed damage. As previously discussed, the cemetery was enlarged by adding the rooms one after another. Therefore, some of the observed damage nowadays can be related mainly to the history of the construction. This damage is seen in the form of separation cracks as that one between the room (5) and the corridor (**Figure 29(a)**), the crack between the rooms (3) and (4) (**Figure 29(b)**), and the crack between the room (9) and the corridor (**Figure 29(c)**).

These cracks appeared either because of the lack of connection between the older parts and subsequently added parts. Alternatively, because of the different deformations of the foundations of the older parts and subsequently added parts. It should be noticed that the foundation depth, size, and materials of the older parts and subsequently added parts might not be identical; therefore, their deformations also may not be identical which results in the observed separation cracks. It should be noticed that the damage process is a very complex one and the other previously mentioned causes of damage might have contributed to these noticed cracks as well.

**Figure 29.** Examples of the noticed separation cracks due to the history of construction: (a) separation crack between the corridor and the room (5) wall, (b) separation crack in the vault between the rooms (3) and (4), (c) separation crack between the corridor and the room (9). (explanations by the authors).

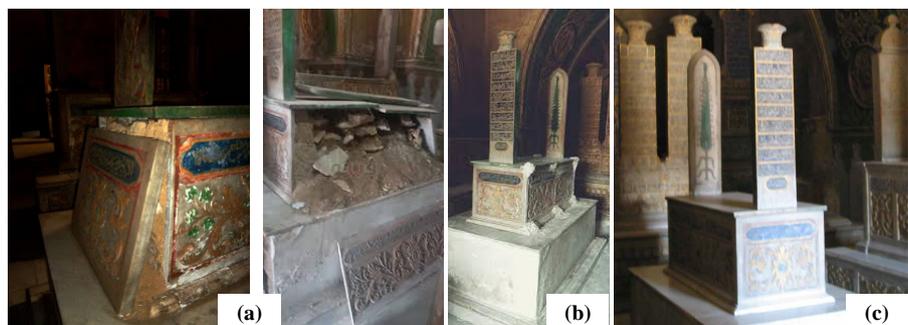
**Figure 30.** The tombstone number (7) in the room (6): (a) separation of the marble side and collapse of the tombstone, (b) during restoration, (c) current state. (explanations by the authors).

and **Figure 30(b)**) and the inside infill also was exposed. For the restoration, the infill was re-turned and confined again by the marble sides and the tombstone was returned to its place (**Figure 30(c)** and **Figure 30(d)**).

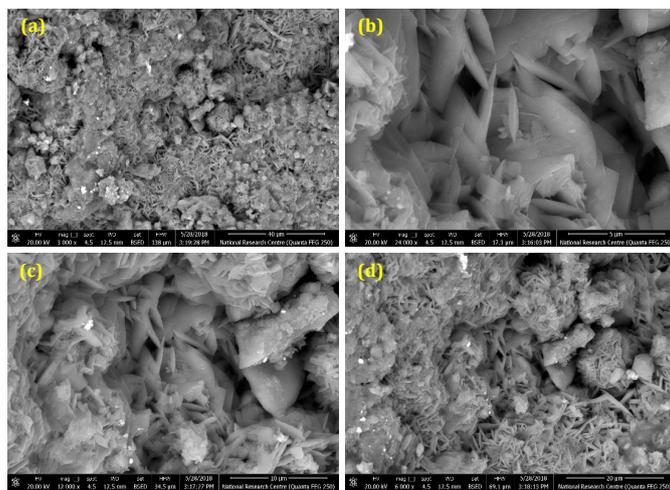
The EDX pattern of the marble had some amounts of Sulfide and Chloride (S and Cl) caused by weathering effects. The SEM results confirmed that the marble deterioration was due to the abundance of soluble salts. The SEM micrographs exhibited several alterations, such as cracks and pores (**Figure 37(a)**). Halite was identified as large prismatic grains (**Figure 37(b)**) and there were losses of cohesion between grains (**Figure 37(c)**). The SEM photomicrographs showed disintegration between the Calcite crystals and micro exfoliation (**Figure 37(d)**).

**Figure 37.** SEM micrograph of the marble: (a) cracks and pores, (b) prismatic grains of Halite, (c) losses of cohesion between grains, (d) disintegration between calcite crystals.
