Surrounding Rock Control Technology of Strong Dynamic Pressure Roadway in Hudi Coal Industry

Yixue Jia

Aiming at the problems of large deformation and difficult maintenance of deep soft rock roadway under the influence of high ground stress and strong dynamic pressure, taking the surrounding rock control of 1105 lane in Hudi Coal Industry as an example, the deformation characteristics and surrounding rock control measures of deep soft rock roadway are analyzed and discussed by means of geological data analysis, roadway deformation monitoring, rock crack drilling and field test. The results show that the main causes of roadway deformation are high ground stress, synclinal tectonic stress, advance mining stress, roadway penetration and surrounding rock fissure development. Based on the deformation characteristics and mechanism of lane 1105, the supporting countermeasures of “roof synergic support, layered grouting, anchor cable beam support, closed hardening of roadway surface” are proposed, which can provide reference for the control of deep roadway surrounding rock under similar conditions.

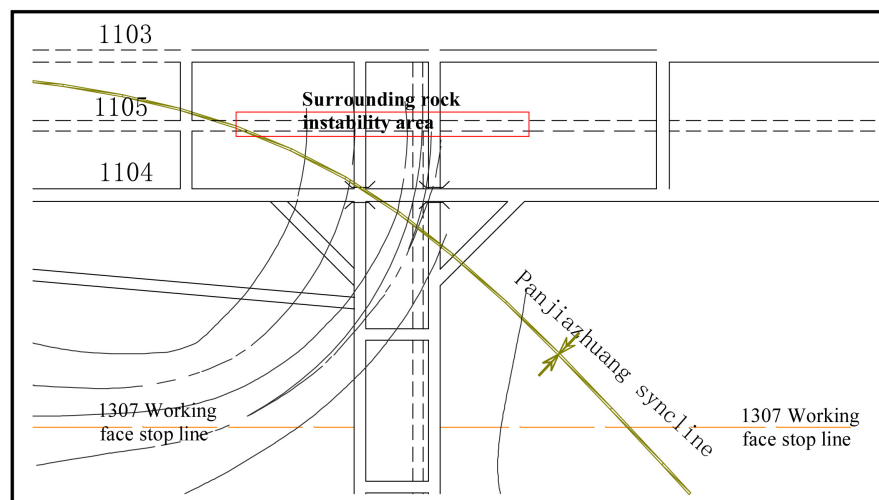
Figure 1. Excavation engineering plan of Lane 1105.

coal seam in the mine field is up to 730 m. The main geological structure in the mine field is mainly fold, and the fault structure is not developed. The ground stress test shows that Hudi coal industry has higher ground stress and the horizontal principal stress is dominant in the field, and the maximum horizontal principal stress reaches 21.7 MPa, which is a high ground stress mining area. The mine adopts pan-type arrangement, with fully mechanized mining face arranged on both sides of the main roadway in pan-area, and adopts long arm comprehensive mechanized coal mining method. The relation diagram of mining engineering near lane 1105 is shown in **Figure 1**.

stress is significant: Section 10# Hengchuan of Lane 1105 is located at the axis of the north wing of the Panjiazhuang syncline (**Figure 1**). It can also be seen from the revealed rock formation that the rock formation is concave and shows obvious syncline characteristics, resulting in the stress concentration of the surrounding rock of Lane 1105, and the structural stress has a great impact on the strength and stability of the surrounding rock of the roadway. c) Influence of leading supporting stress on the working face: When the distance between the working face of 1309 (top) and the stoping line remains 35 m, leading supporting stress has a severe influence on lane 1105. At the same time, the roadway is not effectively reinforced before mining, and the deformation control of surrounding rock is not timely, resulting in serious deformation of the roadway in this section.

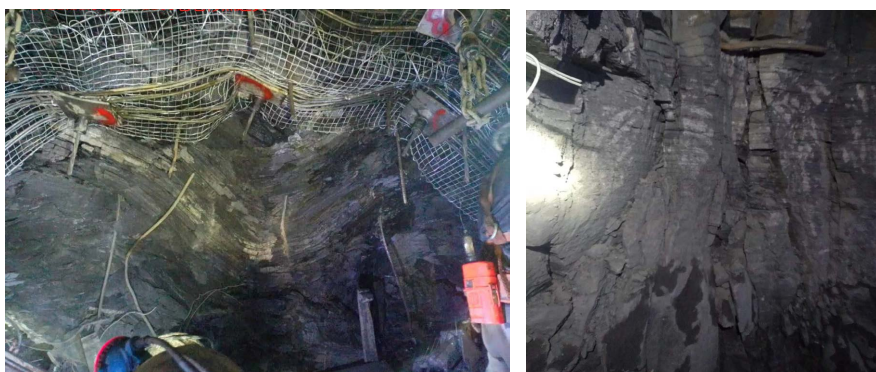
Figure 2. Deformation and failure characteristics of surrounding rock.

1105, it is found that since late April 2022, there has been an obvious ore pressure development in Lane 1105 due to the influence of the mining pressure of the adjacent working face. In the range of 1400 m to 1500 m (10# Hengchuan–11# Hengchuan), there are roof subsidence, tunnel surface grouting layer cracking, anchor cable breakage, serious floor heave and other phenomena. Among them, the floor heave is serious at 1410 m to 1420 m, the distance between the air duct and the belt is less than 200 mm, the cumulative displacement of the top and bottom reaches 3 - 4 m, and the cumulative displacement of the two sides reaches 2 - 3 m. At the same time, the grout on the right side arch shoulder of roadway 1450 m to 1460 m in Lane 1105 is cracking.

In November 2022, Lane 1105 was repaired with brush expansion, and obvious traces of stress release were observed in the surrounding rock of the roadway. The surrounding rocks of the two sides of the roadway are squeezed to the middle of the alley, and cracks are developed, the rock mass is broken and the strength is low, and the subsidence and bending of the roof strata are very obvious, as shown in **Figure 2**.

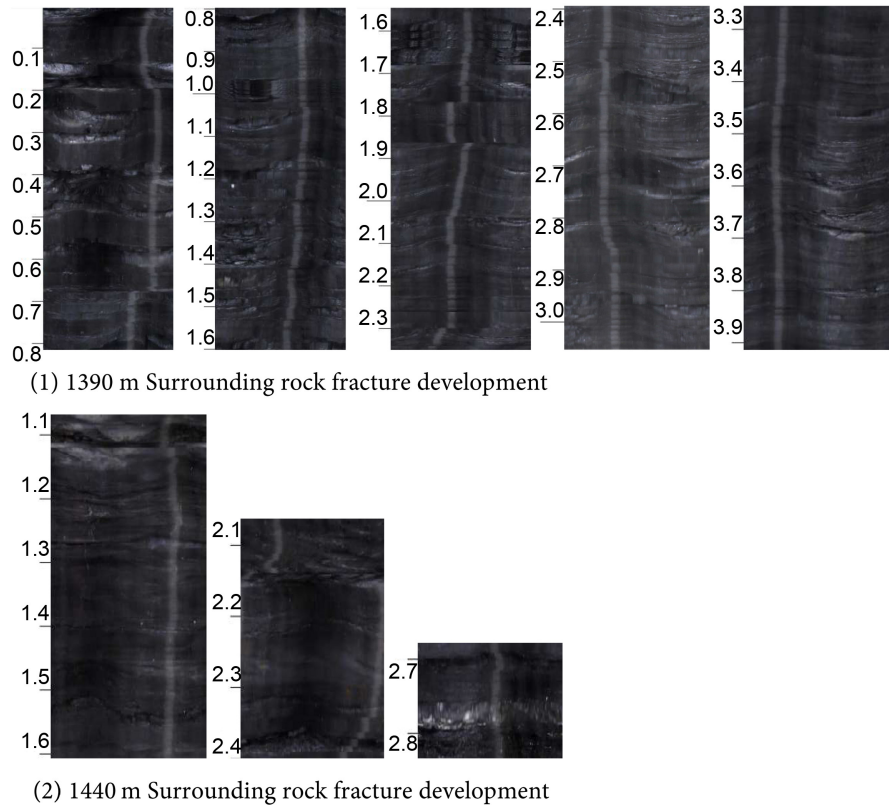
Figure 3. Tunnel 1105 surrounding rock crack borehole peek.

In the follow-up roadway repair project of Lane 1105, the borehole observation was carried out at the roof of the roadway 1390 m and 1440 m respectively. The peephole depth at 1390 m is 15 m, and the peephole depth is determined to be 8m because the deep drilling hole is relatively broken. Among them, 0 - 2.8 m is the rock layer, and cracks are developed at 1.1 m - 1.6 m, 2.1 m - 2.4 m, 2.7 m - 2.8 m in the rock layer. 2.8 m - 8.0 m is coal seam; At 1440 m of Lane 1105, the drilling depth of the roof is 15 m and the viewing depth is 7 m. Among them, 0 - 1.8 m cracks developed and were relatively broken. Horizontal cracks developed at 2.0 m - 2.2 m, 2.5 m - 3.0 m and 3.4 m - 3.8 m, and rocks were broken at 6.6 m - 6.8 m. **Figure 3** shows the drilling results.

It can be seen from the peeping results that under the comprehensive influence of deep high stress, syncline and mining stress near the working face, the surrounding rock failure depth of lane 1105 is relatively large, and the surrounding rock within 3 m from the roadway surface is relatively broken, with low strength and cracks showing a state of penetration. In the depth range of 3 - 4 m, horizontal cracks develop and the integrity of surrounding rock is reduced.

Outside 4 m, the shape of surrounding rock is relatively complete and the crack opening is relatively small.

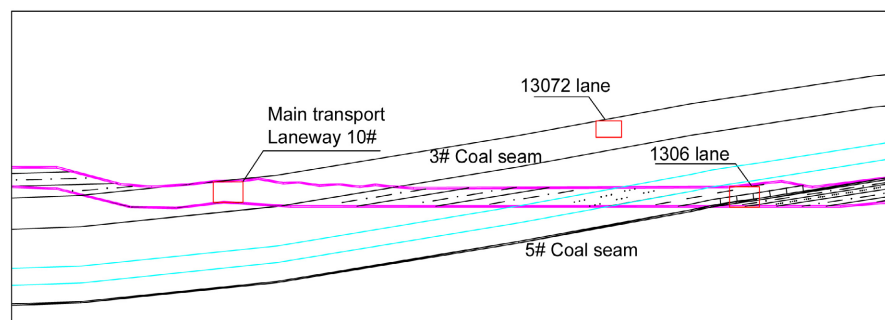
Figure 4. Excavation engineering plan of Lane 1105.

3) Influence of surrounding rock structure: Since the surrounding rock of roadway 1105 presents a “through-layer” structure (**Figure 4**), the surrounding rock of roadway 1105 is prone to deformation and damage along the bedding plane. From Hengchuan (coal lane) of 10#, the roadway 1105 is driven through the strata to expose the coal seam of 5#, and the roadway is driven along the K6 limestone of the roof of coal seam of 5#. According to the data of drilling and drilling during the excavation of lane 1105, the coal rock stratum rises up to about 9° . In addition, the surrounding rock of the roadway is mainly sandy mudstone with low strength, and there is 3# coal in some areas of the roadway roof, so the surrounding rock is weak. Under the common influence of deep ground stress, tectonic stress and advanced abutment pressure of the adjacent working face, the surrounding rock of the roadway presents significant flow plasticity, resulting in the failure of the roadway support system and the increase of deformation.

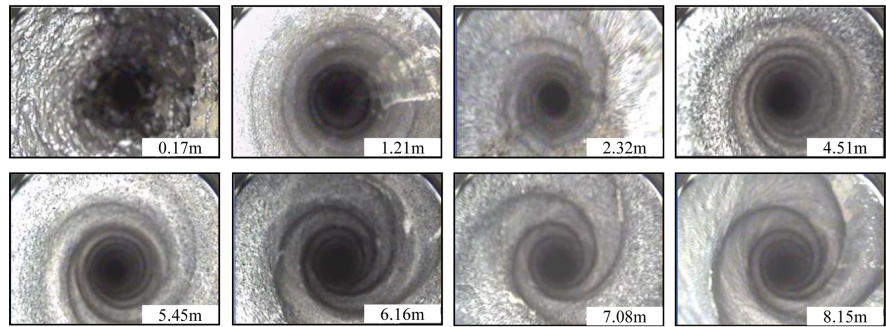
Figure 5. Surrounding rock fracture drilling peep.

The borehole peeping of the roof and side of the roadway is carried out. The results of the borehole peeping of the surrounding rock cracks are shown in **Figure 5**. The surrounding rock has slight deformation in the range of 0.5 m, and the integrity of the surrounding rock in the depth of 1m is good, and no obvious crack development is observed. Overall, the surrounding rock control effect is good.

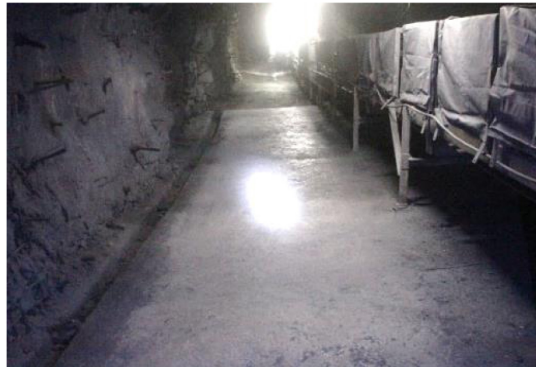
Figure 6. Deformation control effect of lane 1105.

According to the technical parameters of roadway support under strong dynamic pressure, the roadway of lane 1105 in disrepair section of Hudi Coal Industry is applied in the field and the deformation of the roadway is continuously monitored. The observation results show that the deformation of roadway surrounding rock has been effectively controlled after construction, the roof

subsidence is less than 80 mm, the relative movement of two walls is less than 110 mm, and the stability of surrounding rock has been significantly improved (**Figure 6**).
