# Risk Analysis of Cavitation in Hydraulic Structures

Gabriel Echávez

Risk Analysis of Cavitation in Hydraulic Structures. *World Journal of Engineering and Technology*, 9, 614-623.

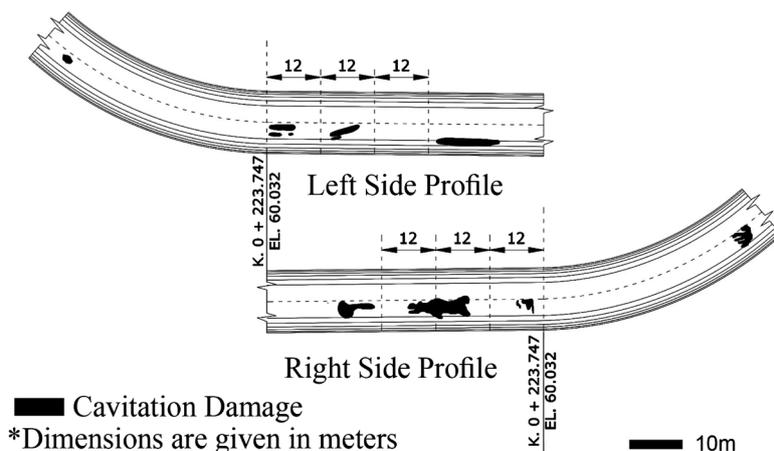
This problem can be reduced by thoroughness in construction procedures, placing special attention to well-aligned forms and no existing steps or changes in direction. **Figure 1** shows the characteristic damages caused in the 13 m in diameter tunnels by misalignment in Infiernillo Dam in Mexico, just after several days in operation in October 1965.

**Figure 1.** Misalignment induced damages on both sides of the 13 m diameter tunnel of Infiernillo Dam in Michoacan, Mexico.

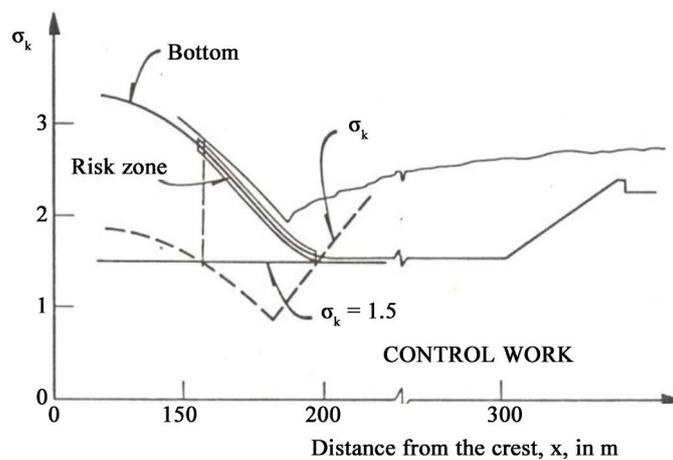
Furthermore, a procedural illustration results are shown in **Figure 7** and **Figure 8**. The analyses applied were to the main and the emergency spillways of the Malpas Dam, Chiapas, Mexico.

**Figure 7.** Cavitation risk analysis of the control spillway.

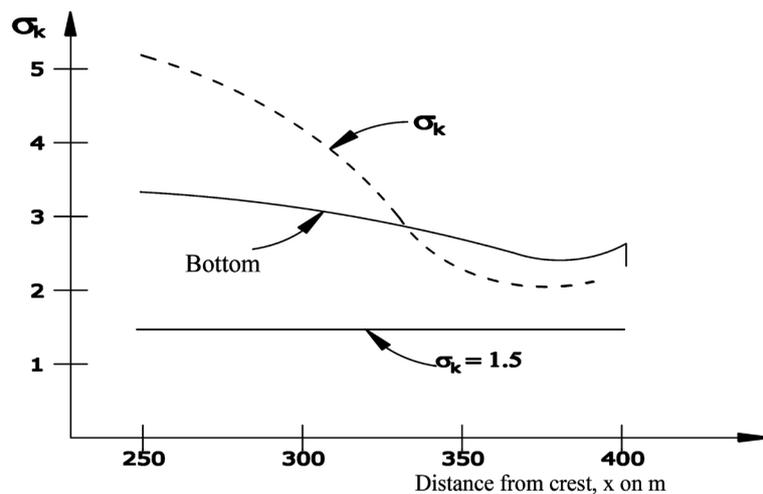
Emergency spillway: In contrast, as shown in **Figure 8**, there is no point along the emergency spillway that showed cavitation risk; this may sound ironic but the emergency spillway was safer than the control spillway in terms of cavitation induced damages.

**Figure 8.** Cavitation risk analysis of the emergency spillway.

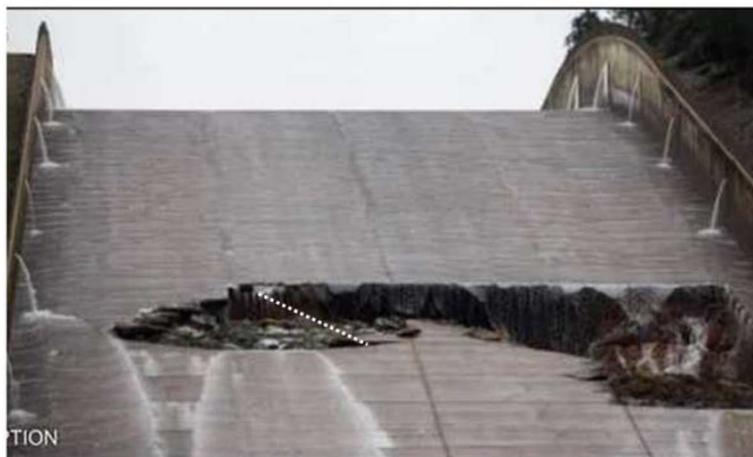
The damage geometry in both **Figure 9**, and its location, **Figure 10**, clearly suggest that the damage was due to cavitation. In addition, the relatively wide angle of the triangularly-shaped damage, shown in the left side of the photograph in **Figure 9** is a characteristic of damage caused not only due to flow velocity, but also to the tendency of a convex flow that facilitates the presence of cavitation, which is a condition that is also fulfilled in this case.

**Figure 9.** Photograph of the damages geometry in the Oroville Dam spillway.

The author dares to predict that if aerators slots or other forms of protection are not placed in Oroville Dam, the same problem will recur in the future.

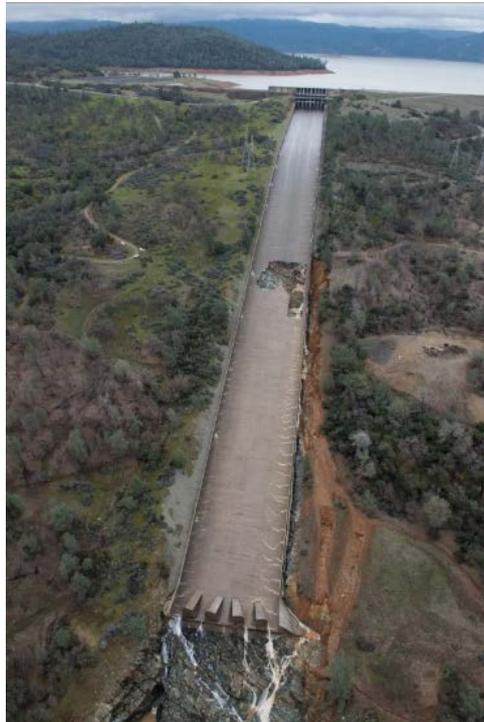
**Figure 10.** Photograph of the location of the damages in the Oroville Dam spillway.
