Study of the Impacts Caused by Anthropogenic Activities over the Last Ten Years on the Djoliba River in the Urban Commune of Kouroussa (Republic of Guinea)

Siba Sagno^{1*}, Haicha Cissé², Mamadou Madaniou Sow¹, Fatoumata Sylla³, Adama Moussa Sakho¹

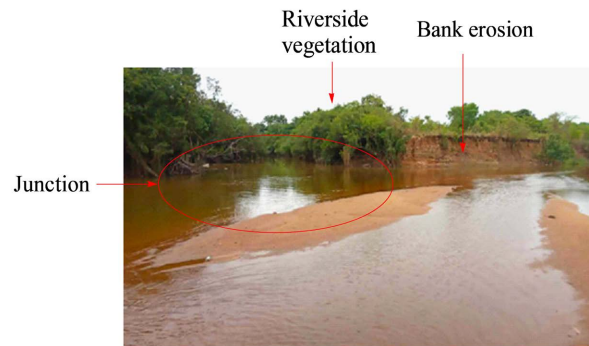
Figure 1. Showing the confluence of the Djoliba river and its bank, with vegetation and signs of erosion.

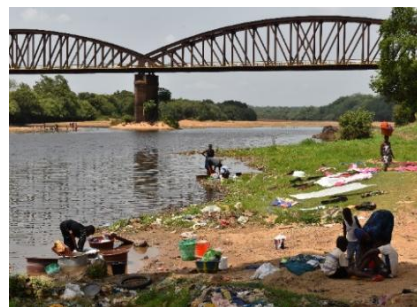
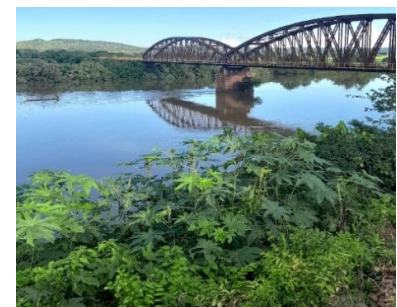
Figure 3. Showing the historic old metal railway bridge linking the two banks of the Djoliba River at Kouroussa, water levels on May 31 (a) and August 16 (b) 2024 with presence of diversified riparian vegetation and washing and leaching activities on a form of dead arm of the natural bank (a) but fed in winter by water (b).

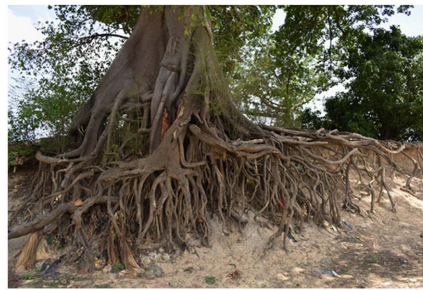
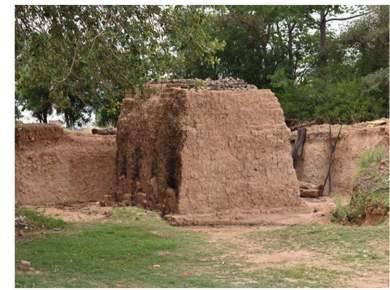
Figure 4. Showing one example among others of a riparian forest suffering (a) from erosion, and brick kiln for firing bricks (b) along the Djoliba River in Kouroussa.

The destruction of the river arms by the builders of the brick kilns (Figure 4), has deformed in some places, the normal river bed and causes flooding during the rainy season of homes near the river. For example, on the site (brickyard) not far from the metal bridge, there is an overflow of the river bed caused by these brick manufacturers, either: 29.7 meters from the natural river bed and 10 meters from the homes and a slaughterhouse next door not shown. The water level in the Djoliba River in Kouroussa has become dangerously low, which suggests the flow stop of the river in the dry season (season without rain). The silting is visible and very worrying for a better future for the riverside populations. However, the distance between the natural bank and the current water level of the river, as well as the width of the river bed are 30.80 and 188.6 meters respectively. In addition, the bank and water level of the Djoliba River, which extends over approximately 50 km in the Kouroussa prefecture, have experienced major disturbances over the last ten years.

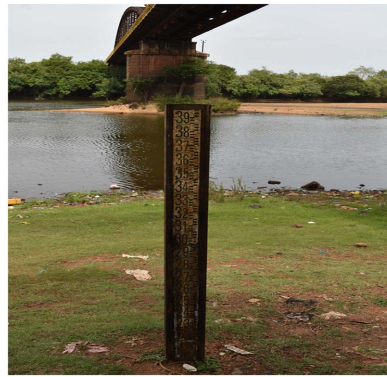
Observation of the Djoliba River took place from May 31 to May 1 and from August 16, 2024. The following results showed extensive degradation of the river by local people, as shown in (Figure 4), an almost dry river from May 31st to May 1st 2024 and a completely full river from August 16th 2024 onwards, as shown by the limnimetric scales on (Figure 5).

Figure 5. Showing the limnimetric scale for measuring the water level in the river bed.
