Geological Hazards Occurred on the Road Connecting Vashlijvari-Lisi (M. Machavariani Street) in Tbilisi

Merab Gaprindashvili^{1,2}

¹Department of Geology, National Environmental Agency, Tbilisi, Georgia ²PhD Student of Mining Geological Faculty, Georgian Technical University, Tbilisi, Georgia Email: gaprinda13@yahoo.com

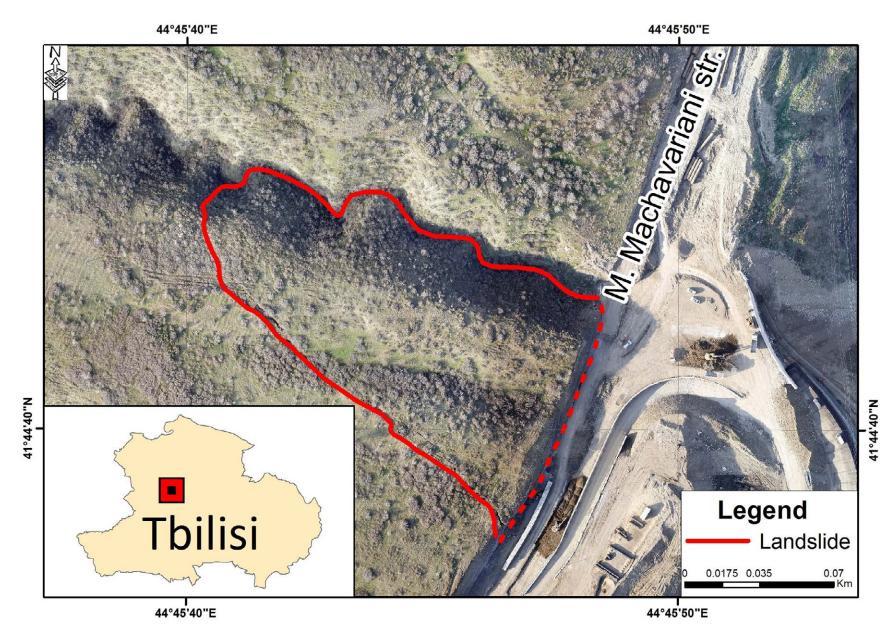
Study area, which includes Vashlijvari-Lisi road section (M. Machavariani Street) on both sides, is bordered by temporarily cut V-shaped ravines. At the top, surface of the watershed is covered with grass and deciduous shrubs. The slope inclination varies slightly from 10° to 15°, and from the slope to the river, in the direction of Mtkvari river, the natural surface is artificially (technogenically) strongly transformed by the ongoing road construction activities and is characterized by sharply variable inclination (**Figure 1**).

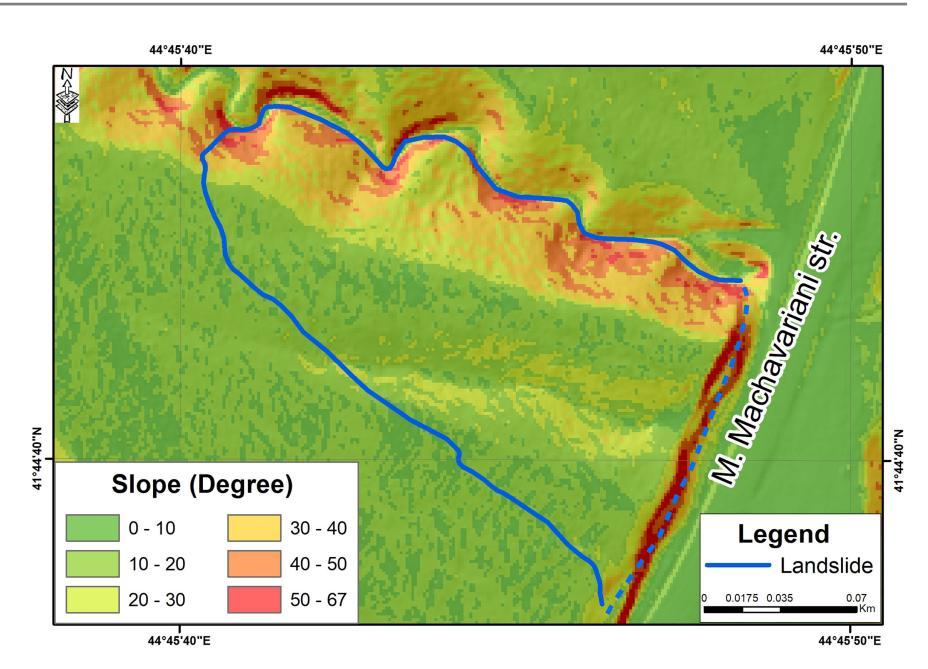
Morphologically, study area is located at the point of contact of two adjacent morphological districts, namely: the first area belongs to the sub-latitudically folded Lisi anticline ridge structured by Middle Eocene Tufogenic, Upper Eocene and Lower Oligocene sandy-clay deposits developed by Lower mountain Plateau-like technomorphic relief type, which is characterized by high degree of erosive separations, variable intensity area erosion and wind erosion processes. The second area belongs to the type of erosive-denudative low-terrestrial relief of the right terraced valley of the Mtkvari River valley developed on the substrate of sub-latitudically folded middle and upper Oligocene sandstone-clay sediments. It should be emphasized that in the conditions of disturbance of the natural balance of the slopes, both districts are characterized by secondary reactivation of the old (historical) landslide bodies, as well as activation of the debris/mudflows and ravine-type discharge process during the seasonal and torrential rains (Figure 2, Figure 3).

Figure 2. Slope map of study area.

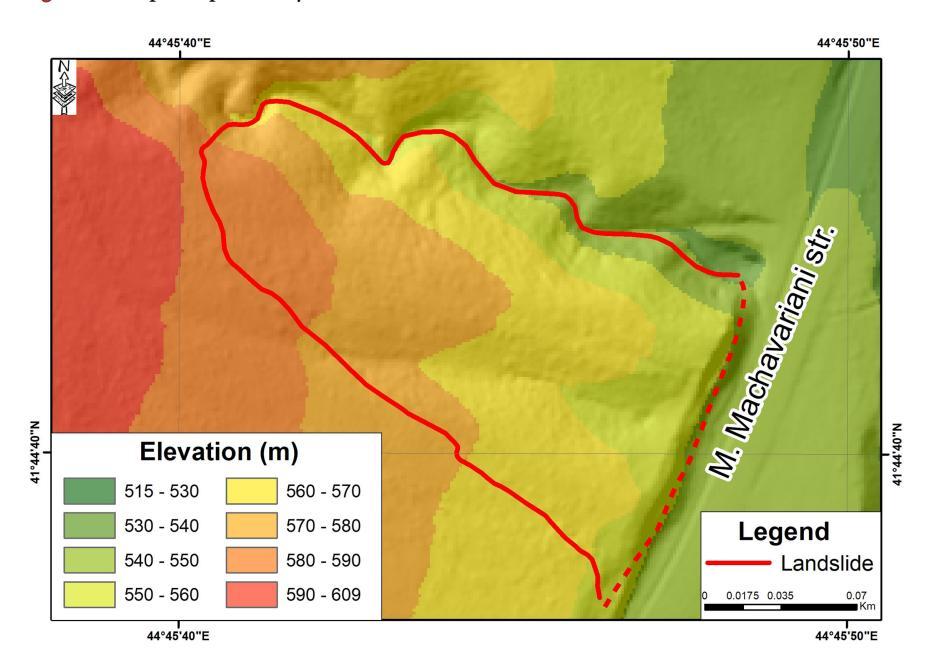
Figure 3. Elevation map of study area.

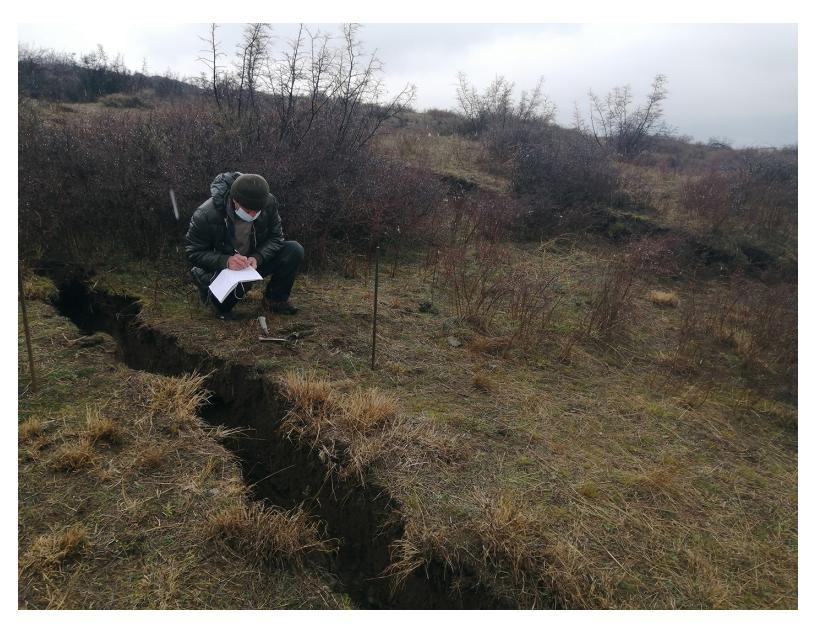
On March 1, 2021, in the north-eastern part of the local watershed on the right side of the Vashlijvari-Lisi road, in the area of the old landslide (historical) block of tectoseismogenic genesis, which is in the phase of temporary stabilization, a secondary generation block-slide type landslide was developed (area 1.57 ha). In order to produce instrumental observations on the nature and dynamics of the subsequent deformation of the formed landslide body, the construction company operatively arranged 11 cross-sections in the form of GPS points placed in a strip along the landslide body (**Figure 4**).

Figure 4. Monitoring rappers (GPS) arranged on a landslide crack.

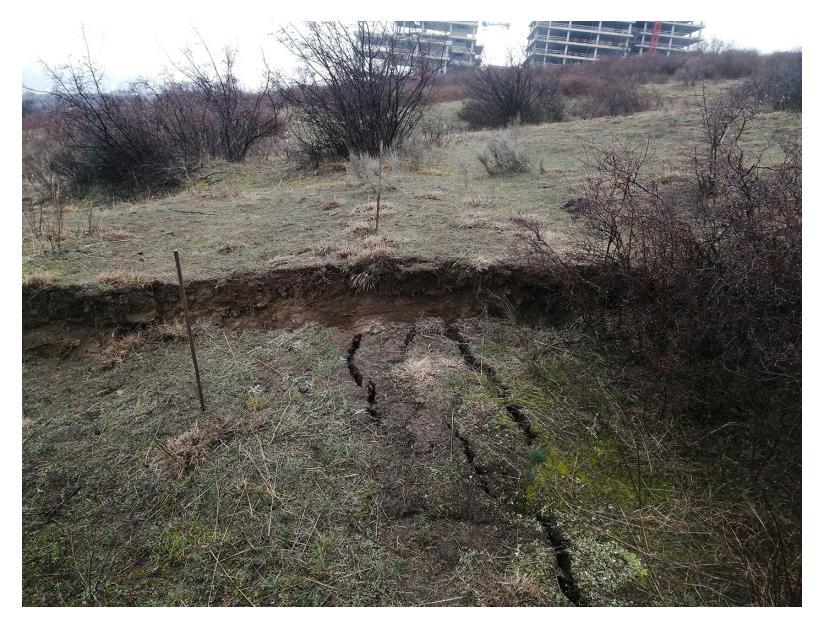
Based on visual and measurement studies of landslide dynamics from 1 to 17 March, a number of cases of regressive expansion of the landslide body at the expense of capturing surrounding areas have been identified, as a result of which most of the observer GPS points are deformed or already within the landslide body (**Figure 5**). The probable depth of the landslide body is in the range of 12 - 14 m, taking into account the morphological and geological conditions of the area, as well as the existing deformations.

Figure 5. Monitoring rappers (GPS) arranged on a landslide crack.

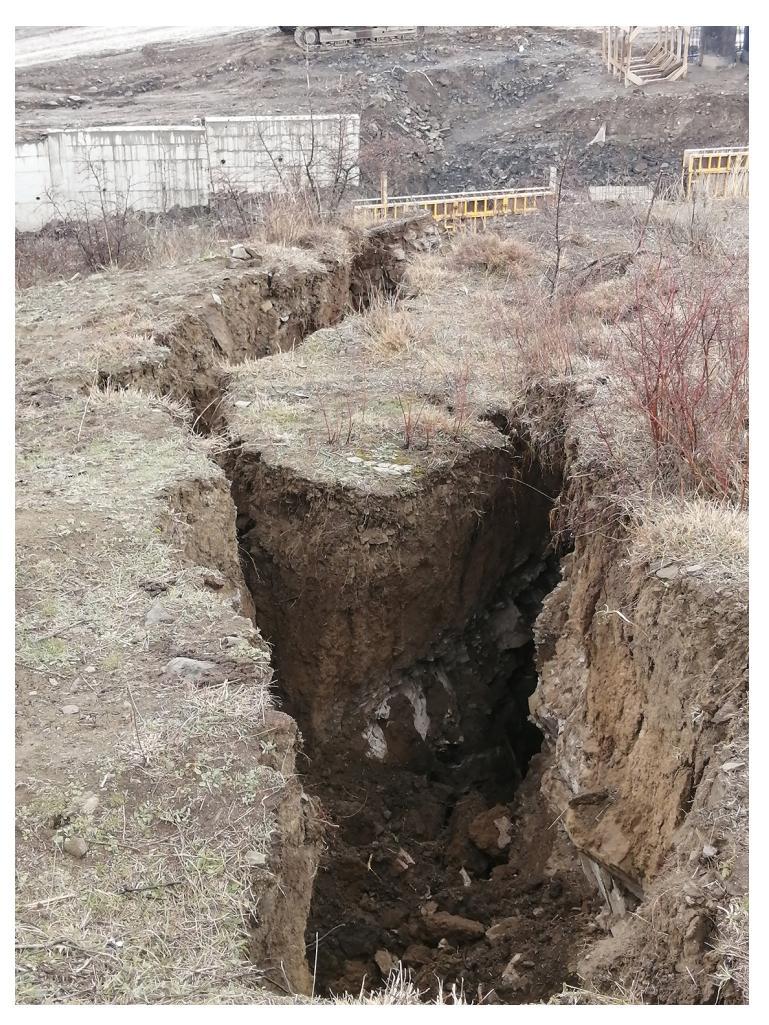
Landslide 1 is developed in the contour of a local catchment with a weakly concave surface in the watershed series. The exposure of the landslide body is south-eastern. Its surface is covered with grass and deciduous shrubs. The slope of the surface varies from $10^{\circ} - 15^{\circ}$, while the inclination of the end of the slope (along the road section) ranges from $75^{\circ} - 80^{\circ}$. Landslide body developed to the local catchment of a dry ravine contour is wedge-shaped in plan and is defined by landslide ditches and cracks with variable width and amplitude along the boards. The width of the trench formed at the foot of the body along the right board varies from 1.99 to 2.485 m, and the visible depth from 1.33 to 3.7 m (**Figure 6**).

Figure 6. Landslide cracks near the landslide scarp.

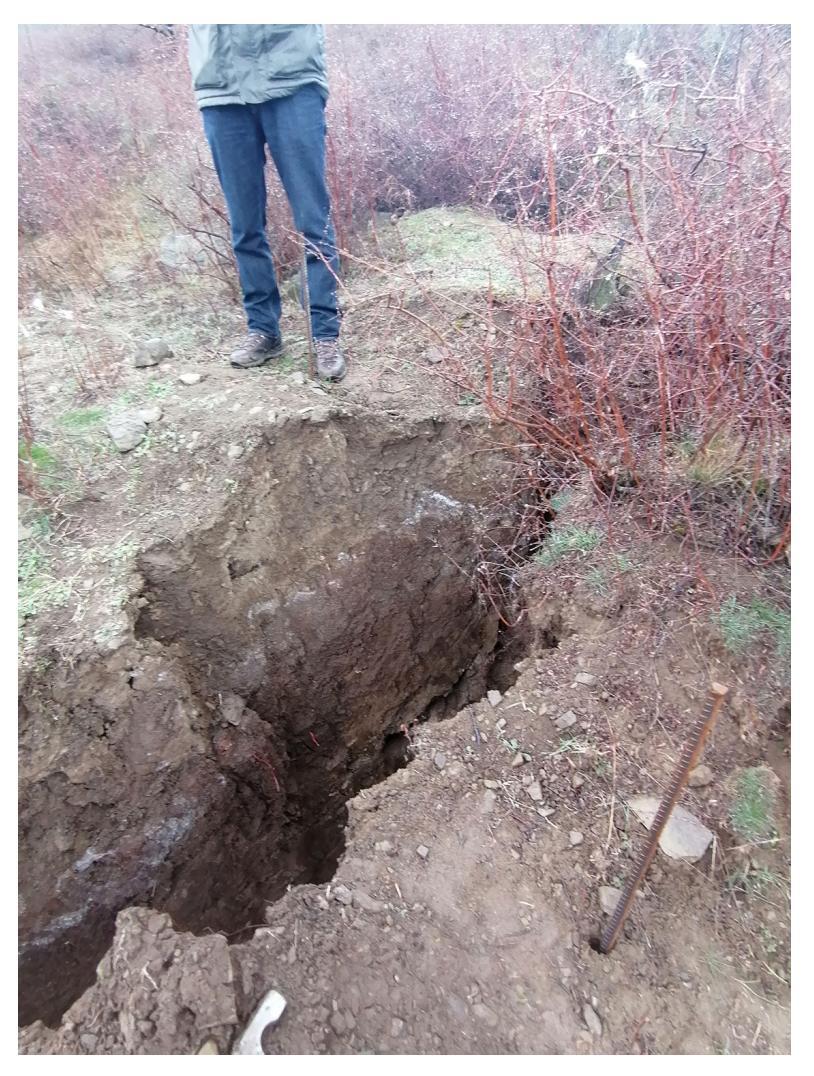
Figure 7. Landslide cracks near the landslide scarp.

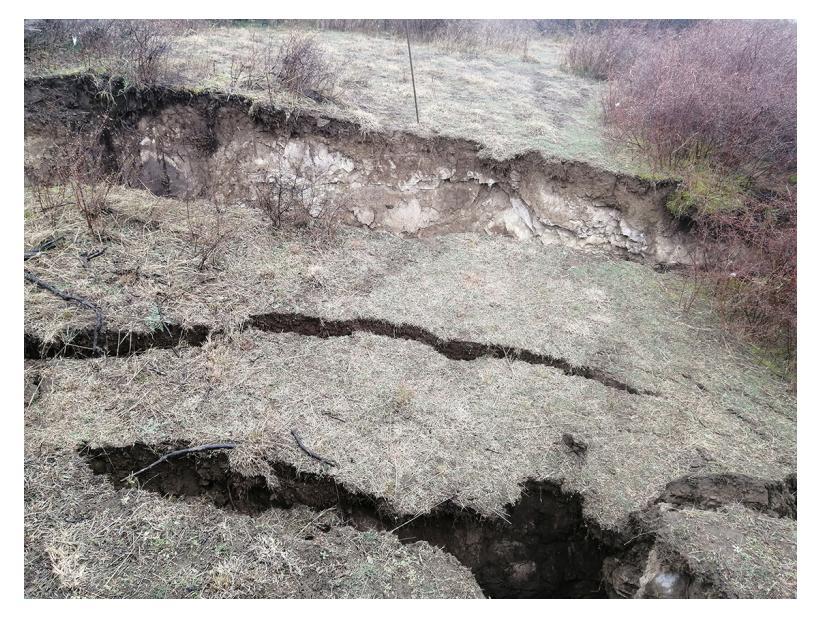
Figure 8. Zones of parallel cracking.

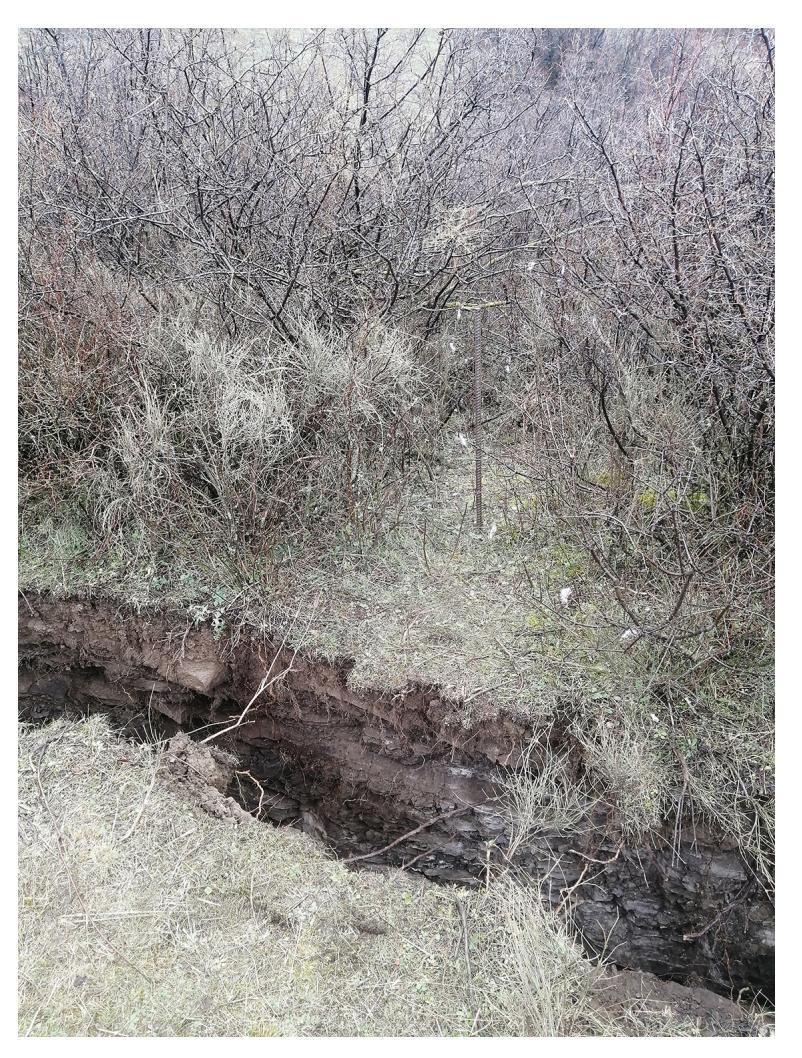
However, it should be noted, that the base of the trench is partially filled with debris and its actual depth is much greater. The deformation of the landslide body in the direction of the head is expressed in the form of cracks, which narrows up to 2 - 3 cm in a separate section in the upward direction, and in some places is transformed into zones of parallel cracking (**Figure 7**, **Figure 8**). The width of these zones reaches 5 - 6.5 m, while the visible depth varies from 2.78 - 2.87 m to 4.5 - 6.6 m (**Figure 9**).

Figure 9. Zones of parallel cracking.

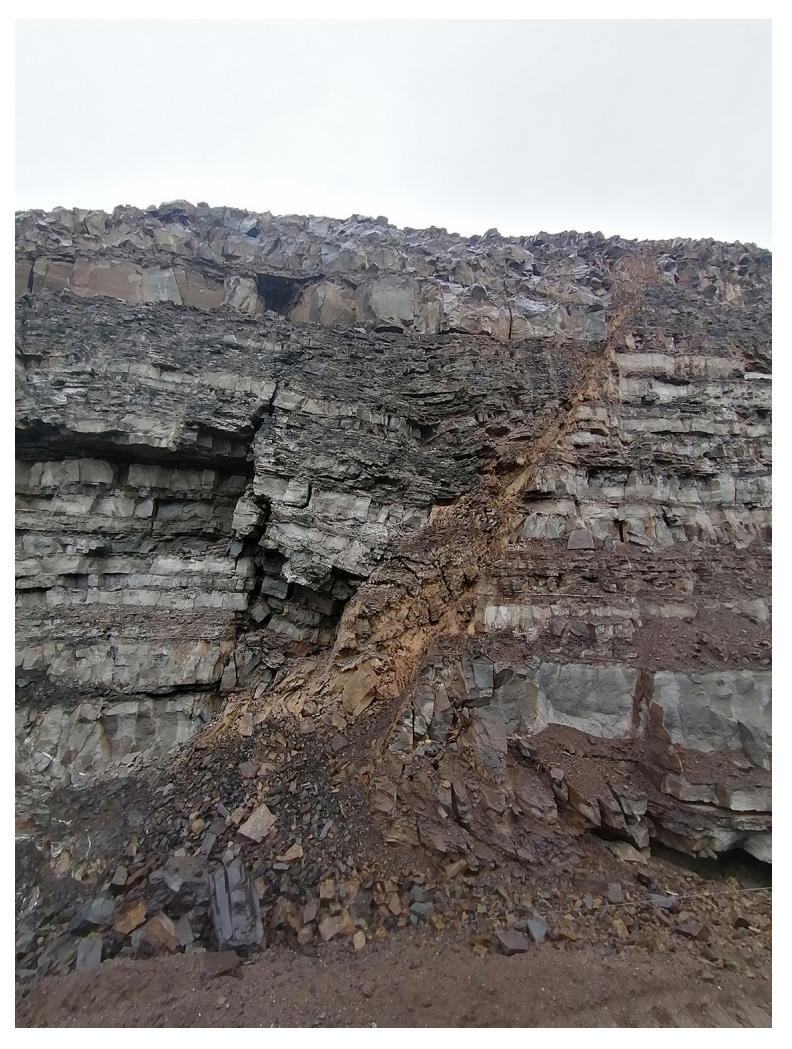
Figure 10. Historic tectonic fault line.

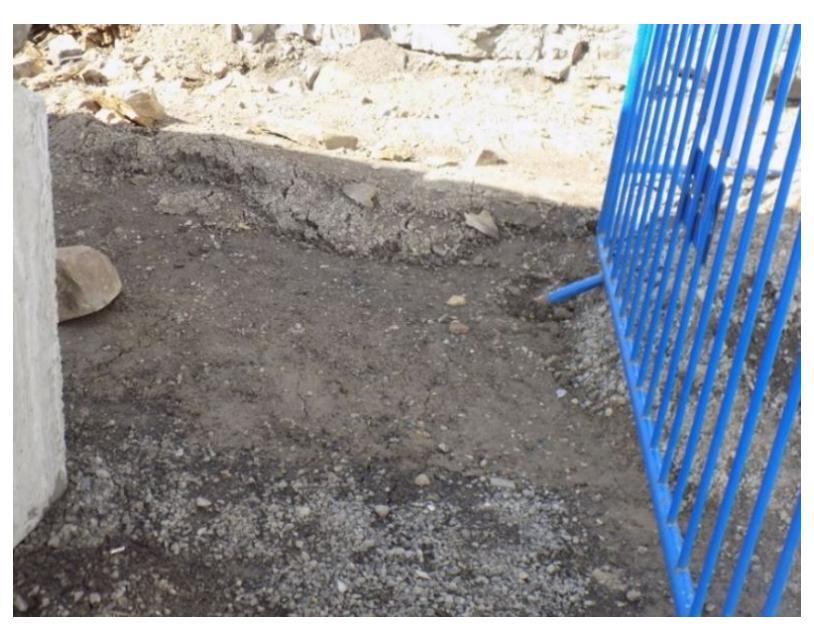
The 1st landslide area is wedge-shaped in the plan. Its length on the slope is 164 m, the base of which is connected to the surface of the semi-excavated slope with an inclination of 75° - 80° . According to the deformation in the slope contour, the depth of the landslide body as of March 17 ranges from 5 - 6 m, and it should be emphasized that signs of new deformation were observed below the plane of the landslide. Slope bearing in the form of subvertically cracked rocks and subdivided into blocks, as well as chaotic cracking of the sediment-type fault line (**Figure 10**). Also in the strip along the water pipeline shelf, in the form of compacted ground compaction, which is most likely an indication of the forma-

tion of a much larger capacity of the landslide body and the apparently invisible to us probably new activation in the depth (**Figure 11**). From the north 1st landslide area is bordered by the 2nd landslide area.

Figure 11. Lifting near the landslide tongue.

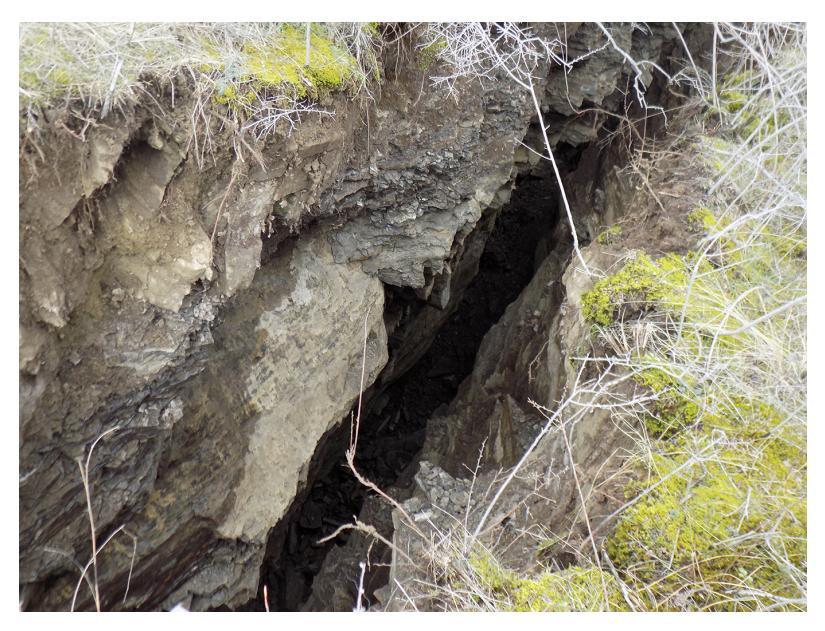
The 2nd landslide area is developed on the right side of the unnamed ravine, with a north-eastern exposure, at the head of the slope, and after a sharp turn from the ridge zone, on a steeply sloping catchment slope. The landslide body spatially includes the ridge of the watershed series and the contour of a steeply sloping local watershed. The landslide body at the head is defined by a crack up to 1.2 - 1.2 m wide and 4 - 11.0 m deep (Figure 12).

The crack extends northeast to the bed of the unnamed ravine and forms the boundary of the left board of the landslide body. The width of the crack along the board decreases to 1.3 - 0.2 m and the depth to 3.2 - 0.5 m.

Figure 12. Landslide crack at the head of the 2nd landslide area.
