# Origin of Erosion and Hydraulic Problems of the San Roque Underground Arched Culvert Channel and Its Relationship with the Maximum Flow Rate and the Maximum Permissible Velocity

# Martín Mundo-Molina\*, Daniel Hernández-Cruz

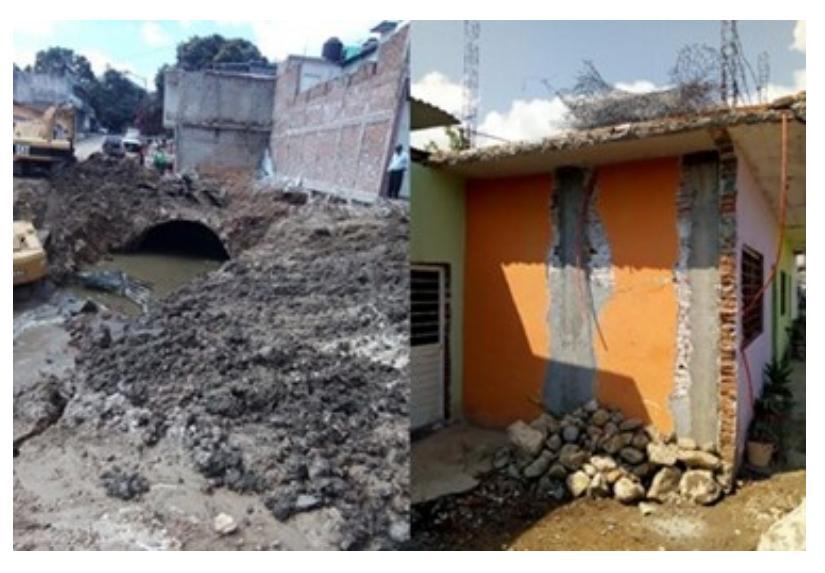
A section of the San Roque UACC collapsed on September 2nd, 2016. A portion of the street (50 meters approximately) built with hydraulic concrete broke and brought down a residential home that was just above the UACC while ten surrounding houses suffered severe structural damage (**Picture 1**). The runoffs generated from a  $102 \text{ l/m}^2$  rain caused this disaster [1].

Picture 1. Collapsed house and damaged house on September 2nd, 2016.

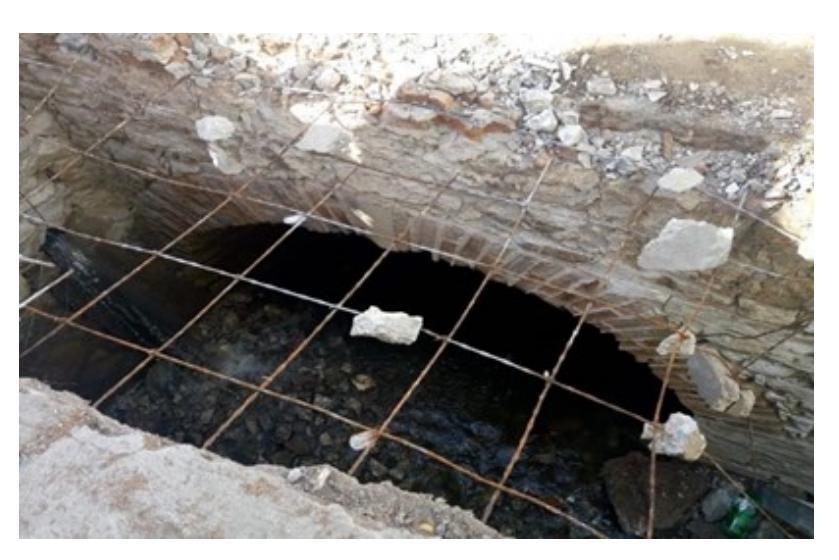
A couple of years later, another small section of the San Roque UACC caved in due to heavy structural damage (**Picture 2**). The collapse happened right beside Fray Matías de Córdoba elementary school in Tuxtla Gutierrez city. Fortunately, the incident didn't cause any harm to students, adjacent houses, and pedestrians.

**Picture 2.** The collapsed site, next to an elementary school.

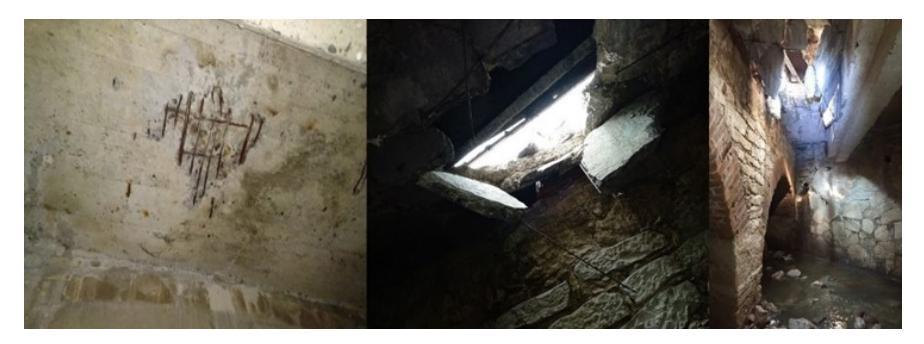
(Picture 3). Pérez *et al.* [5] also reported that in the collapse area and its surroundings the materials of UACC present diverse pathologies. In the studied UACC section and the reinforcing concrete beam [5] observed runoffs and water infiltrations through several fissures and cracks, in the reinforced concrete's coating, which provoked degradation, efflorescences, and calcium hydroxide leaching. Reinforced steel in the concrete (longitudinal and transversal) showed visible corrosion and was exposed in the open, with material detachment typical of the areas without coating and crystallized alkaline leachates. In the reinforced concrete beam that goes through the UACC, at the (0 + 145) chain (145 meters from the CA's discharge into the Sabinal's main channel hydraulic), Pérez *et al.* [5] noticed the most severe structural damage, such as exposed steel structure and partial cracking (Picture 3).

**Picture 3.** Corrosion, carbonation of materials in the collapsed area of the UACC (0 + 145).

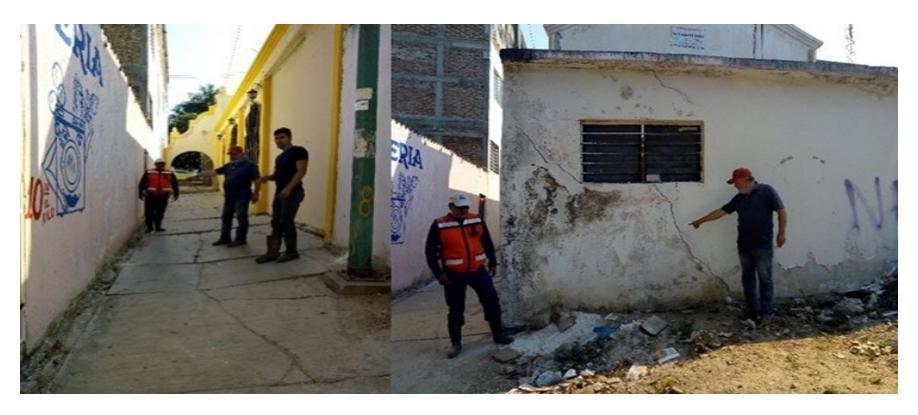
**Picture 4.** House with severe structural damage and slight sinking in the UACC's adjacent constructions.

structural damage and the danger it represents for the families that live nearby, it must be demolished.

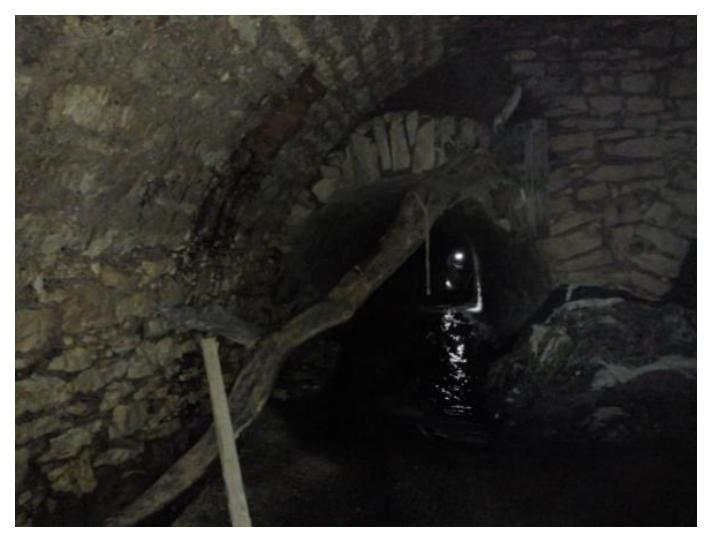
flow's direction, as opposed to good hydraulic design. **Picture 5** shows a reduced geometric area that is prone to clogging due to the accumulation of solid residues. There are many sections in the San Roque UACC as the one depicted in **Picture 5**, which are no longer apt to transport the flow rates shown in **Table 1**.

Picture 5. Hydraulic reductions where solid residue accumulates.

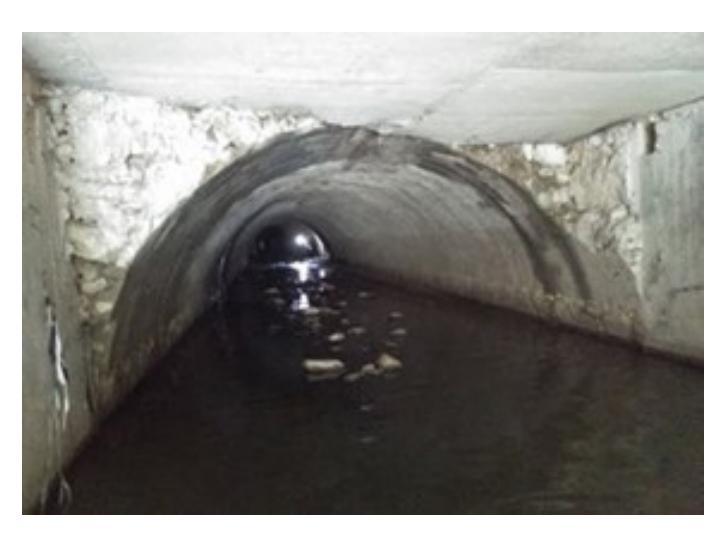
As mentioned before, the San Roque UACC was built in sections, at different municipality managements. These circumstances facilitated that the structure was made with different materials, with sections constructed with brick masonry, others with stone masonry, and some covered with reinforced concrete which are unfavorable for the adequate hydraulic operation of the OCH for the following reasons: 1) The hydraulic transitions were not built as theory dictates. 2) The structure's conditions generate unnecessary changes in hydraulic areas, flow velocity and flow rates, and 3) There are various segments with minimal geometric sections where trash and solid waste accumulate and obstruct the the flow rate. The structure does not have hydraulic transitions, so the water crashes directly into the walls, generating high energy loss (see the straight angles at the top of the arch in **Picture 6**).

Besides the energy loss, water crashing straight into the UACC structure can cause recirculation areas with high turbulence, which is conducive for erosion and abrasion cavity formation. The UACC should have been designed with hydraulic transitions, as shown in **Figure 3**, taking into account the theoric recommendations indicated in Equation (2), to decrease the energy loss, turbulence, minimize erosion and prevent the depth hole formation.

**Picture 6.** UACC without hydraulic transitions.

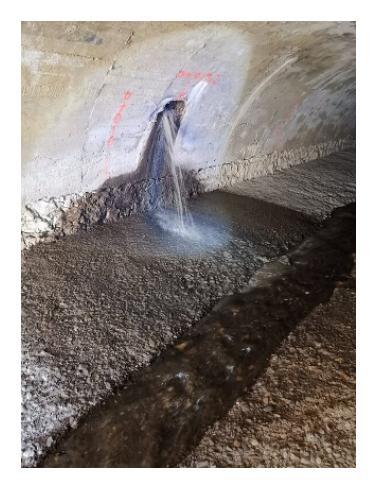
Thus, the concrete's quality and finish in the UACC has great relevance in the behavior of hydraulic depth and can increase or decrease the hydraulic areas, which in turn increases or decreases the water it transports. A low-quality rough concrete surface diminishes the possibilities of the UACC to transport the maximum flow rates ( $Q_{max}$ ) it should.

**Picture 7.** Poor and rough finish concrete [9].

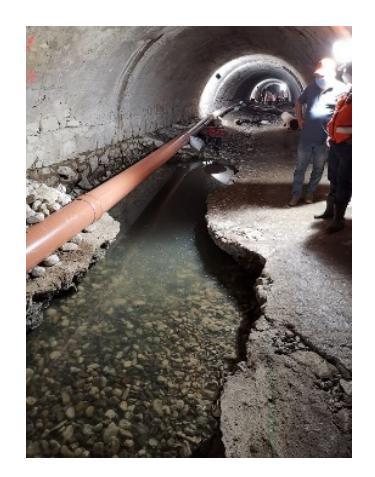
The hydraulic erosion and the abrasion provoke cavities in the natural hydraulics channels or concrete hydrauli channel, as the cavity shown in **Picture 8**, which was formed by the erosive force of the water.

Picture 8. Erosion and cavity in the San Roque UACC.

Thus, the water's tractive force makes the particle begin its movement. The particle also lifts when the gravitational force is lower than the particle's weight (otherwise, it drags the particle away). With the tractive and lifting force generated by the water flow, the detachment, drag, and erosion of material begins, which in turn transforms the eroded point turning it into small, elongated cavities that, with time and continuous water action, turns into a large cavity (see **Picture 8** and **Picture 11**).

On the other hand, Manning roughness generates a different hydraulic behavior compared with a smooth surface. For example, excessive roughness, as shown in **Picture 8** and **Picture 9**, enables the inclusion of air, high turbulence, abrasions, channel bottom erosion, formation of small cavities when water flows in a supercritical hydraulic regime.

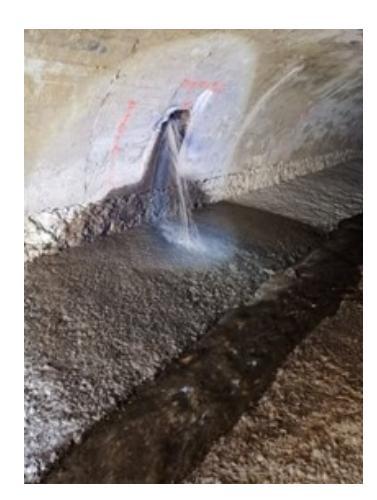
Picture 9. Repaired cavities around May and June, 2019.

When high-speed water gets in contact with the material underneath the concrete layer (when maximum flow and high flow-velocity occurs), the cavities grow disproportionately (**Picture 8**). It is during the rainy season when the cavities formation problem takes a turn for the worse because of v and Q increments. Cavities formation is random, but it takes only one rainy season to have a severe problem, that can compromise abutments, foundation, and the UACC structure.

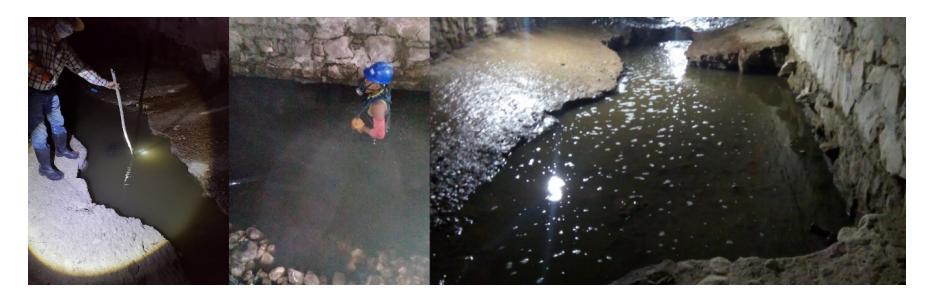
Considering the steep slopes and supercritical flow that runs inside UACC is must conclude it is prone to cavities formation (see **Picture 10** and **Picture 11**). The combination of high-velocity flows (that exceeds the maximum speed allowed, see Equations (5), (8), and (11)) plus the inadequate material of the canal bottom (simple, rough concrete without quality finish) increase the chance of cavities formation in the structure, especially in rainy seasons.

Picture 10. Large cavities in the in the San Roque UACC [18].

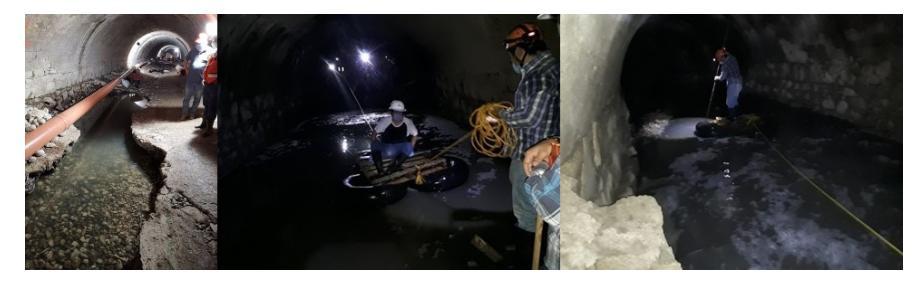
Picture 11. Extensive cavities [18].
