Inadvertent Lead Malposition in the Left Ventricle during Permanent Ventricular Pacing about One Case

How to cite this paper: Dia, K., Mboup, W.N., Ndao, S.C.T., Ka, M.M., Yassine, R., Ba, D.M., Balde, D.W. and Mboup, M.C. (2023) Inadvertent Lead Malposition in the Left Ventricle during Permanent Ventricular Pacing about One Case. *World Journal of Cardiovascular Diseases*, **13**, 756-763. https://doi.org/10.4236/wjcd.2023.1311065

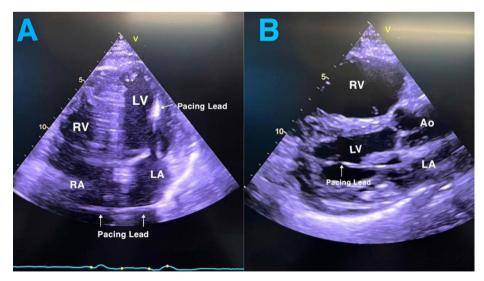
A 71-year-old man was referred in July 2023 to our echocardiography laboratory. The patient had a history of arterial Hypertension and suffered in the past from symptomatic slow Atrial Fibrillation (AF) with syncope. Therefore, in August 2021, he was implanted with a ventricular single-chamber (VVI) PM with prescription of rivaroxaban. At our TTE examination, in parasternal long-axis view an echo bright linear structure was seen in left atrium passing through mitral valve and leaning against posterior LV wall; in short-axis and apical views it was seen to cross the interatrial septum (Figure 1(A), Figure 1(B)). Furthermore, a left-to-right shunt was displayed at this level. Inappropriate lead placement in LV was diagnosed with the lead passing through a patent foramen ovale (PFO), then moving into the Left Atrium and through the mitral valve orifice into the LV (Figure 1(A), Figure 1(B)). No thrombi were detected attached to the lead. At the PM control, ventricular pacing was 82%; electrical parameters were in normal ranges (threshold 0.5 V at 0.4 ms; sensing 15.6 mV, and lead impedance 465 ohms). The electrocardiogram (ECG) showed right bundle branch block (RBBB) QRS-paced morphology with a positive QRS pattern in V1, and a negative QRS pattern in DI. The median paced QRS axis on the frontal plane was -120°. Precordial transition was on V5 (Figure 2). A Chest X-ray was taken: the lead seemed correctly positioned on the postero-anterior (PA) view, while it curved backwards at right atrium (RA) level on the 30° OAG view, thus suggesting electrode misplacement into LV (Figure 3(A), Figure 3(C)). The

Figure 1. Composite image of Transthoracic Echocardiographic images from the apical window (A) and parasternal long axe (B). The pacing Lead can clearly be seen passing from right atrium (RA) to Left Atrium (LA) through the patent foramen ovale and then into the Left Ventricle (LV). Aorta (Ao), Right Ventricle (RV).

tion and the Lead malposition discovered 23 months (730 days) after pacemaker's implantation, we decided to maintain the lead in LV and continue anticoagulation with warfarin 5 mg with a target international nominal ratio of 2.5 - 3.5.

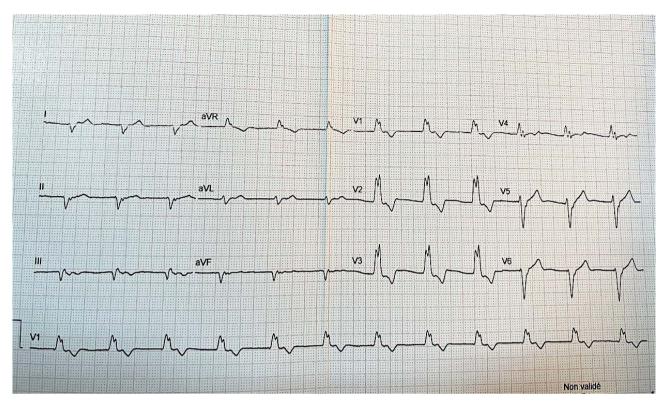
Figure 2. 12-Lead Electrocardiogram (ECG) during ventricular pacing showing right bundle branch block (RBBB) morphology of the QRS complex with a frontal plane axis of –120°. Transition on V5.

Malposition may also be diagnosed through ECG or Chest X-ray [3] [5]. Most of the patients with LMLV have a RBBB pattern at ECG, a QRS transition after V3, a median paced QRS axis on the frontal plane around -120° [5] [10]. Typical QRS morphology during RV stimulation has most of the time a left bundle

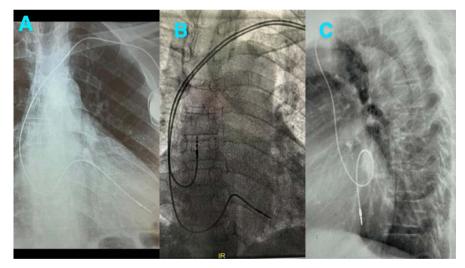
Figure 3. Our Patient's Chest X-ray: posteroanterior (A) and lateral (C) views indicating the pathway of the lead in the two projections. (A) The ventricular lead is positioned higher in the postoanterior view (A) than the standard position in Right ventricle of a patient without lead malposition (B); (C) Malpositioned LV lead is characteristically steered toward the spine and appear posterior, close to the spine.
