Two French Oil Terminals in the WWII

Giancarlo T. Tomezzoli

2. The Talards Oil Terminal (Saint-Malo)

3. The Bouchemaine Oil Terminal (Angers)

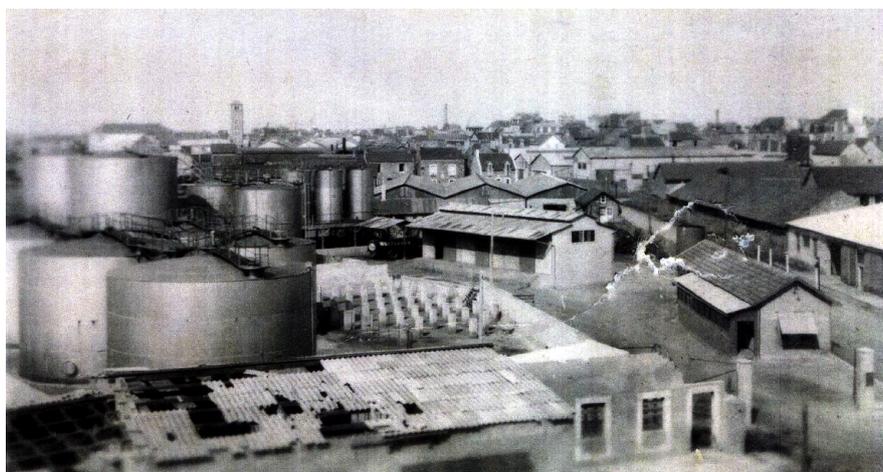
Figure 1. Talards oil terminal—pre-war image, on the left oil tanks, on the right entrance gate, on the foreground left the still existing square tower of the Civic Centre of the Louis Martin Avenue in front of the Commerce Chamber (Pottier, 2013; Archive Saint-Malo, 1940).

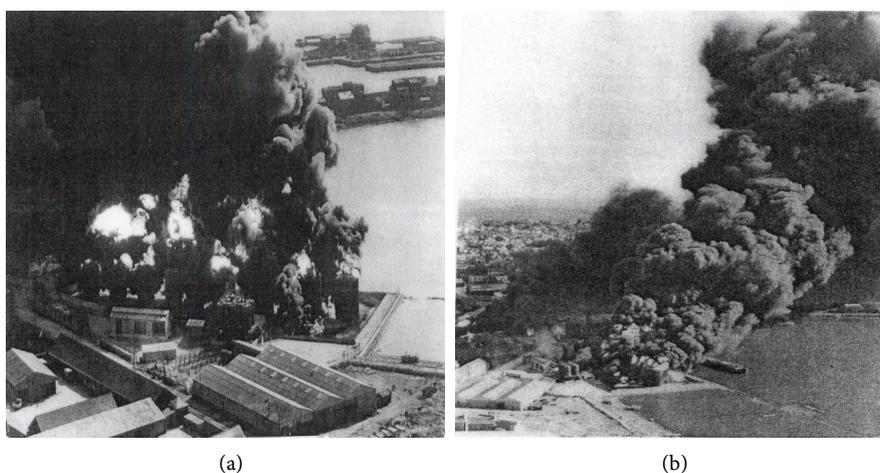
Figure 2. Talards oil terminal—(a) tanks on fire (Imperial War Museum, RAF Coastal Command); (b) smoke column above the tanks (Imperial War Museum, RAF Coastal Command) on the right a tanker at the mooring pier.

A thick column of smoke from the burning terminal tanks remained visible for days. Avro Ansons of 48th RAF Squadron patrolling off the French coast documented columns of smoke and flames from the Talards oil tanks (**Figure 2**, **Figure 3**) set on fire by the Howard-Johnson's demolition group. However, the terminal was not completely destroyed and it was rapidly put back in operation (Brichet & Peyle, 2005) for the supply of kerosene to the Luftwaffe fighters and bombers stationed at the nearby airfield of Dinard-Pleutuit (Lippmann, 2012; Tomezzoli et al., 2013; Tomezzoli, 2014; Dahiot et al., 2009), participating to the battle of Britain (10th July - 31st October 1940). A daily supply of kerosene to the airfield was possible by road, crossing the Saint-Hubertus bridge 15 km south of Saint-Malo or by using the ferry Saint-Malo-Dinard. In both the cases this would have caused unacceptable delivery delays. To overcome this problem, the German *Luftwaffe* decided the requisition of the self-propelled barges in the harbour. Each barge filled its bunkers at the Talards terminal, leaved Saint-Malo harbour, reached the mouth of the Rance river and docked at a mooring pier near La Richardais. There a pumping station extracted the kerosene from the barges and sent it to the airfield by means of a pipeline. The barges were a dozen comprising Esso, Naphta I, Naphta II, Marie-Therese, Chantilly, Galem and Molan (Brichet & Peyle, 2005).

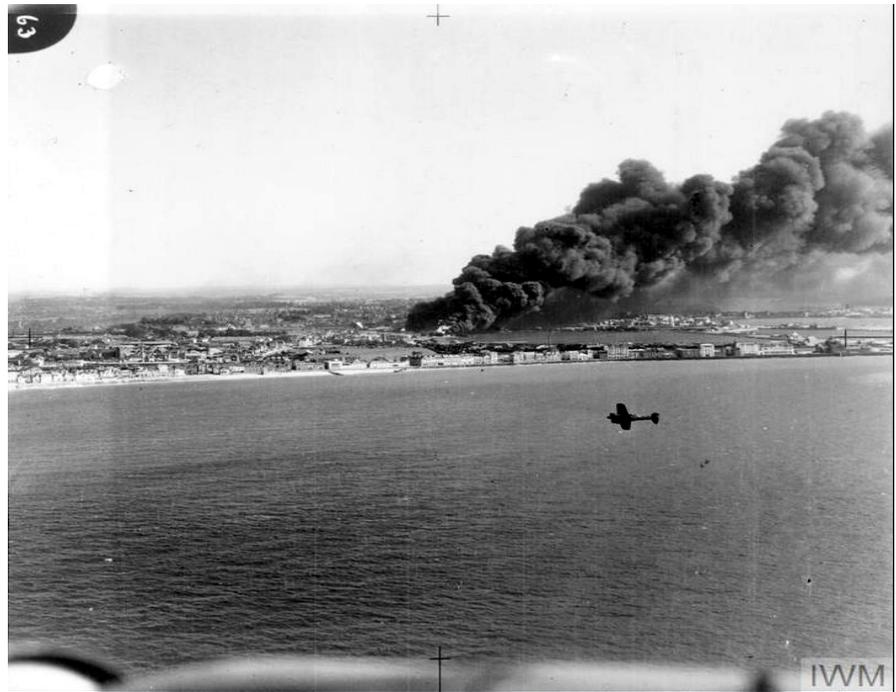
Figure 3. Talards oil terminal on fire (Imperial War Museum, RAF Coastal Command, Cat.: C 1802).

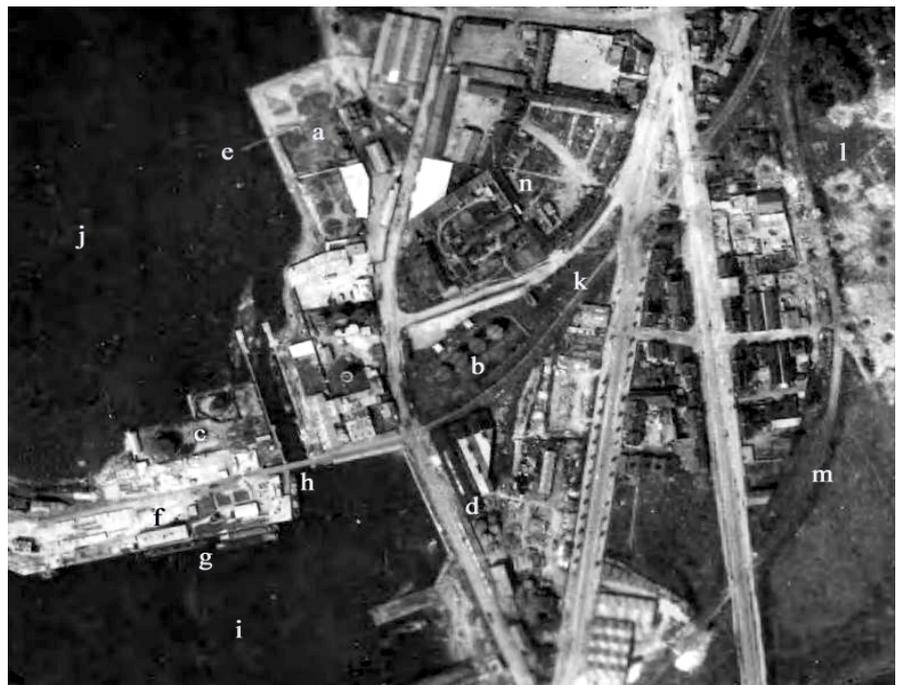
Figure 4. Talards oil terminal organization—a: 1st area—main tanks burned by the Howard-Johnson's demolition group; b: 2nd area; c: 3rd area; d: 4th area, e: mooring pier; f: degaussing station (Tomezzoli & Pottier, 2016); g: moored barges; h: movable bridge; i: Bouvet basin; j: Jacques Cartier basin - Mare aux Canards; k: railway; l: bombed zone; m: railway; n: Talards casern. (Mission identification: C1115-0331_1944_106G1614_4005, cliché n 4005, scale: 1/10313, cliché type: Argentique, Date de prise de vue: 24/07/1944).

The oil terminal (48°38'38.34"N, 2°00'41.61"W) (**Figure 4**) was definitively dismantled at the beginning of the years two thousands. Several visits in the harbour in looking for possible terminal surviving components provided no result.

A French air recognition image of 13th August 1944 (**Figure 4**), few days after the conclusion of the Saint-Malo battle, reveals many details of the Talards oil terminal. It was composed by a 1st area comprising a first group of 11 main tanks, a second group of 2 smaller tanks and a third group of 9 still smaller tanks located close one to the other, a 2nd area b comprising 4 tanks, a 3rd area c comprising 2 tanks and a 4th area d comprising 4 tanks. The tanks of the first group, burned by the Howard-Johnson's group, stored the most required fuel in the region of Saint-Malo, probably gasoline for car and trucks. The fuel supply was ensured by barges and tankers moored to the mooring pier e (**Figure 2**, **Figure 4**). After the Battle of Britain no important *Luftwaffe* unit stationed at the Dinard-Pleurtuit airfield. Therefore, the tanks surviving the burning certainly stored fuels for the *Kriegsmarine* ships in stop or stationed at the harbour and the *Kriegsmarine* and *Heer* vehicles. A pumping station was certainly located on or near the mooring dock e. Because crossing the Channel by oil tankers was dangerous due to the RAF surveillance, it is possible that the fuel came mainly by train, probably from the refinery of Le Havre. A railway contoured the terminal second and third areas b, c; therefore it is possible that the fuel arrived by train was discharged somewhere there, although **Figure 4** does not show a railway depot as in the railway station of Bouchemaine (**Figure 10**). **Figure 4** shows that the Germans did not construct walls for protecting the terminal tanks surviving the burning and that the allied bombardments of Saint-Malo failed to touch the terminal.

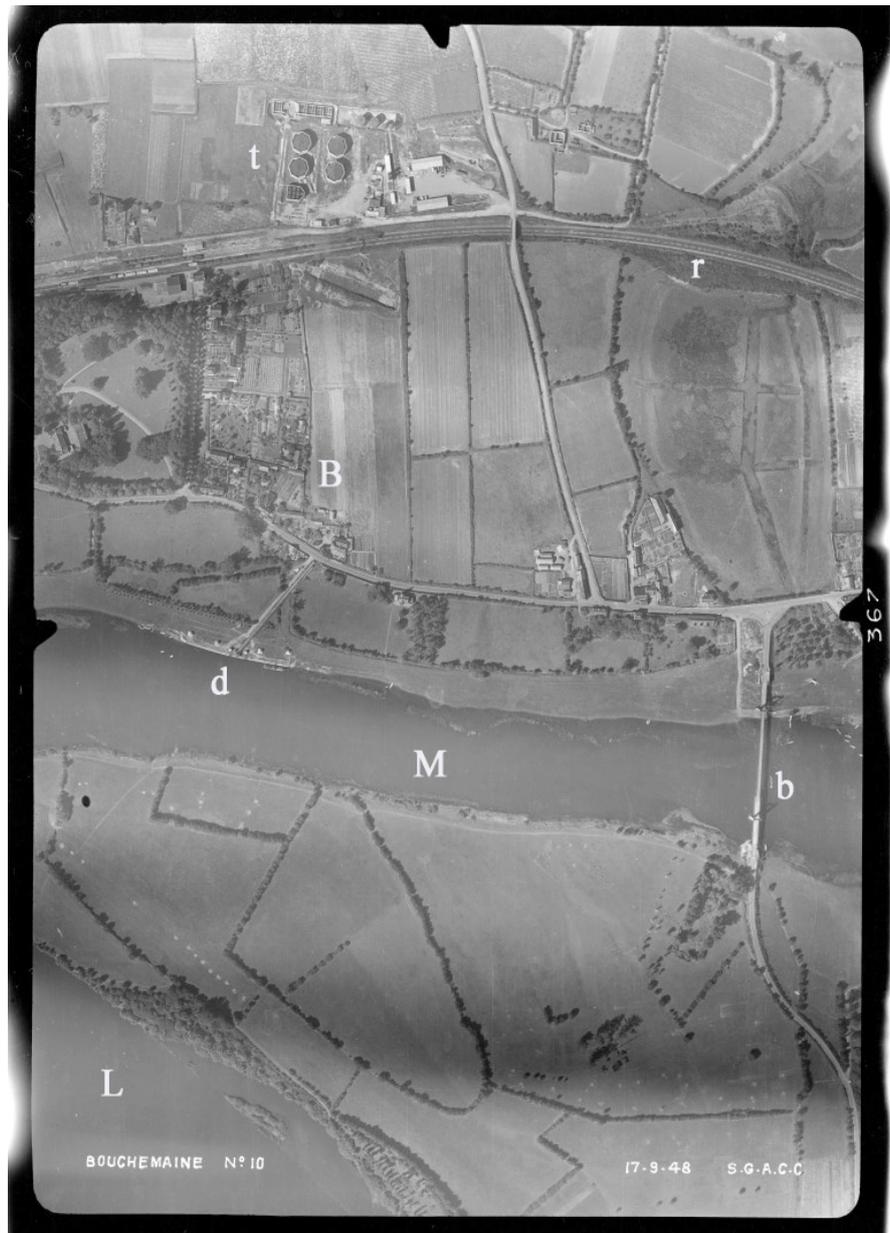
Figure 5: Bouchemaine—b: damaged suspended bridge; d: oil dock; r: railway; t: oil terminal; B: Bouchemaine; L: Loire river; M: Maine river. (Mission identification: C93PHQ8041_1948_CDP3032_0010, cliché n° 10, scale: 1/5034, cliché type: Argentique, Date de prise de vue: 17/09/1948).

one month after the conclusion of the Saint-Malo battle, reveals many details of the Bouchemaine oil terminal. As the Talards oil terminal, it was composed by a 1st area comprising, in this case, a first group of 4 main tanks each protected by an octagonal wall and a second group of 10 smaller tanks located close one to the other and all protected by a six sides wall. The fuel supply was ensured by trains, which parked in the railway depots and by barges and tankers coming from the refinery of Donge, which moored at the oil dock d. The main columnar bollards were so big and high for a sure mooring of barges and tankers in the Maine stream also during the Maine floodings, in which the dock platform was covered by water. The pumping station on the top of columnar bollard c permitted oil pumping also during the floodings. Because no sign of German masonry was remarked, the dock platform and its bollards were of French construction. The small bunker h at the terminal entrance was probably a guardhouse and the bunker i a refuge for the personnel lodged in the building e or an ammunition and material depot bunker. The excavation m inclined with respect to the *SNCF* railway (**Figure 10**) reveals the German intention to expand the railway depots by constructing a second, protected railway depot opposed with respect to the *SNCF* railway to the depots. The adaptation of the oil terminal to the *Kriegsmarine* needs and the excavation m were probably directed by the *Organization Todt* supervising the work of French requisitioned firms, workers and vehicles. The oil terminal t and the tank wagons parked in the depots have not been object of attacks by the French resistance. The nearby suspended bridge on the Maine (**Figure 7(a)**), considered of strategical importance, was dynamited by the Germans in retreat with the loss of one of its two ways (**Figure 5**).

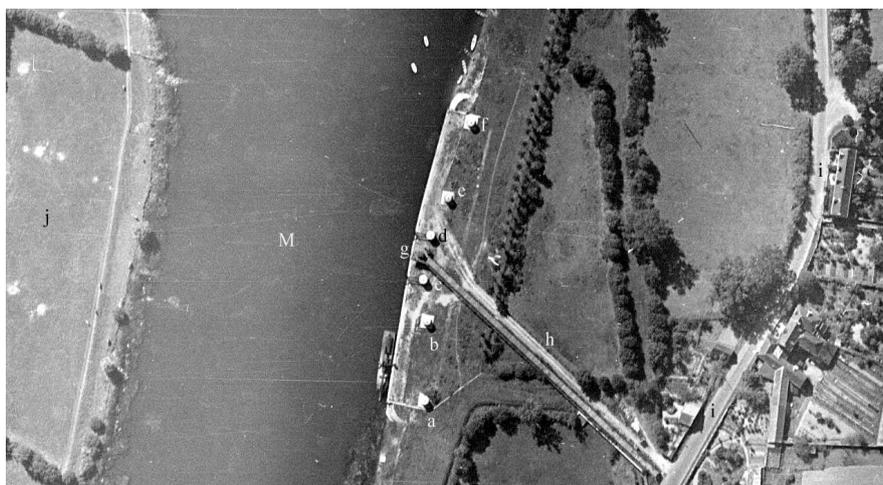
The dock platform (**Figure 6**), about 126×27 m, completely covered by grass, about 450 m far from the oil terminal. Nine well preserved minor columnar bollards, each formed by a concrete prismatic column about 0.5 m large and 1.5 m height with a small metallic bollard at the top, were aligned on its river side. Five main columnar bollards a, b, d, e, f, each having a concrete square base about 5 m large with a superimposed concrete octagonal column of about 3 m in long diagonal and 3 m height with a metallic railing and a metallic bollard at the top, were aligned in its middle. Some well preserved concrete supports of an original metallic barrier and two prismatic, concrete, white columns marking a dock entrance were aligned in its land side (**Figure 7(b)**, **Figure 7(c)**, **Figure 7(e)**).

Figure 6. Bouchemaine oil dock—a, b: main columnar bollards; c: disappeared main columnar bollard; d, e, f: main columnar bollards; g: pumping station; h: dock's access road—pipeline road; i: actual rue Chevrière; j: possible bomb impact craters, M: Maine river. (Mission identification: C93PHQ8041_1948_CDP3032_0010, cliché n°10, scale: 1/5034, cliché type: Argentique, Date de prise de vue: 17/09/1948).

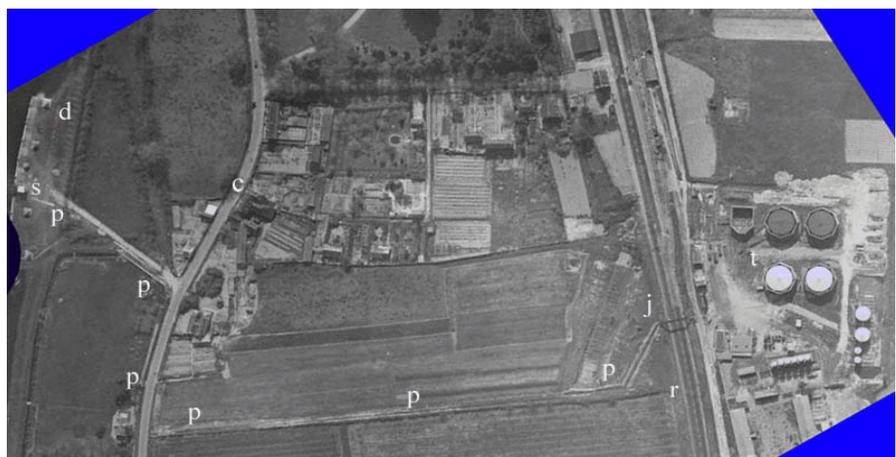
The oil pipeline connected the oil dock d to the oil terminal t (**Figure 8**). The pipeline began at the pumping station initially located between the bollards c, d. Subsequently, the pumping station was elevated on the top surface of bollard c and, in recent years a metallic platform was added for facilitating oil barges and tankers discharging (**Figures 9(a)**, **Figures 9(b)**). From the pumping station, the pipeline, partly buried, continued on one side of an unpaved road and then it turned west along the actual rue Chevière, before to bend at a right angle to cross cultivated fields up to a metal bridge on the *SNCF* railway and enter the oil terminal. The bollard c, the pumping station and the metallic platform were demolished in 2012 (**Figures 9(a)-(d)**). The pipeline was probably dismantled or remains buried in the terrain and no longer visible.

Figure 8. oil pipeline—c: rue Chevière; d: oil dock; s: pumping station on bollard c; p: pipeline; j: pipeline metal bridge on the *SNCF* railway; r: *SNCF* railway; t: oil terminal. (Mission identification: C1522_0281_1954_CDP860_0358, cliché n°358, scale: 1/4090, cliché type: Argentique, Date de prise de vue: 12/04/1954).

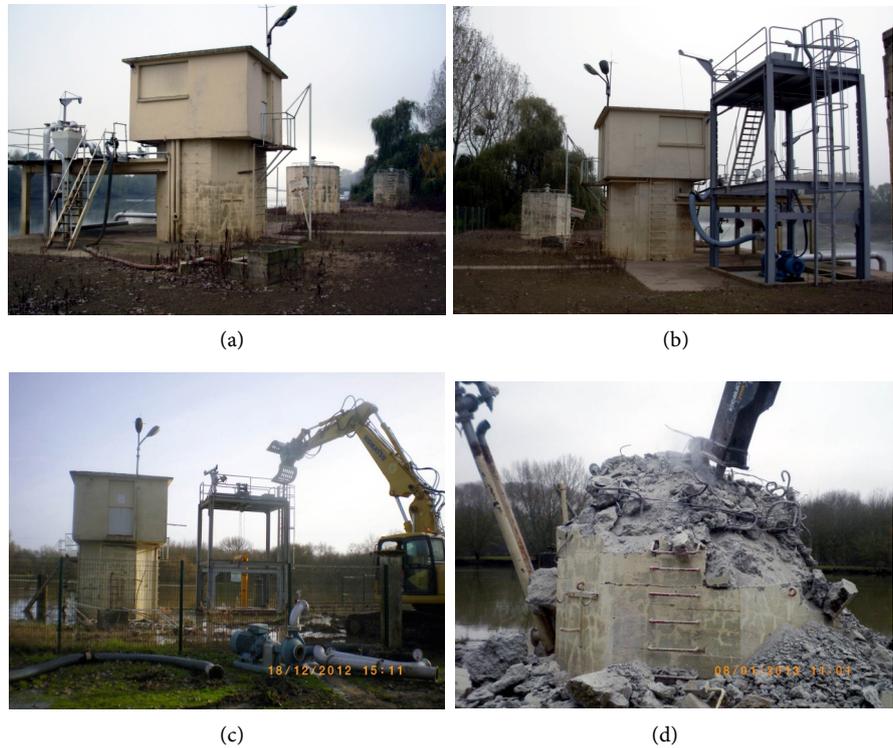
Figure 9. Pumping station and bollard c demolition—(a) side view, on the left the added metallic platform with oil discharging tubes, on the foreground right the columnar bollards d, e (courtesy Mr F. Guillaume, 07th November 2006); (b) side view, on the foreground left the columnar bollard b, on the right the metallic platform with oil discharging tubes (courtesy Mr F. Guillaume, 07th November 2006); (c) platform and pumping station demolition (courtesy Mr F. Guillaume); (d) bollard c demolition (courtesy Mr F. Guillaume).

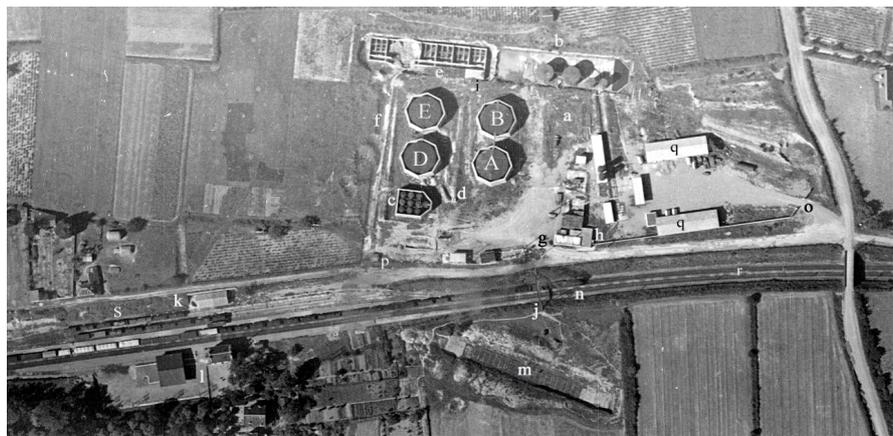
Figure 10 shows the oil terminal organization and is particularly touching because its high quality permits, by enlargement, to distinguish a train formed by a puffing steam locomotive towing 35 wagons crossing the Bouchemaine stations and transiting under the pipeline metal bridge on the faraway day of 17th September 1948.

Figure 10. Bouchemaine oil terminal—a: 1st area; b: 2nd area; c: six side wall with tanks 1 to 10; A, B, D, E labelled octagonal walls and corresponding oil tanks; d: possible disappeared structure; e: damaged building; f: protected passage to the building e or anti-tank trench; g: terminal main entrance/exit; h: bunker; i: bunker; j: pipeline metal bridge; k: Bouchemaine freight station; l: Bouchemaine passenger station; m: excavation; n: train; o: entrance/exit p: minor construction; q: hangar; r: *SNCF* railway line; s: railway depot. (Mission identification: C93PHQ8041_1948_CDP3032_0010, cliché n°10, scale: 1/5034, cliché type: Argentique, Date de prise de vue: 17/09/1948).

No trace on the terrain has been found of the building e, about 60×12 m, the protected passage to the building or anti-tanks trench f and the excavation m (Figure 10).

A French air recognition image of 17th September 1944 (**Figure 10**), exactly

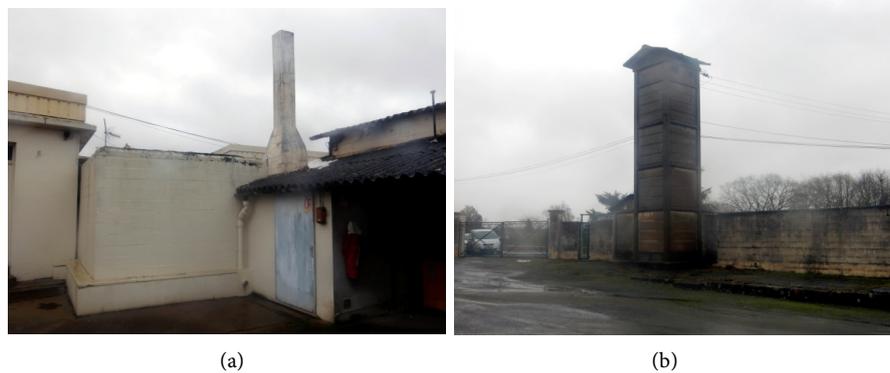
The main terminal entrance g, comprising a well preserved white painted German small rectangular bunker (47°25'9.32"N, 0°37'1.24"W) (**Figure 11(a)**)

Figure 11. Bouchemaine oil terminal—(a) small German bunker h at the entrance; (b) after war electrical distribution cabin.

about 9×4 m. The nearby electrical distribution cabin, not present in **Figure 10**, was built well after the war.

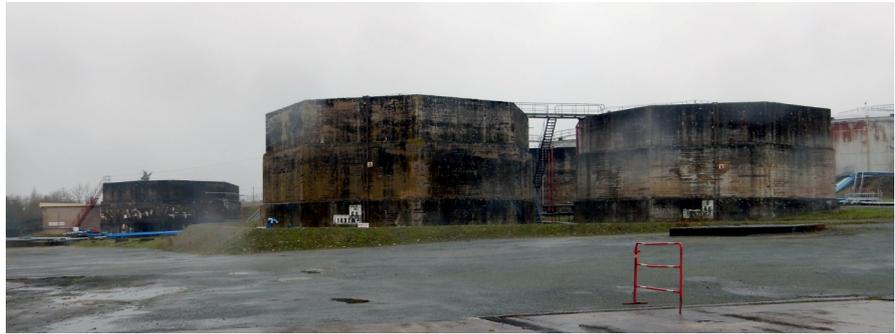
A well preserved oval concrete platform ($47^{\circ}25'9.44''\text{N}$, $0^{\circ}37'3.63''\text{W}$) (**Figure 12**) about 7×3 m, 30 cm high with two bases for vertical structures on its surface.

Octagonal wall B ($47^{\circ}25'8.84''\text{N}$, $0^{\circ}37'4.81''\text{W}$) (**Figure 12**) about 20 m in long diagonal, still protecting the original tank refurbished several times after the war. It presented a three steps external structure with some local concrete superficial failures leaving uncovered rods of the internal armour. On one side was an eroded white board with the label B G8 1897 M^3 . On another side a circular, yellow metallic cover marked with a black label B closed the access to the tank protected by the wall.

Figure 12. Bouchemaine oil terminal 1st area—on the left the six sides wall, in the middle octagonal wall A, on the right octagonal wall B, near the octagonal wall B, on the ground, the oval platform.

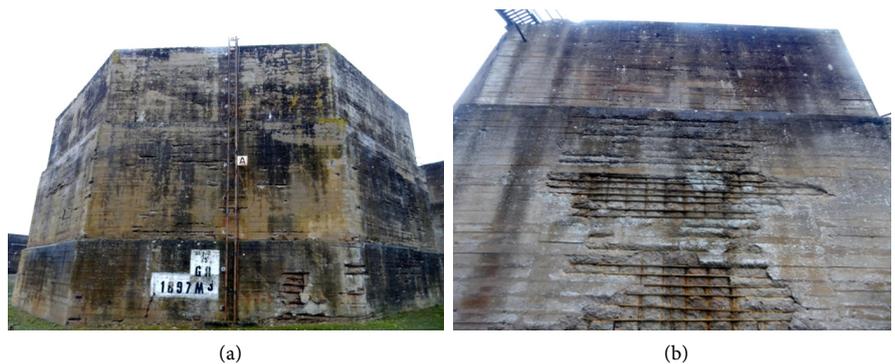
Octagonal wall A ($47^{\circ}25'8.45''\text{N}$, $0^{\circ}37'3.82''\text{W}$) (**Figure 13**) about 20 m in long diagonal, still protecting the original tank refurbished several times after the war. It presented a three steps external structure with some large concrete superficial failures that left uncovered rods of the internal armour. On one side was a slightly eroded white board with the label A G8 1897 M^3 indicating a tank capacity inferior to the above mentioned capacity of 2140 m^3 . On another side a circular, yellow metallic cover marked with a black label A closed the access to the tank protected by the wall.

Figure 13. Octagonal wall A—(a) three steps external structure with white board; (b) local concrete superficial failures.

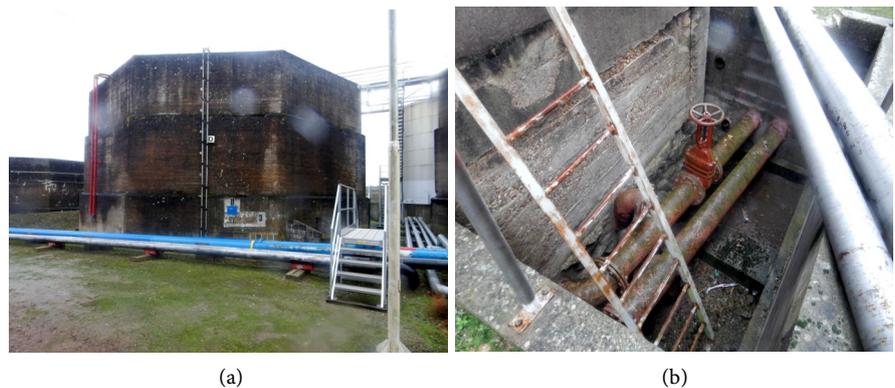
Octagonal wall D ($47^{\circ}25'7.44''\text{N}$, $0^{\circ}37'4.71''\text{W}$) (**Figure 14**) about 20 m in long diagonal, still protecting the original tank refurbished several times after the war. It presented a three steps external structure with some local concrete superficial failures, leaving uncovered rods of the internal armour, and projectile impact cavities due to air attack. On one side was a white board whose label B G8 1897 M^3 was abraded and covered by a blue, square board with a white label Er. On another side a circular, yellow metallic cover marked with a black label D closed the access to the tank protected by the wall.

Figure 14. octagonal wall D—(a) external structure with white board covered by a square, blue board; (b) concrete pit with connection pipes.

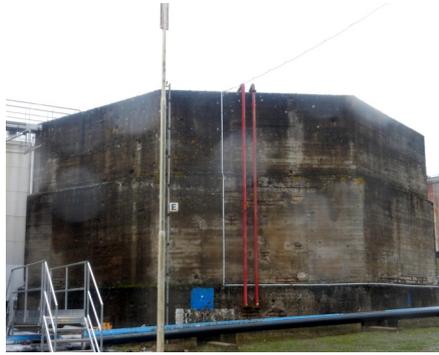
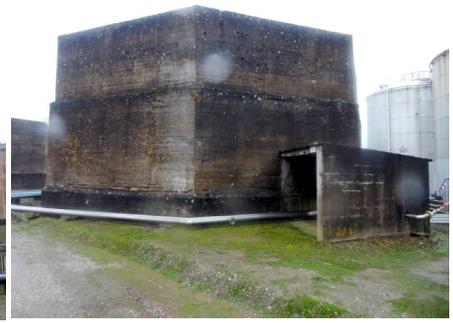
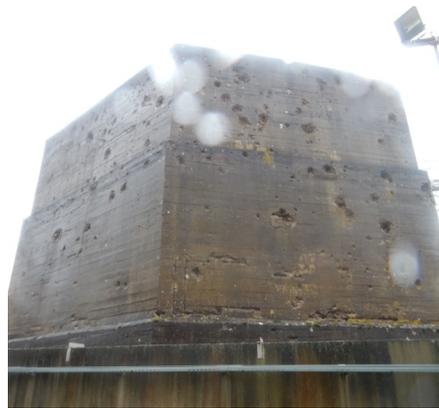
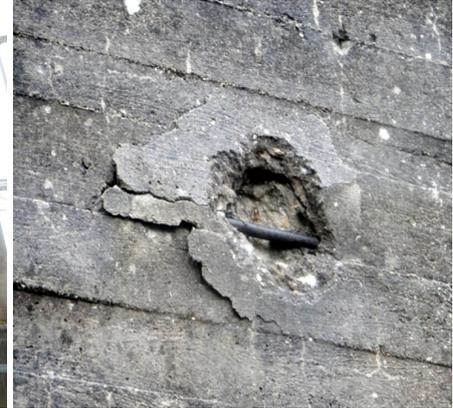
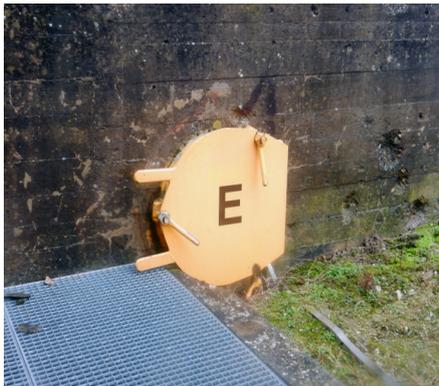
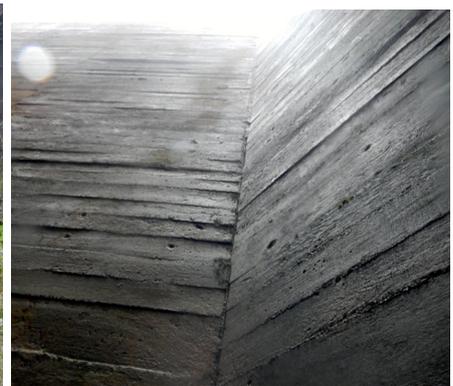
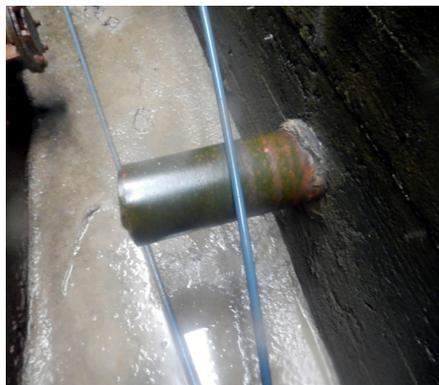
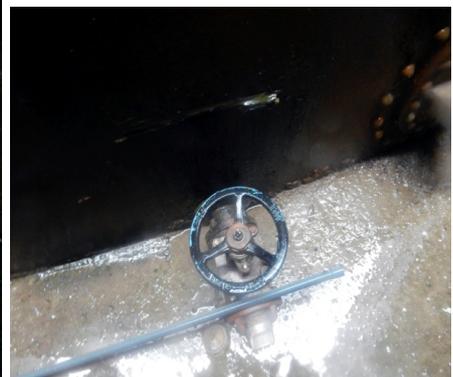
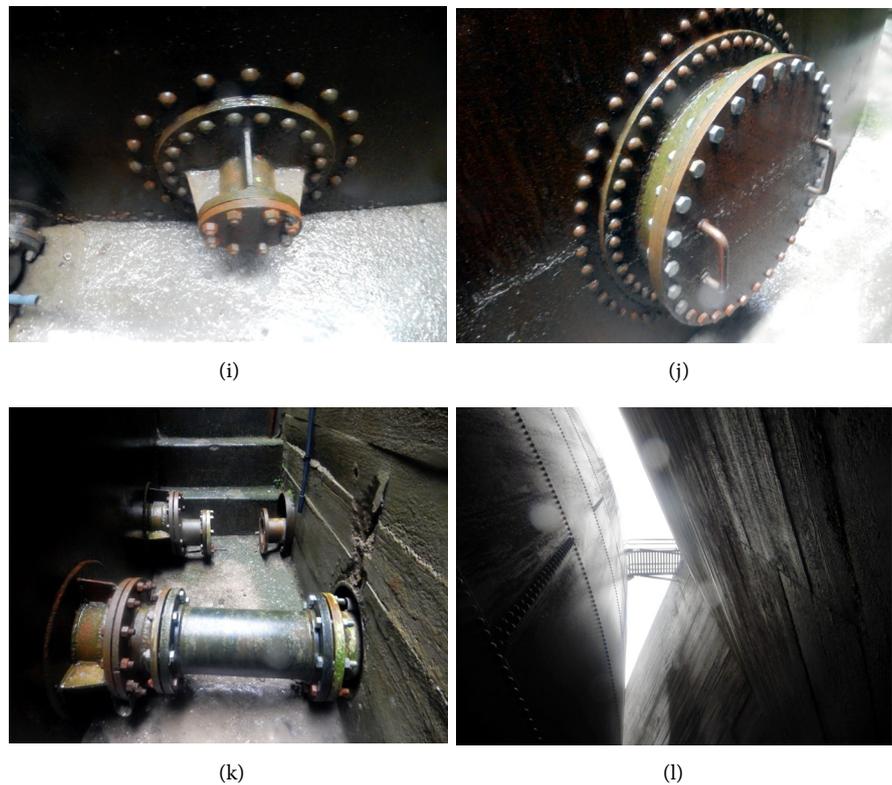
Octagonal wall E ($47^{\circ}25'7.85''\text{N}$, $0^{\circ}37'5.7''\text{W}$) (**Figure 15**) about 20 m in long diagonal, still protecting the original tank refurbished several times after the war. It presented a three steps external structure with some local concrete superficial

failures leaving uncovered rods of the internal armour and projectile impact cavities due to air attack. On one side was a white board whose label B G8 1897 M3 was abraded and covered by a blue, square board with a square, white label. On another side was a circular, yellow metallic cover marked with a black label E closed the access to the tank protected by the wall. The access was a circular, metallic passage in the wall, about 1 m in diameter. The wall internal structure was vertical with no steps and in perfect preservation stage showing the traces of

Figure 15. Octagonal wall E—(a) abraded white board covered by a square blue board; (b) garage leaning against the wall; (c) projectile impact cavities; (d) projectile impact cavity; (e) circular, yellow metallic cover; (f) wall internal structure; (g) metallic pin in the wall; (h) hydraulic valve; (i) riveted tank access; (j) riveted tank access; (k) connection pipes; (l) wall internal structure and tank riveted structure.

the construction formwork elements (**Figure 15(f)**), typical of the German masonry, confirming its German construction. The tank presented a black, riveted surface with connection pipes crossing the wall.

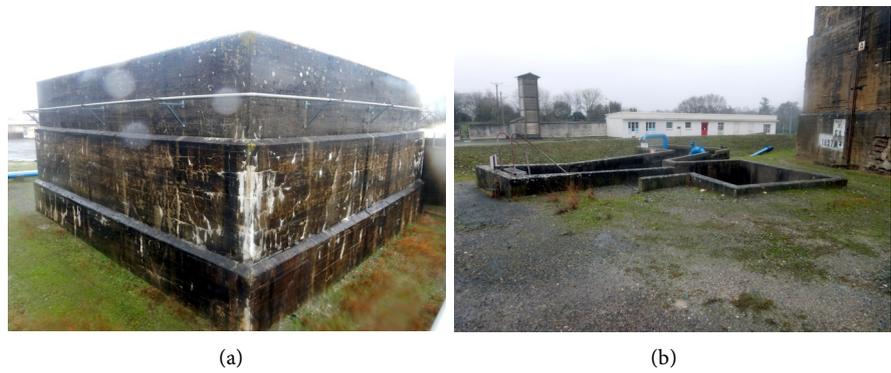
Six sides wall c ($47^{\circ}25'7.01''\text{N}$, $0^{\circ}37'3.79''\text{W}$) (**Figure 16(a)**) about 17×13 m, which encircled the disappeared tanks 1 to 10. It presented a well preserved external three step structure without concrete superficial failures and projectile impact cavities.

A manifold ($47^{\circ}25'8.85''\text{N}$, $0^{\circ}37'3.25''\text{W}$) (**Figure 16(b)**) about 7×3 m of polygonal, irregular shape, about two m deep, near octagonal wall A, containing pipes for the distribution of oil among the tanks. Not present in **Figure 10**, it was built well after the war. From one of its sides a long pipe gone towards the Bouchemaine freight station.

Figure 16. Bouchemaine oil terminal—(a) six sides wall; (b) after war manifold.

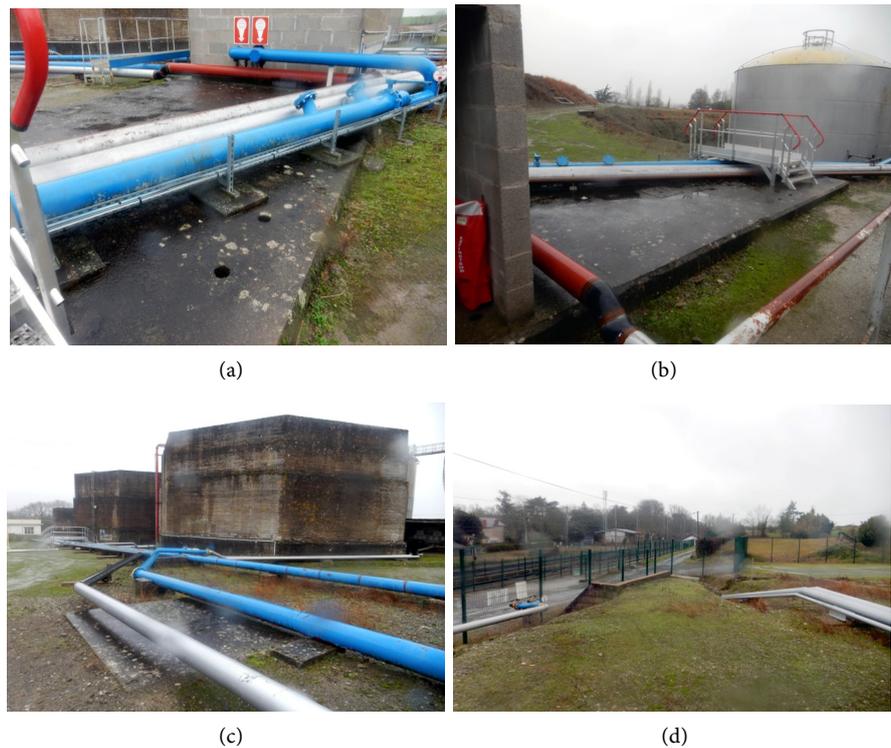
Bunker i ($47^{\circ}25'8.84''\text{N}$, $0^{\circ}37'6.11''\text{W}$) (**Figure 17(a)**, **Figure 17(b)**) about 7×3 m, buried in the terrain. The coverage, crossed by pipes and a light bridge, appeared in a good preservation state without damages due to concrete failures or projectile impact cavities. On the coverage were circular holes of about 5 cm in diameter. The entrance was obstructed by the terrain so that the inspection of the interior was not possible.

Figure 17. Bouchemaine oil terminal—(a) bunker i crossed by pipes, west view; (b) bunker i crossed by pipes, east view; (c) possible buried bunker under pipes; (d) pipes exit toward the freight station, in the foreground left the Bouchemaine passenger station.

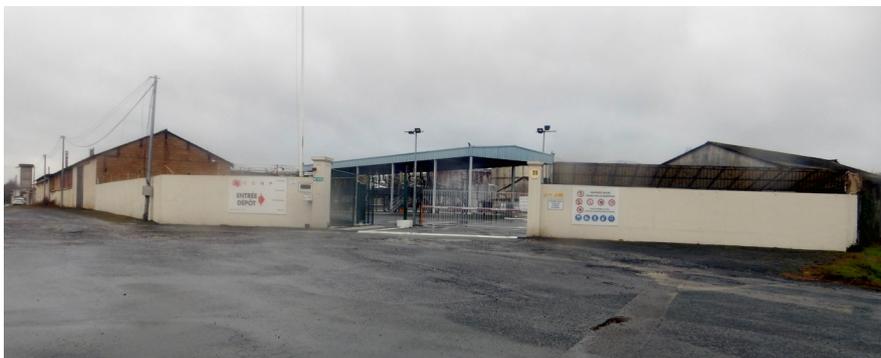
The entrance/exit o (Figure 18) already presents during the period of the German occupation and now main entrance of the oil terminal. Its concrete structure presented no damages.

Figure 18. Bouchemaine oil terminal—present main entrance.
