# Geomorphic Processes, Rock Quality and Solid Waste Management—Examples from the Mt. Everest Region of Nepal

Sagarmatha National Park and Buffer Zone (SNPBZ) in the Everest region in Nepal is among the most popular destinations for trekking tourism in Nepal. The dramatic growth of the tourism industry has increased pressures on the environment and the National Park is heavily affected by the rapidly growing waste issue. Besides, major mass movements play an important role in the Himalaya and have been observed in SNPBZ. Also, seasonal monsoon floods, debris flows, rock falls, landslides and the creation of glacial lake outburst floods are frequently occurring in the region. This paper explores the reciprocal interactions between the geo-environment and solid waste management in Everest's SNPBZ. Therefore, geological characteristics and geomorphological processes, especially the two large rockslides in Lukla and Khumjung, as well as their consequences for rock quality, climatic and hydrologic conditions, are analyzed and simultaneously connected to the rapidly growing tourism-induced waste issue. Rockslide material shows high porosity and permeability. Thus, we argue that rockslid

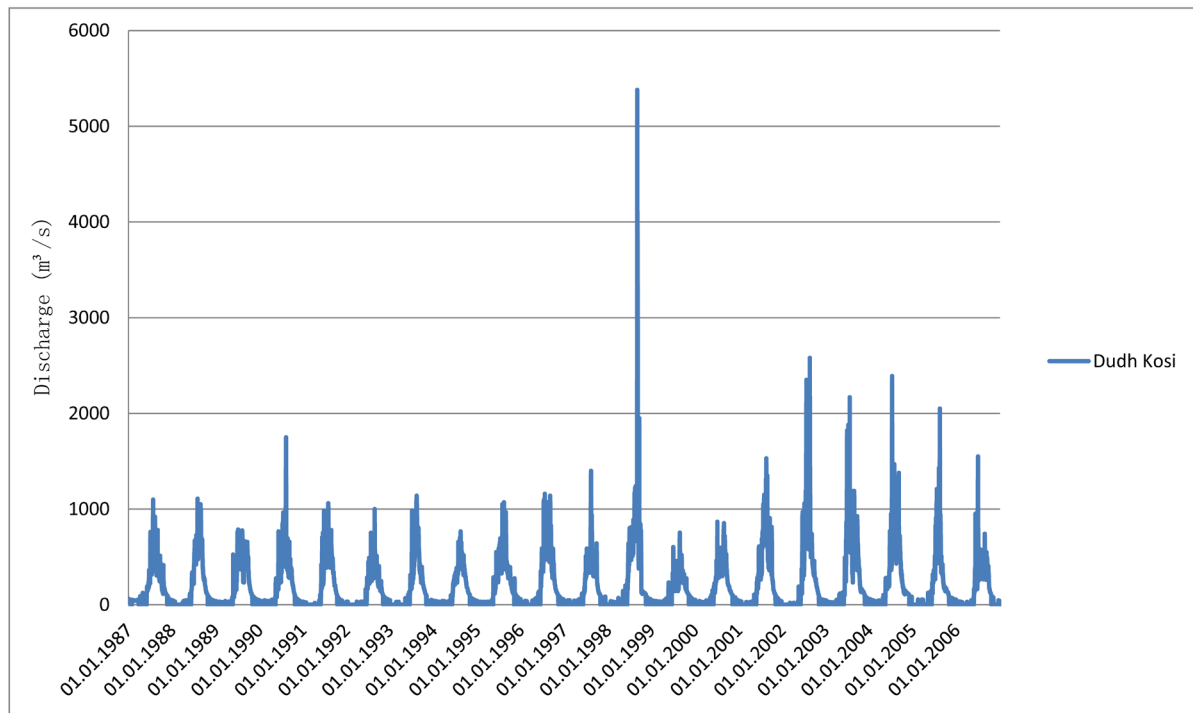
**Figure 2.** Discharge of Dudh Kosi at Rabuwar-Bazaar, which is located 47 km south of Lukla and includes major tributaries like the Inkhu Khola and the Hongu Khola. Respective conjunctions are also south of Lukla. Within the subcatchment of Inkhu Khola the Tam Pokhari GLOF, which did not impact our study area, occurred 03-08 September 1998 which started with a peak discharge of about  $10,000 \text{ m}^3/\text{s}$  [62] (Station: 670; Latitude: 271600; Longitude: 863950; Source: Department of Hydrology and Meteorology, Nepal).

The Everest Region is strongly influenced by the subtropical Asian monsoon regime in summer months, but by a dry climate with snowfall in winter [29] [30]. Summers are generally moist and cool and, on average, about 80% of the annual precipitation occurs from late May to mid-September [40]. Khumbu precipitation generally decreases with increasing elevation because of topographic effects [30]. Therefore, the rainfall in the valley bottom is much higher and villages are hit harder by heavy monsoon rains [39]. The regional hydrology is dominated by the monsoonal precipitation regime. Stream flow dynamics of the river system have strong seasonal components, with annual discharge peaking during the monsoon season [41] (**Figure 2**).

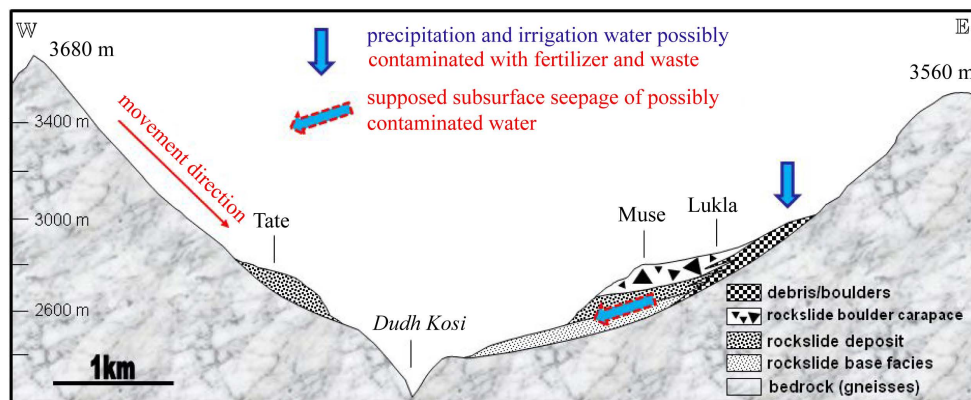
**Figure 3.** Geologic long-section of Lukla rockslide: supposed subsurface way of seepage of possibly contaminated water due to organic and chemical fertilizer as well as open waste pits.

The Lukla rockslide occurred in the paragneiss series belonging to the Higher Himalayan Crystalline. It originated from the WSW at NgotungRi peak (3409 m a.s.l.) and movement was to the ENE (**Figure 3** and **Figure 4**) [15] [42] [43].

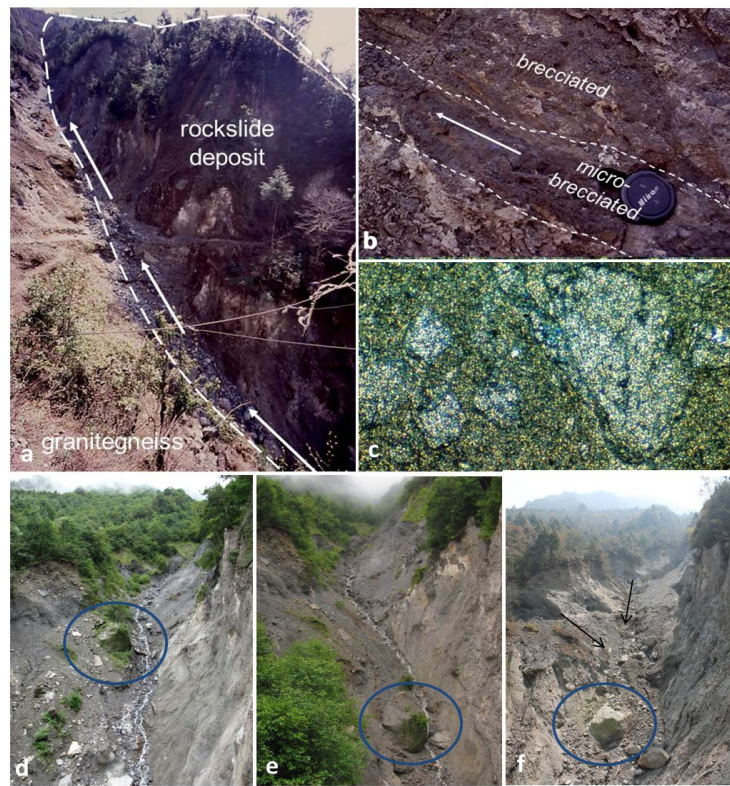
**Figure 5.** Rockslide base facies, generated by dynamic fragmentation during its catastrophic run out, 1 km south of Ghat village: View of micro-brecciated sliding surface of the rockslide (b) as well as a thin section (c) of this material showing high porosity and permeability, even in sub-grain-size scale. This cataclastic rockslide material is further more highly susceptible to progressive gully erosion: outcrop in March 2007 (a), in July 2011 (d), in August 2011 (e) and in April 2013 (f).

Key exposures of the basal brecciated facies on top of the basement of granitic gneisses occur in the dissected gorge along the Dudh Kosi river as well as 1 km south of Ghat village (2600 m a.s.l.). The brecciated rockslide facies material, which even hosted rockslide-typical micro-brecciae and frictionite [26] [44] [45], is highly susceptible to erosion and porosity, which means that rock quality was significantly altered by the event (Figure 5).

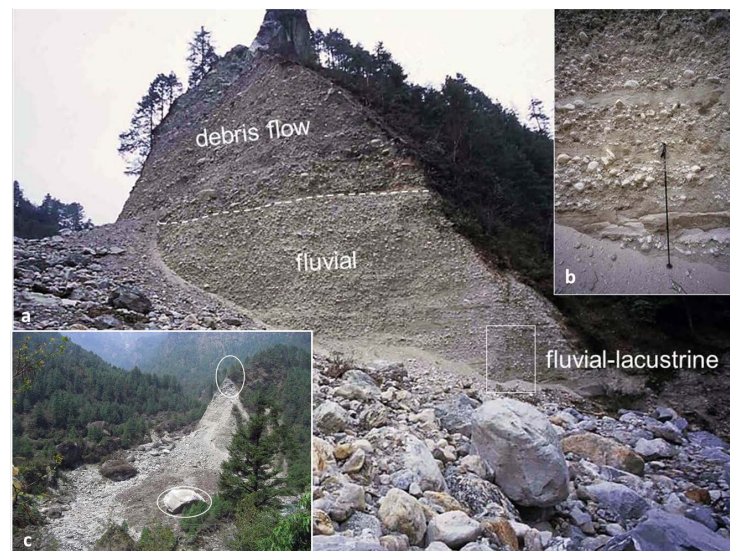
**Figure 6.** Chhuserma village (2560 m a.s.l.) is positioned on top of a dissected sediment cone at the confluence of Chusema Khola (western tributary) with Dudh Koshi. The outcropping sediments on its footwall (a, in 2007) demonstrate the rapid infilling of a former lake by fluvial-lacustrine (insert b), fluvial and debris flow sediments. This material is not only subject to high porosity and permeability but also to high morpho-dynamic activity (c, total view in 2013 with large fallen boulder) and therefore problematical for any kind of waste deposition.

ii) outcrops along its possible former extent, f. i. near Phakding and Chhusema villages, show a highly heterogeneous mix of lacustrine, fluvial and debris-flow sediments, the latter originated from the Panyali Drangka and Chhusema Khola tributaries at their confluences with Dudh Kosi (**Figure 6**);

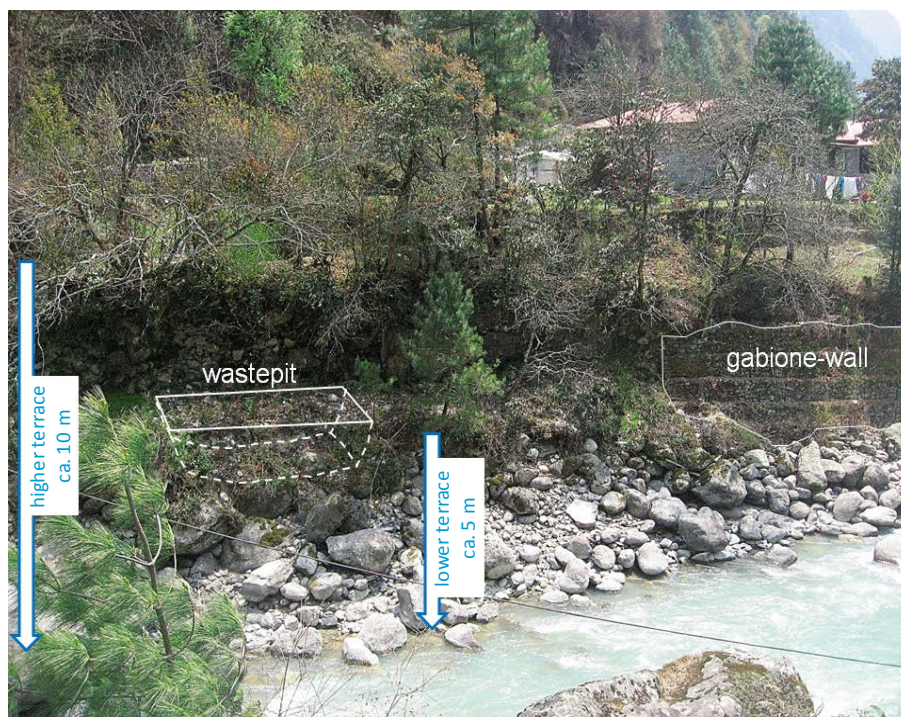
**Figure 7.** View towards orographic left bank of Dudh Kosi river close to Phakding in April 2013: waste pit in the lower terrace. Constructed gabione-wall shows high susceptibility to erosion even of higher river terrace.

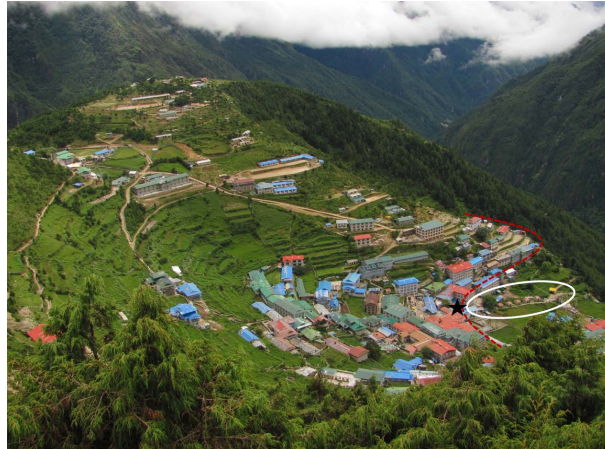
**Figure 9.** View towards S over “horseshoe terrace” of Namche Bazaar and Dudh Kosi valley: lowermost houses of the settlement mark the base of the rockslide (---), (★) marks the main water source, white ellipse mark mills along water runoff on top of mechanically undisturbed bedrock.

Water samples of springs and fountains in Namche Bazaar and Khumjung (**Figure 9**) were collected and analyzed on site. The analyzed water sources were those utilized for drinking water. Results from the Sera test kit show that several springs and streams, particularly in the village of Namche, have high concentrations of nitrates ( $\text{NO}_3$ ) and phosphates ( $\text{PO}_4$ ), which are usually used as field fertilizers (see **Table 1**).

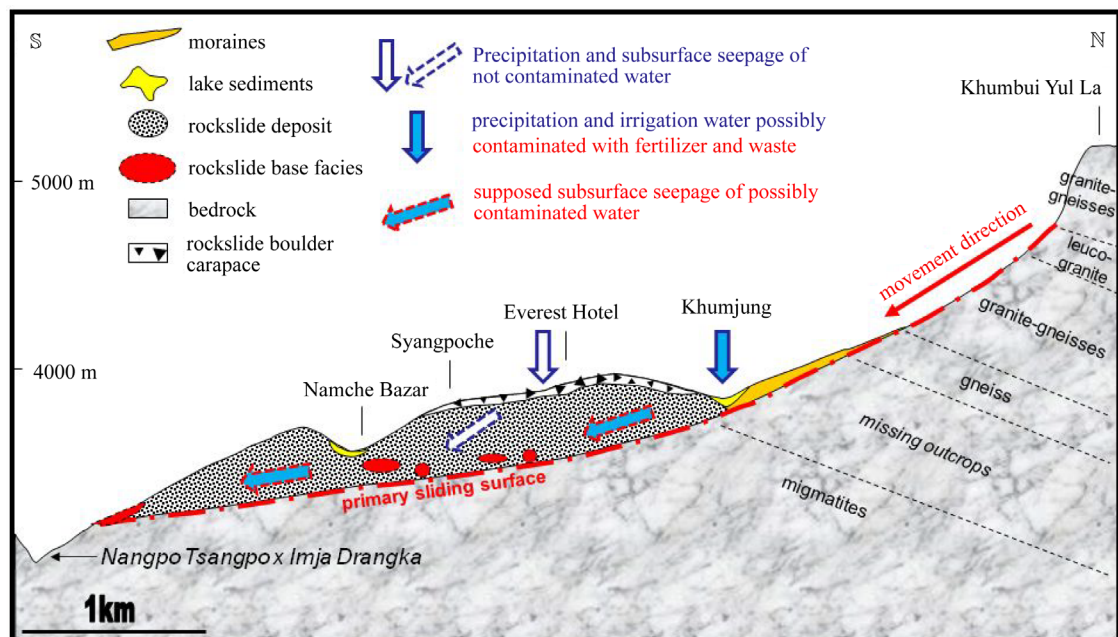
**Figure 10.** Geologic long-section of Khumjung rockslide (after [14]): supposed subsurface way of seepage of possibly not contaminated and contaminated waters due to organic and chemical fertilizer as well as open waste pits. Remarks: precipitation water dropping down on the rockslide’s surface in between Khumjung and Namche Bazaar and seeping through rockslide material may not necessarily contain high phosphate and/or nitrate as this water bypasses the Khumjung-Khunde agricultural area (compare Table 1, No. 4 and 5).

It is likely that the masses detached along one of the major fault-sets in the scarp area with an E-W-strike and a dip  $40^\circ$  towards S. The southward motion of the rockslide ended up in forming a double terraced platform. Flanked by steep rockwalls towards the river valleys of Nangpo Tsangpo and Imja Drangka, these deeply eroded gorges have undermined the deposit and erased any trace of a former zone of collision or dislocated material. The lower terrace is located 600 m above these river gorges, and Namche Bazaar, which is located in an eroded “horseshoe-like” basin (Figure 9). While Vuichard [49] found that this basin is cut back into moraine material, it seems to be more likely that this all is rockslide material according to the interpretation following. The upper terrace sustains the villages of Khumjung and Khunde with an overall exposed carapace of large boulders, followed by lake sediments and huge moraines towards N in the scarp area (Figure 10).

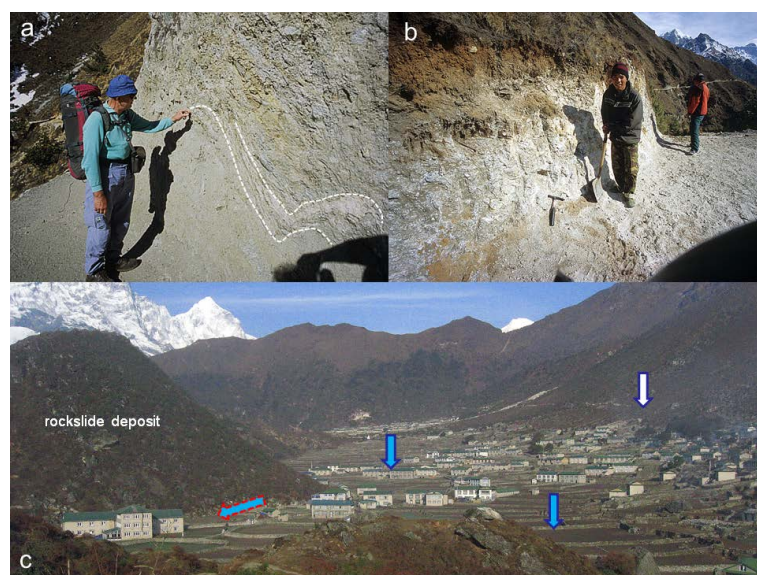
**Figure 11.** Khumjung rockslide deposit: typical “schlieren-like” deformation of primary rock structure in base facies (a), almost mechanically pulverized material, easily erodible for path workers along main trail to Tengpoche, Imja Drangka valley upwards (b), both positions: 1 km east of Everest View Hotel (3600 m a.s.l.); Khumjung and Khunde (in the background) villages—main points of possible water infiltration (colour of arrows see **Figure 10**).

The bouldery carapace facies of the rockslide includes the villages of Namche Bazaar, Khunde, and Khumjung, extends over some 400 m of elevation difference up to 3800 m a.s.l., and is triangular shaped in planform. This area is covered by angular boulders of diameters up to 10 m, which form longitudinal ridges SE of Khumjung, as well as large hummocks between Syangpoche airstrip and Khunde. Formerly ponded areas with lake sediments south of Khunde and Khumjung mark the boundary to the moraine covered rockslide scarp. This area is predisposed for infiltration of natural and anthropogenic influenced waters (**Figure 11(c)**).

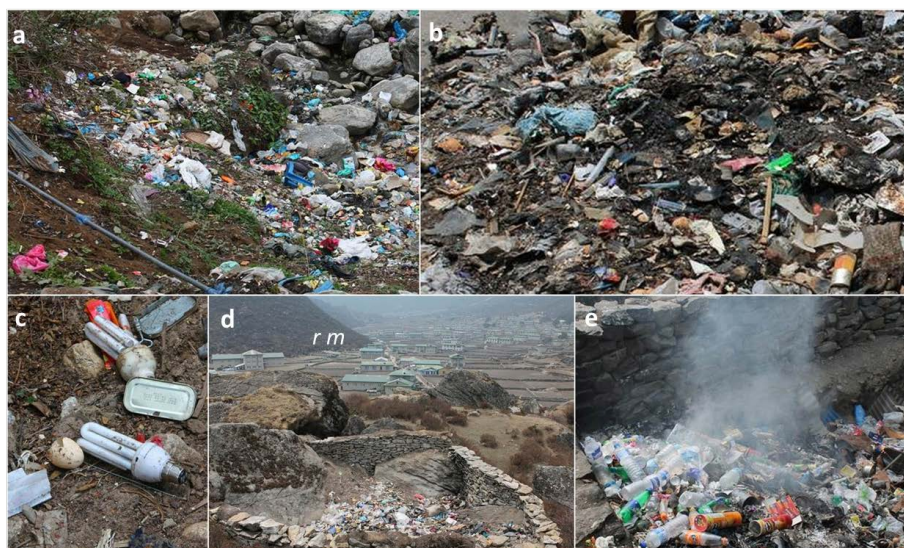
**Figure 12.** Waste situation in SNPBZ: leaking plastic water pipes (a); medical waste in Lukla e.g. used needles, 2 = broken medicine bottle (b); hazardous Waste Items (c), landfill Sites in Khumjung facing west, rm\_rockslide material (d); air pollution caused by toxic gas emission from burning plastics (e).

The existing waste management system in SNPBZ is a rudimentary disposal system with limited resources and capacities, leading to improper treatment of solid waste and waste water. There are different disposal methods for solid waste in SNPBZ. Classified burnable waste (paper, plastics, textiles, plastic bottles) is either burned in incinerators or in open landfill sites to reduce volume, while non-burnable waste (metals, glass, batteries, compact fluorescent lights, medical supplies) is dumped and buried at landfill sites and not handled separately [24] (**Figure 12**).

Another serious issue in the whole study area is air pollution caused by toxic gas emission from burning plastics, metallic objects, synthetic materials and hazardous items (**Figure 12(e)**). Hazardous items include light bulbs, batteries, electrical appliances and gas cartridges, which can be found in large numbers around integrated landfill sites and incineration facilities throughout the study area (**Figure 12(c)**). It is likely that mercury, PCDD/PCDF and other compounds are released into the environment, infiltrating water sources and contaminating the air [22] [24].

In Lukla, almost 50% of the landfill sites are situated on permeable rockslide material above the village and the local drinking water supply (Figure 4). Due to permeable rockslide material and a nonexistent impenetrable in-between layer (aquiclude), it is possible that landfill sites above Lukla infiltrate and contaminate water sources. Waste water and harmful contaminants from these leaking landfill sites are dissolved by rainwater during the monsoon season, and may seep into groundwater. Furthermore, the regional water supply network does not meet minimum quality requirements, as leaking plastic water pipes are laid on bare ground where rain, snow, or cattle may cause damage (Figure 12(a)).
