# Calibration of Numerical Model Applied to a Shear Zone Located on a Slope in an Open Pit Mine—Case History

## ABSTRACT

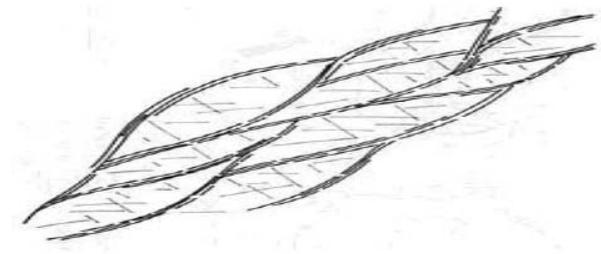
**Figure 1. Profile diagram showing the anastomosed shear zones isolating blocks in the form of almonds [2].**

prises the areas of ductile shear formed under the mylonitic foliation for S1. These areas have a flat curve shape, in order to circumvent almond lentiform bodies of deformed serpentinites, **Figure 1**.

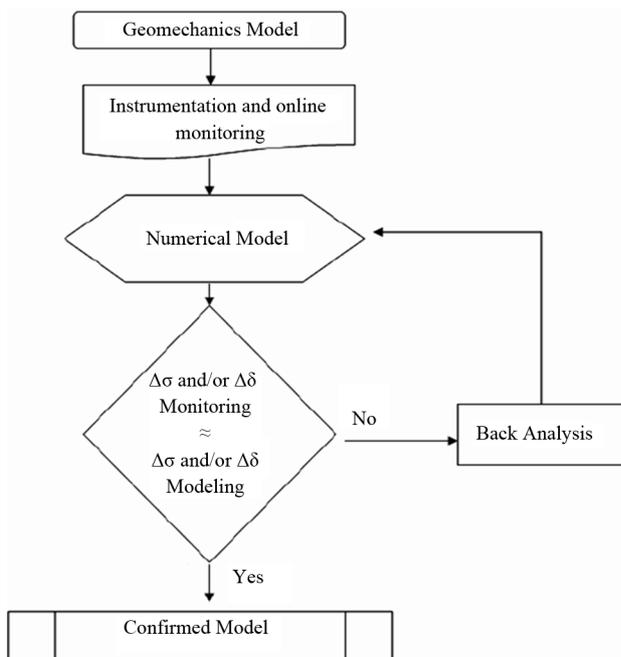
A calibrated model is a numerical geomechanical model that is a synthesis of the main geomechanical structures present endowed with geomechanical properties with this model being subjected to various forces. In our case the massif is subjected only to gravity as its structural mass is characterized by discontinuities to which were attributed geomechanical properties. This massif was monitored using topographical markers at studied and defined locations. When comparing the movement events measured using topography with the movement events calculated at pre-defined points, which were the same as those used in for the topographical markers, in the mathematical model, we are effectively calibrating the model. The comparisons between the movements obtained with the topographical instruments and those

**Figure 2.** Schedule of calibrated explanatory model.

The set of information (detailed mapping, monitoring, topographical and geomechanical properties obtained in laboratory tests and geomechanical classification applied to a numerical model) allowed for the development of a calibrated model of the eastern open pit slope. **Figure 2** shows a schematic of a calibrated model.

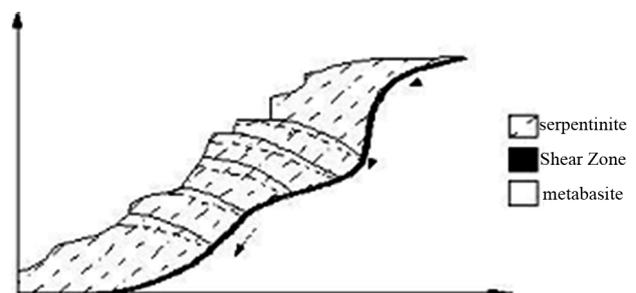
The mass is behaving like a set of blocks limited in depth by shear zones. Traction fractures are found together with the SZs. The movement of the blocks in the opening SZs causes traction fractures that are almost perpendicular to the SZs. **Figure 3** below illustrates the movement of the kinematical disruption of the eastern slope [4].

**Figure 3.** Kinematical disruption.

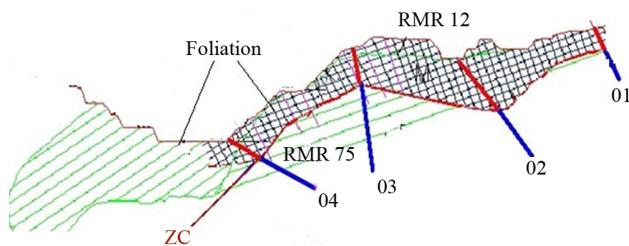
The descriptions showed that the SZ is:

Borehole 01 - 80 meters deep where a crack was found filled with clay.

Borehole 02 - 34 meters deep where there were heavily fractured serpentinites.

Borehole 03 - 21 meters deep where there is a transition from a highly fractured serpentinite to a slightly fractured serpentinite zone with a gap.

Borehole 04 - 50 meters deep where there is an extremely fractured passage of serpentinites to slightly fractured serpentinites.

**Figure 4.** SZ Shear Zone, boreholes 01, 02, 03, and 04 RMR = 12 rock mass fractured, RMR = 75 rock mass no fracture.

The model was based on the size of the blocks in Figure 4. The results of the field mapping were used for the biggest blocks which have dimensions (in meters) of  $6.20 \times 4.50 \times 5.20 \times 2.30$  and  $4.60 \times 2.80$ . The input parameters for a numeric geomechanical model are the mechanical properties shown in Table 1 and the discontinuities mapped in the field. As a synthesis of a structural model, the model presented may appear simple. However, the complexity of this model lies in the fact that there is a numerical convergence of the results.

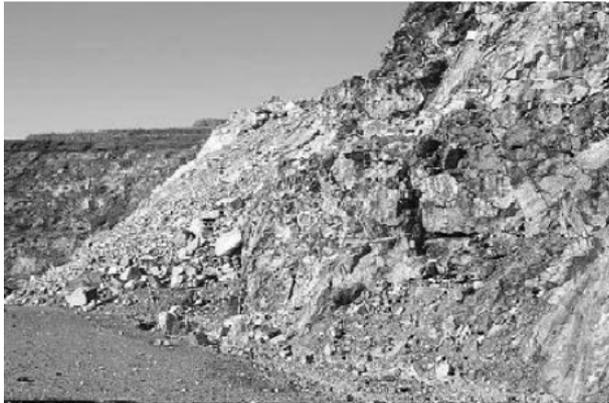
The destabilization involves the movement of a 164, 824 m<sup>3</sup> mass of rock. The photos below show the location.

**Figure 5.** Slope top disjuncted.

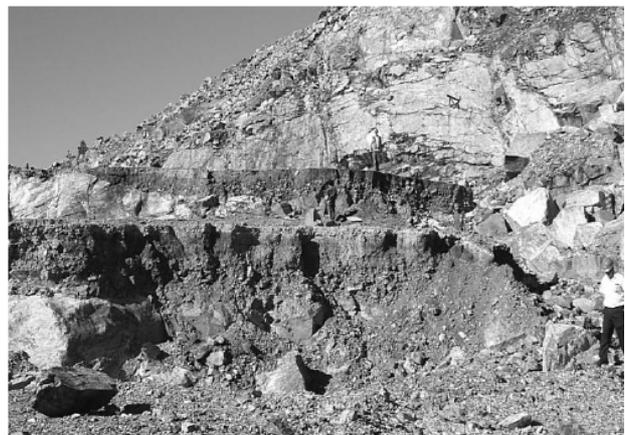
**Figure 6.** Ramp access destroyed.

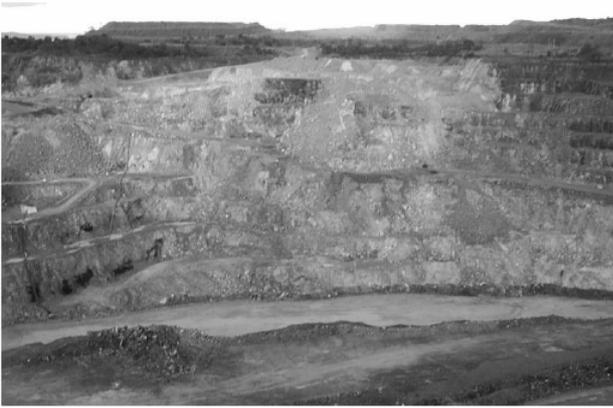
Figure 7. Front View of the Break.

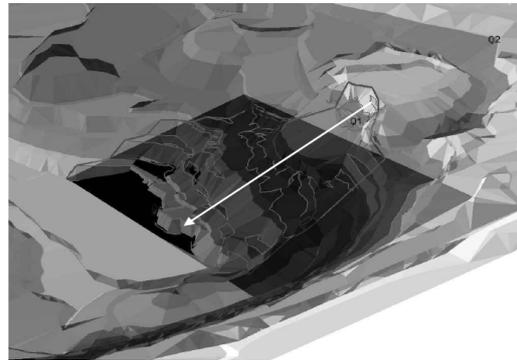
Through a detailed description of the fractures with the aid of detailed topography and measurements taken with a compass, it was possible for us to build a topography model, adding the mapped fractures.

Figure 8. Topography model with structural fractures, boreholes 01, 02, 03 and 04, white arrow aligned with topographical monitoring.

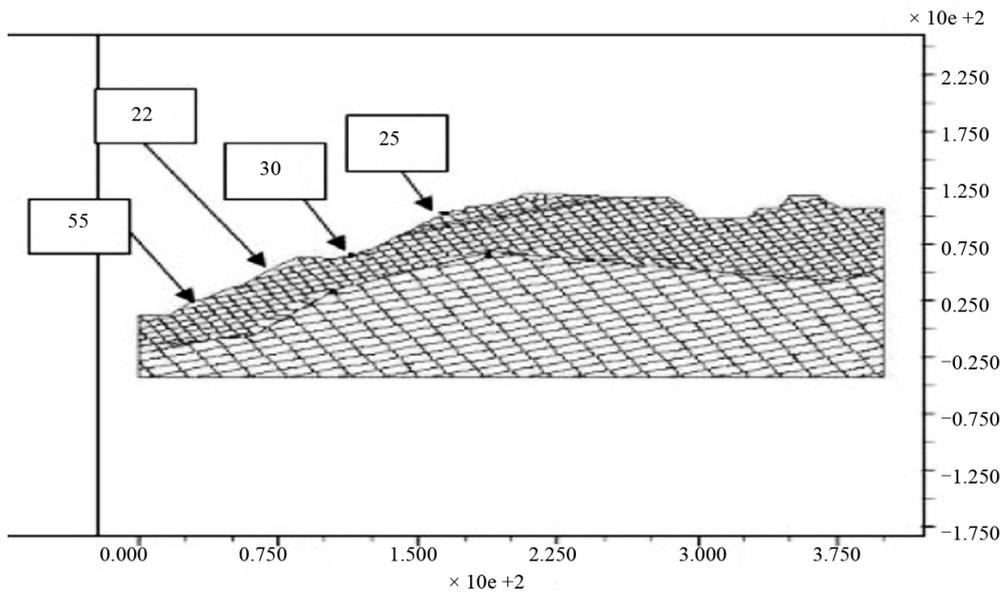
The graphs below, **Figures 10 & 11, 12 & 13, 14 & 15** and **16 & 17**, show and compare the results gathered at the monitoring points of topographic displacement and their respective calibrated modeling points 55, 22, 30 and 25 in **Figure 9**.

Figure 9. Numerical model and monitoring points.

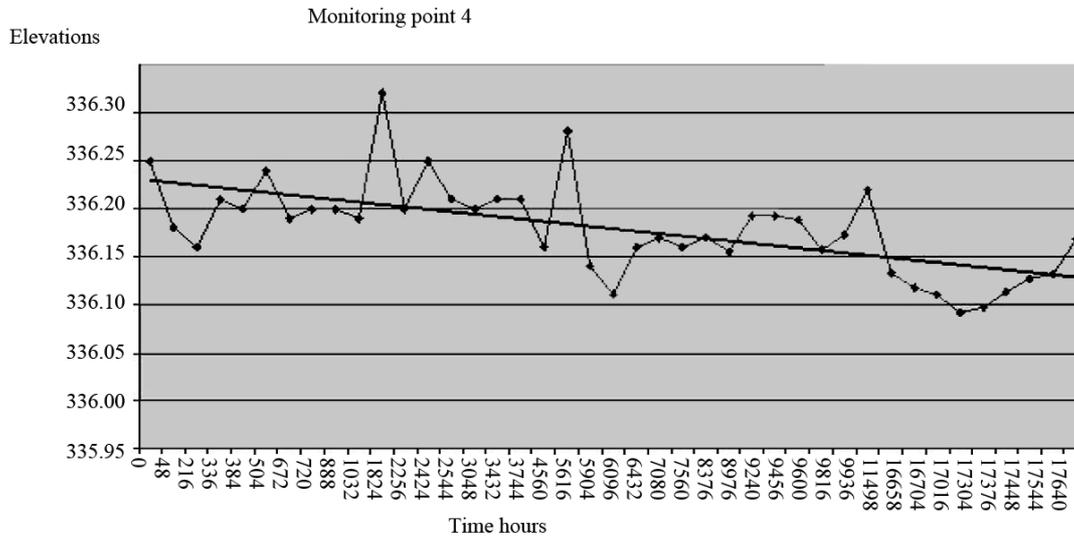
**Figure 10** shows the monitoring of topographic point 4 and **Figure 11** shows point 30 of the calibrated numerical model. There is a rapid vertical displacement, suggesting the accommodation of the blocks at the most fractured

Figure 10. Point 4 topography monitoring.

zone of the ramp, which were the largest blocks. The order of magnitude of the vertical displacements ranged from 0.13 to 0.32 m.

Topographic monitoring, especially from point 04 when compared to the 30th point shows a weak relationship with the displacement of the surface of the tracked slope and a small similarity to the numerical model developed.

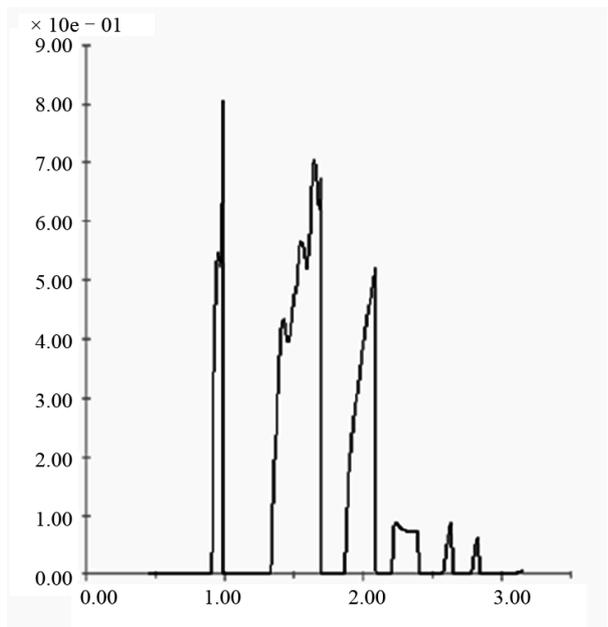
Figure 11. Point 30 calibrated modeling.

We observed the same trend in the accommodation blocks with a vertical variation of between 0.1 and 0.8 m. The numerical model was not able to show a temporal variation as the topographic monitoring was. We did notice, however, that the extent to which the 0 to 3 UDEC cycles are applied determines the vertical displacement decrease.

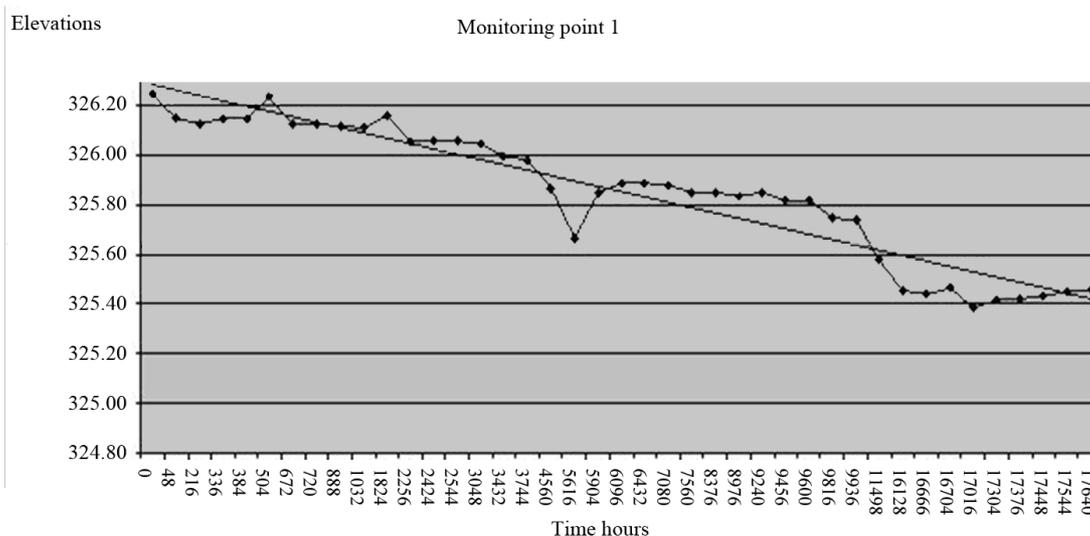
Figure 12 shows the monitoring of the topographic point and Figure 13 shows point 25 of the calibrated numerical model. Section 1, which is monitored via topo-

graphy, shows a maximum displacement of 1.40 m between 0 and 5616 hours. At two peaks, displacements at 1834 hours and 5616 hours were observed. The displacements and absolute magnitude are located between 0.30 and 0.80 m. These shifts are associated with accommodation blocks. After 16,704 hours, shifts are on the order of 0.25 m with a tendency to remain constant for some time.

Figure 12. Point 1 topography monitoring.

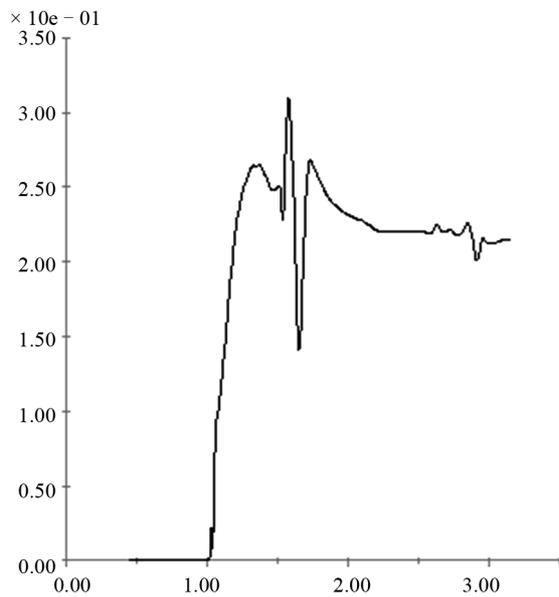
The point 25 of the calibrated model shows two points of maximum displacement of 0.30 m and 0.15 m. After being stabilized at 0.25 m, we kept it this way until the blocks had been stabilized.

Figure 13. Point 25 calibrated modeling.

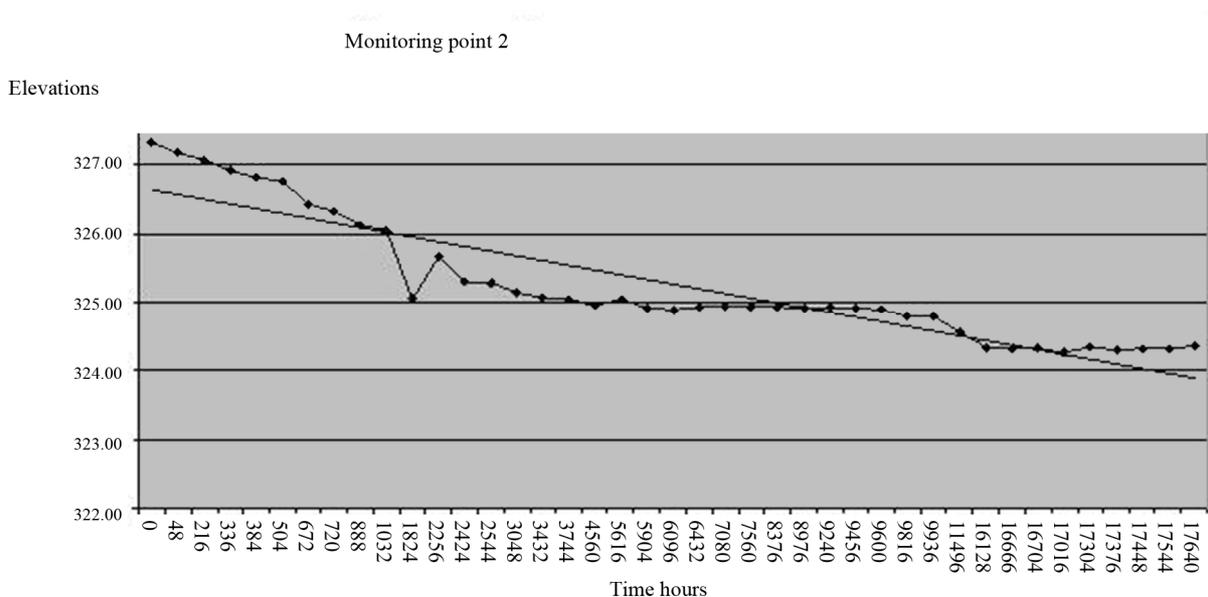
Figure 14 shows the topographic monitoring of section 2 and Figure 15 shows the corresponding point in the numerical model.

Between 0 and 1032 hours there is a maximum displacement of 1.1 m. At the 1032nd hour we have a peak displacement of 1 meter. After this peak, shifts tend to stay at a constant topographic level (325), and show a second set of displacements at elevation 324.5. Figure 11 shows point 35 of the calibrated model where we have the same trend.

Figure 14. Point 2 topography monitoring.

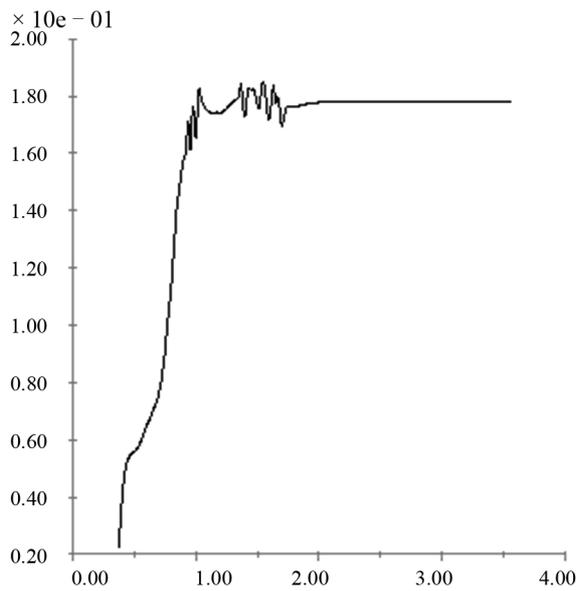
There is a rapid increase in deformation to 0.18 m. Then we have variations of displacement close to 0.18 m. Finally, the model stabilizes at 0.175 m. This point does not show an order of magnitude for displacement similar to the topography and neither do monitoring points 25 and 30. Figure 14 corresponds to the third point of topographical tracking and Figure 15 shows the corresponding point in the calibrated model.

Figure 15. Point 55 calibrated modeling.

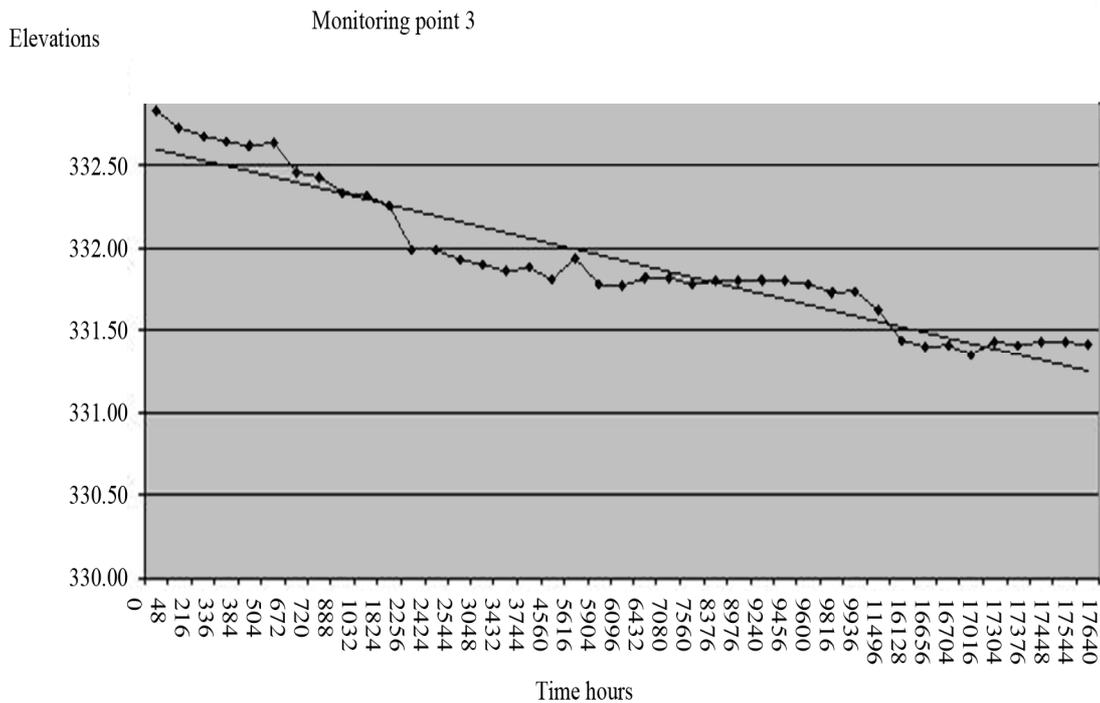
Figure 16 shows a progressive shift from 1 to 2 meters over a 426-hour interval, stabilizing at topographic elevation 332.

From this point we have a gradual stabilization, possibly temporary, with a maximum displacement of 0.5 m.

Figure 16. Point 3 topography monitoring.

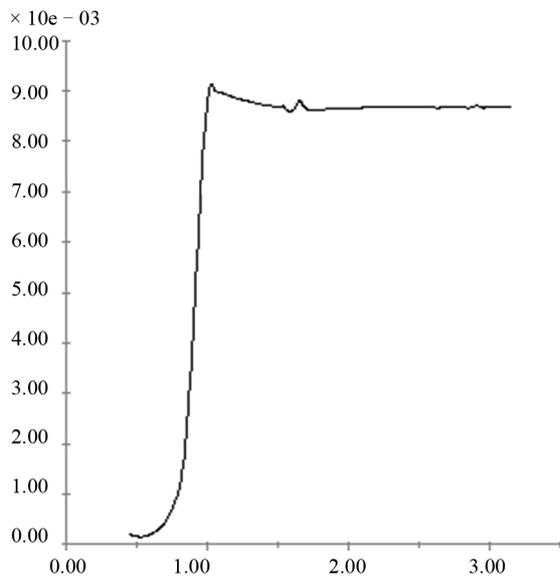
Figure 17 corresponds to the numerical model and shows the same trend. There is a quick shift to 0.09 m after a gradual stabilization near 0.085 m. But this point does not show an order of magnitude for displacements similar to the displacements obtained through the topographic monitoring.

**Figure 17. Point 22 calibrated modeling.**

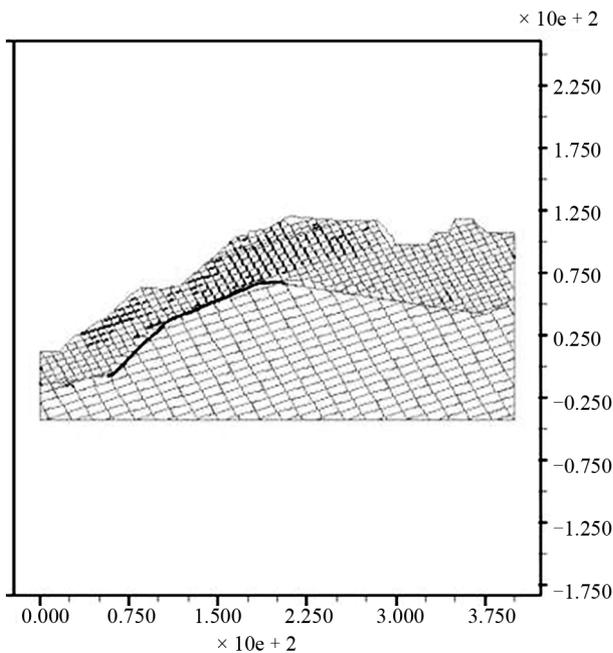
In Figure 18 the dark lines show the model simulation of the slip surfaces of slope, which are within the friction limits, or that is those that are collapsing. They indicate that the SZ, represented by the thick, dark line is found in the process of collapsing. The same occurs at several points of the 66/30 NW foliation family, which are also in process of free shear.

**Figure 18. Joint now at shear limit shown in darker lines.**

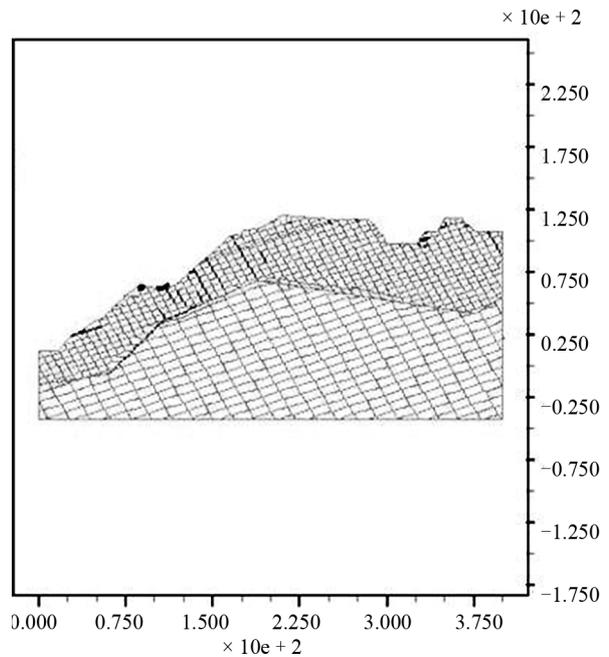
Figure 19 shows that, through the simulation model, maximum displacements of  $4.41 \times 10^{-2}$  m were found, which are represented by the regions highlighted by the thick, dark lines. At such discontinuity points, the displacement opens and continues moving.

**Figure 19. Shear displacement shown in darker lines.**
