Measuring Surface Roughness through the Use of Digital Photography and Image Processing

Abstract

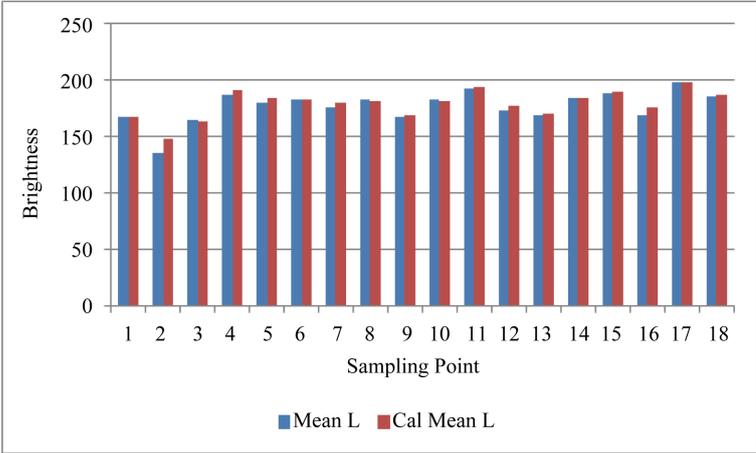
Figure 3. (a) Uncalibrated and calibrated results for Mean *L*; (b) Uncalibrated and calibrated results for Std Dev *L*; (c) Calibrated results for % Mean *L* and % Std Dev *L*.

As appears in Figure 3(a), there was little change affecting Mean *L* values, although there seems to have been

an increase in calibrated Mean *L* values at some three-fourths of the sampling points (except at Sites 1, 3, 6, 8, 10, and 17) and across the two lighting conditions. However, there was not much overall change in Mean *L* values

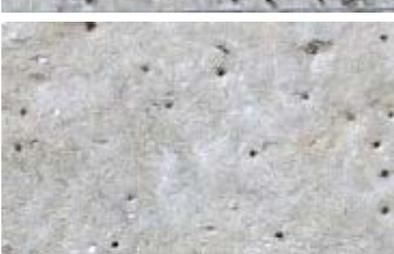
6.42%	Low
Site 18	Clear sky

Based on [Appendix A](#), several observations are possible, including that pits in the wall did not increase calibrated Std Dev L values, as evident at Site 17. For instance, a greatly pitted section of wall at Site 13 only received a medium level of roughness. What seems to make a difference to surface roughness was the amount of undulation in the surface (peaks and troughs) rather than pit depth. Precipitates visible on some of these surfaces, such as at Site 3, increased the surface relief and unevenness and, therefore, the roughness.
