# Investigation into Road Construction Safety Management Techniques

David Nkurunziza

**How to cite this paper:** Nkurunziza, D. (2020) Investigation into Road Construction Safety Management Techniques. *Open Journal of Safety Science and Technology*, 10, 81-90.

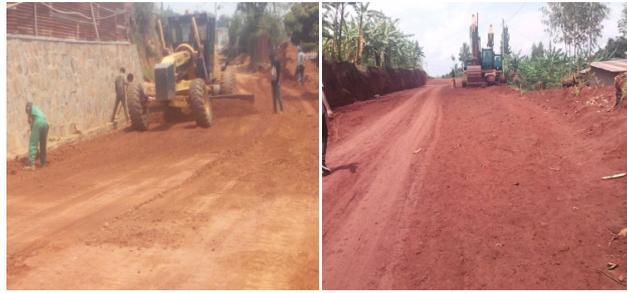
**Figure 1.** Lack of safety measures for site workers with construction equipment.

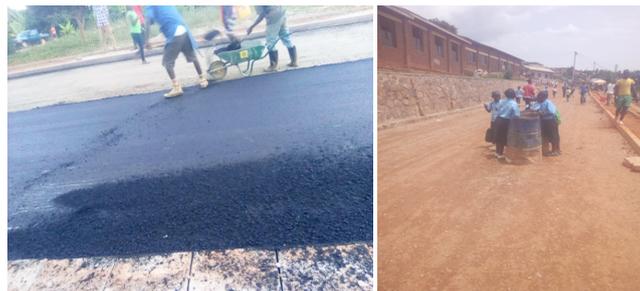
**Figure 2.** Lack of safety measures to road Workers for asphalt and land surveying activities and road users like children.

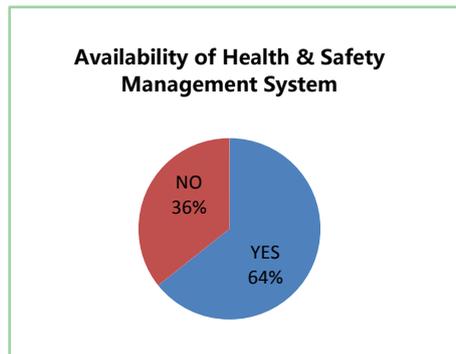
Figure 4. Availability of health and safety management system.

**Figure 4** gives a pictorial understanding about the health and safety management systems found on visited construction sites and the health and safety system is at the level of 64% described as interesting. **Figure 5** proposes some measures that could be implemented in order to deal with health and safety management effectively on construction sites as per the respondent views. **Figure 6** describes the nature of accidents that are more likely on site like minor injury and their degree of occurrence. **Figure 7** informs us about the categories of workers that are affected on site due to the lack of health and safety measures and many fall under unskilled labor category of people. **Figure 8** outlines possible causes of accidents that are mainly negligence that causes more accidents occurring during excavation works. **Figure 9** informs about if the training and induction to workers for site activities is conducted. As per the Indian standards IS 13430:1992, reviewed in 2007, works for trenches and foundation pits in road construction shall be adequately and securely fenced in order to protect the surrounding features such as buildings, workers, road users and environment, provided with proper caution signs and marked with red lights at suitable intervals during night to avoid accidents. Unfortunately this is not the case as shown in **Figure 10** from the field observations. In addition to that, the secondary data suggest that during compaction operator must have a hard hat (helmet), ear plugs, work gloves and steel – toed safety boots and as shown in **Figure 11** an operator has only the safety boots but from the field observations is quite different.

As per the findings 64.28% of the results showed that that concerned construction companies maintain health and safety policy in their road construction sites and stated that different means of maintaining safety, are provided at the level of 57.14% to the workers. **Figure 3** stated about the Population Structure about data collection on three selected sites.

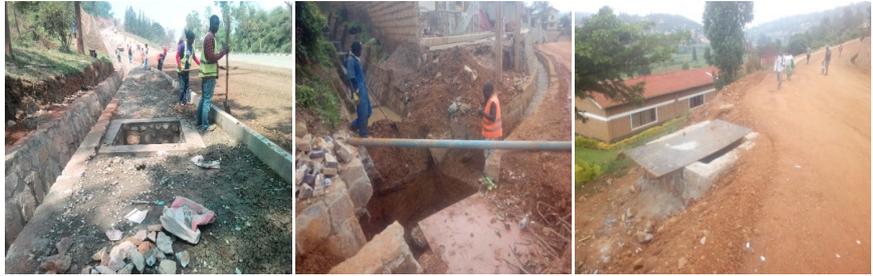
**Figure 10.** Lack of protective information for Manholes at Karama, Akagera and Agatare roads respectively.

- The establishment of a workplace health and safety committee would be suggested on road construction site;
- A construction site should be having a copy of safety rules and guidelines at work and the Safety guidelines must be provided separately depending on type of work not in general;
- The paper also recommended to follow the following guidelines as per IS 13430:1992, reviewed in 2007 which are not included in Rwanda's guidelines but are exclusively important to follow and include caution signs and marked with red lights at suitable intervals, notice boards and danger signals should be provided; danger lights during darkness hours, Barriers or coverings should be provided to excavations, distance where to park unused equipments;

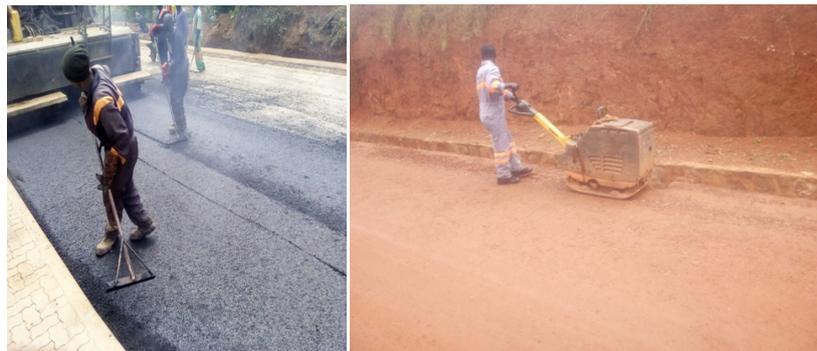
**Figure 11.** Lack of Protective equipment's like masks, helmet and gloves at Karama and Akagera Roads respectively during implementation on site.

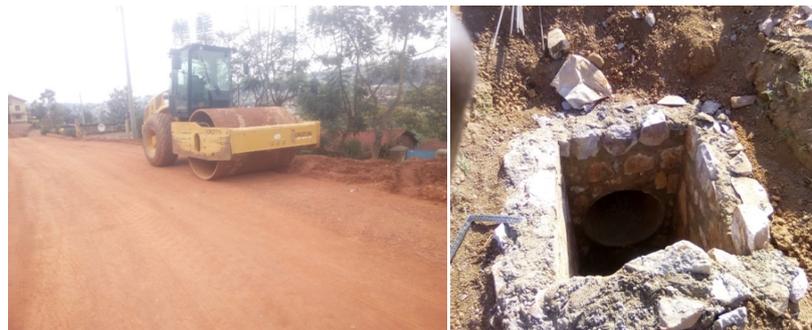
**Figure 12.** Lack of Adequate Signs to warn parked Machine at Karama Road and a manhole under construction at Akagera Road.

**Figure 12** illustrates the field situation of the lack of adequate signs to warn about parked machines and equipment on road construction site and exposes the danger about non-covered and protected manholes.
