The Risk of Flooding to Architecture and Infrastructure amidst a Changing Climate in Lake Baringo, Kenya

How to cite this paper: Victor, N., Eric, P., & Kyeba, K. (2023). The Risk of Flooding to Architecture and Infrastructure amidst a Changing Climate in Lake Baringo, Kenya. *American Journal of Climate Change*, 12, 80-99.

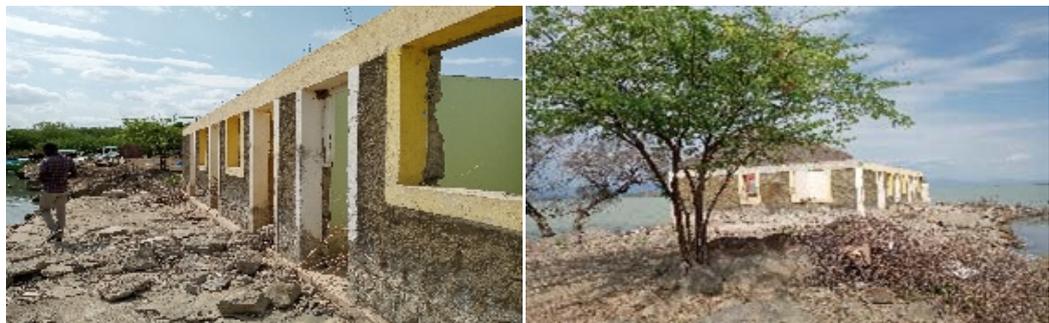
Figure 1. Abandoned houses around the lake (Source: Author).

Global precipitation patterns have been disturbed by climate change, resulting in increasingly intense storms. Rain-related flooding will be more likely as precipitation intensity and variability rise. At the same time, extreme drought and aridity will become more common in continental interiors, particularly in the subtropics (Stout, 1990). Empirical evidence has shown structural failures leading to an increased risk of the effects of flooding as can be seen in **Figure 1**.

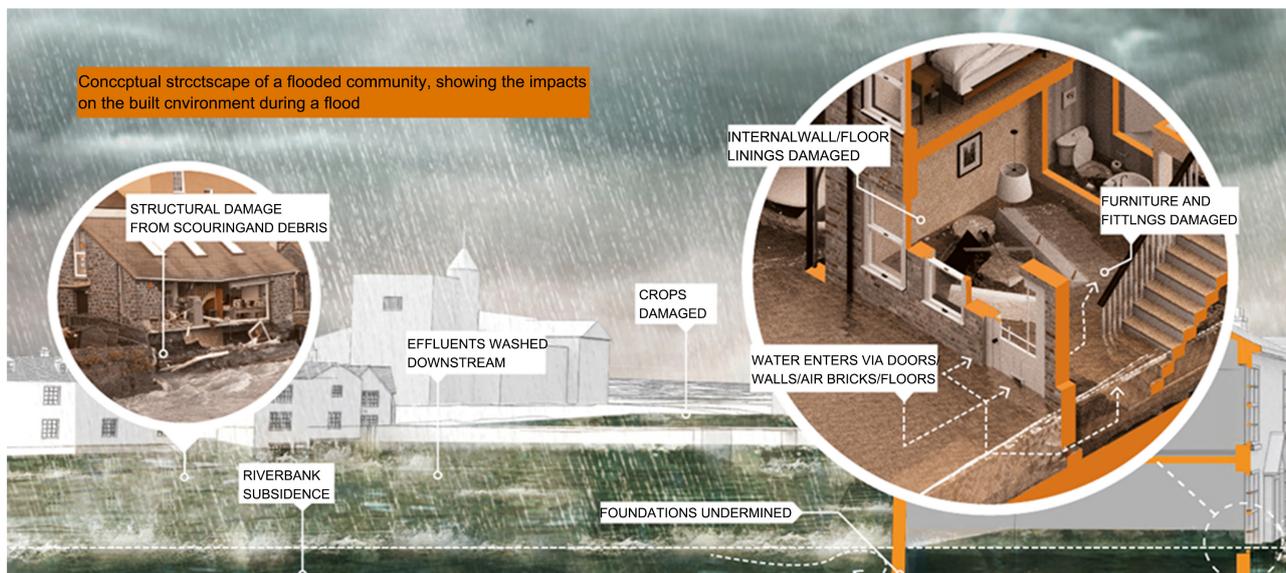
Figure 2. Risks associated with flooding (Source: (Barsley, 2020)).

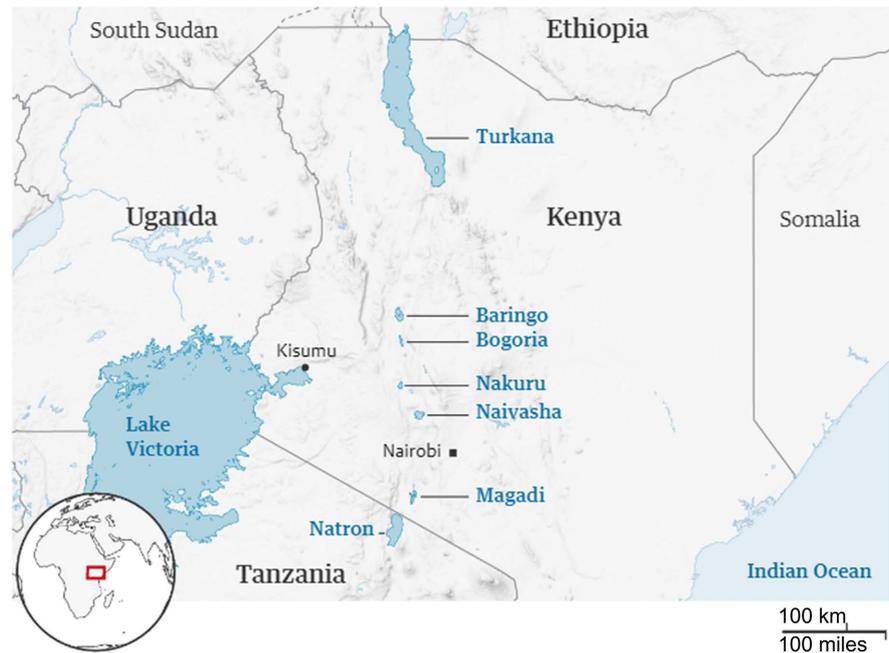
Map 1. Position of the various Rift valley lakes whose levels have been rising (Source: Baraka, 2022).

If we go back in time, the Rift valley lakes as shown in **Map 1**, have had higher water levels. (Avery, 2020) agrees that we are seeing now is not something new." Sean Avery, a hydrologist who has lived in Kenya since 1979, has further pointed out that the current level of Lake Baringo is no higher than it was in the 1970s or the 1900s (Baraka, 2022). Theories have emerged on why the waters have been rising with some researchers claiming the tectonic movement of the Rift valley could be the cause of the current expansion of the lakes.

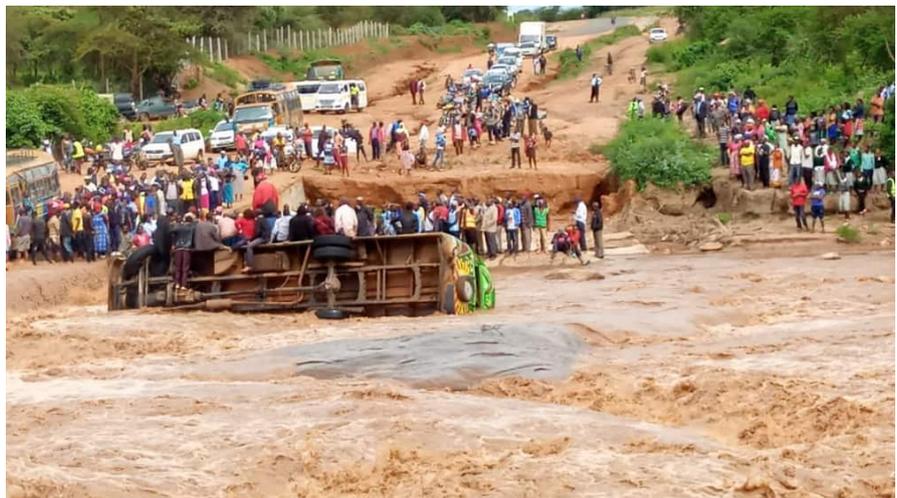
Figure 3. Bus ferrying BBI supporters to Kitui plunges into River Waani in Mbooni, Makueni. Photo: Kambaland updates. Source: UGC Read more: <https://www.tuko.co.ke/338009-bus-ferrying-bbi-supporters-kitui-plunges-swollen-river.html>.

When floods occur, substantial infrastructural damage is caused, for example, bridges are washed away, roads marooned, and floodwater gets contaminated with raw sewage. Additionally, structural failures occur when dynamic and hydrostatic loads and debris impacts affect buildings. Moreover, foundations can be undermined by erosion and scouring. Properties are also displaced by buoyancy forces (Barsley, 2020). Flooding also disrupts services and causes loss of infrastructure and lives as shown in **Figure 3** and **Figure 4** (Chebii et al., 2022).

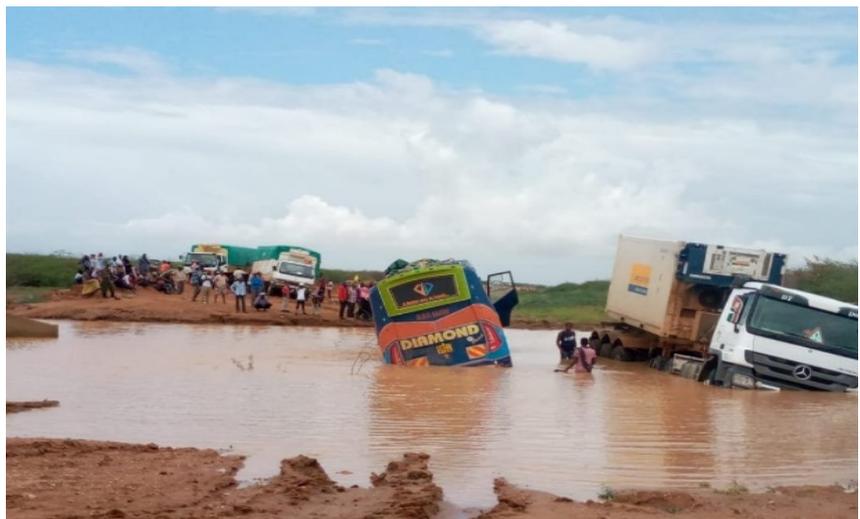
Figure 4. Floods from seasonal rivers have blocked roads in Turkana County, Kenya, October 2019. Photo: Kenya Red Cross Society (KRCS).

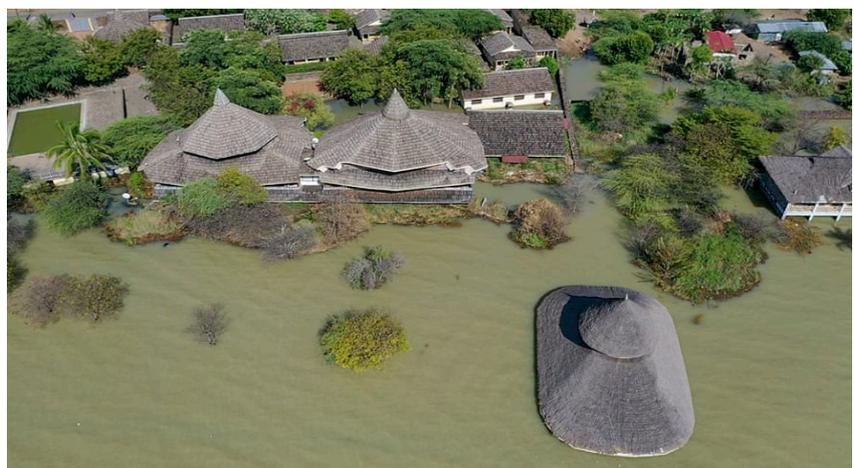
Figure 5. Tourist lodges at Lake Baringo now submerged. Photograph: Celine Clery/AFP/Getty.

Displacements, shortages of safe water, injuries, loss of access to health care, and delayed recovery are all long-term health implications as shown in **Figure 5** and **Figure 6**. The problem of adapting the built environment to the threat of flooding in the face of a fast-changing climate is complicated and multi-faceted, but as explored in this section, there are a variety of techniques that can help to minimize residual flood risk while also increasing the quality of life.

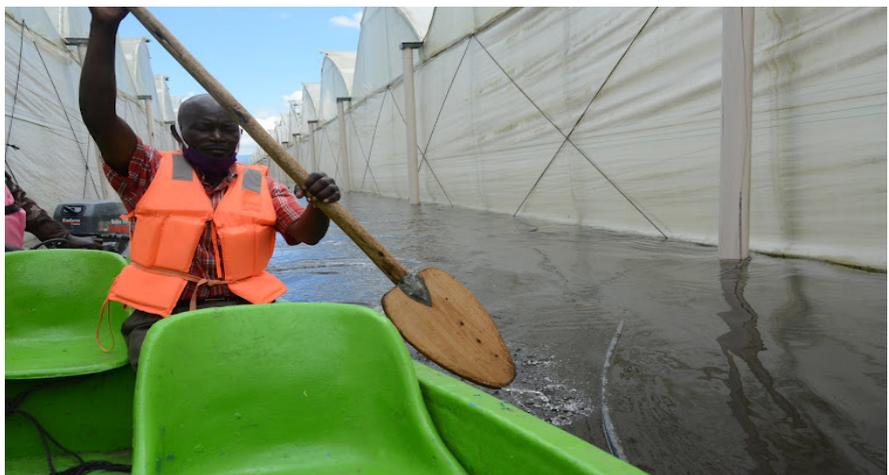
Figure 8. Swelling lakes a man rows his boat between green houses at a flower farm in Niavasha, Flower farms are the most affected in the region as Lake Naivasha expands.

Displacement of families is normally experienced as shown in **Figure 7** and **Figure 8**. A classic case is Lake Naivasha in which flower farms which predominantly

are Kenya’s largest export to Europe, are submerged making it impossible to grow the cut flowers in the greenhouses. This affects business which in turn affects the economy and leads to the loss of jobs.

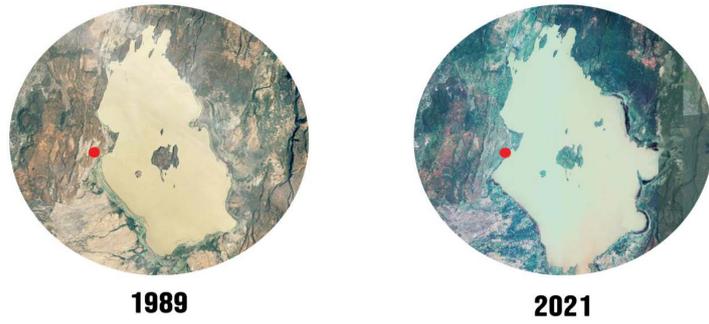
LAKE BARINGO 30-YEAR EVENT

Map 2. A 30-year flood event (Source: NASA Earth Observatory images by Lauren Dauphin).

It is important to point out that while the data for this paper was collected in 2021 as of the time of writing this article, the situation is still as challenging as the water levels have remained high. By the end of 2020, one of Kenya's wettest years on record, Baringo had risen by several meters, and had claimed 34 sq-mi. of land (Muia et al., 2021). Recent reports show that the area covered by Lake Baringo has grown from 236 km² to 278 km² which accounts for about an 18% increase. The depth of floods usually ranges from 0.3 m to 0.6 m and exceeds 0.6 m during seasons of heavy rainfall. Residents living in low areas nearer to the shoreline of the lake experienced severe flooding as compared to those living on higher grounds. The depth of the floodwater usually ranged from 0.3 m up to a staggering 2.7 m where some homes were completely submerged by the lake as shown in **Maps 2-6**.

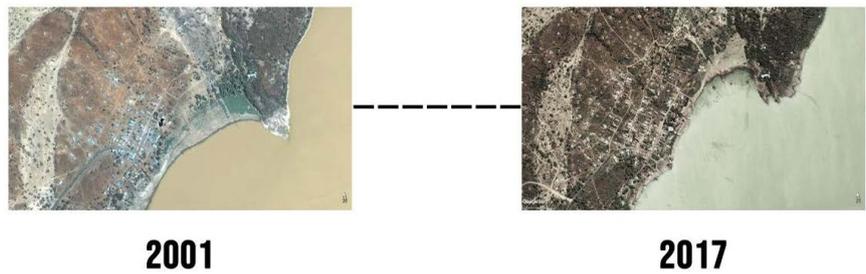
LAKE BARINGO TIMELINE

Map 3. Timeline of the flood from 2001 to 2017 (Source: NASA Earth Observatory images by Lauren Dauphin).

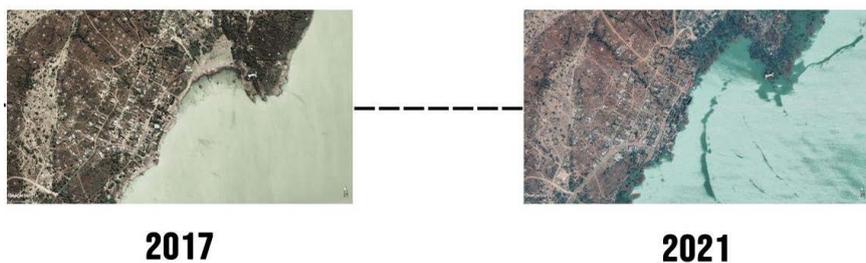
Map 4. Timeline of the flood from 2001 to 2021 (Source: NASA Earth Observatory images by Lauren Dauphin).

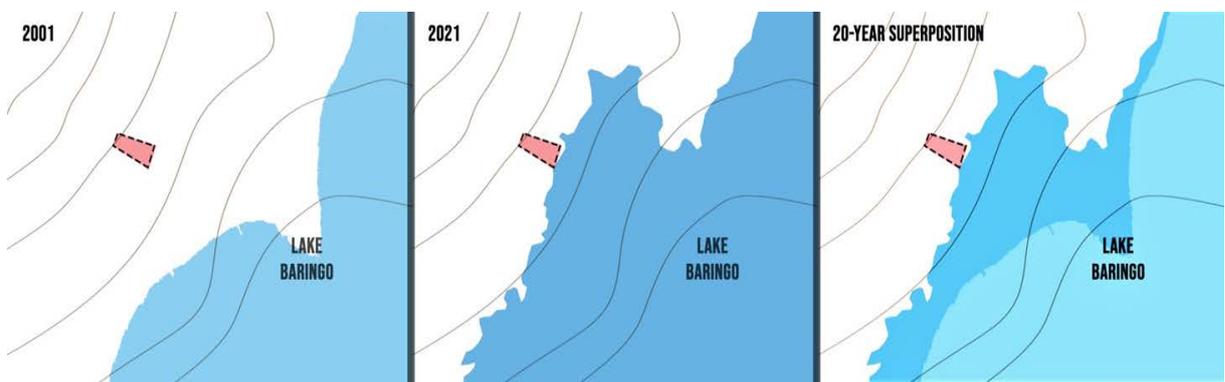
Map 5. Water land cover changes in L. Baringo (Source: Author).

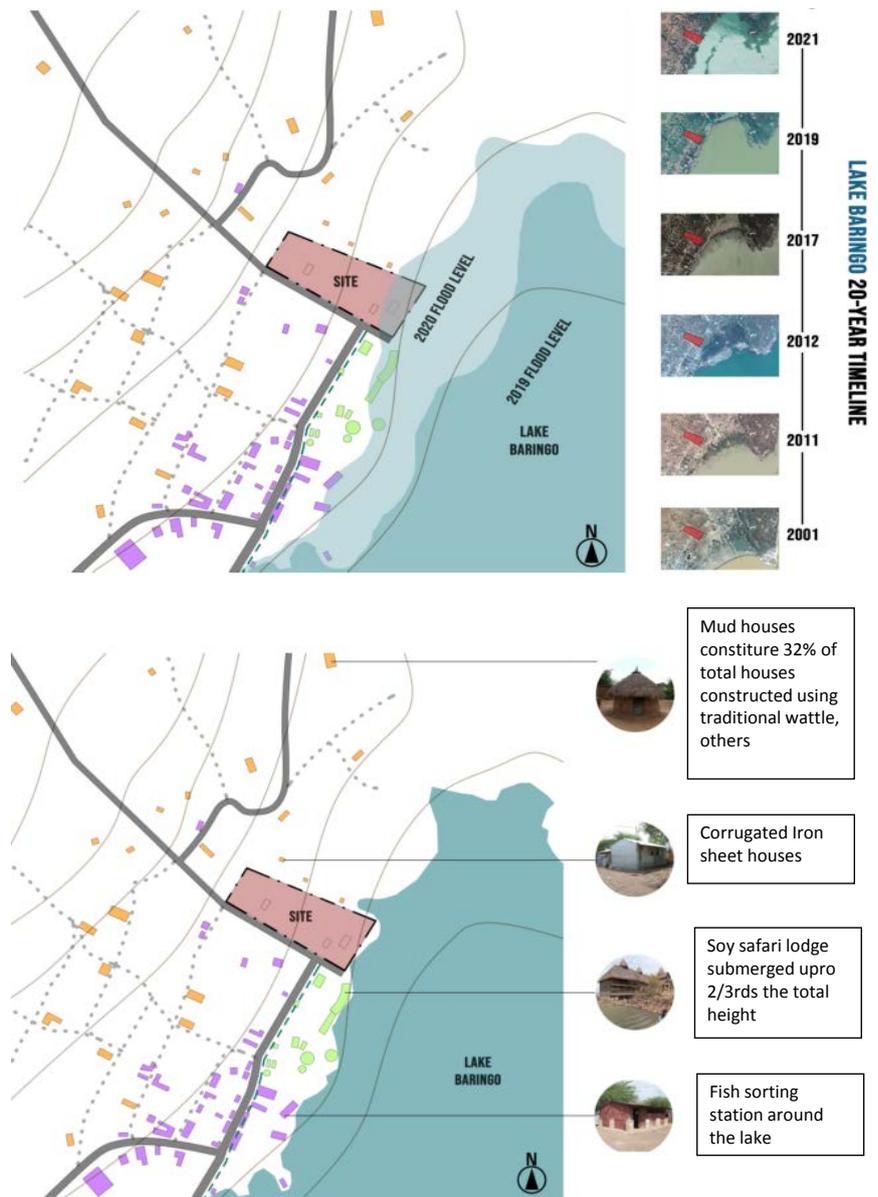
Map 6. An analysis of the flood conditions on the site and a 20-year timeline of the flood (Source: Author).

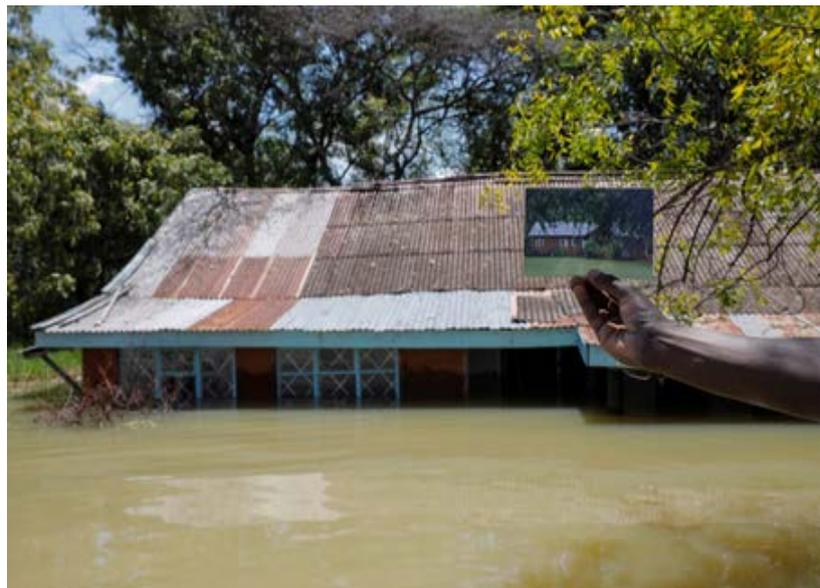
Figure 11. Flood rise levels in photos in affected houses (Source: Author).

Flood depth: **Figure 11** and **Figure 12** show that 41% of houses were more than 1.8 m, 26% were between 0.9 m and 1.8 m, and 33% were between 0.3 m and 0.9 m, respectively. This average depth further shown by **Figure 11** is about 1.6 metres and sometimes exceeding 3.2 m which is too deep for humans to comfortably stay posing a risk of drowning, loss of lives, loss of household commodities among others and sometimes fully submerging houses.

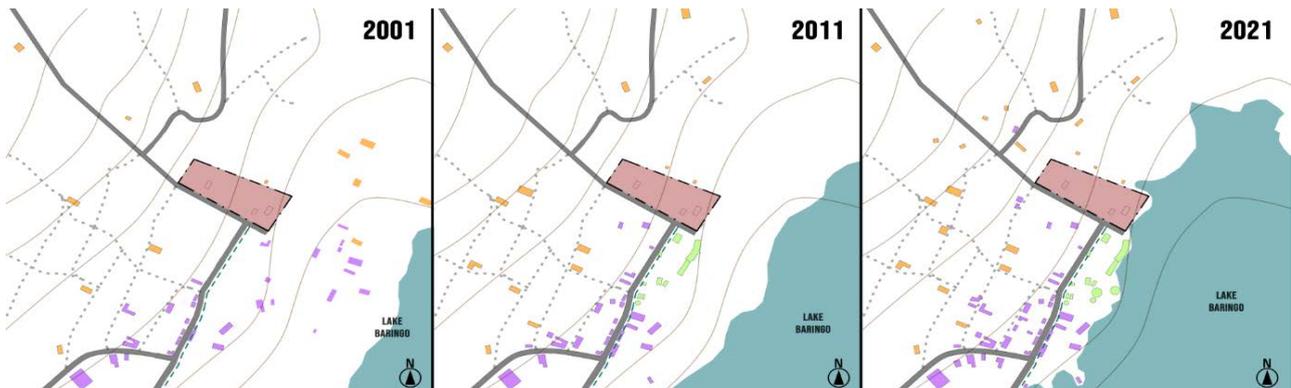
Map 7. Direction of flow of the lake water towards Kampi ya Samaki Town (Source: Author).

The direction of flow: It was outwards from the lake itself and came through the shoreline. It was very rare that the direction changed because of drainage canals and small ponds. Also, respondents who lived close to Lake Baringo expe-

rienced flooding from the Rivers Ndau and Perkerra as shown in the kampi ya samaki **Map 7**.

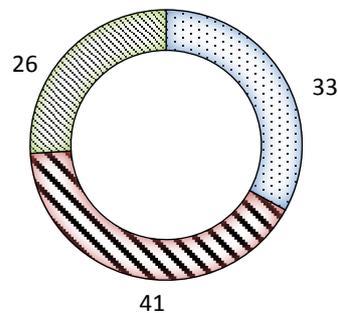
Flood levels in houses

■ 30cm-90cm ■ 90 cm-1.8m ■ More than 1.8m

Figure 12. Flood rise levels in centimetres in affected houses (Source: Author).

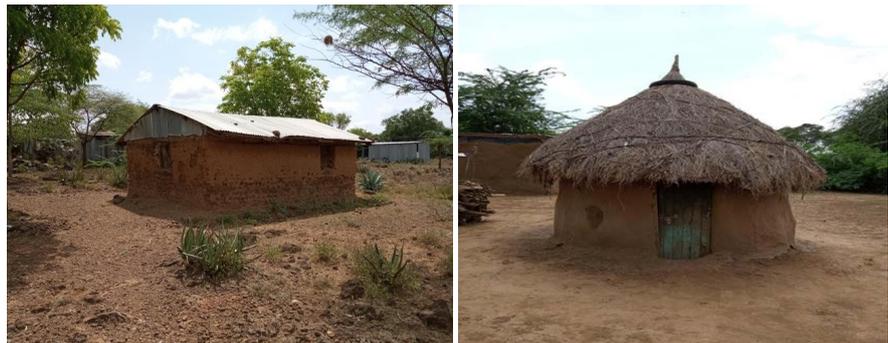
Mud structures as shown in **Figure 13** consisted of 22% of all houses in the study area. Some of them were constructed using the traditional wattle and daub technique, while others with local volcanic rock filled bound together with mud as mortar and plaster. They were the most by floods when exposed to water the earthen walls were easily washed off and crumbled easily.

Figure 13. Mud houses (Source: Author).

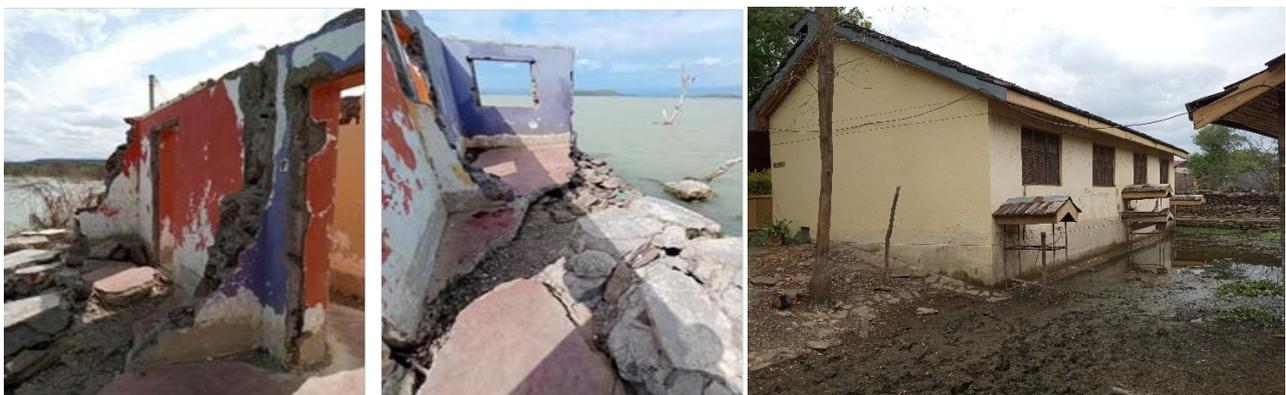
Masonry structures consisted of 8% of all houses in the study area. Some of them only had walls with four courses high of masonry with the rest built with corrugated iron sheets. The masonry structures closest to the lake displayed extreme structural damage while the ones farther inland were able to withstand the floodwaters as shown in **Figure 14**.

Figure 14. Damages on stone walled houses (Source: Author).

Masonry houses due to their permanent nature are left free-standing but critical building elements like windows, corrugated iron sheets, and doors which are more valuable to the owners are removed and owners relocate with them. These masonry houses are left in a dilapidated state and prone to damage.

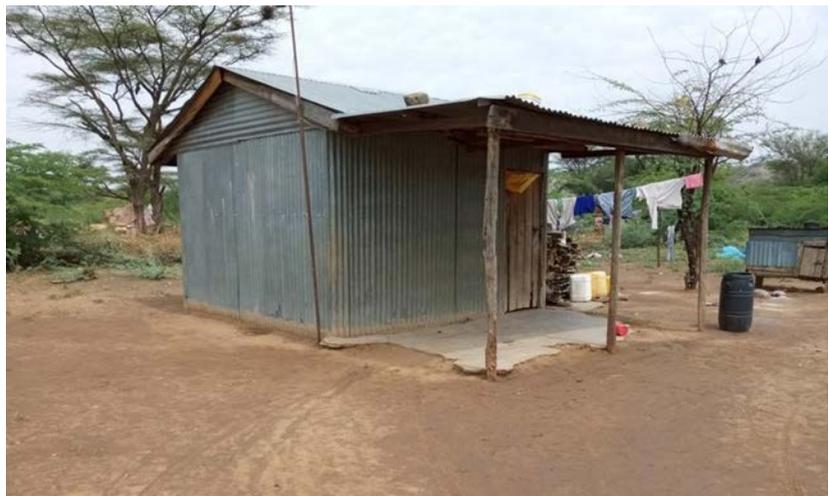
As shown in **Figure 15**, Corrugated iron sheet structures consisted of 59% of all houses in the study area. Most of the affected people were able to recover the iron sheets after the flood events.

Figure 15. Corrugated iron sheet houses (Source: Author).

The timber frames of these structures, however, were susceptible to damage from the force of the floodwater and rot.

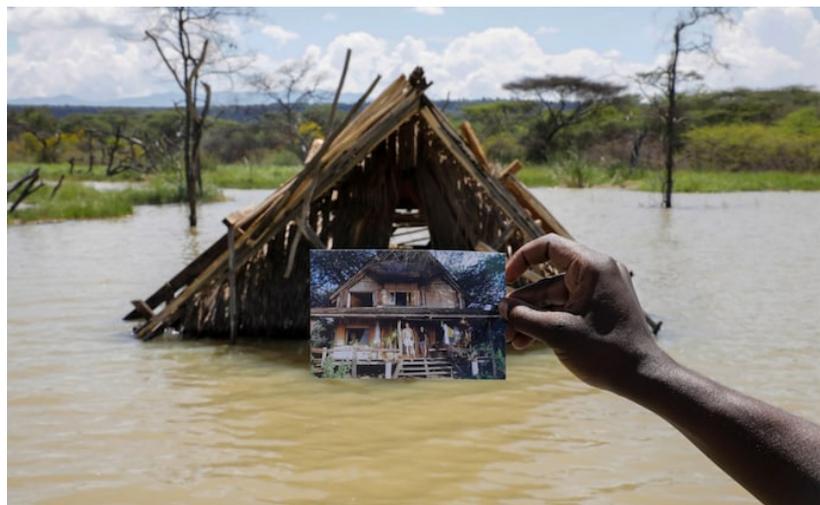
Timber structures with thatch as shown in **Figure 16** consisted of 10% of all houses in the study area. Some of them were constructed using traditional wood and nails others were tied with sisal. They were affected by floods since the untreated timber was exposed to water and rot. 70% of the timber houses were also thatch which caved in and rot upon exposure to heavy downpours.

Figure 16. Photo showing a structure before it was submerged under rising water due to months of unusually heavy rains, in lake Baringo, Kenya. CREDIT: BAZ RATNER/Reuters.
