The Performance of Small Diameter Aluminum Light Support Structures Containing Handholes under Cyclic Fatigue

How to cite this paper: Rusnak, C.R., Al-Hamami, A. and Menzemer, C.C. (2024) The Performance of Small Diameter Aluminum Light Support Structures Containing Handholes under Cyclic Fatigue. *Open Journal of Civil Engineering*, 14, 196-213. <https://doi.org/10.4236/ojce.2024.142010>

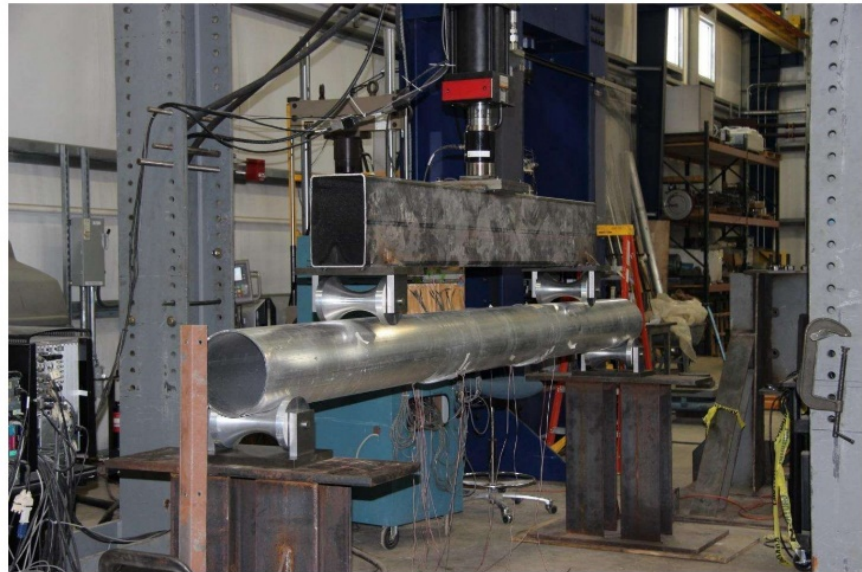
Figure 4. Laboratory photo of test setup.

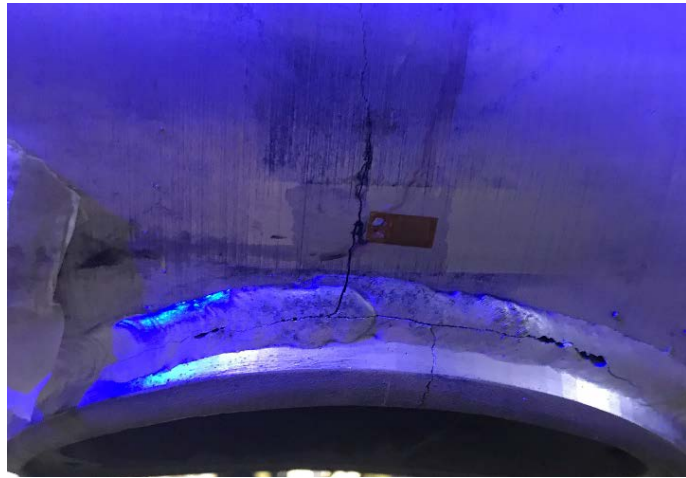
Figure 7. Failure Mode 1 longitudinal fatigue crack and failure of the casting and Pole Case 1.

During experimental testing, two distinct failure modes were identified. The first, referred to as "Failure Mode 1," involved fatigue cracking originating at the throat of the weld. This cracking typically began at either the 3 o'clock or 9 o'clock position of the welded handhole, gradually extending along the weldment until reaching a critical point where the crack penetrated into the casting, leading to ultimate failure. In some instances, the pole fractured at either the 3 o'clock or 9 o'clock position following crack propagation. The second failure mode, referred to as "Failure Mode 2," occurred at the base of the handhole, specifically around the 6 o'clock position, coinciding with the location of weld initiation/termination. In this mode, the pole ruptured at the identified location. "Figures 7-11" depict images of the observed damage and "Table 2" provides comprehensive details of the damage observed, along with corresponding figures.

Failure Mode	Observations/Damage Description
Failure Mode 1	Fatigue crack initiating at either the 3 or 9 o'clock position after propagation and failure. In this case, final failure/fracture occurred in both the casting and pole ("Figure 7" and "Figure 8").
	Fatigue crack initiating at either the 3 or 9 o'clock position after propagation and failure. In this case, final failure/fracture occurred in the pole and no cracking was observed in the casting ("Figure 9" and "Figure 10").
Failure Mode 2	Fracture of the pole at approximately the 6 o'clock position corresponding with the weld initiation/termination location ("Figure 11").

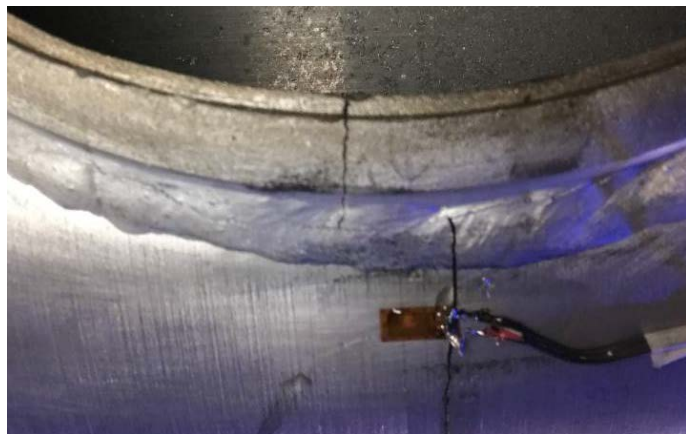
Figure 8. Failure Mode 1 longitudinal fatigue crack and failure of the casting and Pole Case 2.

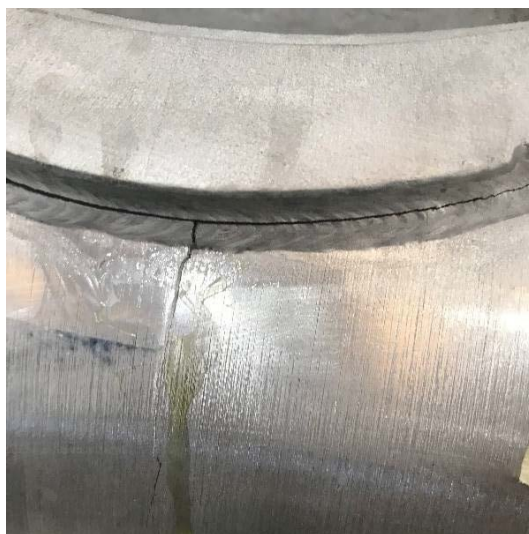
Figure 9. Mode 1 longitudinal fatigue crack and failure of the Pole Case 1.

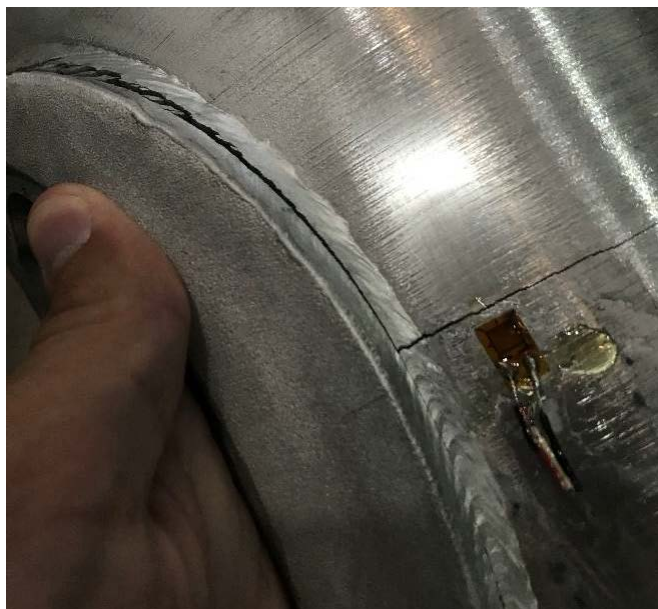
Figure 10. Mode 1 longitudinal fatigue crack and failure of the Pole Case 2.

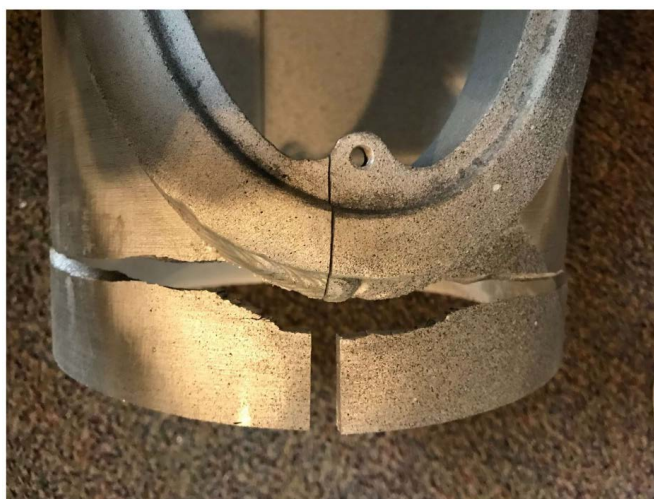
Figure 11. Failure Mode 2 pole rupture.

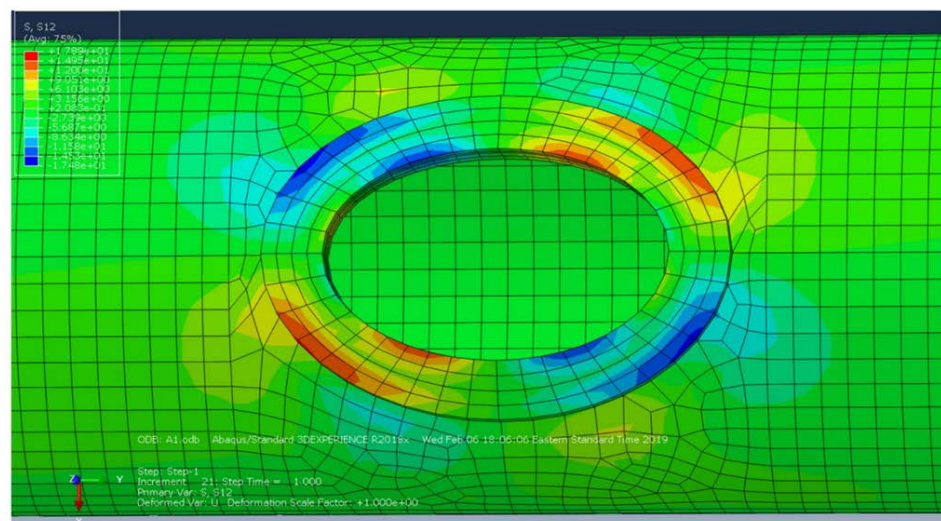
Figure 15. Local shear stress field.

The FEA models are illustrated in “**Figures 13-15**”, each focusing directly on the handhole, which serves as the central point of the study. “**Figure 13**” depicts the longitudinal local stress field, aligned with the major axis of the experiments, while “**Figure 14**” depicts the transverse local stress field, aligned with the minor axis. “**Figure 15**” depicts the local shear stress field around the handhole. In each figure, the color scale depicts how stresses accumulate around the reinforced handhole, with warmer colors indicating tension and cooler colors indicating compression, with variations in between.

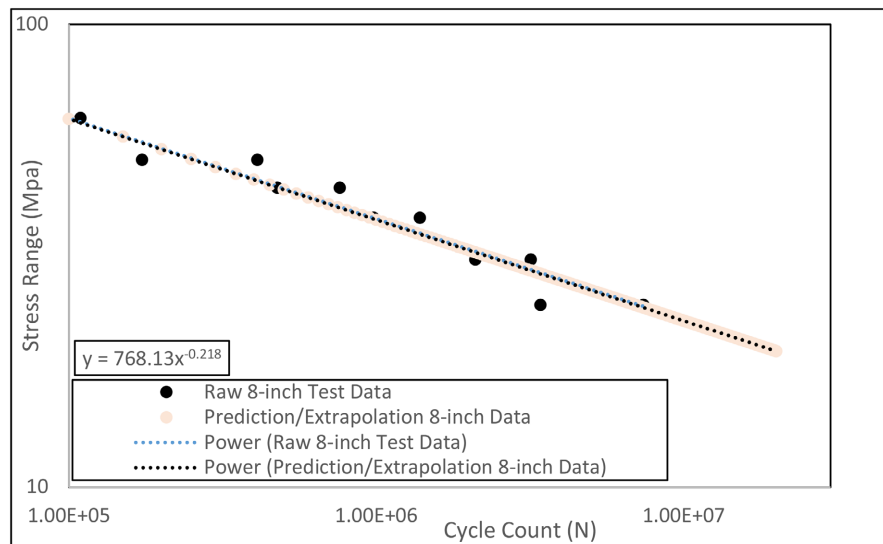
Figure 16. 8-inch diameter specimens power regression statistical analysis.

The power regression statistical analysis of the 8-inch and 10-inch specimens is depicted in “Figure 16” and “Figure 17”. These plots were generated by fitting a power trend line to experimental data within each size category (8-inch and 10-inch), yielding an equation. This equation allows determination of stress range values for any cycle count between 100 and 20,000,000 cycles. Each analysis includes the data points, power trend line derived from experimental data, and the corresponding equation the trend lines represent.

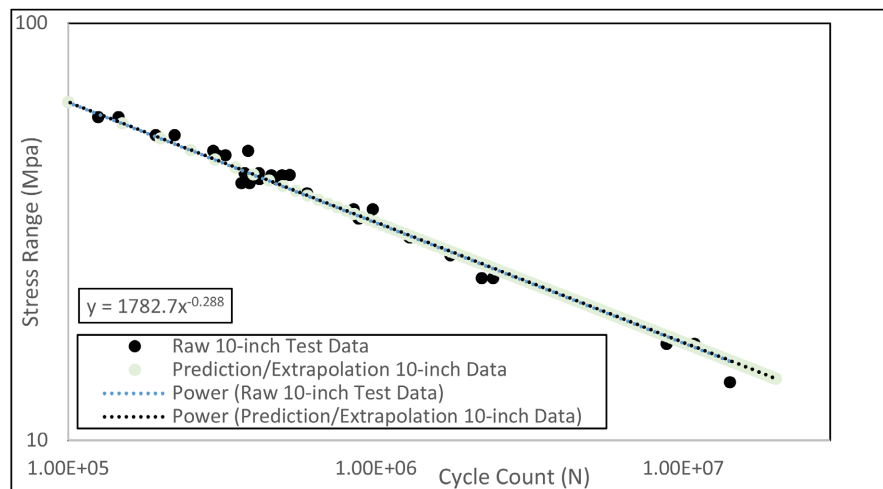
Figure 17. 10-inch diameter specimens power regression statistical analysis.
