# Evaluation of On-Vehicle Bone-Conduct Acoustic Emission Detection for Rail Defects

**How to cite this paper:** Jia, L., Park, J.W., Zhu, M., Jiang, Y.T. and Teng, H.L. (2025) Evaluation of On-Vehicle Bone-Conduct Acoustic Emission Detection for Rail Defects. *Journal of Transportation Technologies*, 15, 95-121.

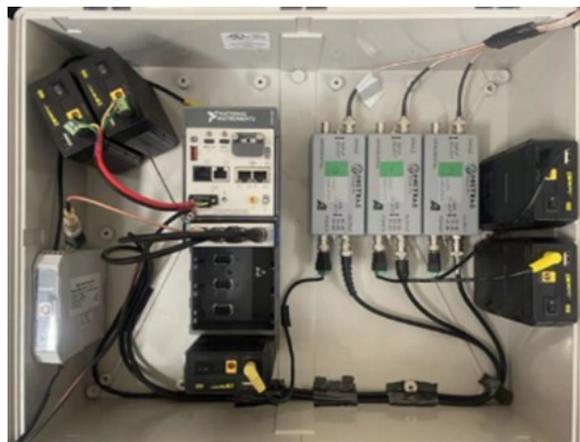
**Figure 1.** AE detection prototype.

The prototype developed included data acquisition equipment, bone-conduct sensors, pre-amplifiers, and high-speed cameras (**Figure 1**). Three identical AE sensors S9215 were used, operating within a 50 - 650 KHz bandwidth and a resonant frequency of 100 kHz. They offer a high limit up to 540 °C, allowing adequate testing in the extreme summer weather conditions in Nevada. A National Instrumental cRio 9041 with module NI 9223 were utilized as DAQ equipment with the sampling rate of 1 MHz. Mistras 2/4/6 voltage preamplifiers were employed to amplify AE signals prior to recording by the DAQ system. The preamplifiers' gain was set to 60 dB and a 20 - 500 kHz bandwidth was used to minimize low-frequency noises during the test. LabVIEW was used to manage the data collection and storage. A go-pro camera set at 240 fps recording recorded geo-information during the field tests. Hammer hit was employed when each test started to sync the time between video and AE signals.

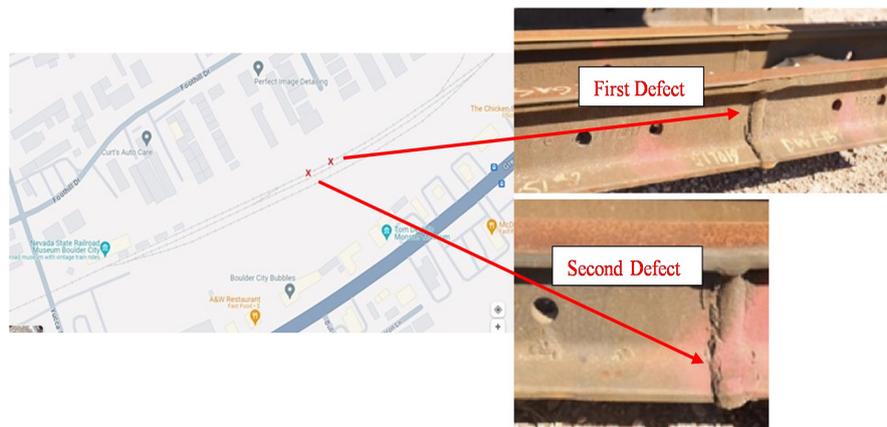
**Figure 2.** Two internal defects and their locations (red x-marked).

The used track was an AREMA 130-lb rail with internal defective welds characterized by the crack types and locations. As shown in **Figure 2**, the size of the first defect was 0.2 inches by 0.3 inches, located 0.7 inches below the rail surface. The second defect measured 0.2 inches by 0.2 inches, located 1 inch below the rail surface. Both defects were evaluated by an Olympus Epoch 1000i ultrasonic inspector to be in the early stages of defect development based on size. The rail track was supported by wood sleepers and ballast. The rail gauge was 4 feet 8.5 inches, and the sleeper spacing was about 19 inches.

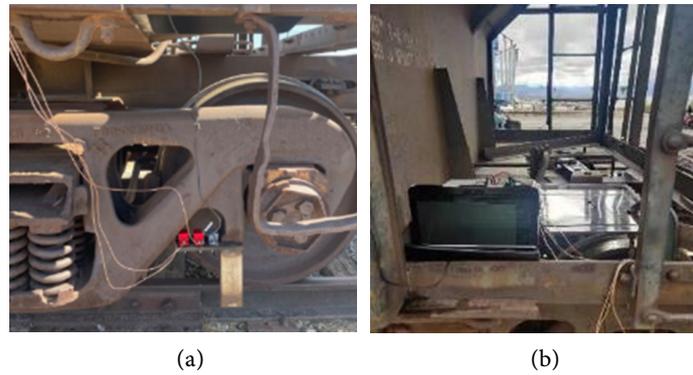
**Figure 3.** Prototype installation.

Three identical AE sensors were mounted on a steel plate attached to the rail suspension frame (**Figure 3(a)**). This location was selected as it is optimal for collecting AE signals generated by wheel-rail impacts. Ultrasonic coupling gel was applied to ensure signal transmission, and a GoPro camera was installed on the back of the steel plate to record the track geo-information. The DAQ equipment and laptop were placed on the platform above the bogie (**Figure 3(b)**).

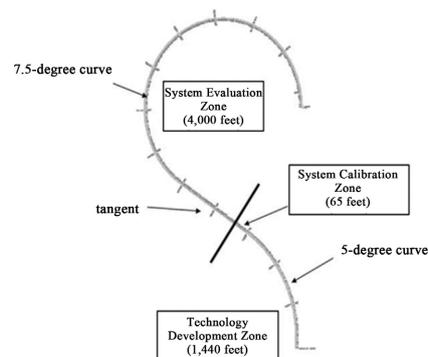
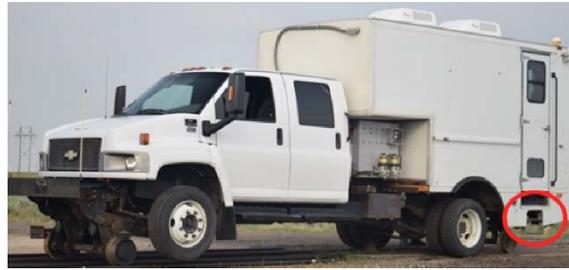
Figure 4. RDTF loop and used hi-rail vehicle in RDTF.

Three tested loops were the Rail Defect Test Facility (RDTF), the High Tonnage Loop (HTL), and the Railroad Test Track (RTT). The RDTF (**Figure 4**) contains over 300 known artificial rail defects. It included a System Evaluation Zone, which spans 4,000 feet and contains over 250 defects with known locations, and a System Calibration Zone, which had approximately 30 defects distributed in dense clusters. Additionally, there was a Blind Zone, which contained various defects with unknown locations and characteristics, designed for verification purposes.

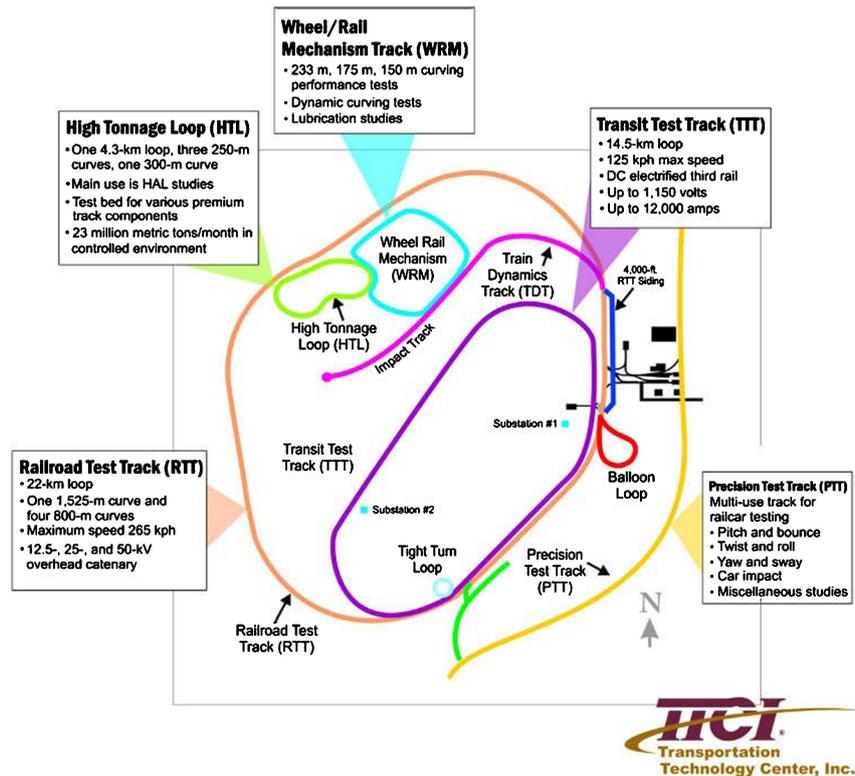
Figure 5. HTL and RTT loops.

Consequently, additional field tests were designed on the HTL (Figure 5) to verify the system’s performance under a broader range of load scenarios, ensuring a comprehensive evaluation. It is approximately 6.4 miles in length and includes over 30 naturally generated rail defects. The heavy-duty hoppers were utilized for these tests, with a speed limit of 40 mph. The final evaluation test was conducted on the RTT (Figure 5), which is 13.5 miles long with a speed limit of 105 mph. No defect information was provided for this loop; instead, the algorithms developed during the earlier tests were employed to identify defects on the RTT.

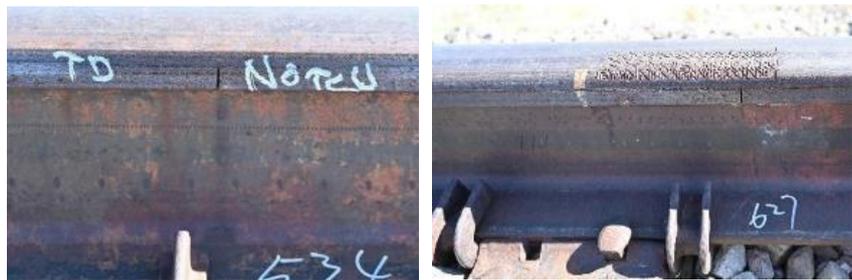
**Figure 6.** Defects in RDTF loop.

**Test Setup in RDTF:** Defects in RDTF were artificially created by cutting or drilling the tracks, as shown in Figure 6. Three identical AE sensors and two Go-Pro cameras were mounted on a steel plate mounted on the bottom frame of the Hi-rail vehicle (Figure 7). The mount locations were carefully selected to ensure

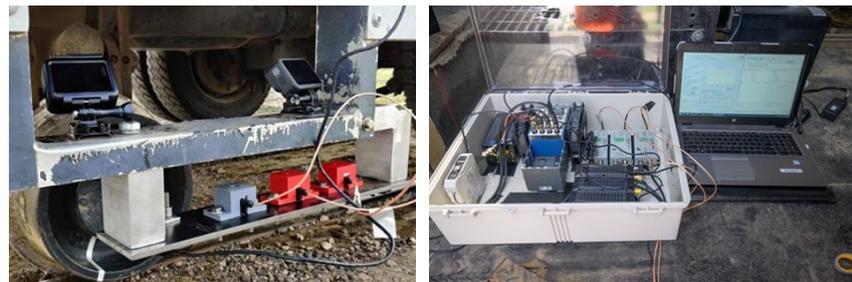
**Figure 7.** Prototype installation on hi-rail vehicle.

safety and the detectability of AE signals generated by wheel-rail impacts. Ultrasonic coupling gel was applied to the sensor surfaces to ensure effective signal transmission between the sensors and the steel plates. The DAQ equipment and a laptop were housed inside the vehicle.

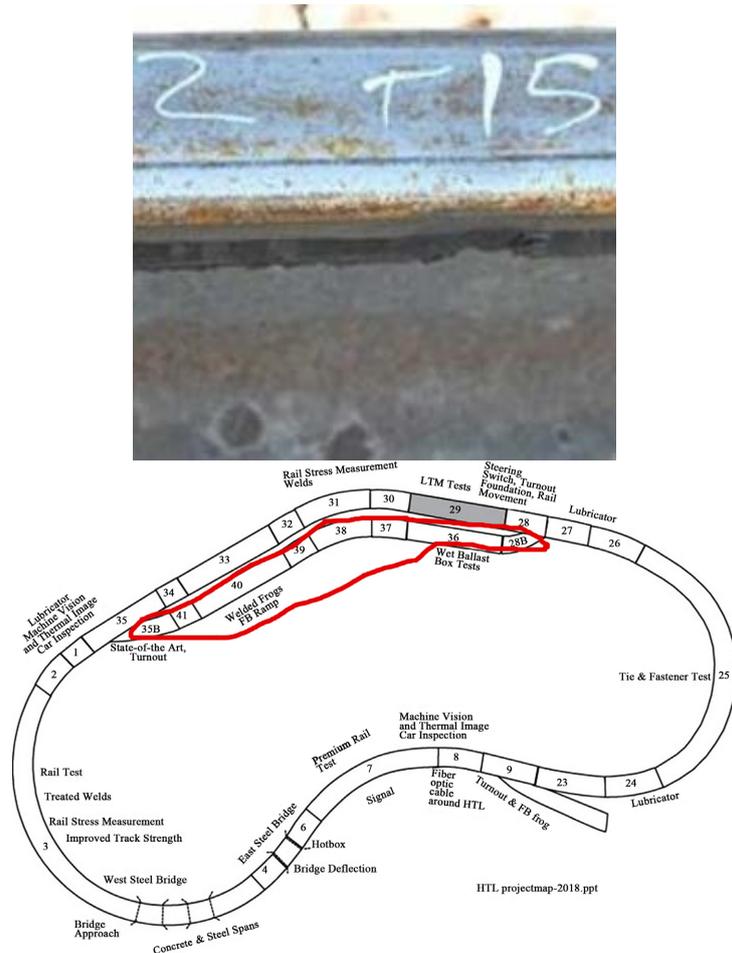
Figure 8. Rail defect and HTL loop.

**Test Setup in HTL.** The HTL loop field tests are different as this loop involves naturally created rail defects. It had 39 defects over a loop span of 6.4 miles. As an example, a typical web crack defect is shown in **Figure 8**. For accurate assessment of rail defects, a preliminary inspection was conducted on all defects, one at a time to identify the size, type, and location of each defect. The results were documented by TTCI. Eight defects were located on the bypass track (zone marked by the red area) and thus were excluded from this field testing (**Figure 8**). Therefore, 31 defects distributed on the main loop were used for data collection and further analysis. The vehicle used in this field test was a 30-ton empty hopper (**Figure 9**). The sensors and cameras were installed in the same configuration as in the RDTF tests, and the DAQ equipment was securely placed on top of the bogie.

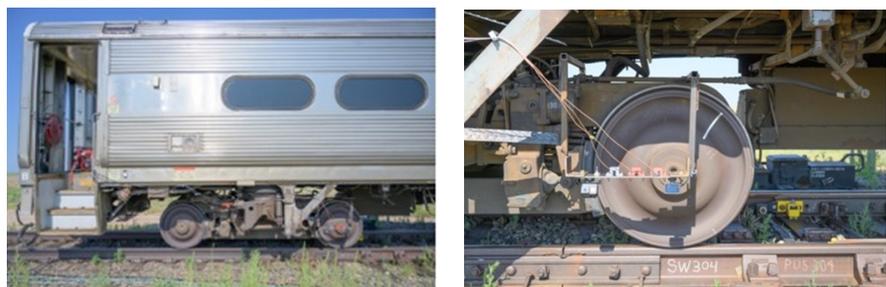
**Figure 10.** Testing car and sensor installation on RTT Loop.

The entire length of the RTT loop was 13.5 miles, with a maximum allowable speed of 165 mph. The testing system was installed similarly as installed in the Nevada field test, as presented in **Figure 10**. However, due to safety concerns regarding the sensors and cameras, the maximum speed during this test was limited to 105 mph. Five tests were conducted: two at 40 mph and three at 105 mph. The purpose of the 40 mph tests was to evaluate and compare the effects of ambient noise with those observed during the HTL tests.

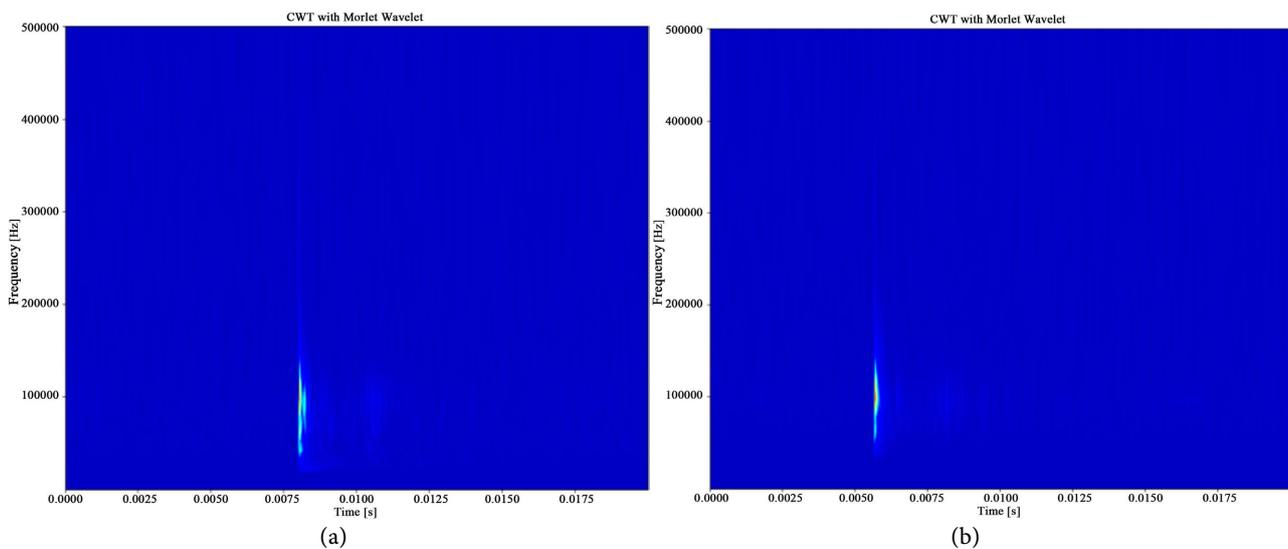
**Figure 11.** Defect-induced AE signals: (a) single impulse; (b) dual impulses.

To effectively present the AE features, a high-pass filter with 60 kHz was employed to reduce the effects of low-frequency noises. **Figure 11** indicated that the wave energy was primarily concentrated in the 60 - 120 kHz and a notable amount of energy was in the 200 - 300 kHz range. In contrast, **Figure 12** presented the CWT of two typical ambient noises, where the energy was mainly concentrated below 150 kHz. This is significantly different from the defect-induced AE signals. Therefore, filtering out the lower frequency components of the AE signal can significantly reduce the impact of noise. Additionally, these visible differences made identifying and canceling ambient noise possible in the future.

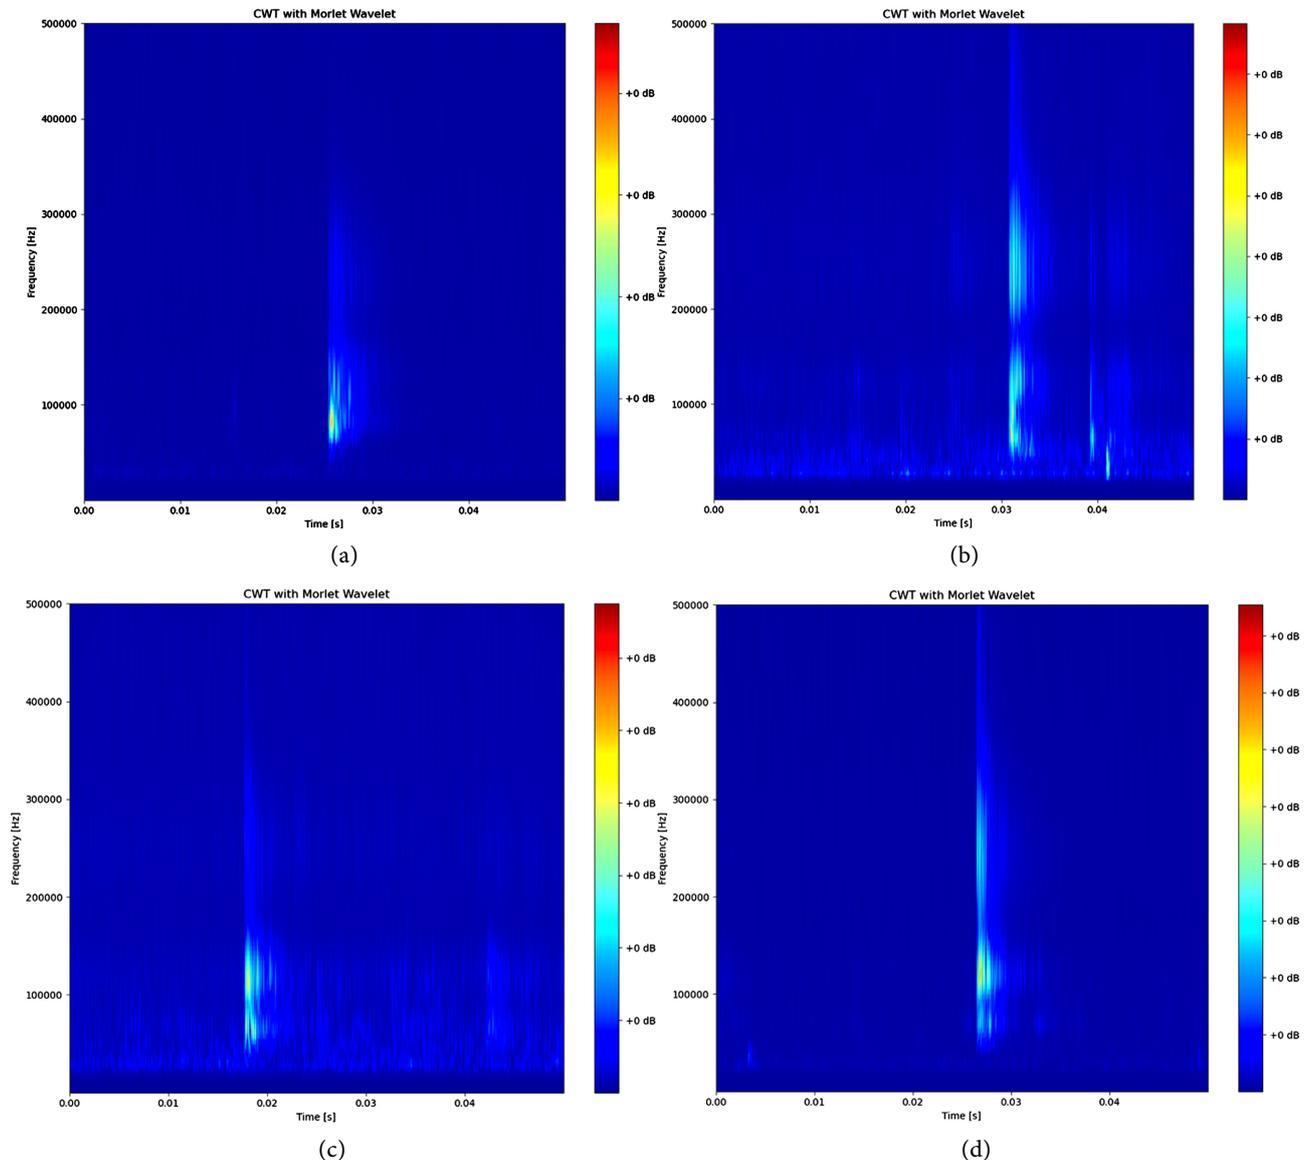
**Figure 13.** AE signals in RDTF tests: (a) 5 mph; (b) 10 mph; (c) 15 mph; (d) 20 mph.

**Figure 13** presents the CWT of typical impulse signals from different testing speeds involving complicated frequency distributions. While these signals generally lasted very short, the frequency range was typically distributed from 60 to 500

kHz across the tested speeds. Meanwhile, the wave energy was primarily concentrated in the 60 - 150 kHz range, and a notable amount of energy was observed in the 200 - 300 kHz range. These findings are aligned with the conclusions of the first stage field test in Nevada.

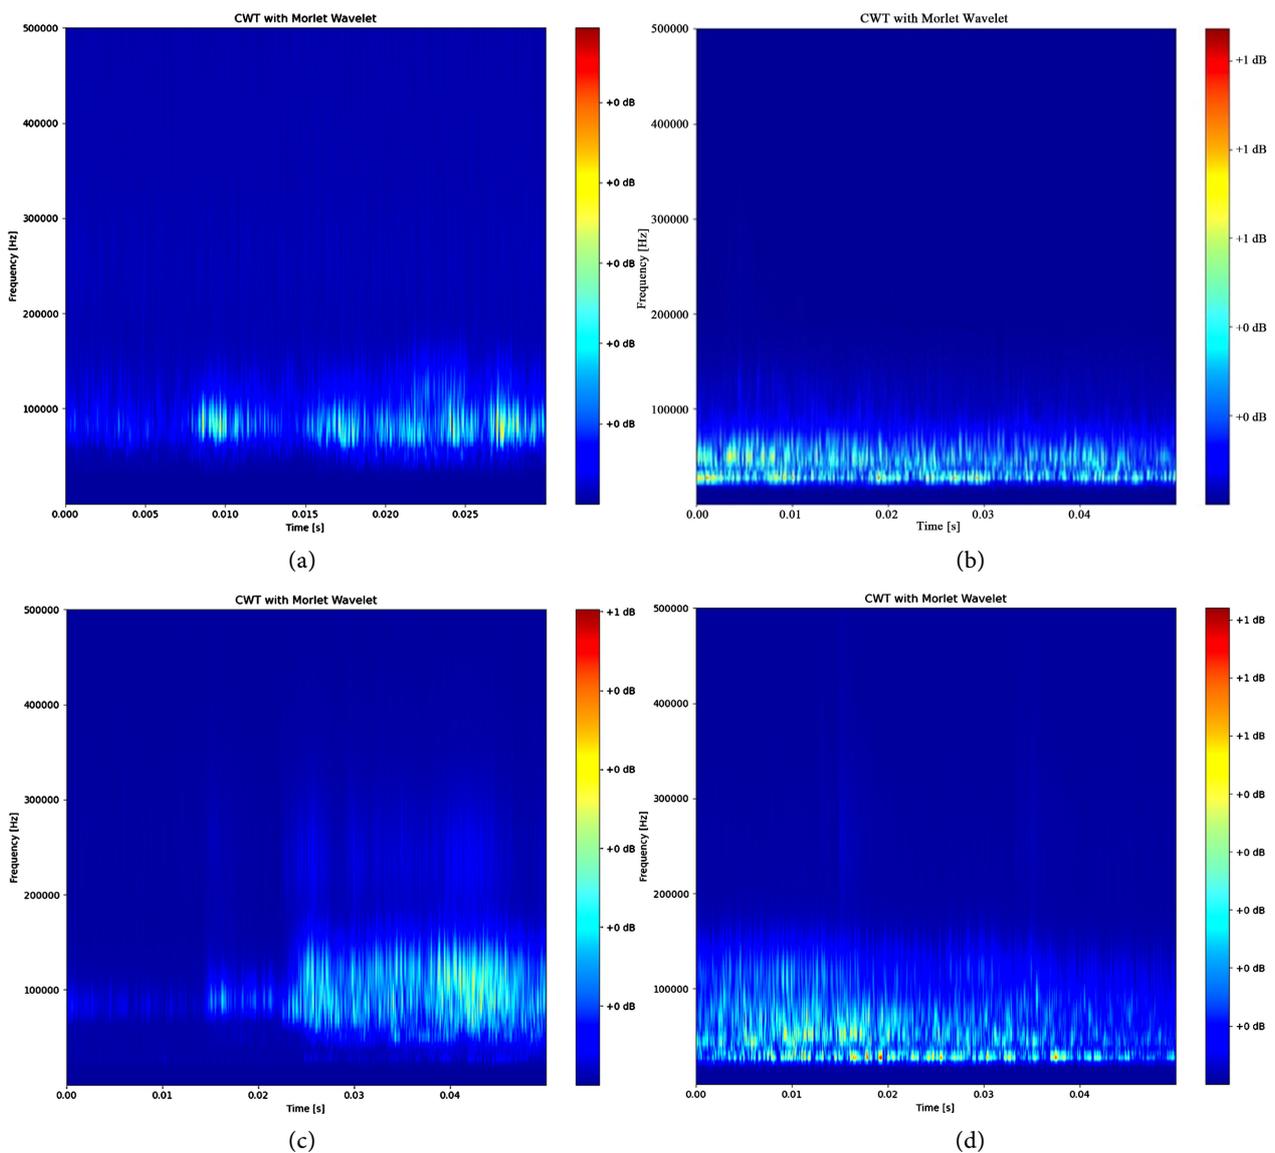
**Figure 14.** Ambient noise signals in RDTF tests.

**Figure 14** presents the time-frequency plots of ambient noise across four testing speeds, where the energy was primarily concentrated below 150 kHz, a clear distinction from the defect-induced AE signals. Ambient noise, compared to the impulse signals, is characterized by relatively low frequency, continuity, and randomness. This observation is consistent with findings from the initial stage of the field test in Nevada. Further analysis was conducted with a narrower time scale to examine the time-frequency characteristics, as shown in **Figure 15**. This figure represents a typ-

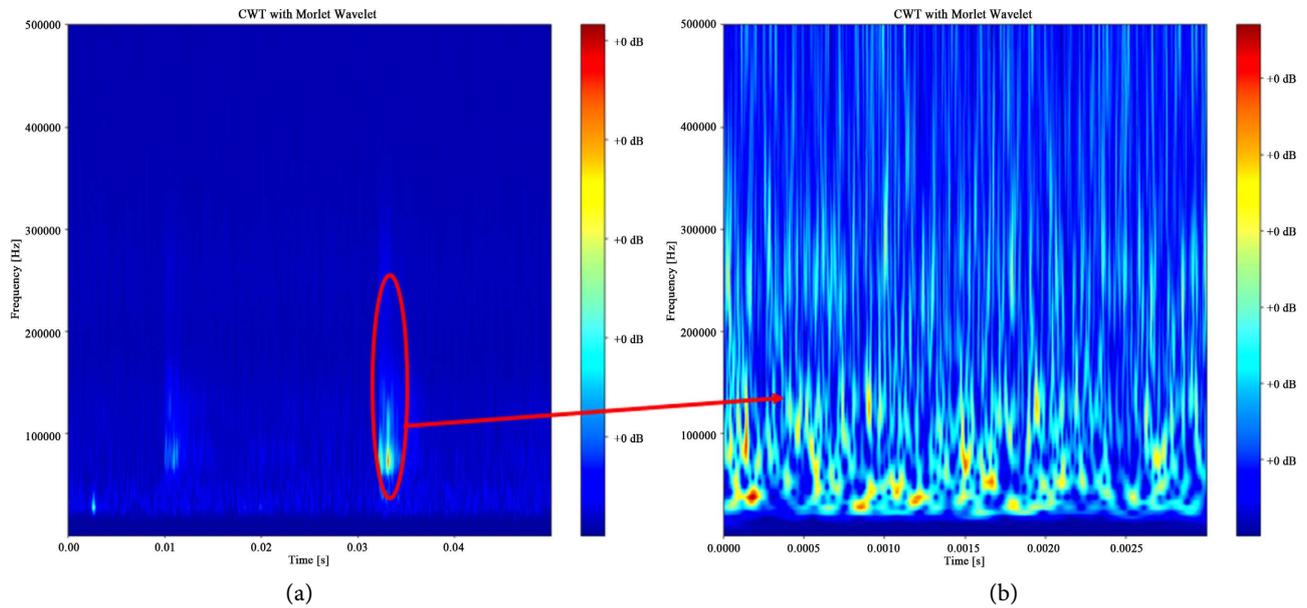
**Figure 15.** CWT of impulse signals: (a) overview; (b) narrower time window.

ical AE pattern for events collected during the test. It is interesting to note that the signal did not exhibit significant attenuation during the impulse period. However, given the defect density within this loop, the number of detected events was relatively low. Two factors may have contributed to this: firstly, the testing vehicle was a hi-rail vehicle modified from a pickup truck, resulting in a significantly lower axial load than a commercial hopper. Secondly, all defects in the loop were artificially induced through cutting or drilling, which may have stabilized these defects, preventing further development under low compression conditions.

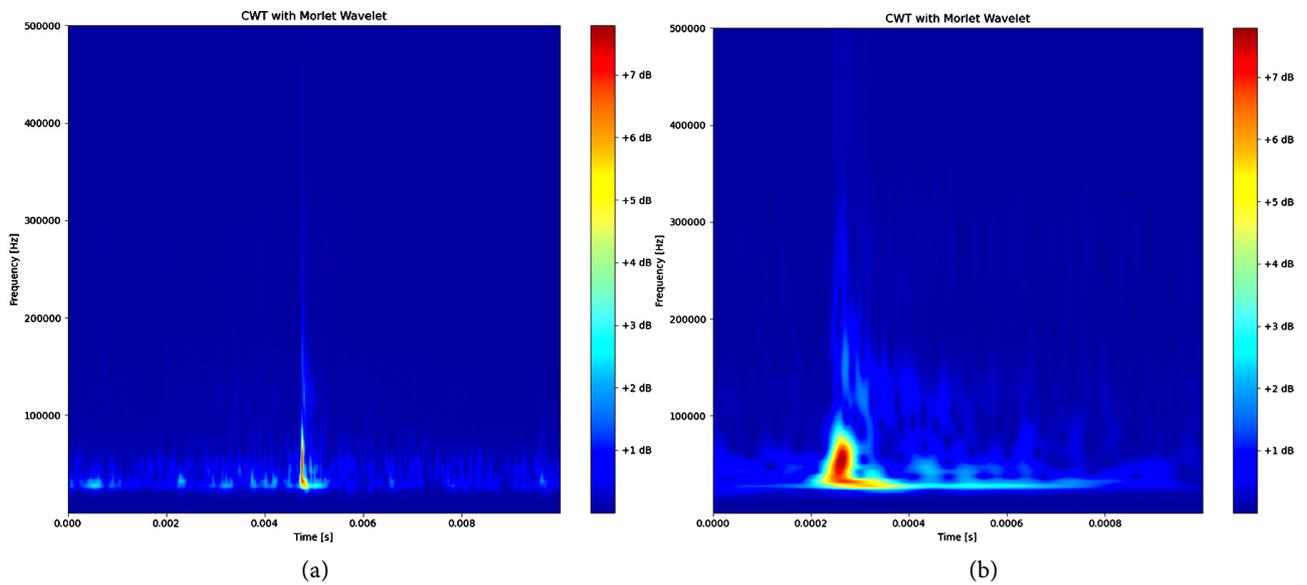
**Figure 16.** Visible AE signal detected in HTL loop.

Unfortunately, the CWT features observed from different defects showed significant variations in certain defect area plots. Some plots clearly identified AE characteristics, as shown in **Figure 16**, where a distinct AE impulse is visible with a major energy distribution between 20 - 90 kHz along with a notable high frequency range from 120 kHz to 500 kHz. However, other plots presented more complex patterns. In many defect areas, multiple AE-like impulses were observed throughout the defect regions (**Figure 17**). These impulses also appeared in non-defect areas, complicating the identification of AE signals. When the analysis was conducted on a narrower time scale, the signals exhibited continuous features, making it challenging to distinguish AE characteristics.

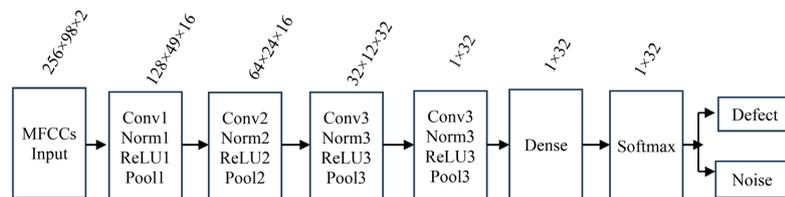
**Figure 18.** General architecture for defect classification.

In this study, the model took MFCCs and deltas as input, initially structured into  $256 \times 98 \times 2$ , where 256 represents the number of Mel bands, 98 is the number of frames, and two channels denote the original MFCCs and their delta values. The architecture comprised multiple convolutional layers with batch normalization and ReLU activation functions to ensure stable and efficient learning, as shown in **Figure 18**. The convolutional layers progressively extract features from the input data, with the layers and the subsequent layers using various filter setups, with the consideration of optimizing the classification rate. The kernel size was set to  $3 \times 3$ . Max pooling layers with a pool size of  $2 \times 2$  followed each convolutional layer, reducing the spatial dimensions of the feature maps while retaining the most salient information. A global max pooling layer was incorporated to condense the feature maps further, followed by fully connected layers. The first dense layer had 16 units with ReLU activation, and the output layer consisted of 2 units with SoftMax activation, corresponding to the two classes in the classification task. The model was compiled with the Adam optimizer, using a learning rate  $1e-4$ , and trained with the sparse categorical cross-entropy loss function, with accuracy as the primary evaluation metric. To ensure robust performance, the model undergoes K-fold cross-validation, allowing it to be trained and validated on different data splits, providing a comprehensive evaluation of its classification capabilities. However, the data structures were modified to optimize the training performance, including revising the layer numbers, input structure, and layer filter amount.

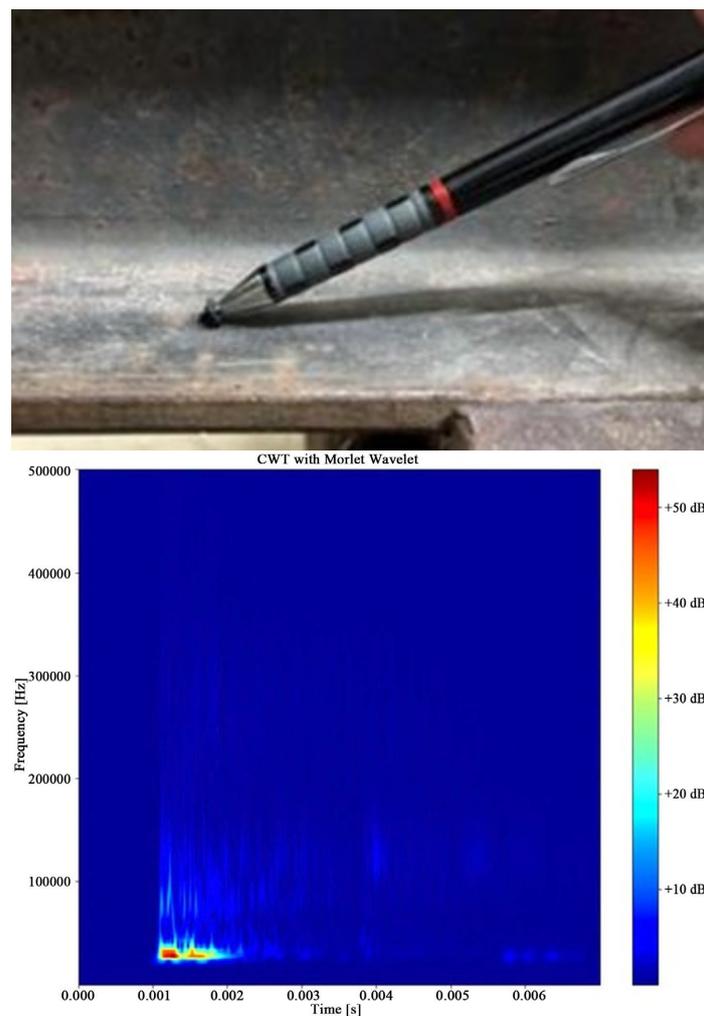
**Figure 19.** PLB test and time-frequency analysis.

were conducted both in the lab and in the field. The PLB test is also known as the Hsu-Nielsen test, is commonly employed to replicate AE signals by breaking the tip of a pencil lead against the material surface. As the pencil lead in a specially designed pencil breaks, an elastic wave can be generated as a result of the sudden stress release. The ASTM E976-15 [22] recommends using a mechanical pencil with 2H leads of 0.5 mm diameter as the AE source for reliable results. Each lead to be broken was approximately 3 mm in length. The Nielsen shoe is used to position the pencil lead correctly towards the testing materials at a 30° angle (Figure 19). Researchers adopted PLB as a simulation tool to produce AE signals and investigate the acoustic features of AE signals.

The first question focused on whether the detection prototype was properly configured to receive AE signals. To evaluate the system setup and ensure the prototype's ability to capture acoustic signals accurately, a PLB test was made with sensors attached to the surface of a steel plate. The results from this test were positive, with the time-frequency analysis clearly indicating successful detection of
