# Evaluation of the Effectiveness of Traditional and Nano Materials Used in Consolidation of Sandstone Used in Ramesses III Temple, Karnak, Egypt

This experimental study assesses the effectiveness of traditional and nano-materials in enhancing the physical and mechanical properties of deteriorated sandstone from Ramesses III Temple, Karnak, Luxor, Egypt. Treatments included Nano Estel (5%), Paraloid B-72 (3%), Paraloid B-72/Nano Estel (3%/5%), and ethyl silicates. Treated samples underwent Scanning Electron Microscopy (SEM) and physical/mechanical testing. Results show that Paraloid B-72/Nano Estel (3%/5%) yielded optimal consolidation, significantly improving sandstone's physical and mechanical properties.

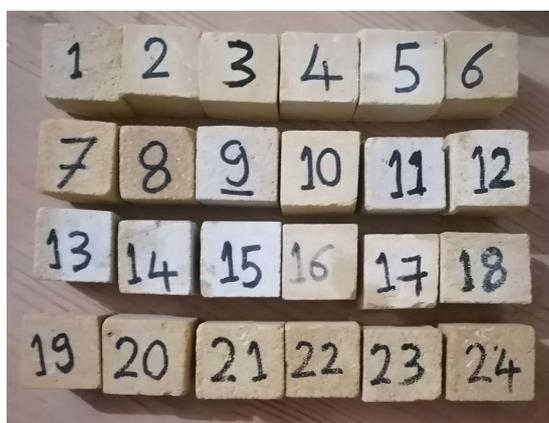
**Figure 4.** The prepared representative samples.

Sandstone samples from Jabal Al-Silsilah quarries (**Figure 4**) were precision-cut into  $3 \times 3 \times 3$  cm cubes, oven-dried ( $65^{\circ}\text{C}$ , 24 h) and cooled (RH 50%) according to ASTM standards, ensuring constant weight for treatment testing.

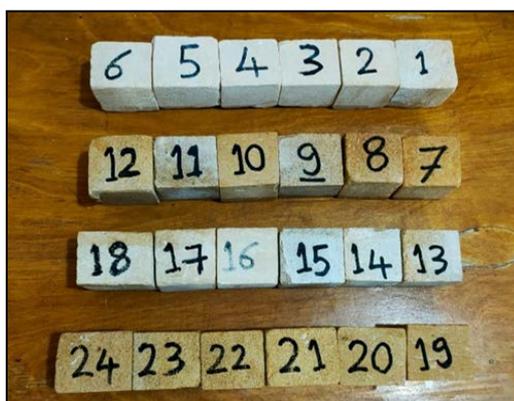
**Figure 5.** The sandstone samples after consolidation.

Treatment materials' suitability for consolidation of sandstone were assessed through immersion testing to ensure safe and effective application, Sandstone samples underwent 21-day consolidation treatment via immersion in respective materials, allowing complete polymerization, as shown **Figure 5**.

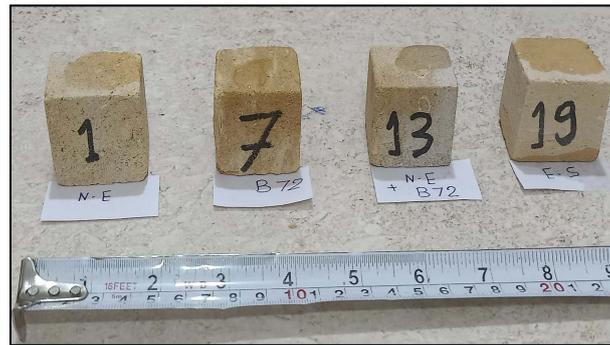
**Figure 9.** Water Repellents of the treated samples after consolidation.

Water repellency testing ranked consolidation materials: Paraloid B72 (1st), Paraloid B72/Nano Estel (2nd), Ethyl Silicate (3rd), and Nano Estel (4th) (**Figure 9**).
