## **Sigma Phase Formation and Embrittlement of Cast Iron-Chromium-Nickel (Fe-Cr-Ni) Alloys**

### **ABSTRACT**

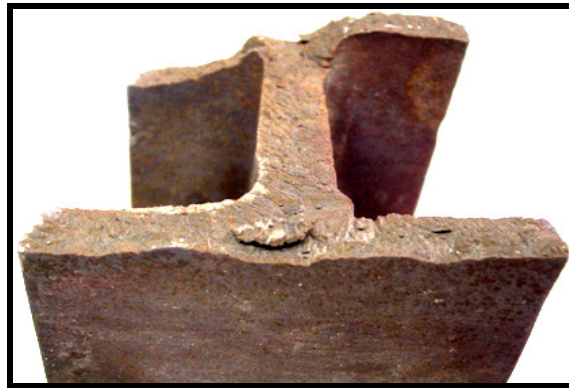
Figure 1 shows a fracture surface of one of the samples. Clearly, the fracture surface exhibits that of brittle failure with large facets. There was no apparent corrosion of any type and surface appeared oxidized. In addition, there was no plastic deformation or otherwise observed.

Figure 1. Fracture surface of one of the samples-HK-40.

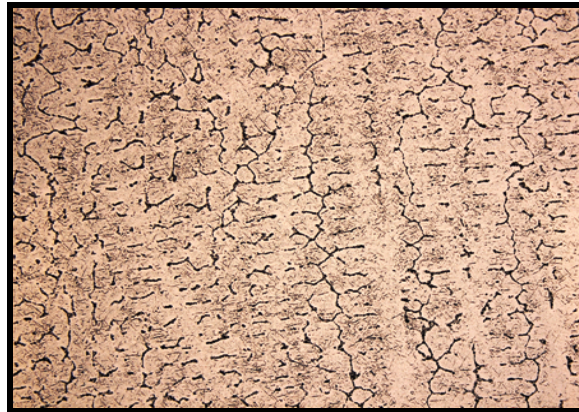
Figure 2 shows an optical micrograph of a sample showing cross section of the fracture surface in the as etched condition showing dendritic microstructure typical of cast materials.

Figure 2. Cross section of the HK-40 sample, etched, KOH.

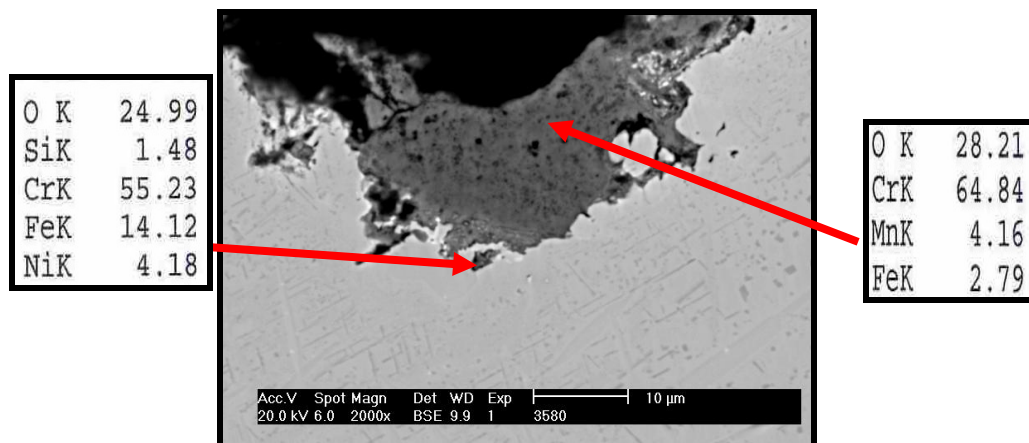
Figure 3 is SEM photomicrograph showing a location just below the surface of the fracture. The whole surface has been oxidized. In the area of the same figure, sigma- $\sigma$ -phase has been identified with aid of EDS. Figure 4 shows an image of an area within the sample along with its identified phases. Attacked phase was again  $\sigma$ -phase.

Figure 3. SEM optical micrographs showing cross section sample in the as polished condition along with its EDS analysis. Elemental analysis indicates oxide formation.

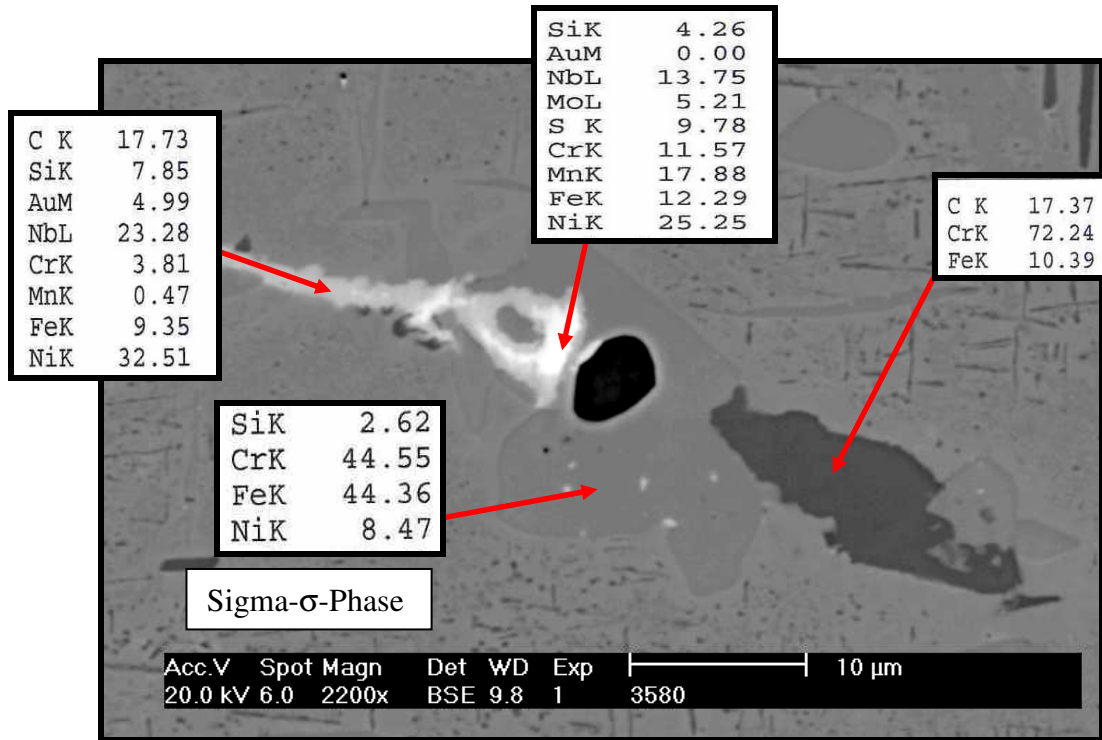
Figure 4. SEM photo micrograph of an inner section within a sample below the fracture surface along with EDS analysis. Composition of lower part is typical of sigma phase. High temp attack in on  $\sigma$ -phase.

Sigma ( $\sigma$ ) phase (iron-chromium compound) can develop in austenitic stainless steels as seen in the Figures 4 to 9. It is hard-brittle intermetallic phase. For this reason it has a direct effect on the mechanical property of the metal. It can form when service temperature is within 565-952°C (1050-1700°F). The upper limit for sigma phase formation varies from 870 to 980°C (1600 to 1800°F) [35, 28]. For example, embrittlement in 304SS usually occurs slowly. Only about 2 to 3% sigma phase will show in its macrostructure after 10 years at 650°C (1200°F) [36]. Near 900 °C, it forms within a couple of minutes [37, 38].

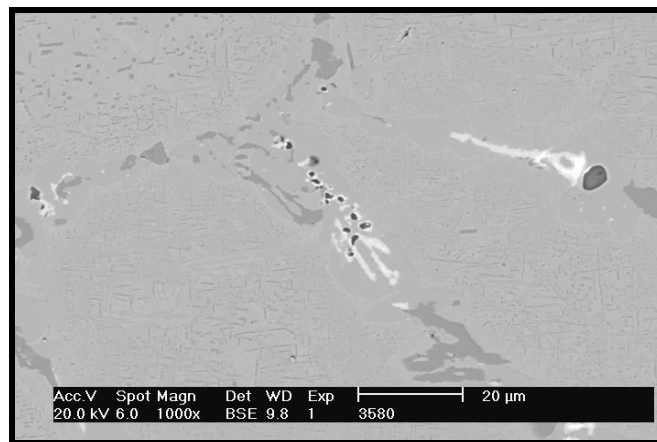
Figures 5, 6 and 7 show different locations within the sample where it has been attached and also contain  $\sigma$ -phases and secondary carbides precipitates. Cracks were filled with

Figure 5. SEM photomicrograph showing signs of high temperature attack mainly on sigma phase location.

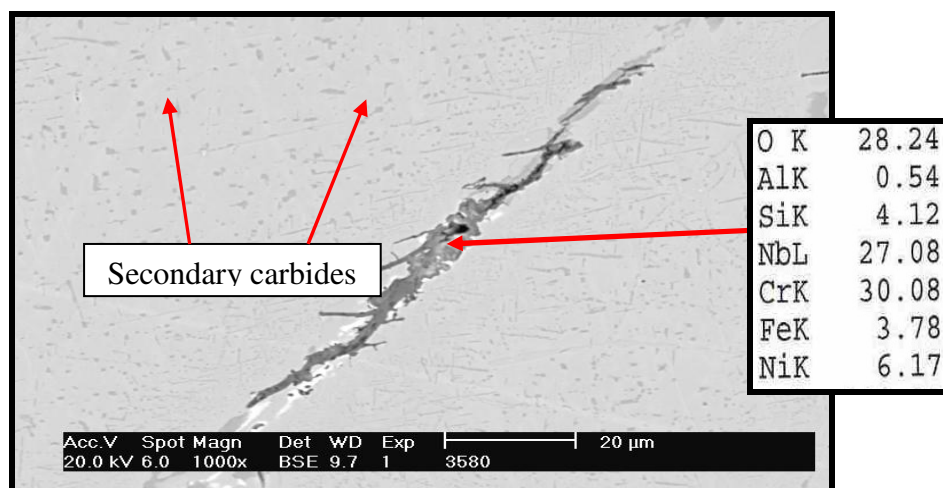
Figure 6. SEM photomicrograph along with its EDS analysis showing cracking filled with oxides.

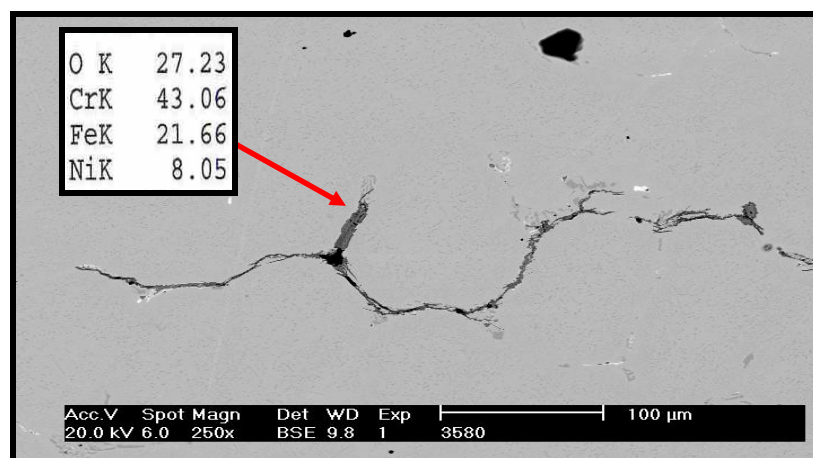
Figure 7. SEM photomicrograph along with its EDS analysis showing high temperature cracking mainly following sigma phase locations.

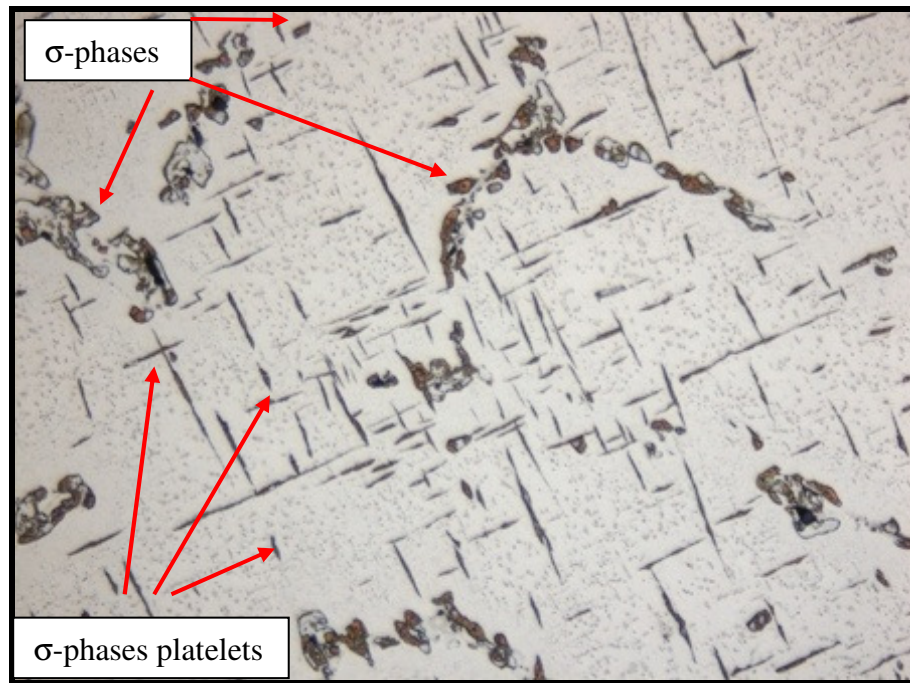
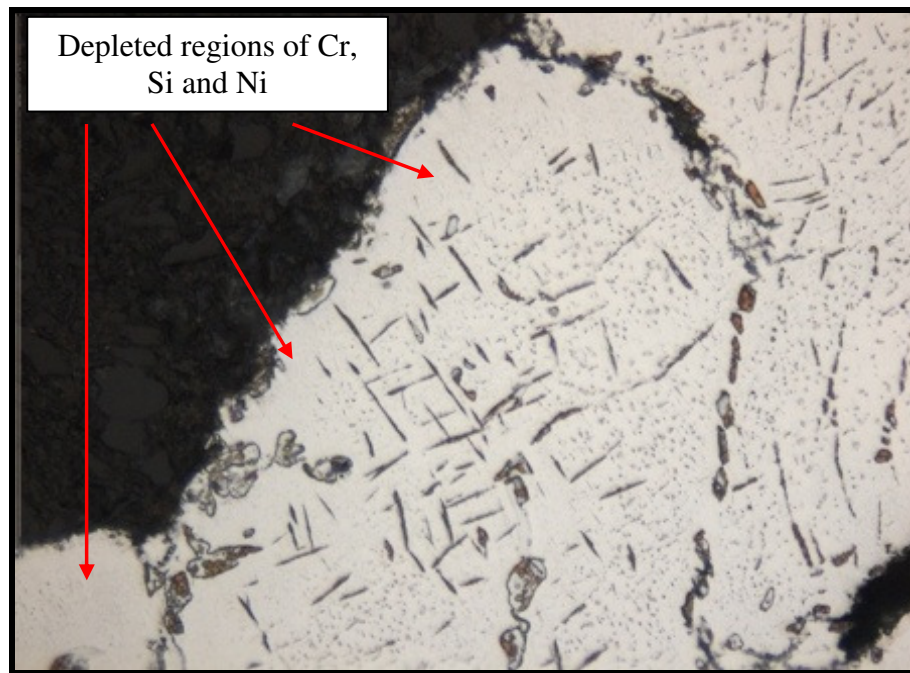
oxides. Figures 8 and 9 are optical micrograph of a sample etched using sigma phase etchant. It is clear that the cross section of the fracture surface exhibited an excessive amount of  $\sigma$ -phases along grain boundaries and along the fracture surface itself. It was also clear that the areas adjacent and below  $\sigma$ -phases were depleted of Cr, Si and Ni. This has prevented formation of  $\text{SiO}_2$  and  $\text{Cr}_2\text{O}_3$  as clearly shown in Figures 8 and 9. In addition, the stringers also have transformed into  $\sigma$ -phase. Cracking is inter-dendritic.

Figure 8. Optical micrographs of the samples in the as etched condition, showing excessive amount of sigma phase. Sigma phase etchant been used.

A lamellar (stringers) constituent tentatively identified as an austenite, carbonitride eutectoid resembling pearlite also is frequently observed in HK alloys but its exact nature is in doubt [40]. If these phases are present in excessive amounts, it will not affect the alloy strength at high temperature. Only affecting factor in the failure is the unbalanced composition of these phases. This is always possible within the previously mentioned nominal chemical ranges of this grade, and in this event, some ferrite is present in the austenite matrix, which will directly affect the local metallurgical and mechanical properties. This ferrite that is adjacent to the austenite will transform to the brittle sigma phase if the alloy is held for more than short times around 816°C (1500°F) with consequent weakening at this temperature and embrittlement [43]. The direct implication of sigma phase precipitation and growth will cause Cr and Si depletion, in the surrounding metallic matrix next to it (Figure 8), and will further reduces HK-40 metal dusting resistance as been reported elsewhere [44].

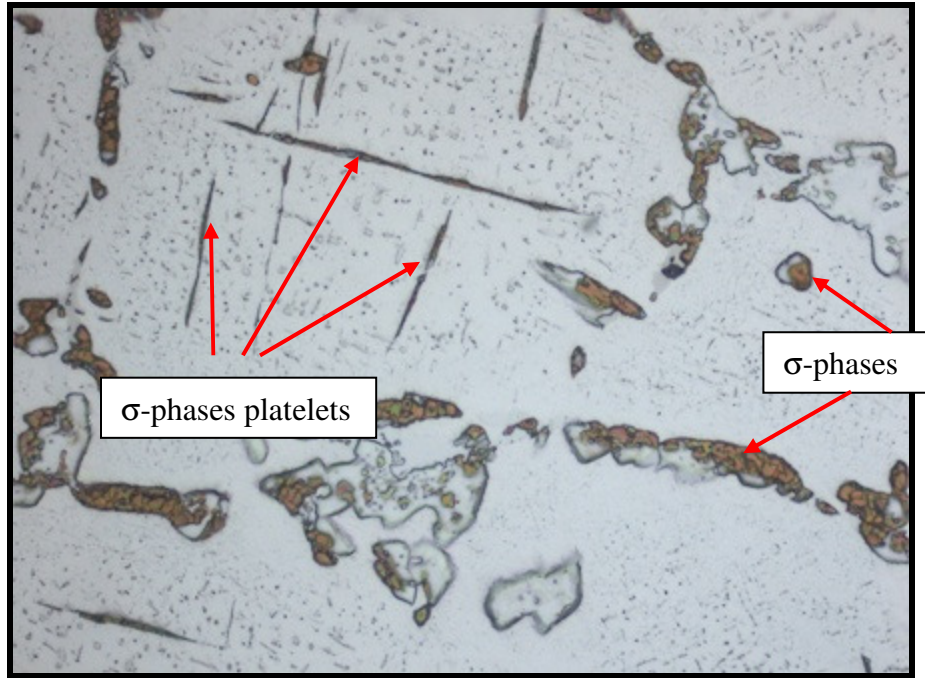
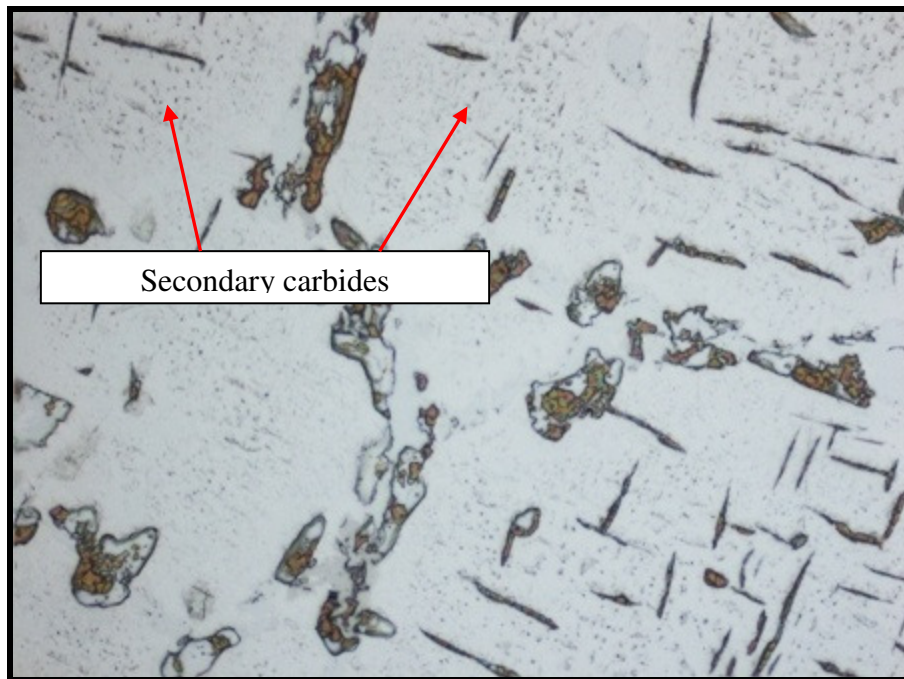
Figure 9. Optical micrographs of the samples in the as etched condition showing sigma phases and secondary carbides precipitates.

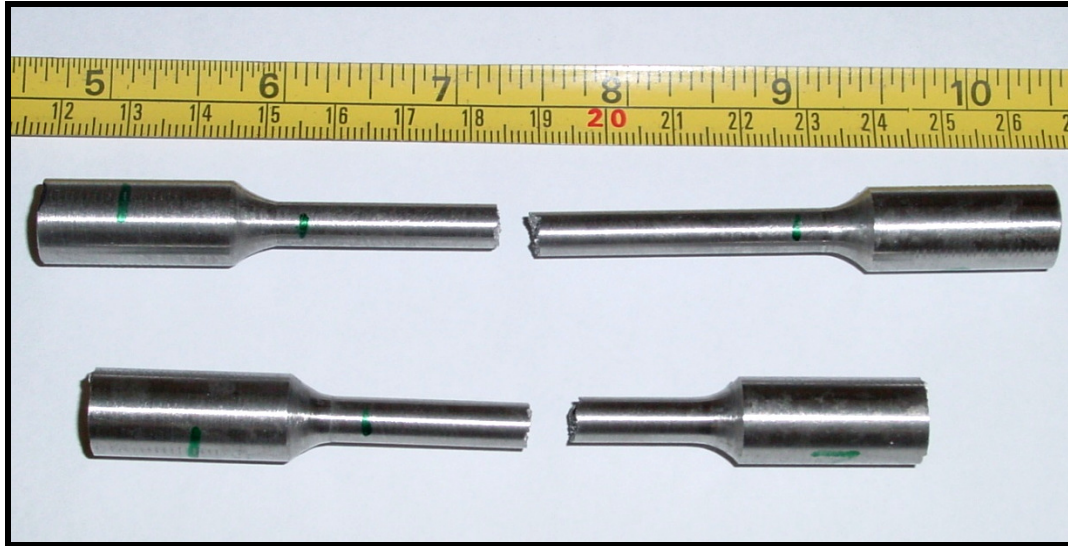
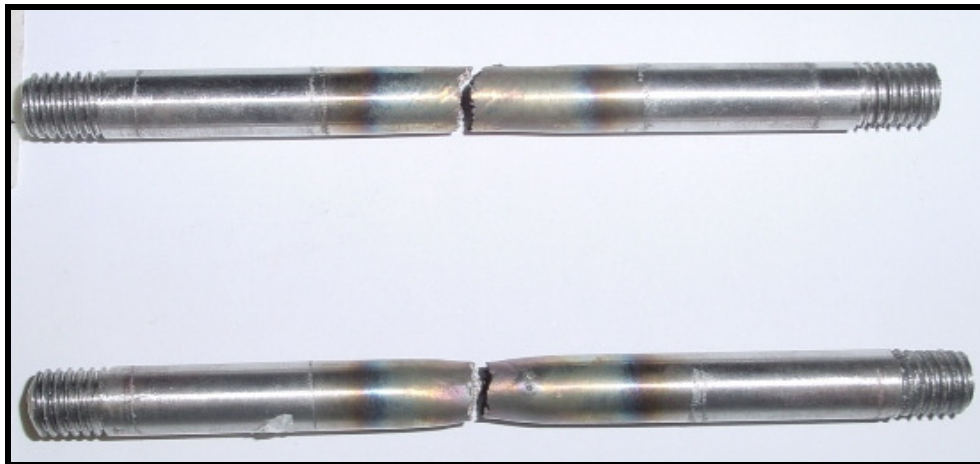
Results of the tensile samples are shown in Figures 10, 11, 12 and 13. There is clearly no defined yield point on most of the graphs, Figure 13. The room temperature samples broke while the tensile test curve was still going in the upward direction, with very little

elongation. The two 800°C samples, on the other hand, showed a little ductility, which is also reflected in their figures for reduction in area (%A).

Figure 10. Photo of the room temperature (RT-top) and at 800°C tensile samples after the test. The samples of the RT shows no plastic deformation, indicative of brittle fracture; while the slight necking is observed in the high.

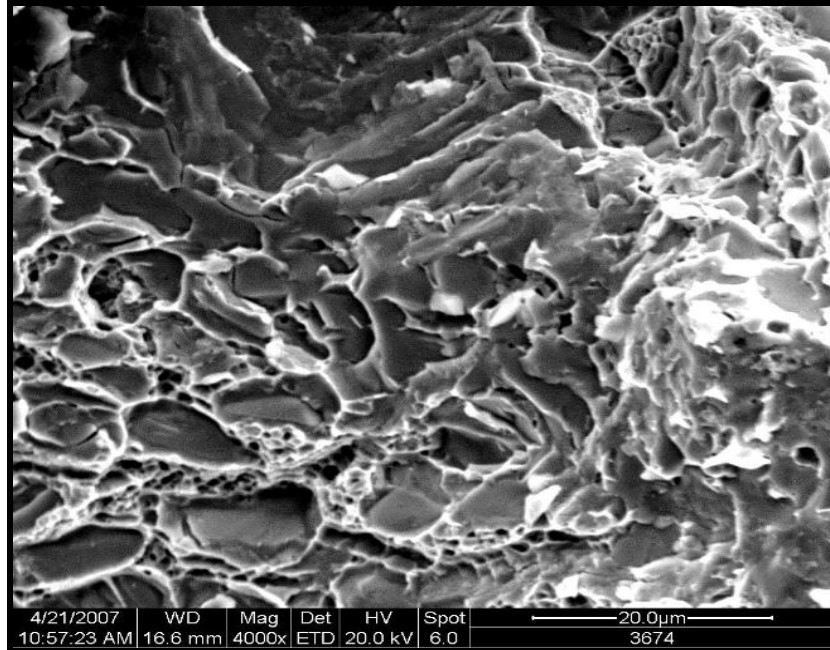
Figure 11. Fracture surface of the tensile sample after testing in RM showing cleavage morphology of brittle fracture.

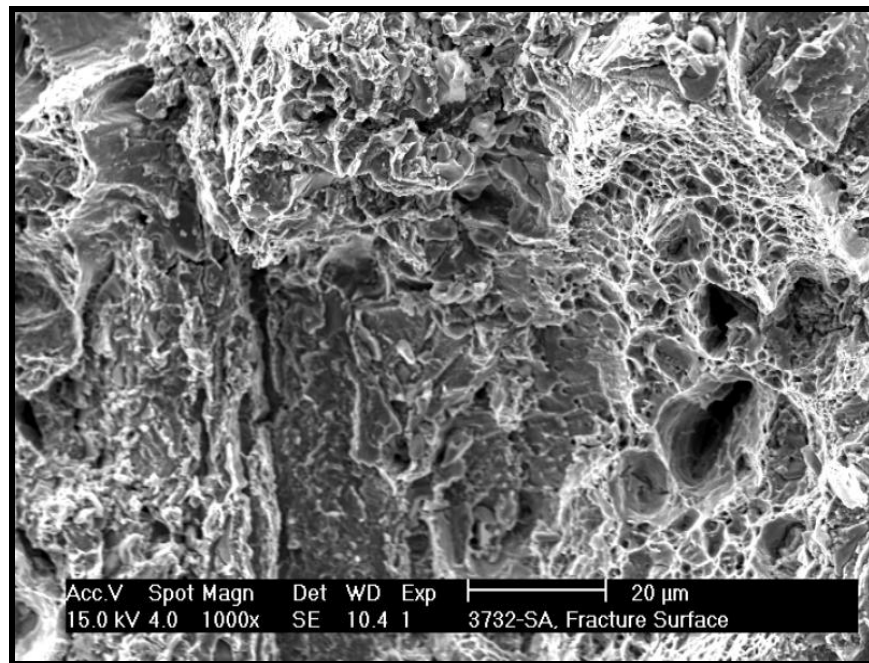
Figure 12. Fracture surface of the tensile sample after testing at 800°C showing mixed mode fracture-cleavage morphology of brittle fracture and dimples of ductile. Still the major part is brittle. The dimples explain the necking part on the sample.

The fact that the maximum strength values are about the same for both the room temperature as well as the 800°C samples is really the result of the brittleness of the material. The room temperature samples broke very soon after reaching the yield point, while still very much on the upward part of the curve. Had they been able to last until their “normal” ultimate tensile strength point, at the “normal” apex of the tensile test curve, the maximum strength for the room temperature samples would have been much higher. The maximum strength for the 800°C samples is probably about what the ultimate tensile strength of the material is at that temperature. Proof of the actual weakening of the material at the elevated temperature is seen in the much lower yield point strength at 800°C. All of the fracture surfaces showed brittle appearances; although, the samples in the 800°C test exhibited ductile fracture. Still, the major part of it was brittle.

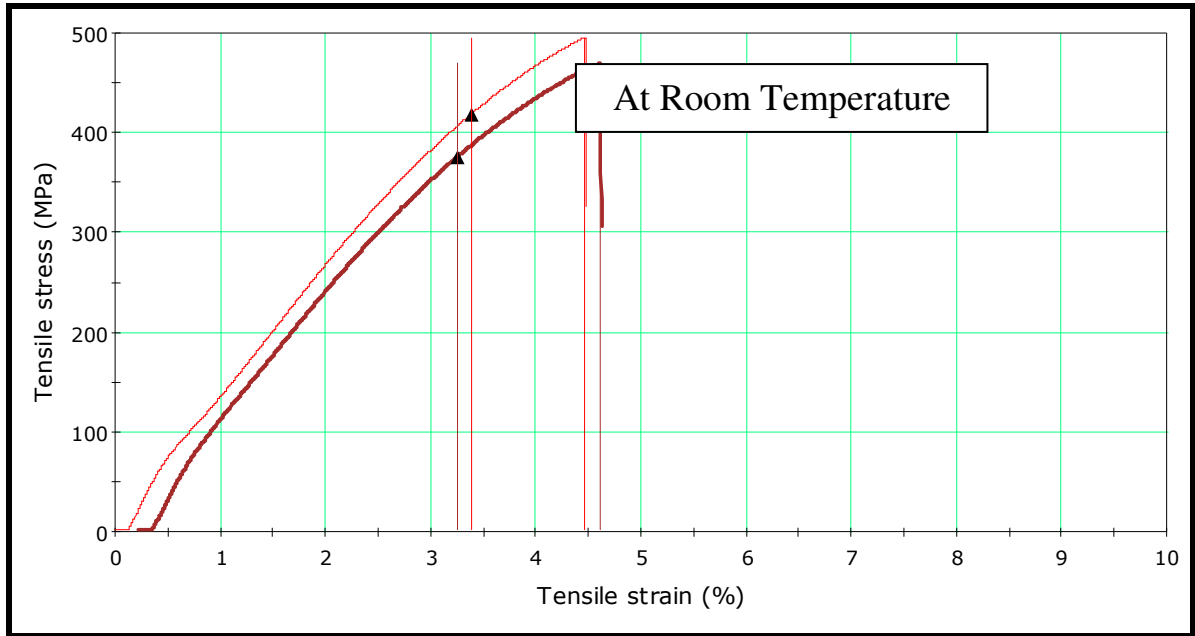
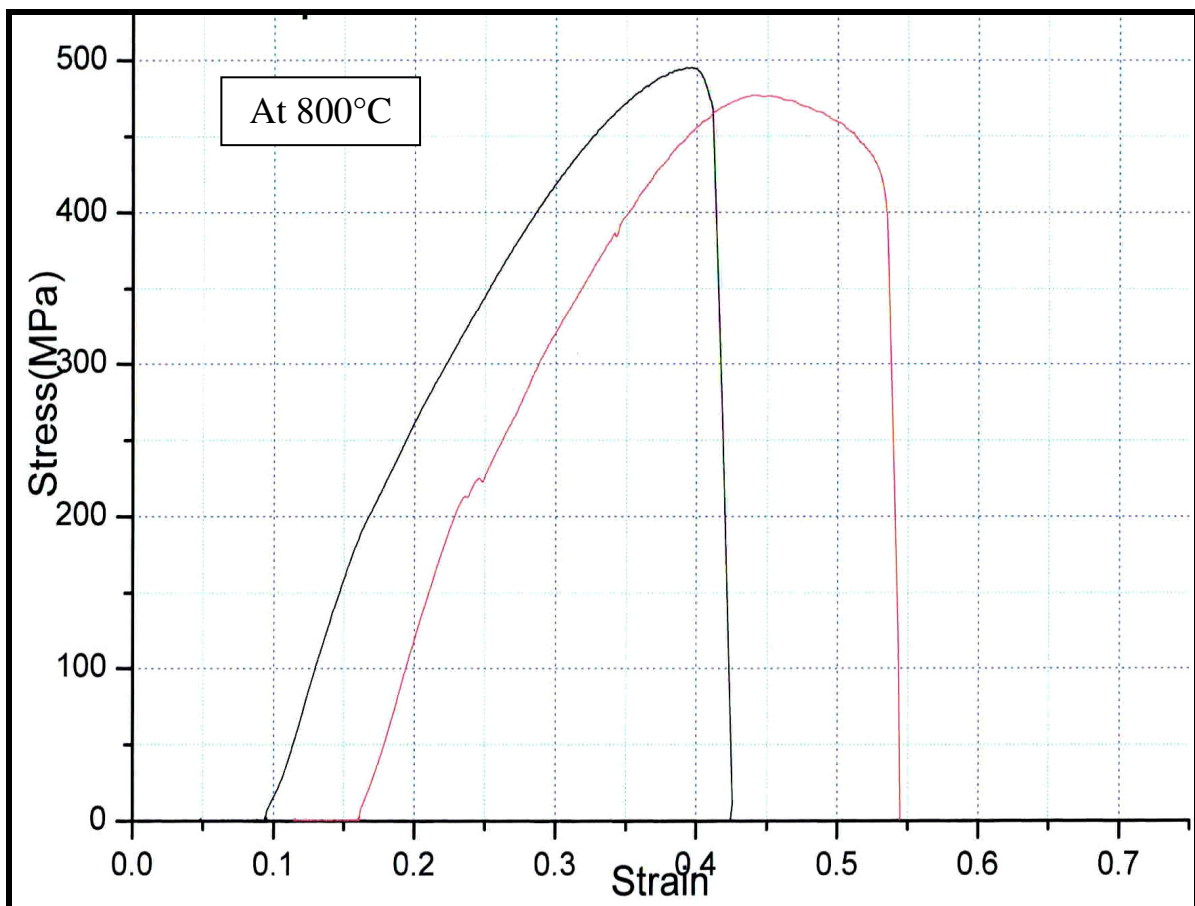
Figure 13. Tensile tests stress and strain graphs of the samples tested in room temperature (top) and at 800°C (bottom).
