Carbonate Coatings as Protective Barriers for Pipe Borne Water Transport Material

ABSTRACT

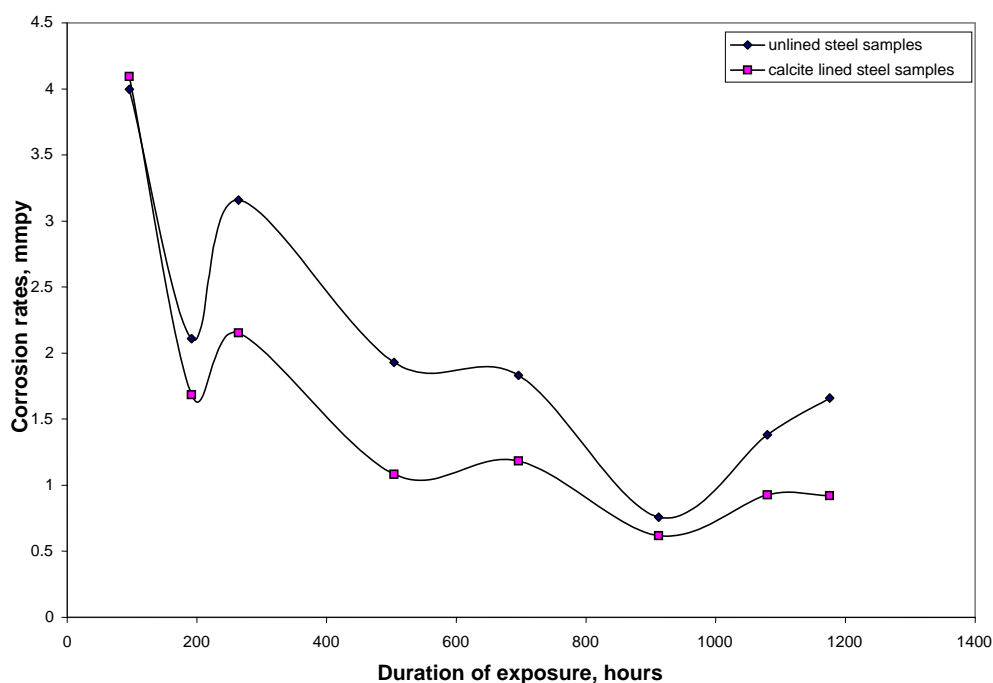
Fig.1: Graph showing the effect of calcite lining on the corrosion resistance of a plain carbon steel.

Figures 1-3 show the effects of the calcite, magnesium carbonate and dolomite linings respectively on the corrosion rates of the plain carbon steel. The unlined steel exhibited higher corrosion rates than the other ones. Comparing the three figures, it is clear that dolomite conferred the greatest corrosion resistance on the lined steel. This is corroborated by the relative corrosion rates of lined and unlined steel as contained in the composite representation of the overall results of the study.

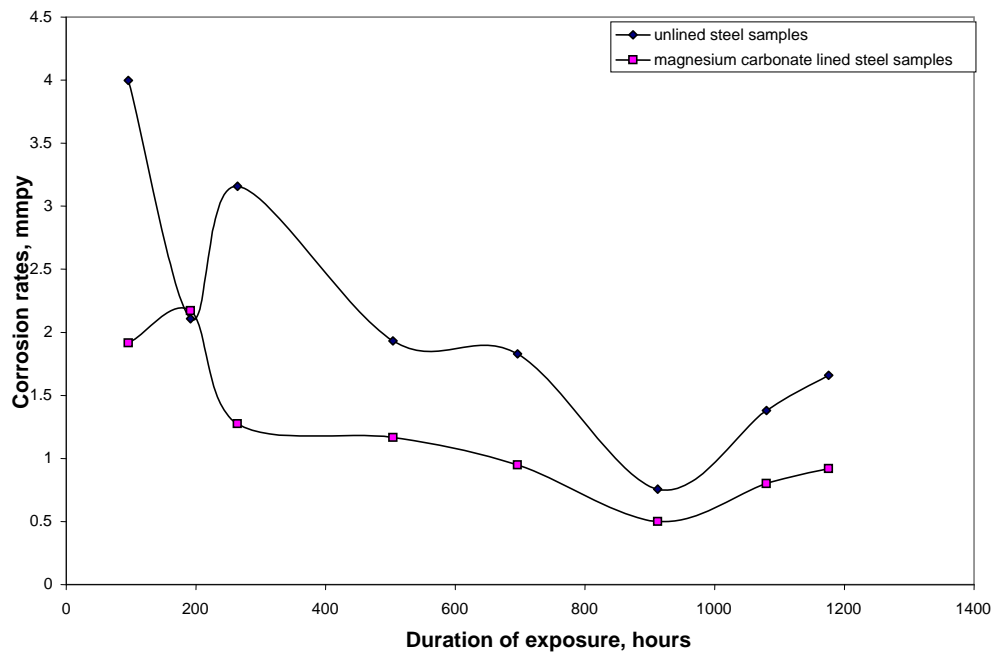
Fig.2 Graph showing the effect of magnesium carbonate lining on the corrosion resistance of a plain carbon steel.

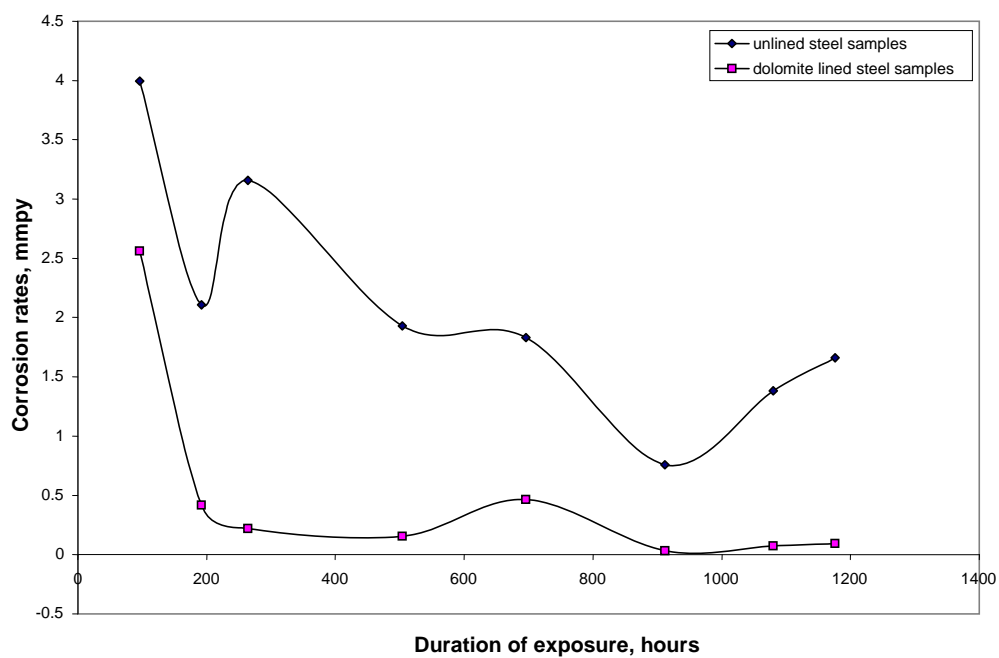
Fig.3 Graph showing the effect of dolomite lining on the corrosion resistance of a plain carbon steel.

Dolomite ($\text{MgCO}_3 \cdot \text{CaCO}_3$) offered the best corrosion protection (least corrosion rate) when compared to the other lining materials – calcite (CaCO_3) and MgCO_3 . Samples coated with dolomite initially had a sharp decrease in their corrosion rate from above 2.5 mm/yr to below 0.5 mm/yr within the first 192 hours of exposure time and the corrosion rate remained stable below this value for the remaining time of exposure. In the case of MgCO_3 , the corrosion rate remained on the high side of the 0.5 mm/yr mark all through the entire time of exposure. While for calcite lined samples, the corrosion rates fluctuated above 0.5 mm/yr for the first 911 hours; dropped below this mark at the 912th hours and returned above the mark after this time. The unlined samples (control) shows the highest degree of corrosion rate which stood at about 0.8 mm/yr. The composite results of the samples were as presented in Fig. 4. This figure gives the clear representation of the performance of the coatings as barrier for corrosion protection.

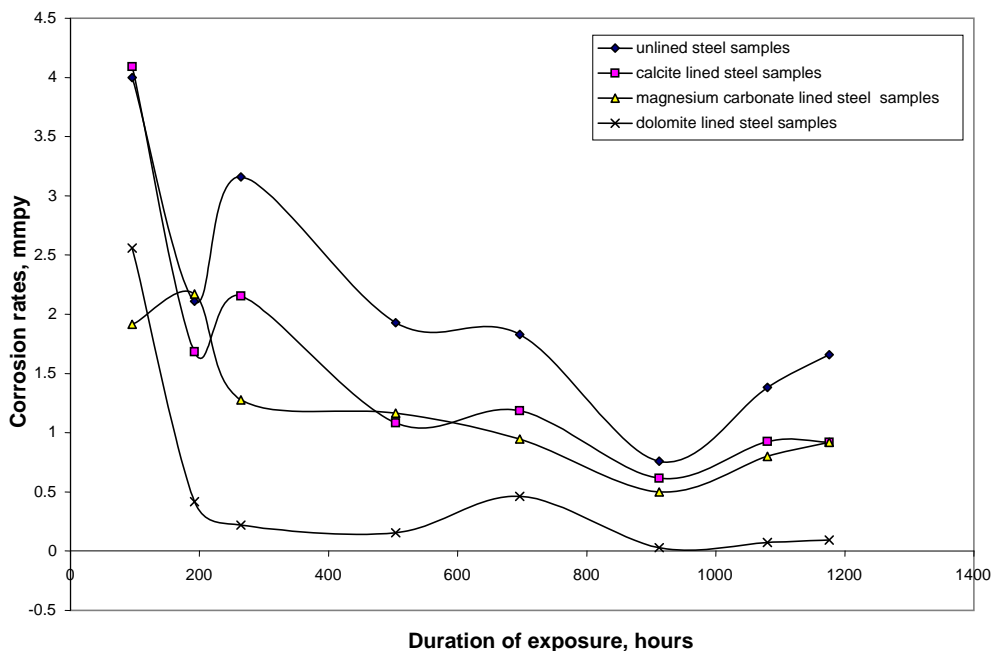
Fig.4 Graph showing the effect of different linings on the corrosion resistance of a plain carbon steel.

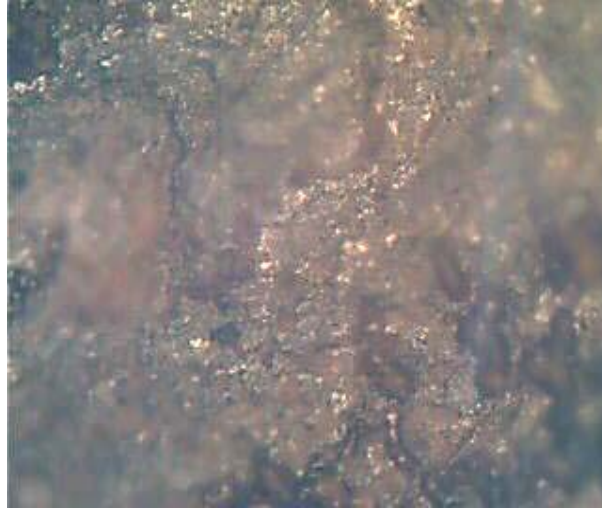
Plate1: Micrograph of unlined sample after 21 days of exposure. 100X

The micrographs will be evaluated based on the presence of the severity of the dark spots (cavities) and the presence of corrosion product and these determines the level of corrosion degradation encounter by the mild steel. Plate 1 shows the micrograph of unlined samples exposed after 21 days, it is characterized with severe localized corrosion attacks and the attacks are widespread. This implies that the samples suffer serious localized attack and coupled with the fact that there is no or little corrosion product on them. Corrosion products on the surface of a material are known to reduce the rate at which an environment can attack the material.

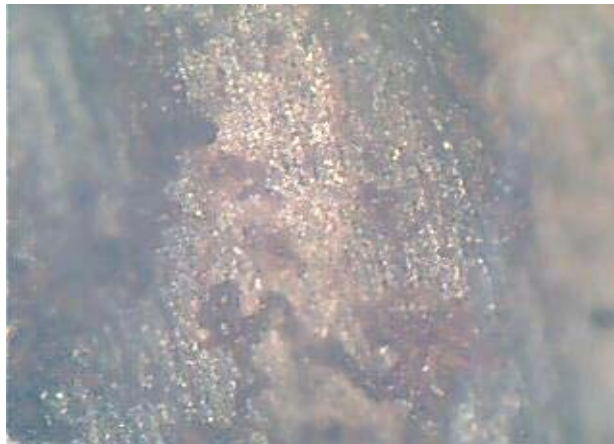
Plate 2: Micrograph of calcite lined sample after 21 days of exposure. 100X

Plate 2 shows the micrograph of calcite lined sample exposed after 21 days. The corrosion attack were severe and highly localized while the corrosion product is scanty. The attack occurred along the grain boundaries with characteristic of deep pit which may be as a result of high energy associated with the region or it may be attributed to dissimilar corrosion. The microstructure of dolomite lined samples exposed after 21 days is as shown in Plate 3 and it revealed almost uniform corrosion product and localized attack. The corrosion product is also widespread but the attack is not served and the size of the pit is small. Plate 4 illustrates the corroded surfaces of MgCO_3 lined sample after 21 days exposure in the pipe borne water. The cavities as found on the surface are smaller in size but are more widespread.

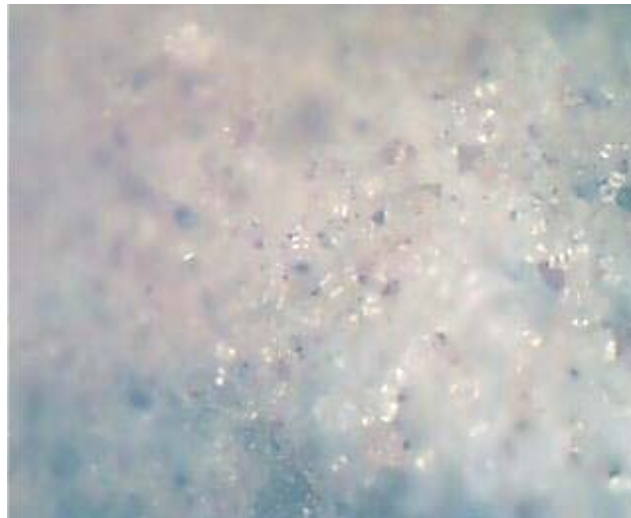
Plate 3: Micrograph of dolomite lined sample after 21 days of exposure. 100X

Micrographically, it was observed that samples lined with CaCO₃ and MgCO₃ resulted in the formation of an oxide film on the metal. A double film was formed with dolomite lining. The thicker lining as expected provided better corrosion protection by providing for a greater probability of pore blockage by the corrosion products. Bulk density of the lining which represents the degree of porosity of the lining has a profound effect on the corrosion current. It was seen that increase of bulk lining density reduced the corrosion rate [4].

It has been established that uniform corrosion is preferred to localize attack due to the fact that they are less insidious [9]. This probably accounted for the low corrosion rate observed for samples lined with dolomite because they exhibit uniform corrosion unlike unlined samples which is characterized by localized attack and as such they do have low corrosion resistance. While the corrosion rate for calcite is more than that of MgCO₃ because it suffers more localized attack. Generally the severities of the localized attacks were observed to follow this trend; unlined sample, calcite, MgCO₃, and dolomite. Similarly the corrosion products are seen to be increasing in the same order and with spread is uniform. Corrosion protection of calcite lining

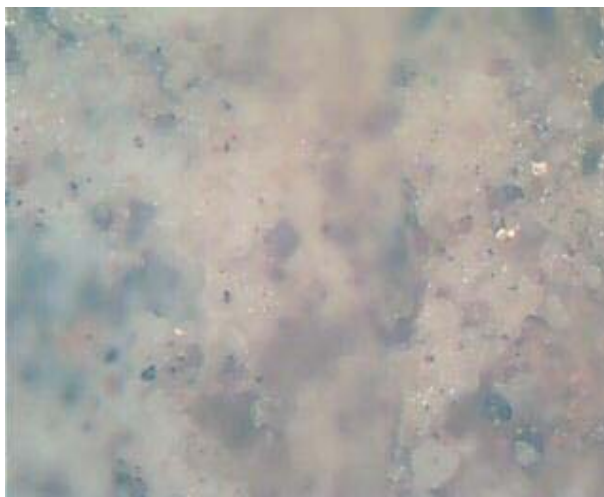
Plate 4: Micrograph of MgCO₃ lined sample after 21 days of exposure. 100X
