Erosion and sediment budget of the 2008 Wenchuan earthquake: A case study on Mianyuan River basin

ABSTRACT

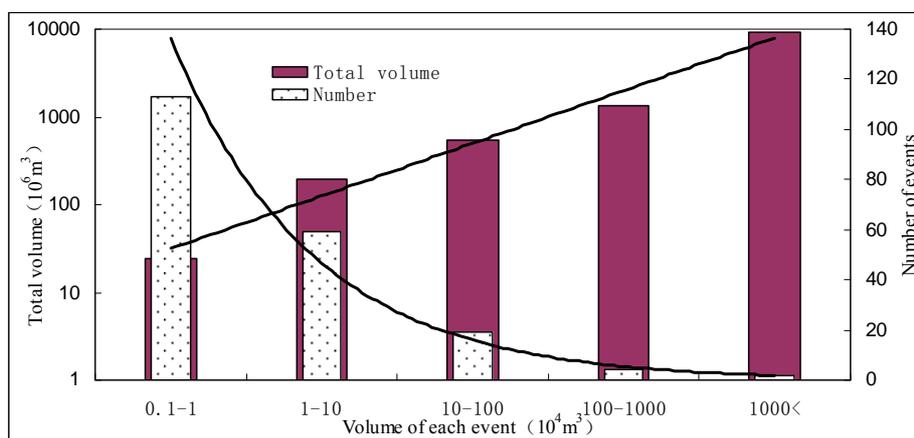
Figure 2. Distribution of the main collapse in Mianyuan River.

The sediment volumes above 1000 m^3 are measured and surveyed in this study area. **Figure 2** shows that although there are only 2 accumulation body which is above $10 \times 10^6 \text{ m}^3$ in Wenjiagou and Donghe, the whole volume is more than $90 \times 10^6 \text{ m}^3$. The number of the volume about $1 \sim 10 \times 10^6 \text{ m}^3$ is 19, the total volume is more than $13 \times 10^6 \text{ m}^3$. The number of the sediment body at the range of 1000 to $10,000 \text{ m}^3$ is 113, but the total volume is only $0.23 \times 10^6 \text{ m}^3$. The relationship between the range and number of sediment body is exponential distribution. According to **Figure 1** and **Table 1**, the collapse landslides in the upstream of Famuchang are distributed intensive, especially the small landslides below 1000 m^3 ; but the landslides of downstream in Famuchang are distributed sparsely but the single volume is generally larger than that in the upstream.

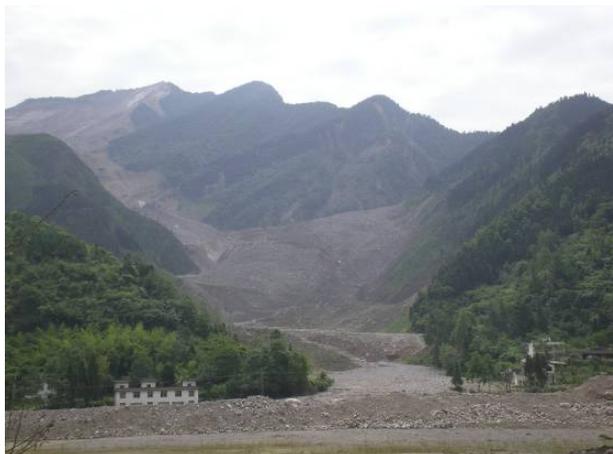
Figure 3. Wenjiagou landslide.

There are 196 landslides and debris sediment above 1000 m^3 in Mianyuanhe and the whole volume are $114.6 \times 10^6 \text{ m}^3$ (**Figures 3** and **4**). The collapse accumulations less than 1000 m^3 are not considered in this survey. Actually the sediment yield by earthquake is a little more than the statistical results, but the rate is extremely small compared with the total amount of erosion.

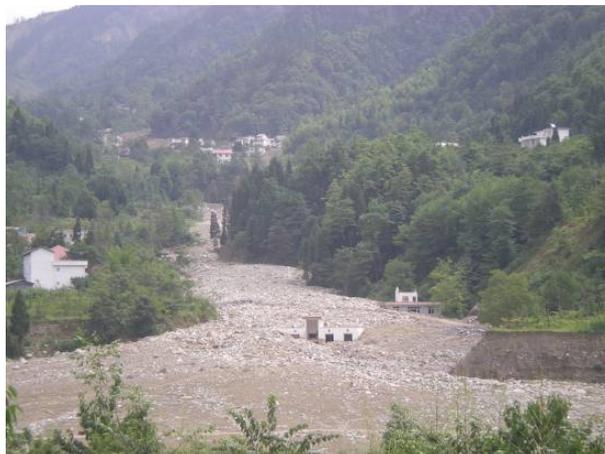
Figure 5. Debris flow in Zoumaling.

some debris flow entering the river. The volume of debris flow into Mianyuanhe is about $5.31 \times 10^6 \text{ m}^3$ in 2008 - 2010. The main source of debris flow is from Wenjiagou, Yongjiagou, Heidongyan, Zoumaling, which is shown in **Figure 5**. The debris flow in Wenjiagou has been improved and that in Zoumaling is under programming. The sediment in the main stream of Mianyuanhe will increase in the next 5 - 10 years while the increase rate will be decreased conspicuously. In addition, the slope sediments are piled on both sides of the river, so the debris flow will go into the river on a small scale.

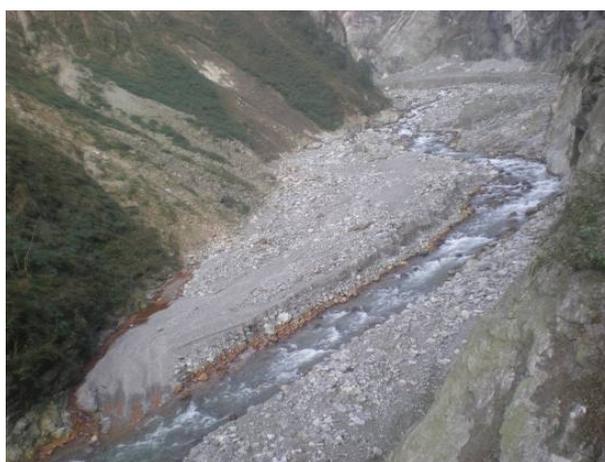
Figure 6. The fierce scouring and silting changes in Zhayaoku.

The movement of bed load is violent in the flood season and there is conspicuous change in some rivers, presented in **Figure 6**. The node of the range of motion of the bed load is barrier lake, which moves between two lakes and silted at the end of the lake. As the channel of the upstream is shallow and deep, the silting between the collapse and bed load make the riverbed raised obviously. The riverbed adjacent to Famuchang has risen about more than 10 m. There is close relation between the river silting degree, both barrier lakes and the size of the col-

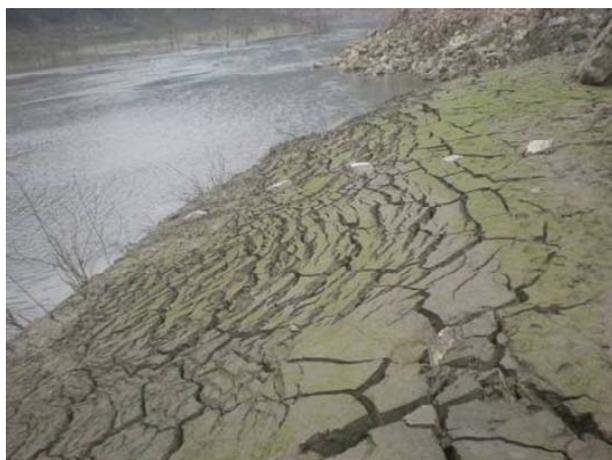
Figure 7. Silt measurement in the Xiaogangjian Barrier lake.

slow speed. The silting depth in the downstream of the beaded barrier lakes are thickest, such as the depths of three beaded lakes in downstream of Changheba are 1.5, 4.0, 10.0 cm. The silting depths are more than 30 cm in Xiaogangjian (Figure 7), Yujunmen, and Heidongyan, which is caused by the slow flow speed and weak sediment-carrying capacity, especially the suspended load can be up to thousands of cubic meter. Since the lithol-
