Possible Signs of Life on the Planet Venus

Leonid V. Ksanfomality

Space Research Institute of the RAS, Moscow, Russia
Email: ksanf@rssi.ru

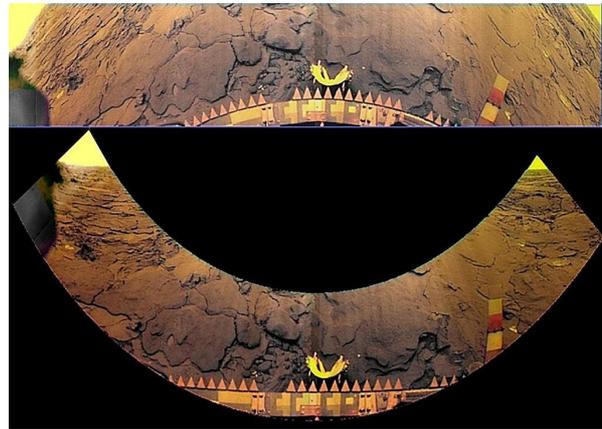
Figure 2. Above same as **Figure 1** after 2012 processing. Below—the VENERA-14 landing site, as it would have seen by a human eye (the geometric distortions eliminated). The white arc at the center is the detached lid of the scanner window.

Of importance is a sophisticated image processing, as seen in **Figure 2**. After it the details not noticed before are getting visible. As a byproduct **Figure 3** shows the crater, probably of a volcanic origin, for the first time photographed directly on the surface by the VENERA-13 camera. It has a diameter of about 1400 m and it seems that it is surrounded by the old traces of broad lava

As noted above, due to tilt, the camera image distortions occur (see **Figure 2**). But near the “scorpion” camera’s distortions are small and no corrections required. There is another possible cause of distortion—the movement of an object during scanning. The panorama’s V-13-1-6 BW shooting was spent 780 s, and the part of the image with a “scorpion” took 32 s. The displacement of the object’ image could have caused, for example, an apparent elongation or reduction of the image.

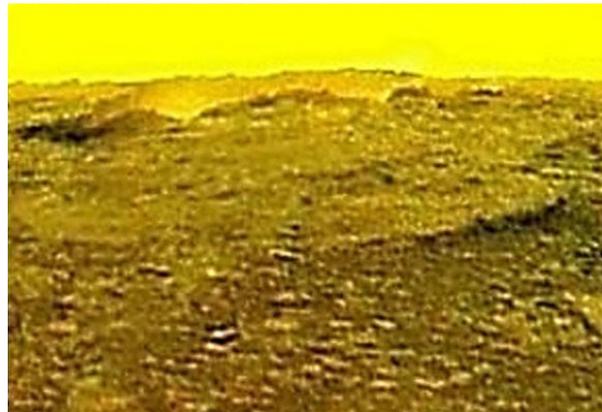
Figure 3. An old distant crater with a diameter of about 1 km, is probably of volcanic origin. The yellow color is inherent to the sky of Venus.

flows. One can even assume that the crater is filled with a fog, a stuff of unknown nature. Similar volcanic craters are observed only by radar facilities orbiting Venus.

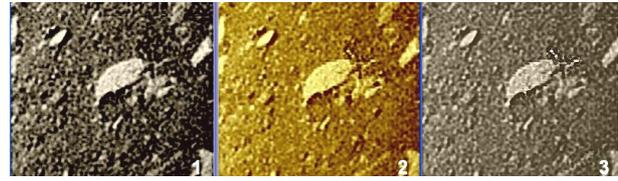
Figure 5. Three versions of the combined processing of six images on panoramas of the V-13-1-1 and V-13-1-2 series. An unknown complicated light structure (probably not connected to the object) is located before the hesperos.

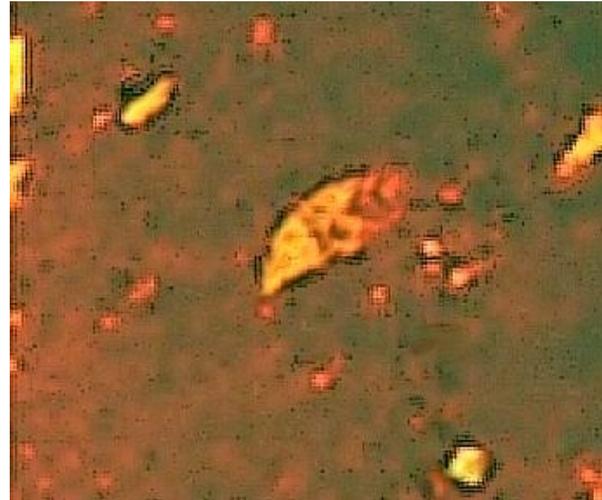
Figure 6. Processing with the preferable use of red color-divided images. The structure and the regularity of lines and spots hardly intrinsic to stones are seen.

The more detailed **Figure 6** presents a complicated

structure of the hesperos. The image is slightly dispersed; however, fine details are distinguishable. Here, a transverse band is clearly seen that separates the left-hand yellowish part of the hesperos from the darker right-hand one, having a dark head-shaped segment. The structure of this object is marked by regularity of its lines and spots, which is not a case for stones. In **Figure 6**, the irregularities of the ground are smoothed.

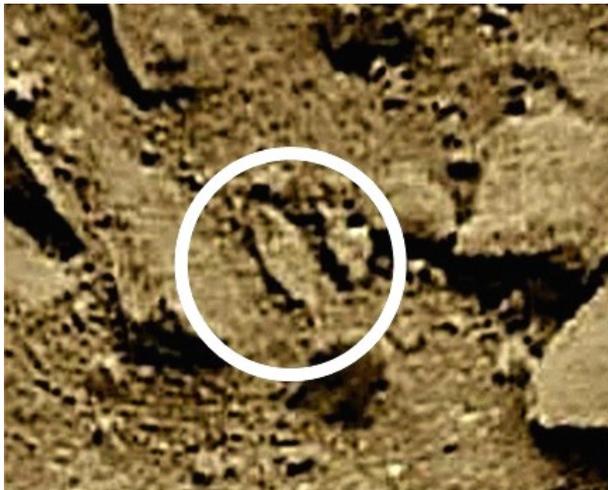
Figure 7. Fragment of new processing of panoramas of VENERA-9. In the circle, there is an object of the hesperos type, which is located close to the camera. The object length is 25 cm; the distance of the landing site to the hesperos shown in **Figure 1** is 4400 km. To be compared with **Figures 5** and **6**.

similar hesperos is presented in the panoramas of VENERA-9. This lander reached Venus surface by seven years earlier in the southern foothills of the Theia mountain region, at a distance of 4400 km to the north from the future VENERA-13 landing site. In [20] two large objects, found on the first 174°-panorama of VENERA-9 were considered. In the same mission, the second (incomplete) panorama enveloped an angle of 120°. The quality of the second panorama is significantly worse than that of the first one. The hesperos is most clearly seen on the fragment obtained as a result of the combined processing of the both VENERA-9 panoramas (**Figure 7**).

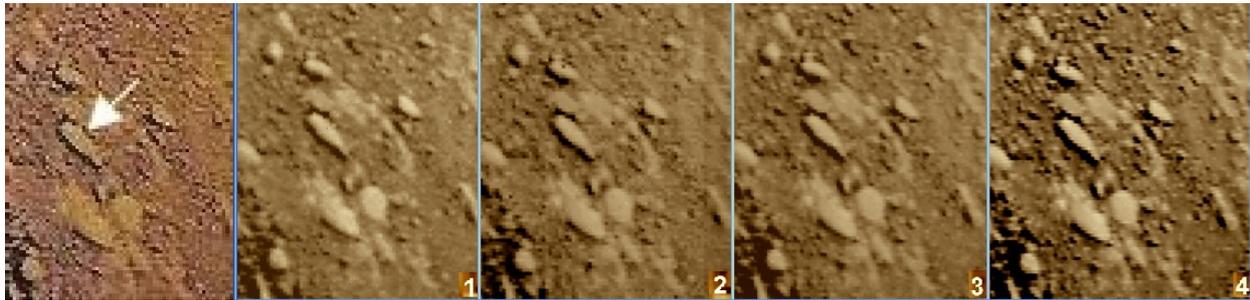
Figure 8. Hesperos on the side of camera 2: a fragment of the first color panorama (arrow) [14] and results of processing of 13 fragments of panoramas of VENERA-13, which were obtained in time intervals from 13 to 49 min. The hesperos is 12 - 13 cm in size; 1, 2, and 3 are the results of processing of 3 to 4 different original fragments, 4 is the result of the combined processing of the whole sequence.

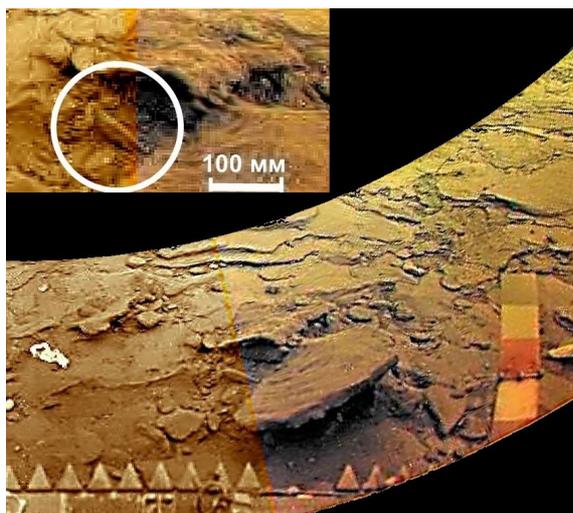
Figure 9. An object on the side of camera 2 of the VENERA-14 panorama is marked by white circle. To be compared with Figure 8. The size of the hesperos is about 10 cm. The distance to it is 1.3 m. Its head-shaped part (on the left) is connected by a certain manner to the adjoining detail, like a semi-ring.

An object was found in the panorama of camera 2 of the VENERA-14 lander (**Figure 9**). It is seen clearly and is located sufficiently close (only 1.3 m) to the optical input window of the camera and is seen at an angle of 61° to the horizon. Its size is 10 cm. The object is in a protected place resembling an alcove or a broad hole. Comparison with **Figures 7** and **8** indicate the unquestionable similarity and identical size of these forms. However, comparison with **Figures 4** and **5** show the difference in the colors and shades of the objects, and the object's

body being more bulky. The left-hand head-shaped part of the object seems has a complicated structure. This part is surrounded by a regular detail, like a semi-ring whose plane is inclined to the left. The nature of the semi-ring, of course, is unknown. But one may recall that on the frames with the “scorpion”, a similar semi-ring closely adjoining the object is clearly seen [21].

The objects found on the panorama of VENERA-14 are not exhausted by similar features exhibited in **Figure 9**.

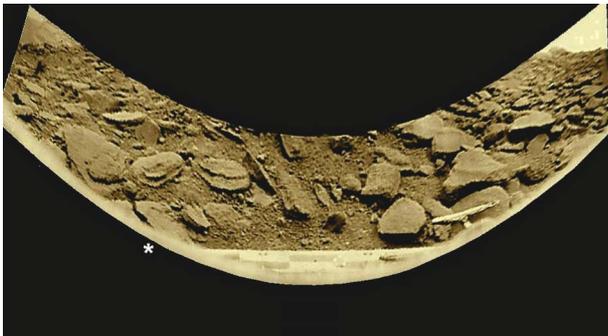
Figure 10. The panorama transmitted by the VENERA-9 lander on October 22, 1975 from the planet surface. The new processing of the same initial image was applied. When processing the telemetry insets were replaced, where possible, by fragments taken from another panorama.

In the far right of **Figure 10**, in the foreground, there is an object of a complex structure, which immediately attracted the attention of researchers. In papers [16,23] the object is called a “strange stone with a rod part protruding and a lumpy surface”. Presenting a somewhat blurred image of the fragment, their authors wrote ([16], p. 113): The shape of the “strange” stone which is located to the right of the gamma densitometer is difficult to determine. It is seen in a strong perspective. A distinctive feature of this stone is the overall roundness of the convex side facing the camera, which is combined with the surface color darker than that of the plate-rocks, of a spotted (probably pit-and-mount) nature. The transverse dimensions of the spots (mounts?) are 3 - 5 cm. At the top of the stone there are two clear round protrusions, with a diameter of about 5 cm and a height of about 3 cm. To the left of the stone described there is a bright elongated direct protrusion, which is identified as protruding from the stone rod-like feature of a lighter material and about 15 cm in length and about 5 cm thick at its base. On the right the dark spotted surface is joined by a crooked

alignment to a lighter surface, its character is not clear because of its proximity to the edge of the panorama. In general, this mottled stone makes an impression of a weak non-homogeneous formation (at least at the surface) consisting of lightly cemented breccias”. The authors presented two images of the “strange stone”, corresponding to the direct and reverse camera scans. That part of the panorama with the “strange stone” was used for the cover of the “First panoramas of the surface of Venus” edition [8]. My attention was attracted by the “strange stone” immediately, on October 22, 1975, when the VENERA-9 panorama was obtained. Unfortunately, later all my attempts to interest my colleagues in the strange object were in vain. The notion of impossibility of life in high temperature conditions for colleagues at the Space Research Institute of the Academy of Sciences of the USSR and the administration of the Institute was an insuperable barrier to any discussion. Yet, when a year before the publication of the work cited above [23], my book “Planets discovered anew” [17] was published, it did give the image of the “object of an unusual shape”. The following comment to the picture was given: “The object details are symmetrical relative to its longitudinal axis. Lack of clarity hides its contours, but... with some imagination you can see a fantastic inhabitant of Venus”. Accordingly, the text on pages 50 - 51 read: “... Did VENERA-9 land near a living inhabitant of the planet? ... We most likely see a stone of an unusual shape, like a volcanic bomb... With a tail”. Only the sarcasm of the final phrase showed that the opponents had not quite convinced the author in the physical impossibility of life on Venus. However, in the monograph “The planet Venus” [7] the hypothesis of life on Venus was not mentioned, since the issue of energy sources essential for life in the oxygenless atmosphere was (and still is) unclear. Below the “strange stone” is conventionally referred to as the “owl”.

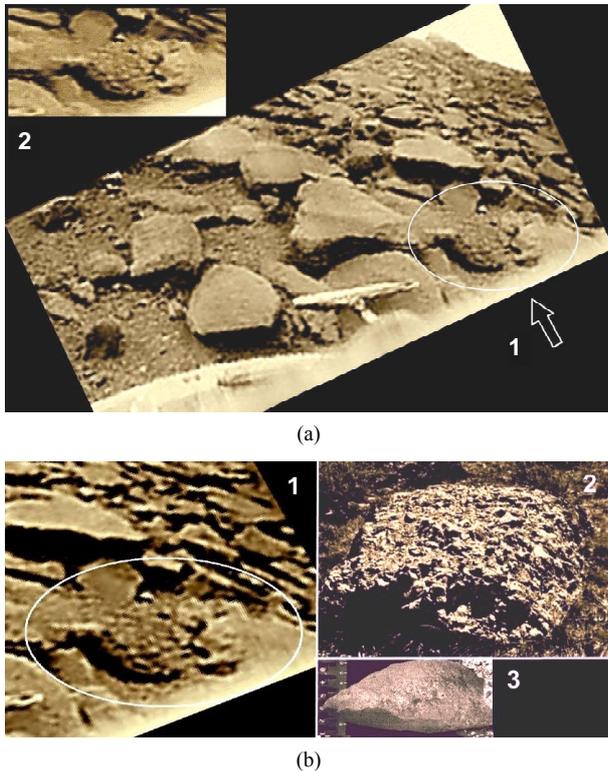
Figure 11. (a) Complex symmetrical shape and other characteristics of the “owl” object (arrow 1) distinguish it against the planet’s rocky surface at the VENERA-9 landing site. The object is about half a meter in size. The “owl” object can be a real inhabitant of Venus. Its regularly organized morphology with a pronounced longitudinal symmetry seems to make this assumption quite plausible. Above (2)—the geometric distortion of the image is corrected. (b) (1)—Repeated image from Figure 11(a) the size of “owl” is about a half meter. (2)—A piece of volcanic breccia of 1-meter in size which, according to [24], “is similar to the owl body”. (3)—A piece of lunar basalt that according to [24] “is resembling the owl’s tail”.

In 2003-2006 the image processing was improved and the quality of the image with the “strange stone” was noticeably improved too [20]. Detailing of the panorama gets better, but still insufficient for definitive conclusions. Only in 2012 a final processing was developed. The processed fragment of the right side of **Figure 10** is presented in **Figure 11(a)**, where the “owl” object is marked with a white oval and arrow 1. It is seen from above, at an angle of about 55° to the horizon. The “owl” object is distinguished by its strange longitudinal symmetry, and its appearance can hardly be interpreted as a “strange stone” or “volcanic bomb with a tail”. The position of the “spotty surface” details reveals a certain radially extending from the right side, from the “head”. The tail continues strictly the longitudinal symmetry of the “owl”. The “head” itself is of a lighter hue and has a complex symmetrical structure with large shapely dark spots, also

symmetrical, and perhaps with some bulge at the top, as mentioned in [23]. In general, the structure of the massive “head” part is rather difficult to understand. It is possible that some small stones, accidentally coinciding in light hues, are arranged so that they seem to be features of the “head”.

One may conclude that **Figures 11(b)-2** and **11(b)-1** have few in common. The object in **Figure 11(b)-3** looks more like a shark. It is possible that much more similar in their shapes stones could be found. However, most important is the fact that the limited original material contained in panoramas neither permit consolidating categorically that the object belongs for sure to the Venusian fauna, nor that it is a stone. Yes, regularity in the “owl”

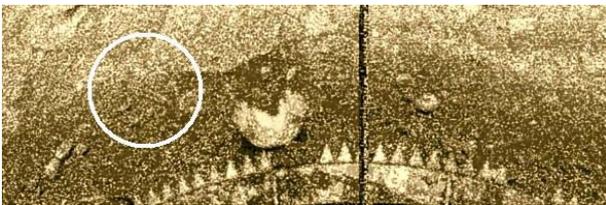
Figure 12. The V-13-1-6 BW panorama was scanned during the period 87 to 100th minute after landing. A noise as numerous white dots appeared probably due to the growing temperature of the lander’s electronics. The object “scorpion” is marked by the white circle.

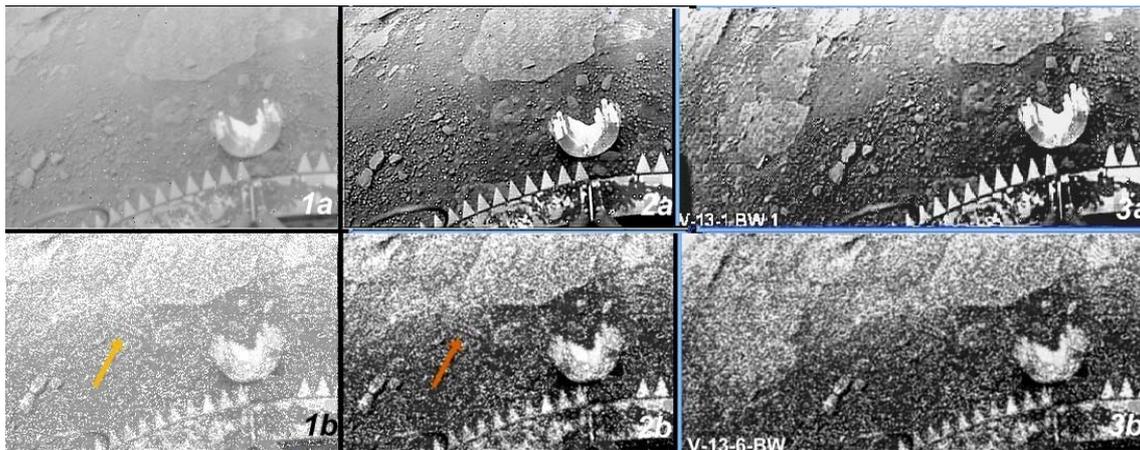
Figure 13. (a) The object “scorpion” appeared in the image V-13-1-6 BW at about the 90th minute after landing. (b) (1)—A pair of fragments presented in the article [25] as one and the same picture; (2)—The same images after processing by the author’ system; (3)—Identification of the images as panoramas fragments V-13-1-1 BW (top) and V-13-1-6 BW (bottom) obtained during the time intervals 0 - 13 min and 87 - 100 min, respectively.

“scorpion” could be connected with the soil destruction and its throwing aside when landing, rather than with direct influence of the wind. The work [30] provides the information that the wind speed in this period was low (0.4 m/s) and decreasing only. In Figure 12 the object is placed to the left of the center. It has a more or less regular structure (Figure 13(a)). The length of the object is about 17 cm.

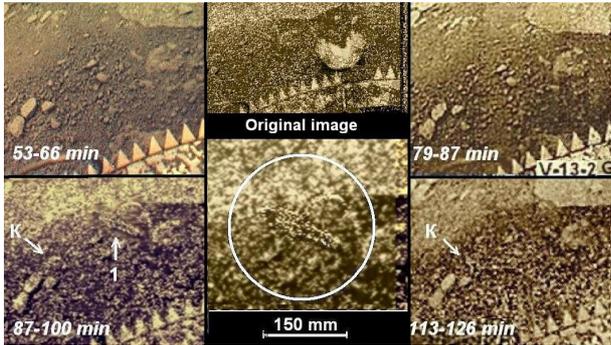
Figure 15. The object “scorpion” (1) appeared in the panorama that was being snapped from the 87th to 100th min. On the images obtained before the 87th min and after the 113th min the object is absent. In the images of the 87th - 100th and 113th - 126th min, at the left, in the group of stones, a new pattern K appeared which is changing its position. It is absent in the images of the 53th - 66th and 79th - 87th min. In the central part of the figure both original image and the result of the image processing are shown. The size of the “scorpion” is about 17 cm.

returned to it, the image resolution at a large distance deteriorated. At a distance of 3 - 4 m the object became indistinguishable from stones. The object would have to move off at such a distance in 26 minutes—at that time the scanner returned once again to the same area on the panorama. For such displacement a minimal speed of the “scorpion” should be 2 mm/s.

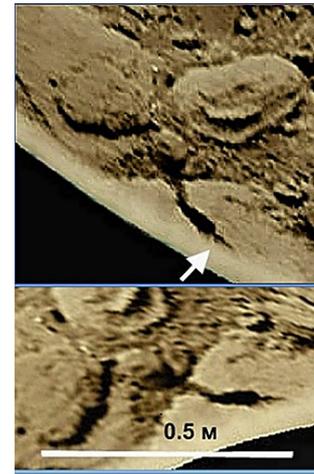
Figure 17. The dark trace stretches from the point of the landing buffer marked by an arrow. It is supposed that the trace was left by a wounded object. The trace is formed by some liquid substance of unknown nature (there can be no liquid water on Venus). The object having about 18 cm in size managed to travel a 26 - 30 cm distance during no more than 6 min. In the bottom, there is a fragment of a photoplan that enables to measure scene details at equal scale and compare their location.

A trace of a possible movement of an object in VENERA-9 panorama is shown in **Figure 17**. A dark continuous trace stretches from the torus of VENERA-9 landing buffer (point marked by an asterisk in **Figure 10**

and by an arrow in **Figure 17**) to the left over the surface of a stone. A black trace continues coming off the stone, broadens and ends near a round light-colored object with a pointed black left part which may be similar to several other objects of the Venus’s fauna. It is nicknamed “colobok”. The trace after the “colobok” is very dark. There are no similar traces on the panoramas made by any VENERA probes. And judging by the trace’s density it is formed by some liquid substance of unknown nature which cannot be water. 647 K and 22 MPa are critical data for water. The temperature 735K and pressure 9.2 MPa at the surface are beyond critic point that is 578 K for Venus. Thus, there could not be any liquid water there. This substance should be represented by some unknown high temperature water solution, or some other unknown substance. However, how did the trace appear?

The second part of the critical paper [24] concerns the trail as “just a gaping crack in the stone with a flat surface, within which this dark band is observed”. But, as seen in **Figure 17**, the track goes down from the rock, continues and expands on the ground.

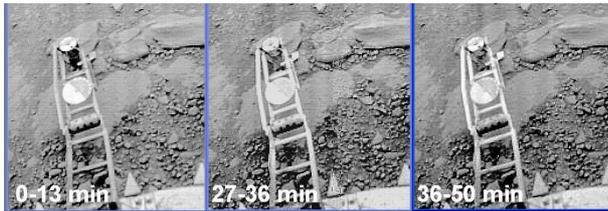
Figure 21. The unknown object “the black rag” originated within the first 13 minutes after landing around the conical measuring hammer which had partly penetrated into the soil. The details of the mechanism can be seen through the black object which indicates its semi-transparency. Subsequent images (obtained in the period from 27 to 50 minutes after landing) show a clean surface of the conical hammer, the object “the black rag” disappeared.

of the VENERA-13 camera 2, there was an instrument for measuring mechanical properties of the soil [34].

The length of the arm was 600 mm. Since the overall objectives of the mission included the analysis of minor constituents of the atmosphere and soil, the presence of any organic charring material on the instrument and on the outer parts of the lander was excluded, same as detach of any films from the lander. During laboratory tests these conditions received much attention. After landing, the scanning cameras’ lids (the large white semi-cylindrical detail on the image **Figure 20**) were thrown off by means of pyro cartridges. At the same time several other instruments were opening up. In the first image of **Figure 21** (obtained in the period of 0 - 13 minutes after landing) one can see that a vertically elongated black object of unknown origin, “a black rag”, measuring about 60 - 80 mm in height, emerged, wrapping along its full height the measuring cone (for soil mechanical properties measurements). On the two subsequent images taken in 27 and 36 minutes respectively, the object disappeared without a trace. From a comparison with other entities discussed elsewhere, one possible explanation may be that the appearance of the black object has something to do with destruction of soil crust by the measuring cone and some gaseous media appearing from there, condensing on the surface of still relatively cold measuring cone. When getting hotter the condensed media evaporated from the cone. There is no explanation, why it condensed on the cone only. The object cannot be a defect of the panorama: **Figure 21** shows that the details of the

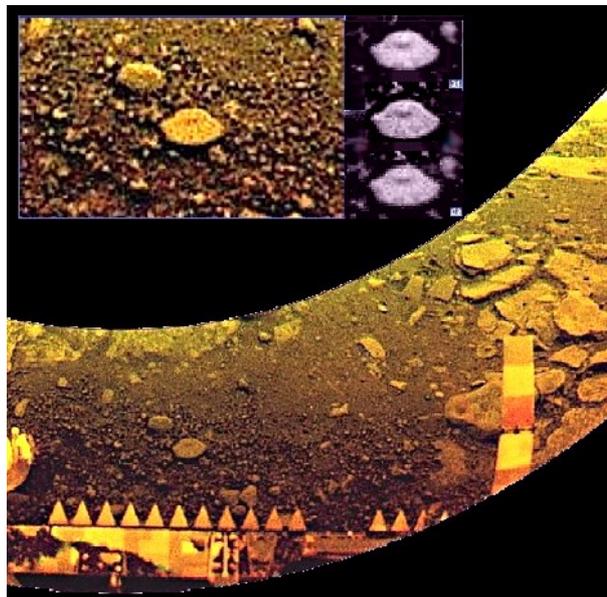
Figure 23. Fragment of the VENERA-13 panorama with an object reminding a mushroom. The size of it is about 8 cm. At the inset 3 different versions of the joint processing of 6 fragments are presented.

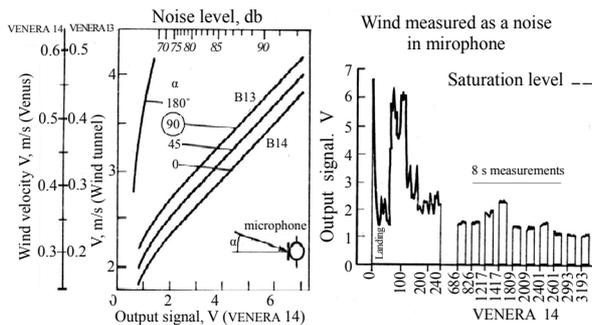
Figure 24. Results of acoustic experiments onboard the VENERA-13 and -14 probes (1982). At the left—calibration curves for the microphone as the device for wind measuring; at the right—sound channel output signal (VENERA-14). Horizontal axis—the time since landing. After 240 s the data were transmitted only in 8 sec intervals every 200 and 392 sec. The output signal was 70 dB in tranquil regime and reached 93 dB from noise produced by the lander itself.

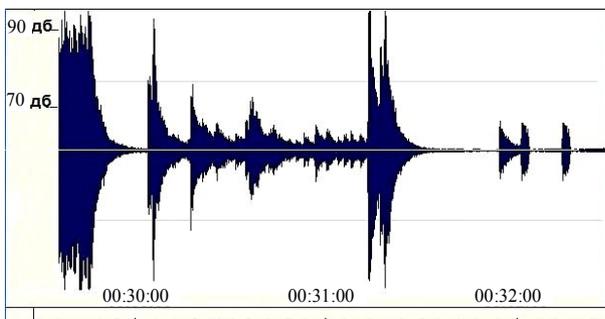
Figure 25. Detailed results of the acoustic experiment onboard the VENERA-13 probe (1982) in 30 - 33 min interval. Landing was at 00:29:36. Exponential decline of output signal trailing edge of a sound channel is explained by the properties of the electronic device output and is not connected with the characteristics of the sound source.

More detailed data of the sound experiment are presented in **Figure 25** by the fragment of VENERA-13 data (from the 28th to the 33rd min). The main noisy operations of the lander concluded in 20 min. The peak of more than 75 dB observed at the 31st min is most proba-

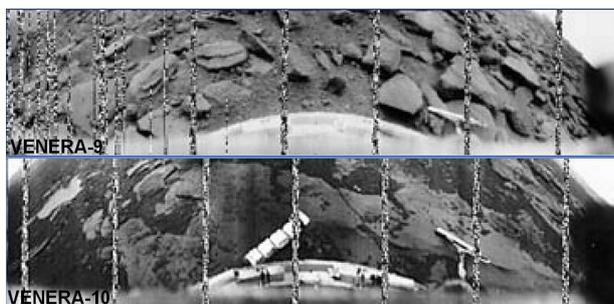
Figure A1. Historically first images of Venus' surface. VENERA-9 and 10, October, 1975. Figure 10 presents the VENERA-9 image after 2012 processing.

Unfortunately, on both VENERA-9 and -10 only one camera opened, the lid of the second one was not released. The second camera worked fine, but the window remained closed. The problem worsened when after landing, at VENERA-11 and -12 all lids of the cameras remained closed, although the cameras continued to work.

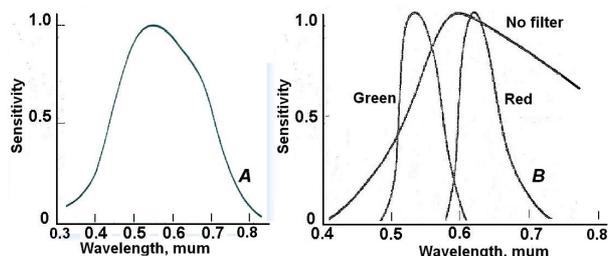
Figure A3. Spectral sensitivity of cameras VENERA-9, -10 (A) and of cameras VENERA-13, -14 (B).

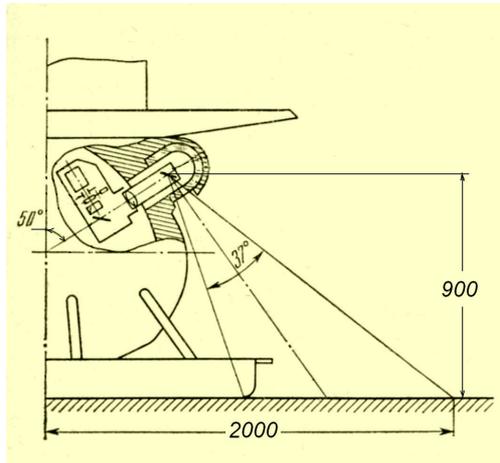
Figure A4. Field of scanning cameras of VENERA-13, -14. Sizes are given in mm. The width of field for cameras of VENERA-9, -10 was 40° and position of the optical entrance was 820 mm. The cameras were installed on opposite sides of the lander.

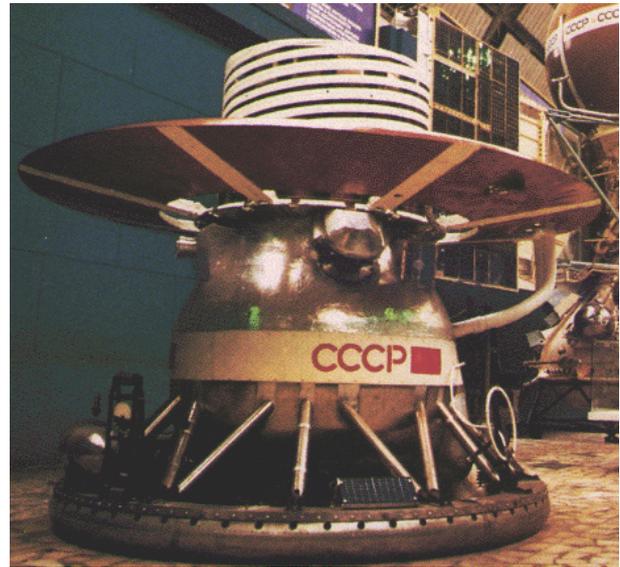
Figure A5. VENERA-13 lander at laboratory testing. The TV camera window is placed just above the СССР inscription.

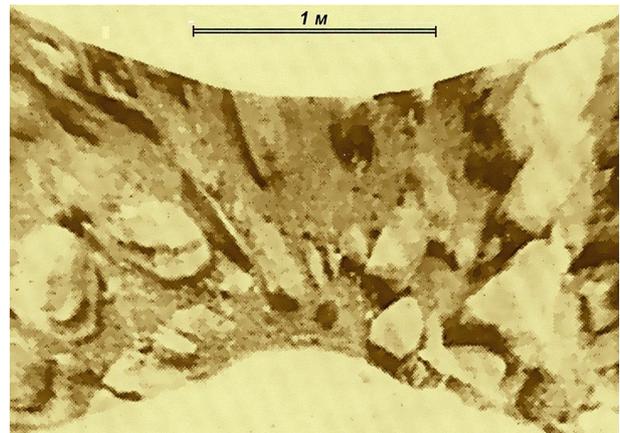
Figure A6. Photoplan of the central part of the VENERA-9 panorama. The photoplan is convenient as it shows all details at equal scale.

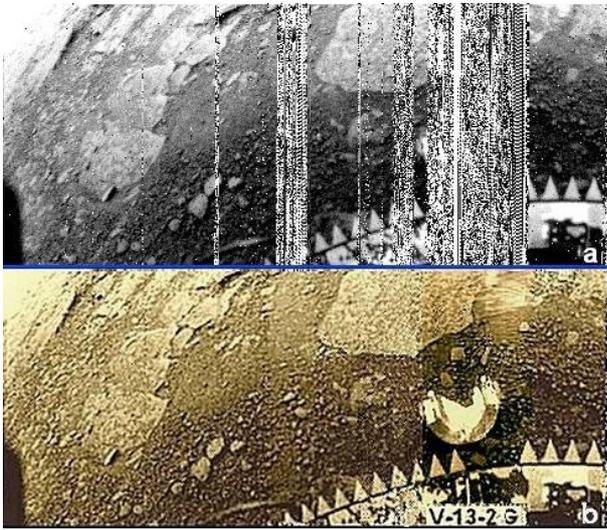
Figure A7. The original image V-13-1-2 G with lost lines (top) and its processed version (below) where the affected areas of the image are replaced by V-13-1-1 G fragments.

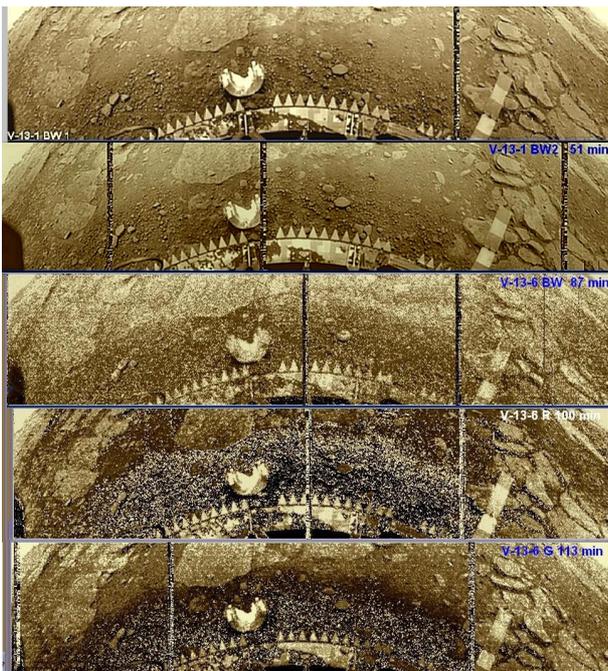
Figure A8. Different level of noise in panoramas of the VENERA-13 lander: two first BW images (series 1 and 2) and all last panoramas of series 6.
