Shockproof Experimental Study of Automated Stocker System in the High-Tech Factory

Jyh-Chau Wang¹, Jenn-Shin Hwang², Wei-Jen Lin¹, Fan-Ru Lin², Chin-Lian Tsai^{1*}, Pin-Hong Chen¹

¹Innolux Corporation, Chinese Taipei

²National Center for Research on Earthquake Engineering, Chinese Taipei

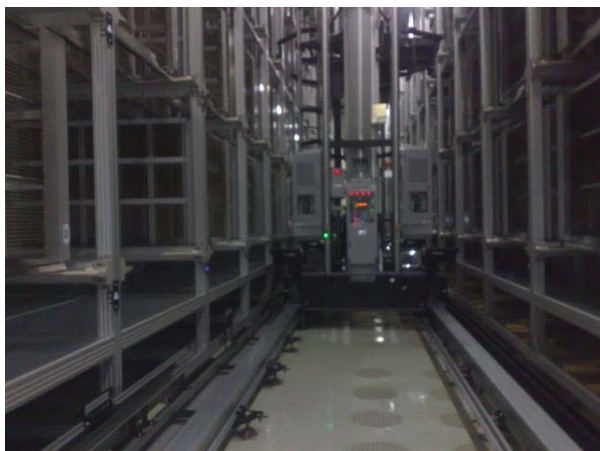
Figure 1. Automation stocker system.

mation. The clean room stocker is one of important components in display factory. The automation Stocker System was shown in **Figure 1**, Lin, Kun-Bin (2007) [6].

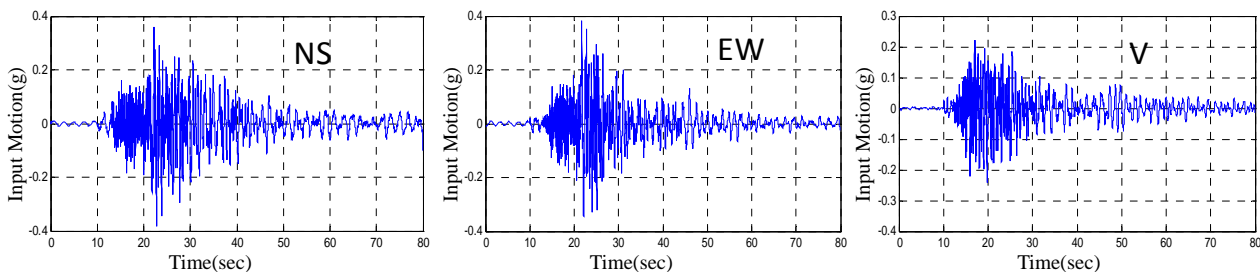
Figure 3. The signal, the X shock waves GX (NS), Y shock waves GY (EW), and Z axial shock waves GZ (V) were inputted respectively for the shake table test.

Figure 3 shows the inputted signals following the research of all the shake table tests, respectively, the X is shock waves GX (NS), Y is shock waves GY (EW), and Z is axial shock waves GZ (V). The time history showed at **Figure 3**. For simulation of the ground surface acceleration, the team established the response spectrum of artificial acceleration, the tri-axial duration history shown in **Figure 4**. The response spectrum met the Taiwanese official code Seismic Design Specifications and Commentary of Buildings. Furthermore, the team simulated the seismic waves of actual floor to investigate the seismic behavior of equipment in the high-tech factory.

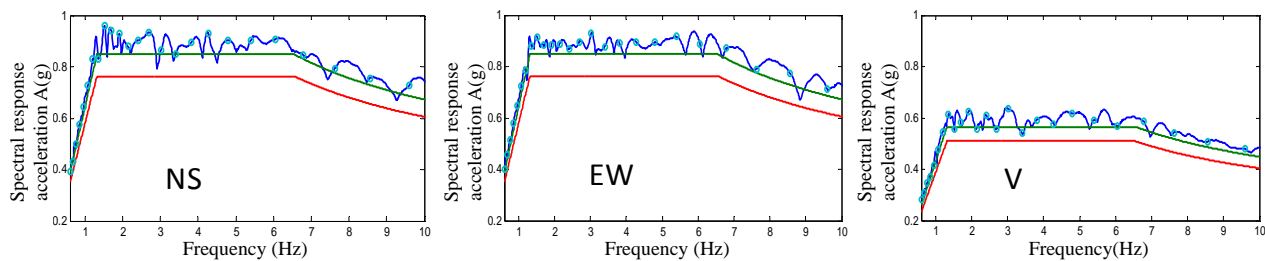
Figure 4. The tri-axial duration history: GX (NS), GY (EW), GZ (V). The 0304 seismic wave, Chiahsien Earthquake in Taiwan, from CHY099 the Shanhua Elementary Measure stations. The response spectrum met the Taiwan Official Code Building Seismic Design Specifications and Commentary.

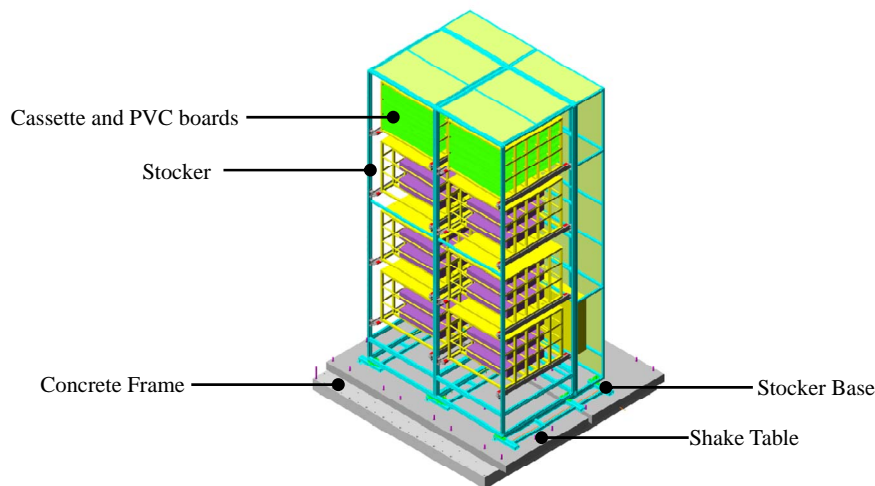
Figure 5. The configuration of overall experimental stocker structure.

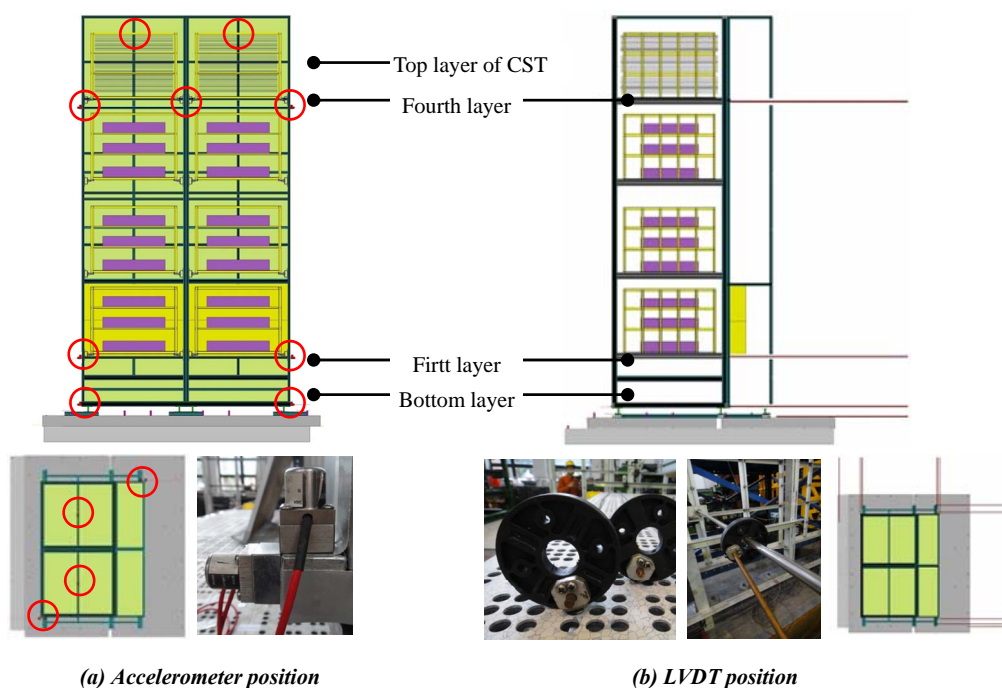
Figure 7. Accelerometer and displacement meter of the installed position.

The accelerometer and displacement meters of the installed position was shown in **Figure 7**. Both sensors are installed on the diagonal corners of the top layer, the first layer and the bottom layer of the stocker. The accelerometers measured the three axes—X, Y, and Z axes. The displacement meter measured for the X and Y axes.

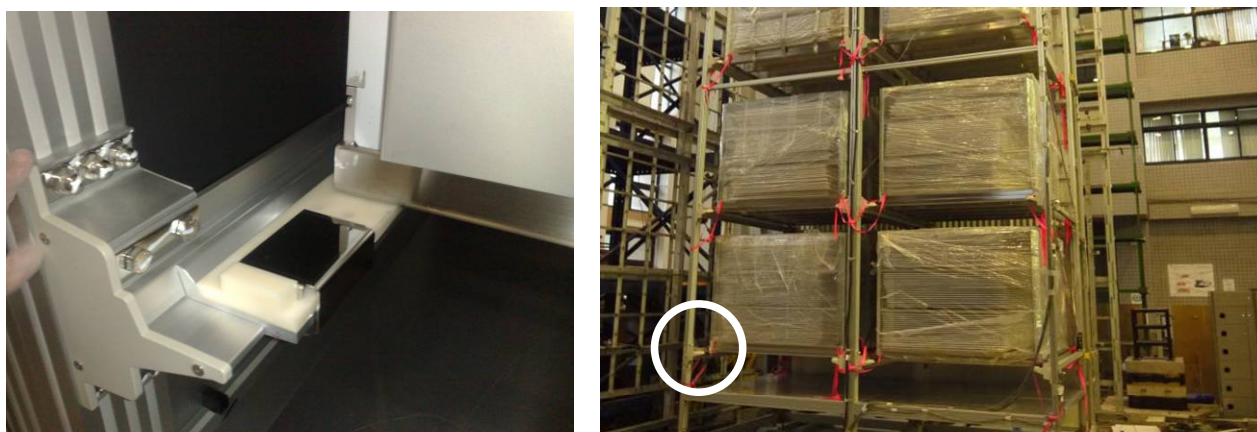
Figure 8. The screw was loosened at the first layer of left cassettes flange with trellis joint.

The second phase: the aim for the experiment was to understand the ultimate strength of stocker. When PA was 500 gal, rocking and shaking in the storage spaces of the stock occurred violently. The top-layer CST are displaced and hit the stopper and darted out of the PVC boards, and the screws were loosened on the first layer of left cassette's flange with trellis joint, shown in **Figure 8**.

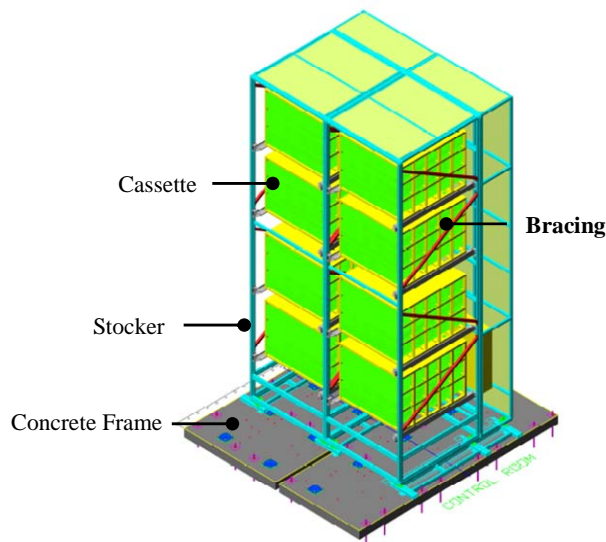
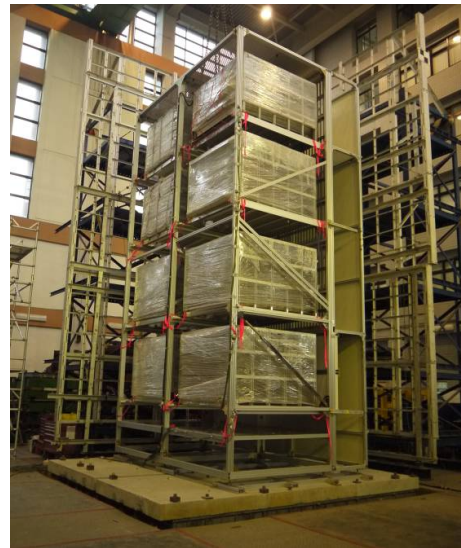
Figure 9. The installing bracing to improve the stocker stiffness.

Method 1, the installation of bracing to improve the overall stiffness. The reinforcing braces installed on both sides of the stocker: the bracing section 50×100 mm of aluminum extrusion. The locking manner was the L-type angle iron block and T-fixed bolt to lock Stocker scaffold's aluminum extrusion groove. The installed bracing to improve the Stocker stiffness was shown in **Figure 9**.

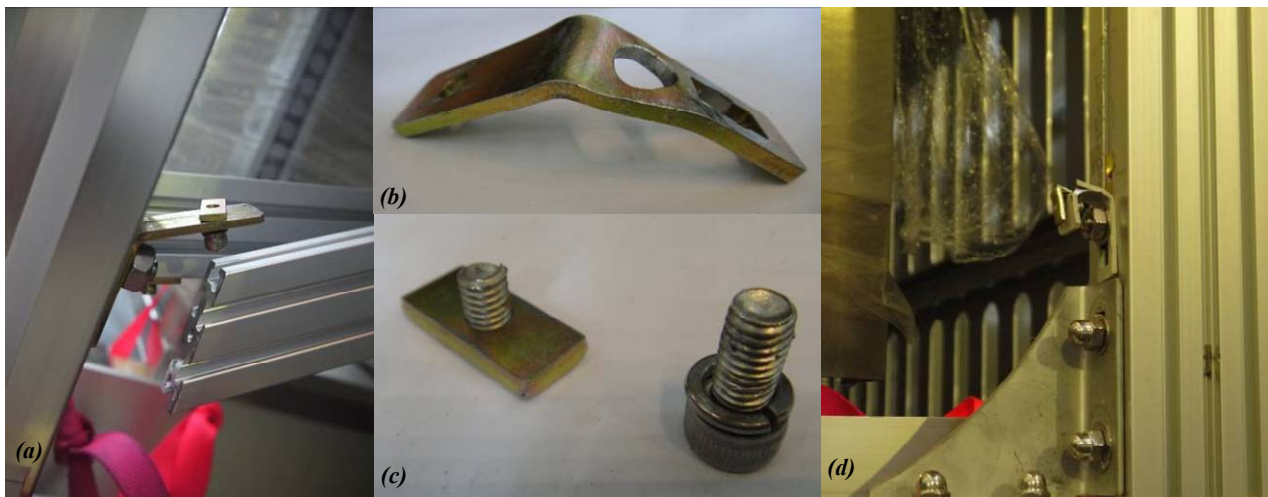
Figure 10. The destruction issue of installing bracing. (a) Bracing joint burst; (b) The link piece, L-type angle iron block, was bent and deformed; (c) T-fixed bolt was cut and stood idle; (d) The main destruction was link piece at the bracing joints and framework.

the link piece showed bending and deformation. The link piece: the L-type angle iron block at the bracing and aluminum extrusion framework groove. When PA was 300 gal, bracing joints loosened in a large number. The reason may due to the size of T-fixed bolt for L-type angle iron block locked being too small. Due to the excessive force, the T-fixed bolt was prone to cause destruction that the T-fixed bolt had been cut and stood idle and could not be removed. On the other hand, the un-loosened T-bolt joints buckled if the bracing loaded with the force. The result of the experiment after installing bracing was the main destruction was at the link piece on the bracing joints and framework. The destruction issue of installed bracing was shown at **Figure 10**.

The possible reasons of destruction were summarized, 1) since the Stocker-D6000 size was bigger, the reinforcement test was relatively too slender; therefore, it could not provide the expected effect of the tensility and compression. 2) The bracing joints were fixed poorly. There were no beams on the top layer of the original Stocker design; damages are prone to occur easily at the line piece, when the bracing loaded force.

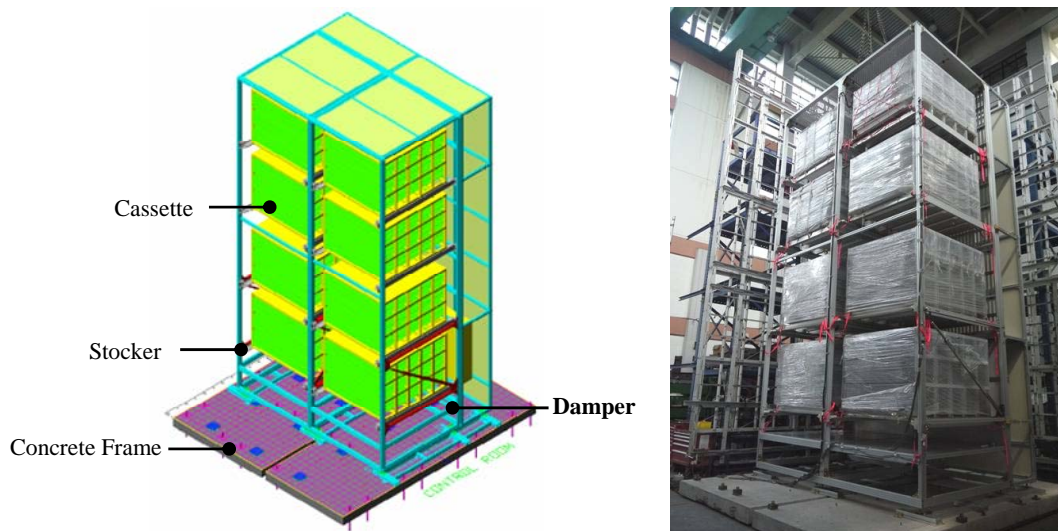
Figure 11. The team installed the dampers focus on the outside and inside of the first layer.

whether the installation of a damper was a possible reinforcing method. According to the result of the original machine test, the maximum displacement of stocker was at the first layer. Therefore, the team focused on installing the dampers on the outside and inside of the first layer. The installation of the viscous damper was shown in **Figure 11**.

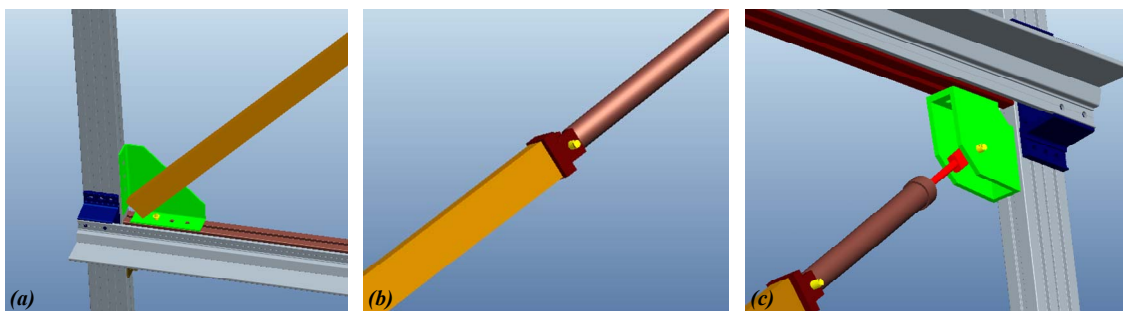
Figure 12. The installation condition of locking components for dampers connector. (a) Design of locking components for dampers connector; (b) Design of installing lower reinforcement beam; (c) Design of installing upper reinforcement beam.

For the damper only bear the axial force, the damper joint design is as follow: the damper extremity was hinged to the bolt groove. One side of the bolt groove was welded with extensible square tube; the other side of the bolt groove was jointed with 4 T-fixed bolts. The single damper installation condition was shown in **Figure 12**.

The objective of installing the lower reinforcement beams and upper reinforcement beams was to increase the strength of the Stocker, at the same time, to solve the weakness of the connector between the damper and the Stocker. The damper installation condition was shown in **Figure 12**.

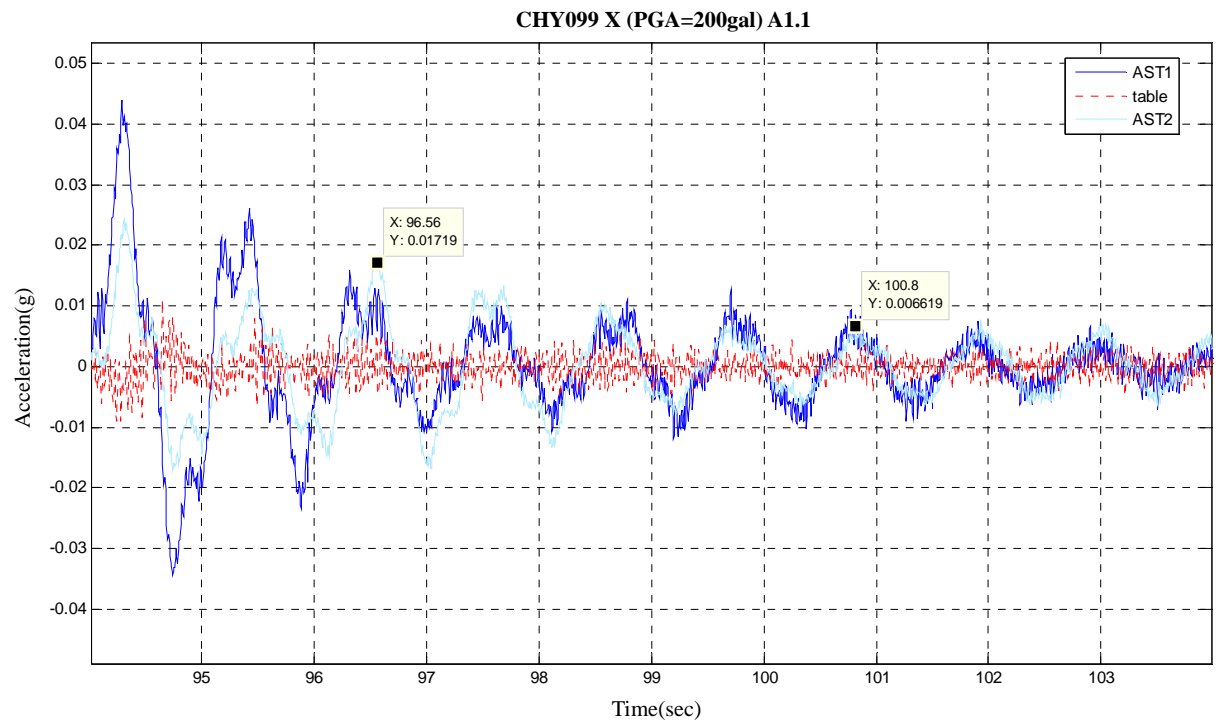
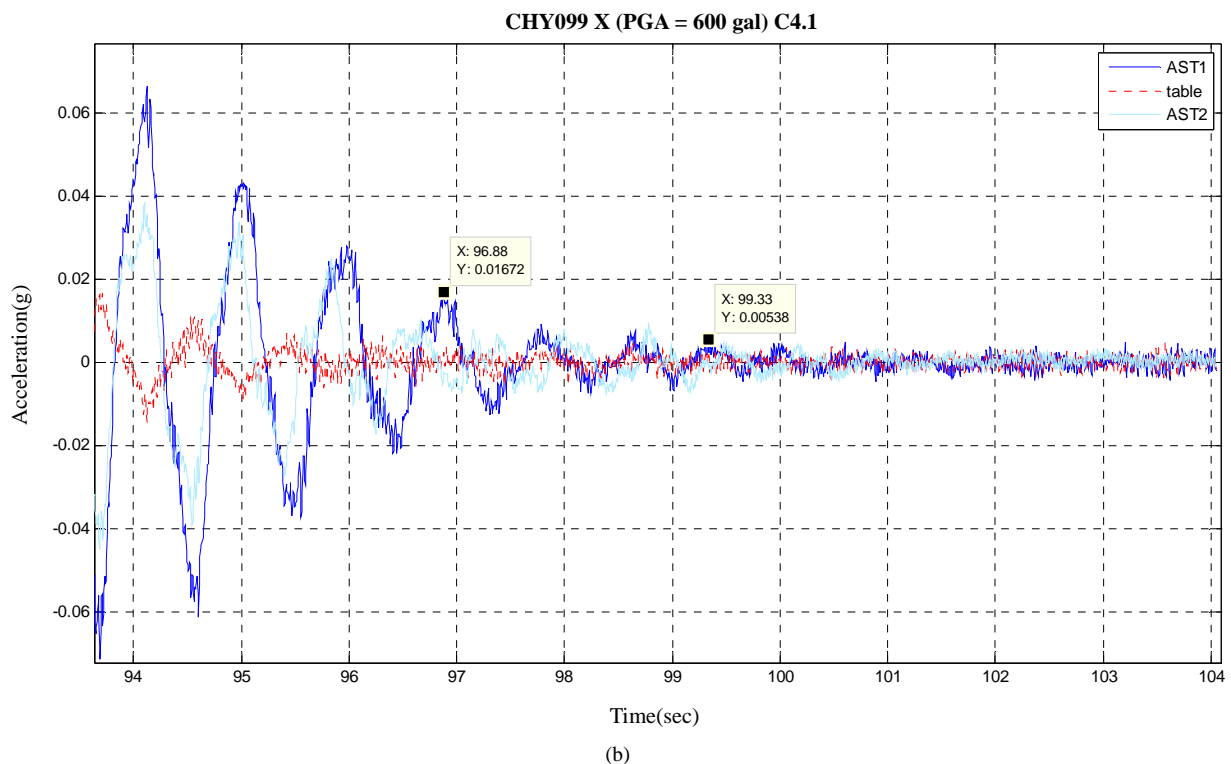
Figure 13. To compare the acceleration time history of the stocker top layer and shake table inputted the shake wave. (a) The damping ratio of original machine was $\zeta = 3.7\%$; (b) The damping ratio of Installation of the damper was $\zeta = 6.01\%$.

To compare the effect before and after installing damper, the team compared the acceleration of the top layer of the stocker and the shock wave of the shake table in the original machine, and the result of the damping ratio of the original machine was calculated $\xi = 3.7\%$. After installing the damper, by observing the acceleration time history, the response peak of the acceleration was significantly attenuated and the energy demolished. The damping ratio of installed damper was $\xi = 6.01\%$. The top layer of the stocker and the shake table inputted the shake wave was shown in **Figure 13**.

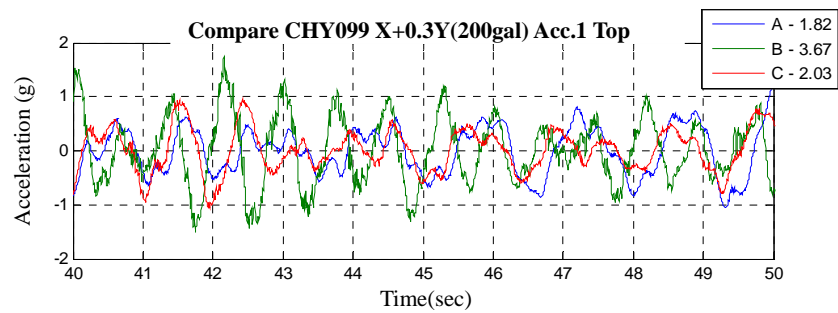
Figure 14. Acceleration time history in PA = 200 gal.

In PA for 200 gal, the time history for Stocker at the top layer was compared and shown in **Figure 14**. From **Figure 14**, we see the time history of the absolute acceleration shown obviously that the installation of bracing, the acceleration response peak in the sample B-3.67 was the highest. As we can see, upgrading the stiffness of Stocker could increase the acceleration from bottom to top layer. The original machine, A-1.82, and damper, C-2.03, had no significant differences.

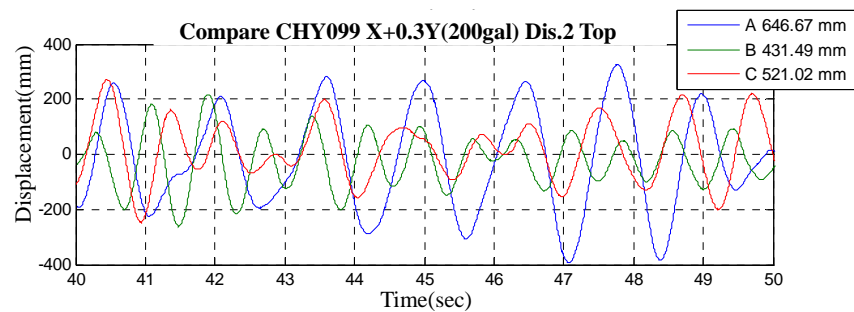
Figure 15. Displacement time history in PA = 200 gal.

Comparison of the relative displacement in time history was shown in **Figure 15**. The displacement reaction issue, the original machine, sample A, was the highest, followed by installed damper, sample C.

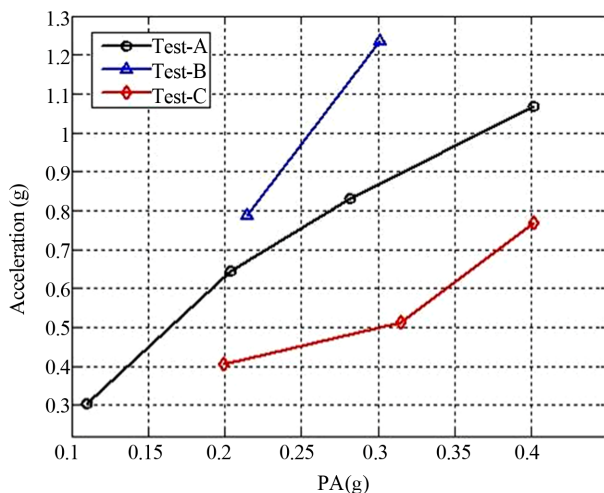
Figure 16. The absolute acceleration time history in the PA data comparison.

The absolute acceleration time history PA was shown in **Figure 16**. It shows the installation of bracing, sample B, has the highest acceleration response peak, followed by the original machine. The installed damper has the lowest acceleration response peak.

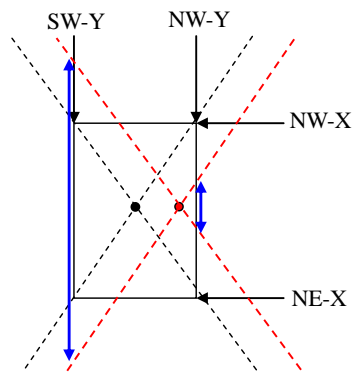
**Figure 17. Stocker's gravity position dislocated from the center of mass position.**

The result of the comparison of the maximum relative displacement for the shake table and the top layer of the Stocker was shown in **Table 2**. In PA for 300 gal, the displacement reactions of northwest side (NW-Y) and the southwest side (SW-Y) were different. The reason may be due to the large amount of FFU fans behind the cassettes. The FFU fans affected the overall stocker's position of center-gravity. It caused the overall stocker's center of gravity position to be not located at the center of mass position which led to the result of maximum relative displacement in the southwest side (SW-Y) being larger than it in the northwest side (NW-Y). The stocker's gravity position dislocated from the center of mass position was shown in **Figure 17**.

Through the comparison of relative displacement, we found that the Stocker's gravity position was not located at the center of mass position, and it caused severe torsion. In the future, installing tensional component and compressional component on the top layer to link the structure of the stocker can enhance the stability of the stocker system and reduce the effect of eccentric torsion.
