Evaluation of Cavity Formation and the Use of Cut-off Wall to Reduce the Risk of Washing Subsurface Fine Material

Fouzan Alfouzan¹, Muawia A Dafalla², Akeel Alharbi³

ABSTRACT

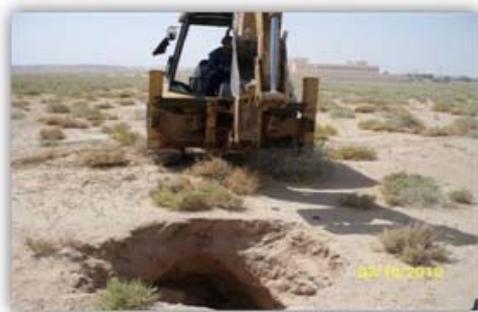
Figure 2. Typical sink hole close to ground surface.

surface soil layer. Loose spots of clayey sand were formed due to the loss of fine material being washed away. The subsurface soil was subjected to great hydraulic head difference created by topography and rainfall. When soils got wet and liquefied, interstitial pores increase, hollow tiny voids and vugs develop into fissures, cracks, big voids and then collapse by time (**Figure 2**).

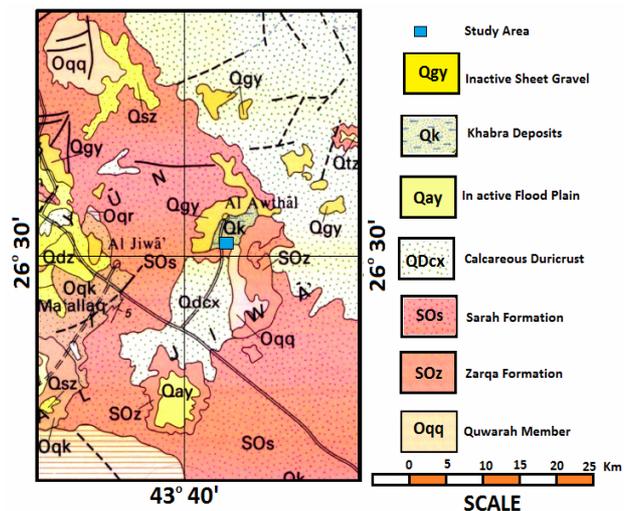
Figure 3. A geologic map of the study area within recent khabra deposits.

The area under investigation lies on recent deposits of an active khabra, of Quaternary Period in age, **Figure 3**. It is located in a low area, compared to the surrounded topography. During the rainy season, the khabra is crossed by surface runoffs that drain rainfall and water flowing from the upstream drainage basin, in which the silt and clay carried by wadis settle, and natural vegetation flourishes.

The khabra deposits are typically silty and clayey with small amount of eolian sand and no pebbles or gravel. It looks like sand sheets of different sizes.

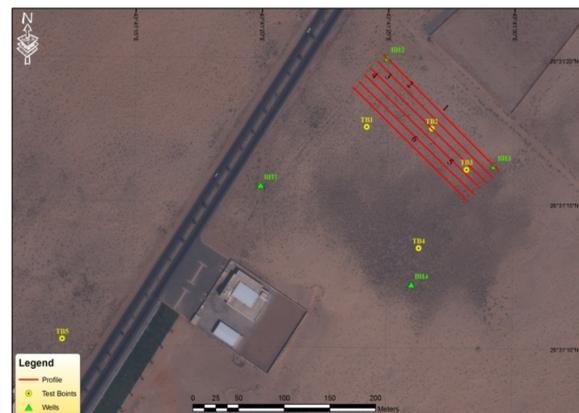
Figure 5. Satellite image showing the location of the 2D electrical resistivity profiles and borehole locations.

The electrical resistivity survey lines were designed to be of 2 dimensions, with 177 m length and 3 m electrical node spacing. 9 parallel electrical survey lines, with 9 meters spacing distance between each other's, have been conducted, and in a way that the first survey line extends to the north of the site and the last one extends towards the south as shown in figure (5). The 2D electrical resistivity profile No. 2 shown in **Figure 7** was selected to extend along a direction that crosses boreholes No. 2 and No. 3. Borehole No. 1 is situated 10 meters away from the start point of this profile, and the distance between the two wells is 157 meters.

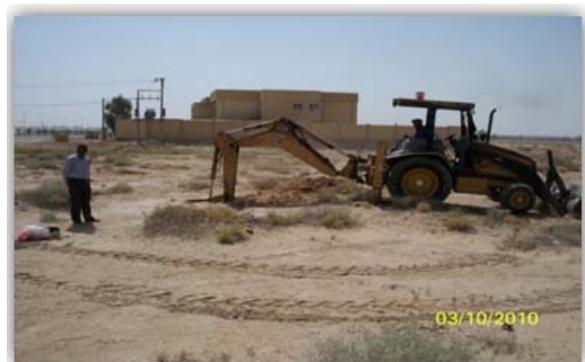
Figure 6. Digging an open hole at study area.

Four (4) open hole tests were excavated, 2 - 3 meter in depth, in order to study the constituents of the subsurface soil, to preview the possible cavities, to present a geologic and geotechnical description and to provide laboratory with some undisturbed samples for some tests, **Figures 5 and 6.**

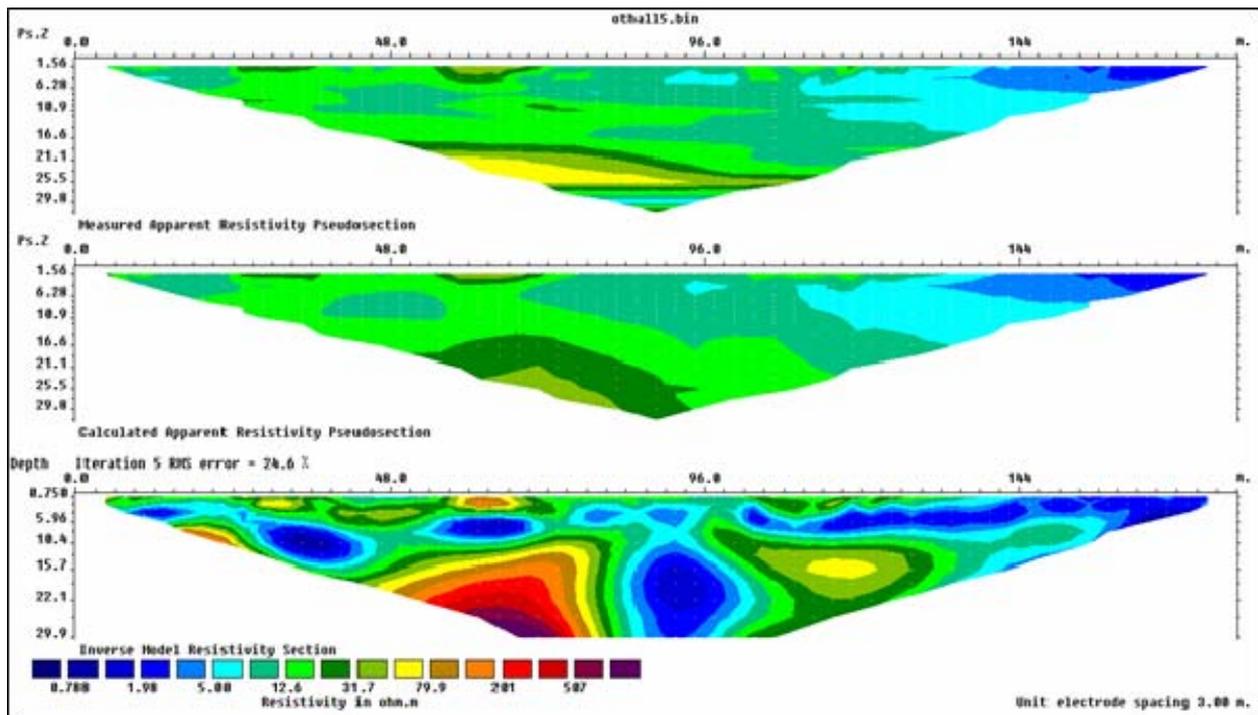
Figure 7. Typical electrical resistivity profile.

Results of electrical imaging tests showed that the resis-

tivity was low and in the order of (5 Ω), in a vertical section ranging from earth's surface to a depth of 6 meters. This low resistivity is believed to be a result of loose sand that is almost moist and wet. Then, the resistivity increases between 7 meters depth to the bottom of profile section, indicating more cohesive sandy layers. Evaluation used the approaches and guides by [6].

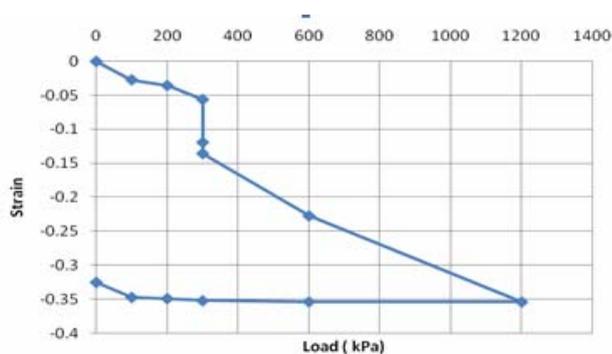
Figure 10. Collapse potential test profile.

A collapse potential test was carried out for samples extracted from the test pits in accordance with ASTM D

5333-9 [7]. The collapse Index measured at 300 kPa stress was found 6.3% (Figure 10).
