Colonial Houses and Cultural Identity in New York State's Mohawk River Valley

Abstract

Mohawk Valley; Colonial America; GPR; Earth Resistance; Magnetometry; Built Environment

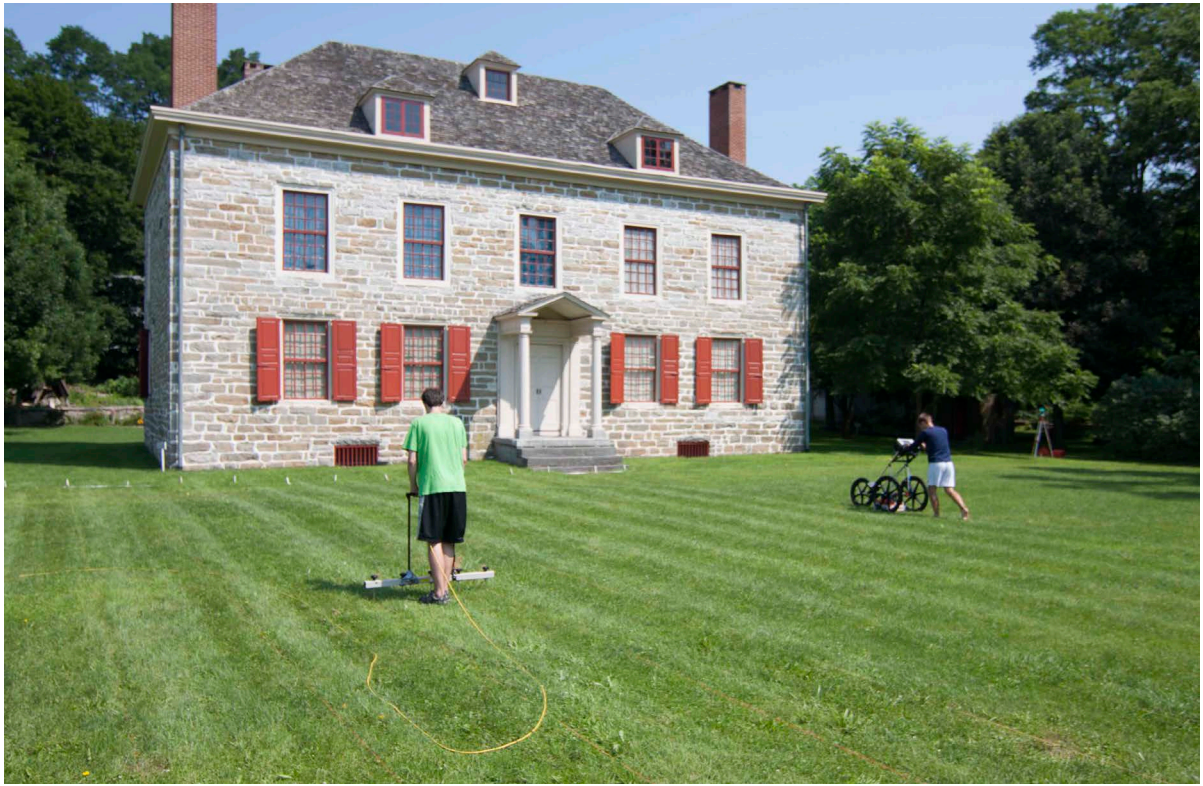
Figure 2. Old Fort Johnson taken from the south looking north.

The house Sir William Johnson built was the embodiment of his elite status (Figure 2). The structure is a central passage house with two rooms on either side of the passage, and had a full second floor with attic, and a working cellar. In this house, the attic was used, at least in part, for defense, with gun swivel mounts in the attic window frames. The remainder of the house was mainly used for domestic purposes. Additional structures, or outbuildings, provided space for other activities including industry with a mill and related buildings. The house faced the King's Road, which ran along the Mohawk River, and displayed a symmetric front façade to all who passed.

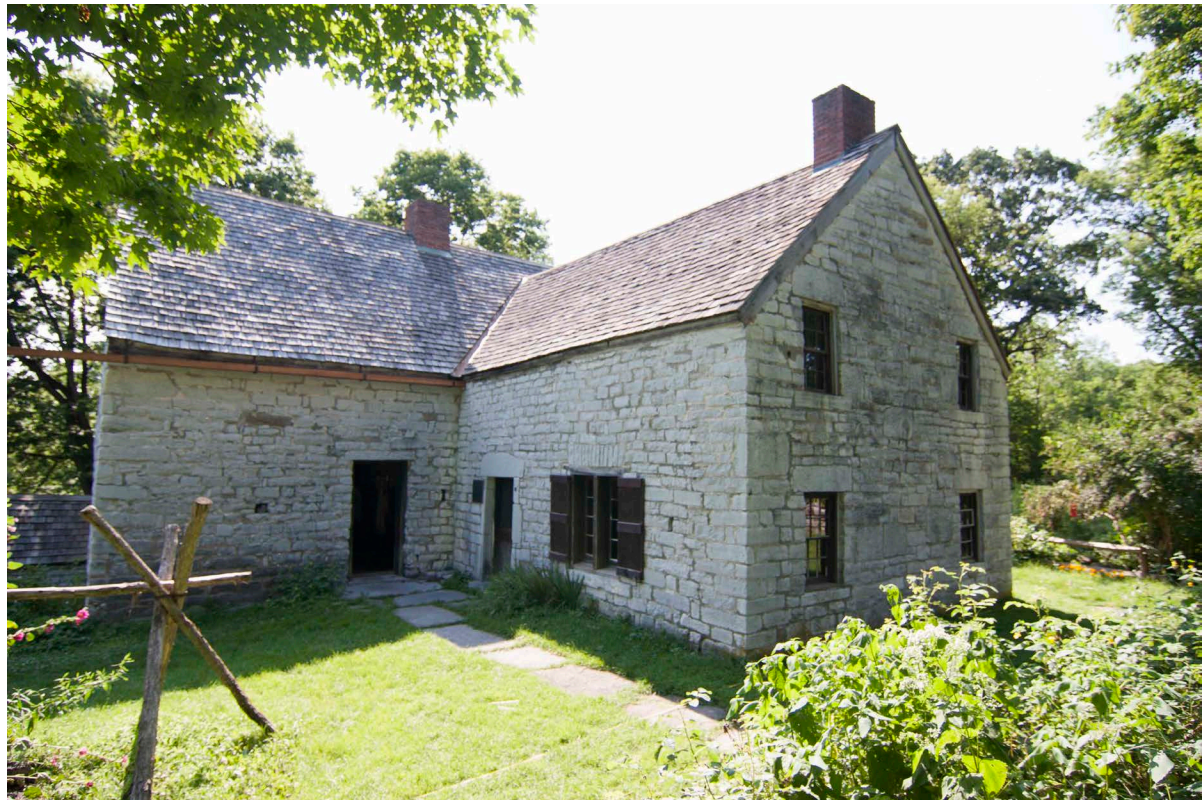
Figure 3. Fort Klock taken from the east looking west, originally the rear of the house.

Fort Klock, like Old Fort Johnson, still has the gun loops and thick stone walls of important houses of the mid-eighteenth century Mohawk Valley (Figure 3). It also faced the King's Road and the Mohawk River. However, Fort Klock is built on a river terrace, and access to the house from the road was accomplished by an access road up the slope, which led to the house being approached from the south. The southern gable of Fort Klock displays what is called “mousetooth” or tumbling masonry (Figure 4), a distinctive characteristic of

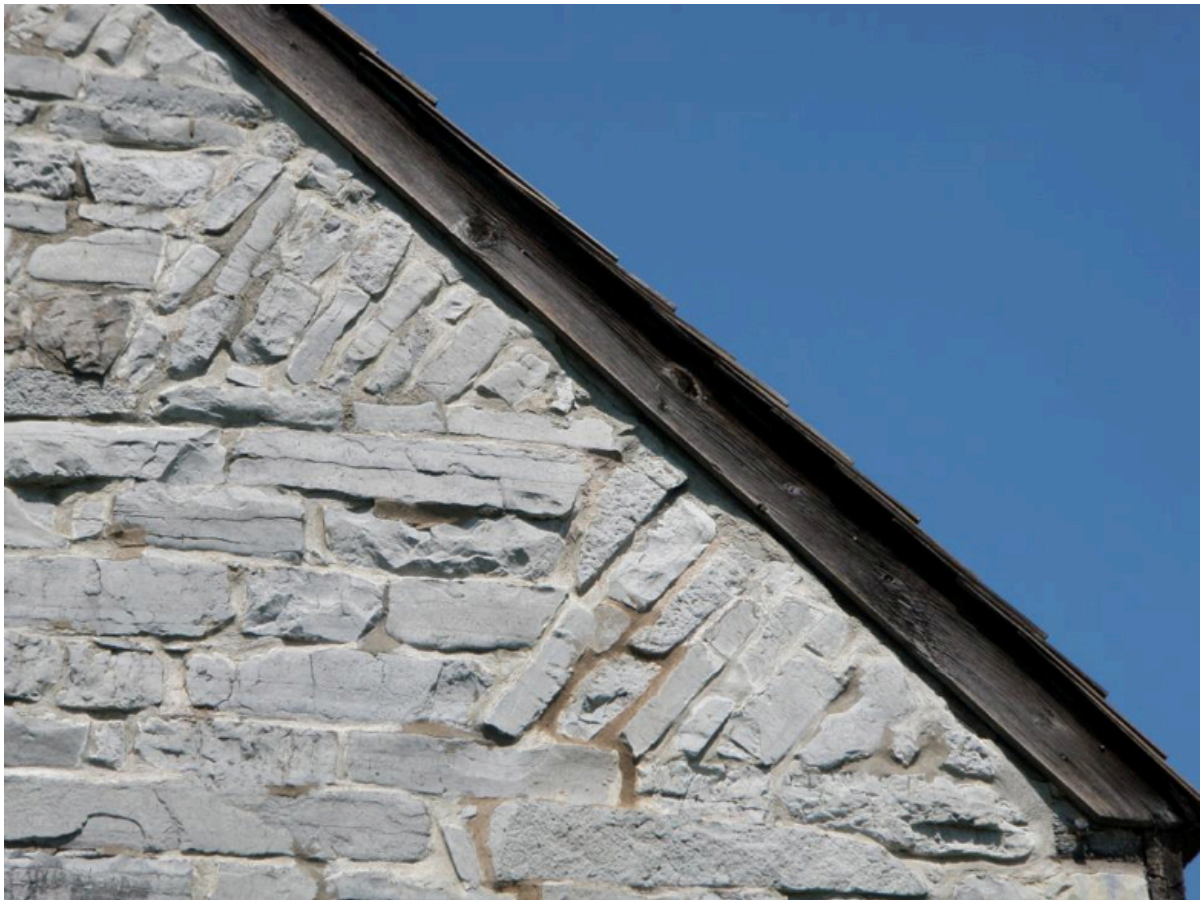
Figure 4. Dutch-influenced tumbling masonry on the south gable of Fort Klock.

Dutch construction (Stevens, 2005: p. 50). The northern gable, which faces a small creek with waterfalls, does not have this construction, but has plain courses of masonry. The house itself is one and a half stories, with two original rooms on the lower floor and two rooms under the roof on the second floor, plus a full basement. A later expansion added a third room in an ell off the back of the house. Like the Jonathan Hager House, a Palatine house in Maryland, Fort Klock has a spring and pool in one chamber of the basement, a recurring feature of Palatine houses (McMurray, 2011: p. 40). The interior of Fort Klock was restored in the mid-twentieth century so the precise layout and details are uncertain, but the layout appears to parallel that of the Mabie House, a Dutch house in the Eastern Mohawk valley built around 1706. The use of the house was mixed domestic and commercial, with one of the rooms of the house used as a trading post, also similar to the Jonathan Hager House in Maryland. Fort Klock also has two bearing beams supported by the chimney mass, typical of Palatine construction and markedly different from both English and Dutch construction of the mid-eighteenth century (Upton, 1981: p. 77). Like Old Fort Johnson, Fort Klock was built to display a specific status in this mixed colonial society. Klock was attempting to construct an identity distinct from the dominant political power, in part as a defensive measure in an effort to protect themselves from French attack, and also to appeal to the Dutch and German settlers who preferred to trade with someone other than the British.

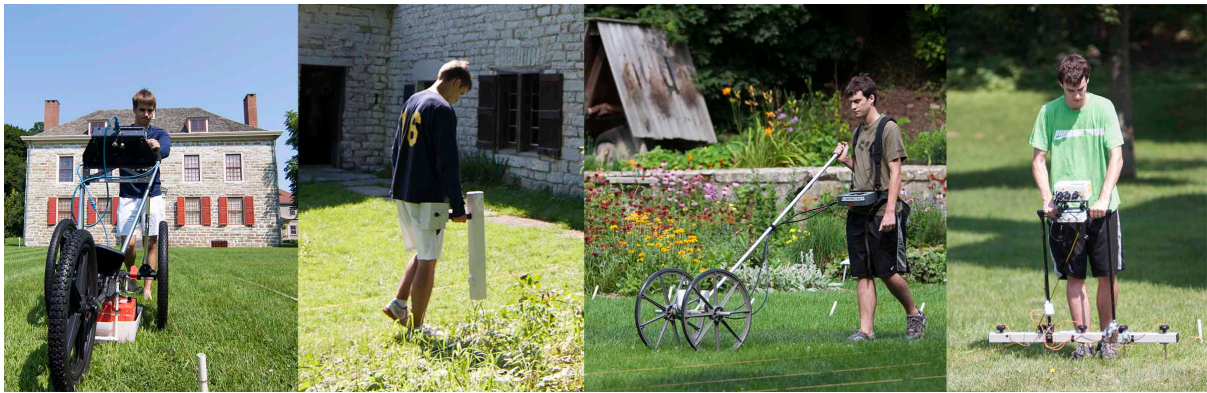
Figure 5. Archaeogeophysical instruments used at Old Fort Johnson and Fort Klock; from Left to Right: GSSI SIR 3000 GPR with 400 MHz antenna, Geoscan FM256 Fluxgate gradiometer, Geometrics G-858 dual cesium gradiometer, Geoscan RM15 earth resistance meter with multiplexer.

The ground-penetrating radar (GPR) survey was conducted using a Geophysical Survey Systems, Inc. (GSSI) SIR-3000 ground-penetrating radar system and survey cart was used with a central antenna frequency of 400 MHz (Geophysical Survey Systems, Inc., 2009). The control unit was set at 100 scans per linear meter, which corresponds to a radar pulse into the ground every centimeter along the each transect with transects spaced 0.50 m apart. A time window of 30 nS with 512 samples per scan was used, which corresponds to a reading taken every vertical 0.002 m down to a depth of approximately one meter.

The soil resistance survey was conducted using a Geoscan Research RM-15 with multiplexer Resistance Meter configured in the twin parallel probe array mode (Geoscan Research, 2009). The instrument has five mobile probes attached at the bottom, which are stuck into the ground, while two remote probes are set a fixed distance away. The mobile probes are inserted into the soil every 0.50 m along each transect. In the twin parallel array mode with five mobile probes are fixed to the instrument four soil resistance readings are recorded at 0.25 m intervals between the probes. The sensing depth is dependent on the spacing of each mobile probe, where the greater the distance between probes correlates with a greater signal depth.

The fluxgate gradiometry survey was conducted using a Geoscan FM 256 fluxgate gradiometer (Geoscan Research, 2004). The instrument samples at a rate of 16 data points per second, resulting in a data point every 0.06 m along each transect with transect lines spaced 0.25 m apart. This gives us a total of 25,600 data points in a 20 m × 20 m grid unit. The sensors are fixed at 0.50 m apart in a vertical gradient. The fluxgate gradiometer has two sensors, orientated perpendicular to the ground, that take a reading which are then subtracted from each other to measure the change in the strength of the magnetic field at each point.

The cesium magnetometry survey was conducted using a Geometrics G-858 optically pumped magnetometer system (Geometrics Inc., 2001). The two sensors were spaced horizontally 0.25 m apart on a cart to cover two transects with each pass. The sampling rate was set to 10 Hz corresponding readings taken every 0.05 m along each transect at the chosen walking speed. All instruments gathered data using a bidirectional survey method where data were collected from south to north on the first transect and then north to south along the next transect with a continued alternating pattern.

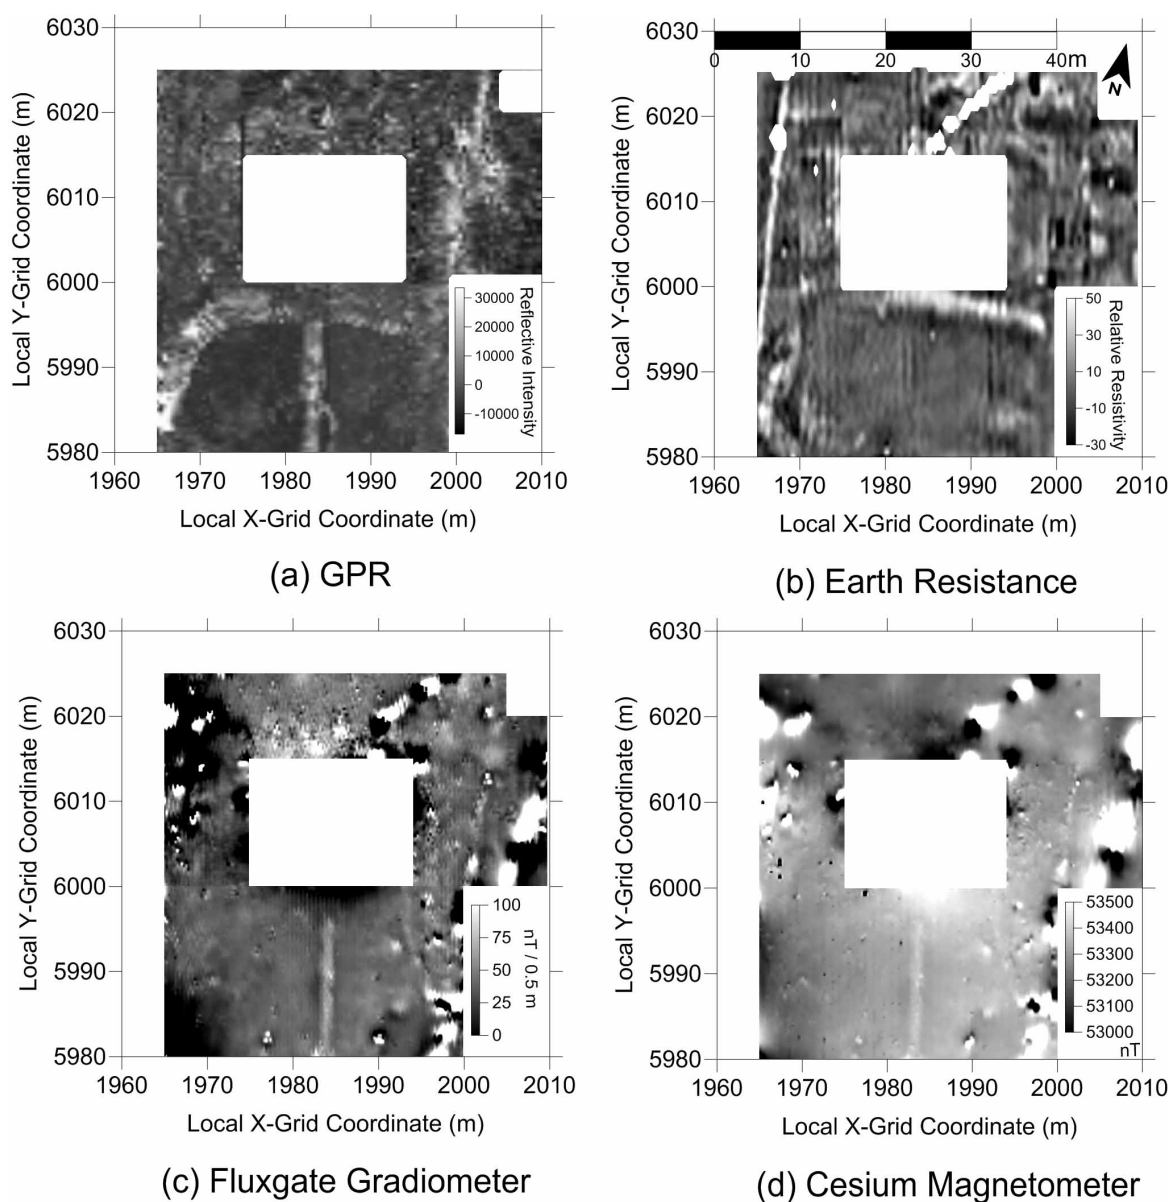
Figure 6. Archaeogeophysical data from Old Fort Johnson (a) GPR time slice from 29 cm - 37 cm; (b) earth resistance; (c) fluxgate gradiometer; and (d) cesium magnetometer total field.

dar wave travels deeper into the ground (Hurley, 2011). The GPR data were processed entirely using GPR-Slice V7.0, the cesium magnetic data were processed using Geometrics's MagMap2000 V4.0 (2002), Microsoft Excel for Mac 2011, and Golden Software's Surfer 10.0, and the earth resistance and fluxgate gradiometer data were processed using Geoscan's Geoplot 3.0 and Surfer 10.0 (Golden Software, Inc., 2010). Figures 6 and 7 present the image plot results of the surveys at Old Fort Johnson and Fort Klock.

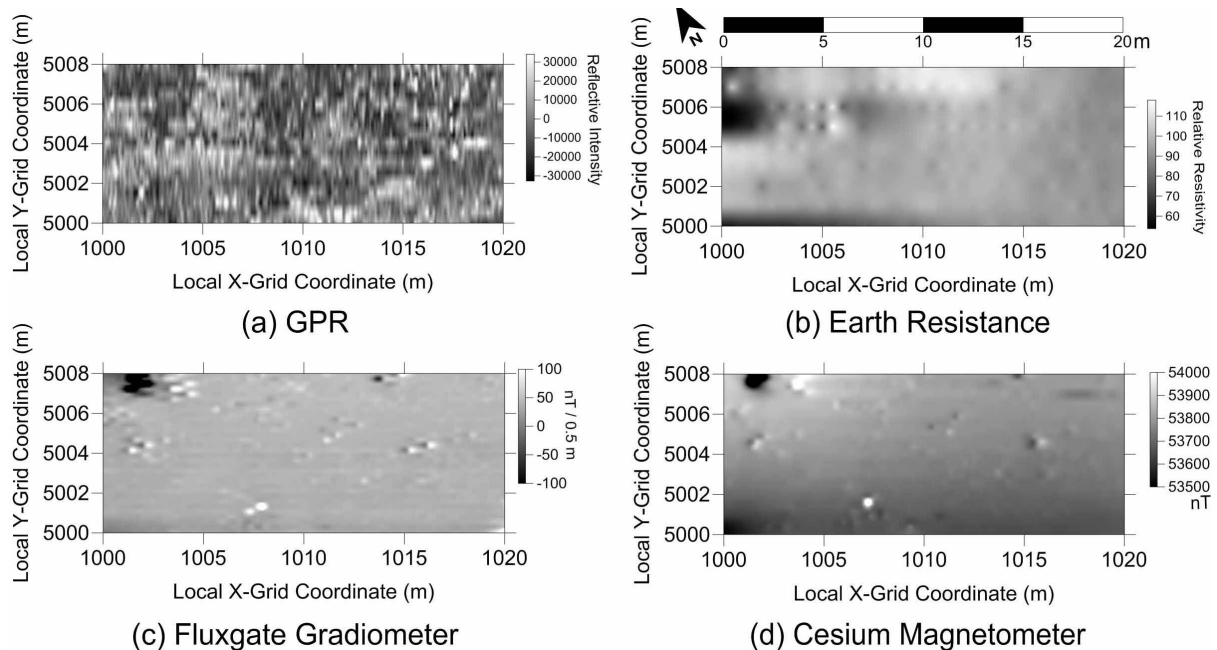
Figure 7. Archaeogeophysical data from Fort Klock (a) GPR time slice from 22 cm - 27 cm; (b) earth resistance; (c) fluxgate gradiometer; and (d) cesium magnetometer total field.

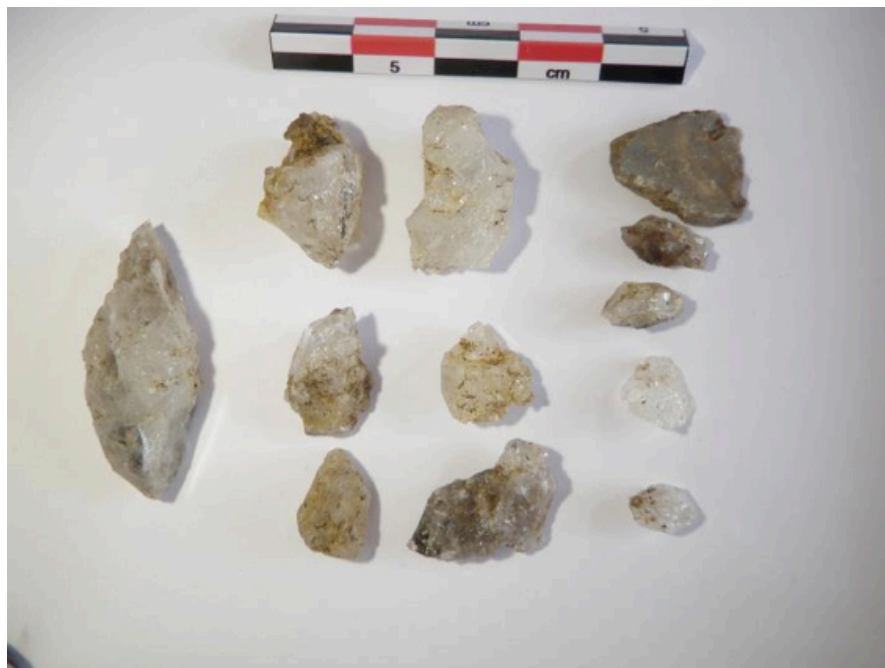
Figure 8. Herkimer diamond and other quartz fragments recovered from Fort Klock.

Unit 1 was excavated in six levels comprised of two strata. Architectural debris, mainly brick fragments and nails with some window glass, was abundant. Approximately one hundred quartz fragments and Herkimer Diamond crystals or broken crystals were recovered from Unit 1 (**Figure 8**), along with a slightly lesser quantity of

stone debris from processing the quartz from its surrounding matrix. Most of the Herkimer Diamonds are small, broken, or discolored. A ceramic triangular object, interpreted as a bead blank, was found in Level 6, either lost or discarded during manufacture. Household debris, including pipe fragments, creamware, pearlware, and salt-glazed stoneware were recovered. Food remains were represented by shells and bone, including ten teeth indicating animal heads were processed at the site.
