Diagnosis Study of the Louga-Ouarack-Ndoyene R31 Regional Road (Senegal)

Abstract

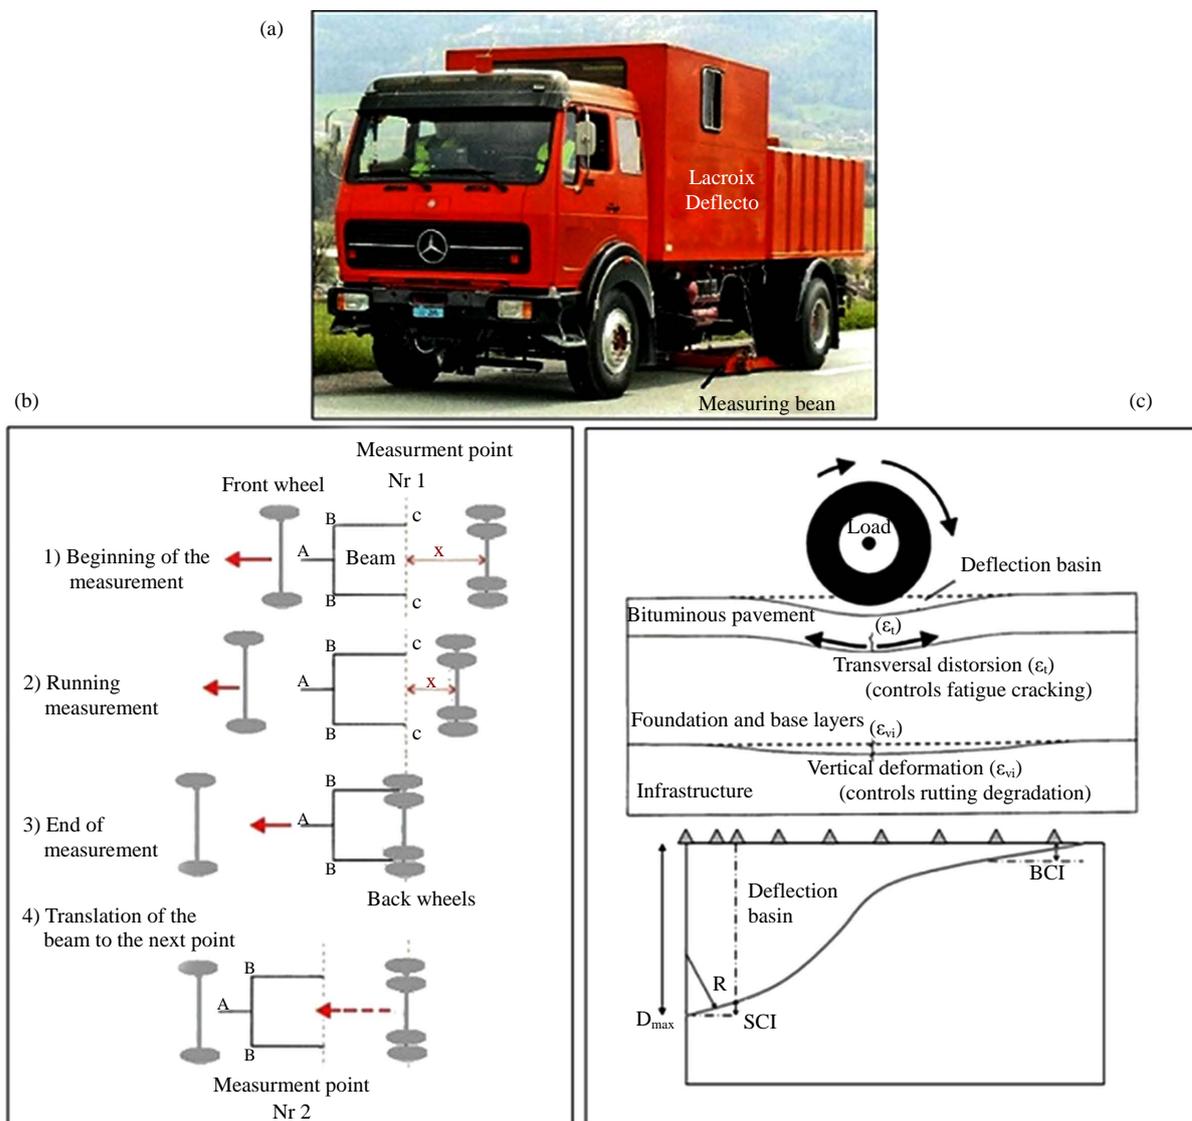
The data bank available for the investigations comprised of measurements of the deformability of the pavement structure using the type O2 Lacroix deflectograph (LD) (**Figure 2(a)**). These data were complemented with other available information such as data from auger holes drilling by hand and mechanical shovel at different PKs, and from the retrieved samples, and data from the VIZIR campaign conducted in May 2012 by the APAVE Sahel company in order to assess the severity of pavement degradations.

Figure 2(b) schematizes the measurement principle of the LD. The operating procedure involved: first, placing of the measuring beam on the surface of the pavement, along the wheel paths between the wheel axles. The vehicle then drives at a steady speed. The measuring beam under the vehicle remains fixed until the rear axle exceeds 10 cm of the point of measurement. The stress related to the passage of the vehicle causes a deformation

Figure 2. The Lacroix deflectograph: (a) Measurement frame; (b) Measurement principle; (c) Deflection basin and main parameters. (D_{max} is the deflection under the rolling load; R is the radius of the deflection basin; ϵ_{vi} is the vertical deformation in the subgrade; ϵ_t is the transversal deformation in the asphalt concrete (pavement) layer; SCI is the index of surface curvature and BCI represents the index of base curvature) (modified after [14].)

on the road floor which is recorded by the sensors (Figure 2(c)). The deflection basin thus created by the passage of the vehicle is subjected to 65 points of measurement before the system moves forwards over 4 - 6 meters to the next measuring station by pulling the measuring beam. Further details on the measurement principles and procedures are presented elsewhere in cited reference standards and literature (e.g., LPC No. 39 [4]).

However, it should be noted that the resulting data from a LD measurement campaign can be used for various investigation activities and design of pavement structure ([15]-[19]), particularly in the analysis of deflections as indicators of performance (diagnosis and control) as well as in “back-calculations” of the ground E-modules to evaluate the residual modules of the road’s component layers and to optimize the prediction for the reinforcement of a pavement structure. There are formulae linking the value of the measured deflection to related “efforts” in the layers and thereby allowing the determination of the structural conditions and critical parameters responsible for the road degradation in terms of ageing and deformation of the pavement at the location of measurement (see Figure 2(c)).

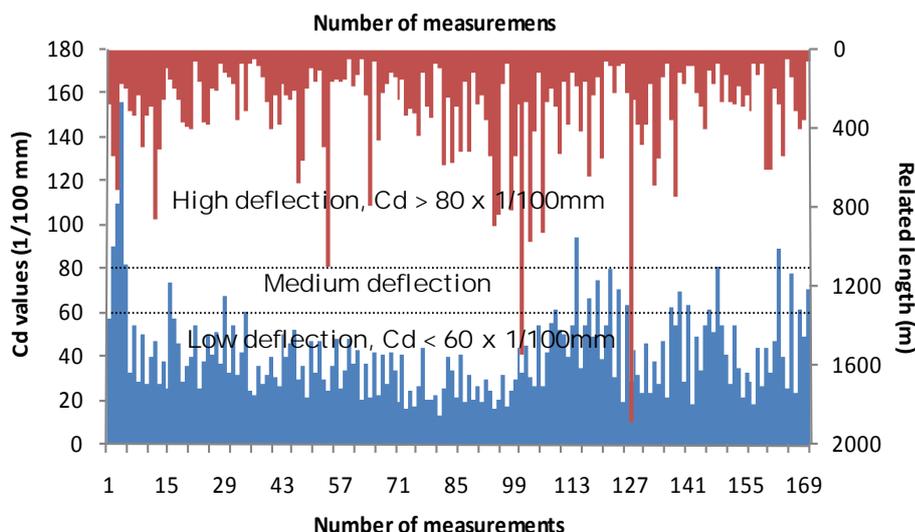
Classes of Cd values. These were defined based on **Table 4**. The distribution pattern (**Figure 3**) shows a high variability of the values, although suggesting a predominance of the low deflection levels ($Cd \leq 60 \times 1/100$ th mm). Since the road has been initially designed to support a T2 traffic class and still exhibits a S3 bearing capacity platform class ($15 \leq CBR \leq 30$; see **Table 6**), the levels of deflection could be classified as weak to moderate on the most part of the road section length. This would mean a road structure of *good to doubtful* quality on the road sections. Further discussion on this will be presented later in the subsequent section below.

Figure 3. Histogram of section lengths surveyed and their corresponding Cd values. Note the following features of the graph: range of Cd values $< 60 \text{ mm} \times 1/100$: low deflection (elevated residual bearing capacity, the road edifice is still good); values range $60 \times 1/100 \text{ mm} \leq Cd \leq 80 \times 1/100 \text{ mm}$: medium deflection (poor residual bearing capacity, the structure of the road edifice is doubtful); Cd values $> 80 \times 1/100 \text{ mm}$: high deflection (low residual bearing capacity, the road edifice is bad).

It is worth noting at this stage of the discussion that the measurement campaigns resulted in a large data set. The data were then processed in a multistep procedure which allowed for division of the monitored road into some 170 separate sections or segments regarded as homogeneous zones. Each homogeneous zone is regarded as a zone where the maximal deflection does not vary significantly (standard deviation $\sigma \leq 15 \times 1/100$ mm); in other words, within a homogeneous zone the pavement responds in a similar way to the applied load. Consequently, the decision to take a particular action is based separately on the individual homogeneous zone. For convenience, however, the monitored road section need not be divided into relatively short zones [20], so the minimum length can be set for the survey. In this study a minimum length of 50 m was arbitrarily adopted for the zones. The large number of the individual zones implied the use of the graphical dual axis mode of representation (**Figure 3** and **Figure 4**) for the parameter values.

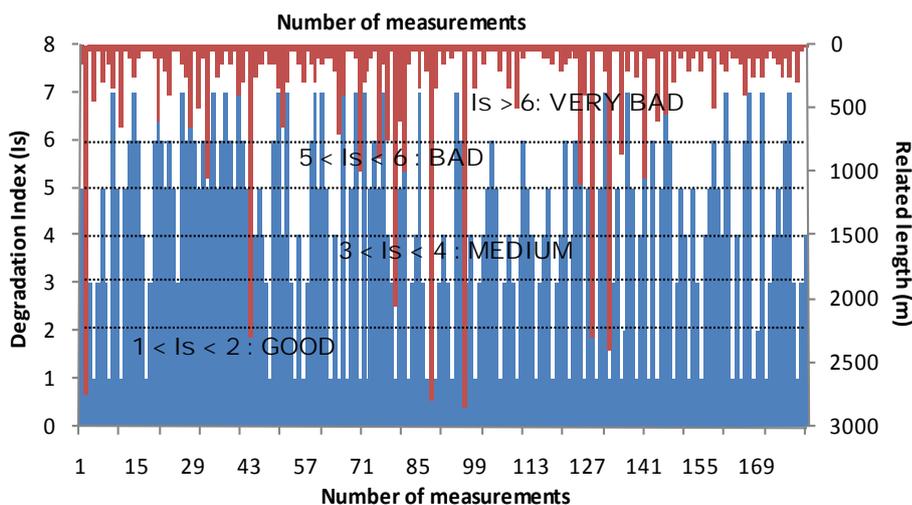
The results of classifying the apparent pavement damages using the index values (I_s) derived from the VIZIR study [21] are graphically presented in Figure 4, while the results were also categorized based on Table 5 [22], after some corrections taking into account the recent cosmetic reparation works on the study road. The I_s value was calculated by combining the cracking index (I_f) (*i.e.* degradation couple: cracking/crazing) with the deformation index (I_d) (*i.e.* degradation couple: deformation/rutting). As shown by the graphic presentation, zones with degradation indices greater than 3 ($I_s > 3$) occur more frequently suggesting that many zones of the road section exhibit large surface structural damages. Consequently, their degradation's level can be characterized as medium to bad which ultimately require that rehabilitation works should be undertaken.

Figure 4. Histogram of the section lengths for surface damages (apparent pavement damages) based on the I_s index [21]. Note: A comparison with Figure 3 suggests a fairly close correspondence between road segments' length with high D_c values and those with high I_s values.

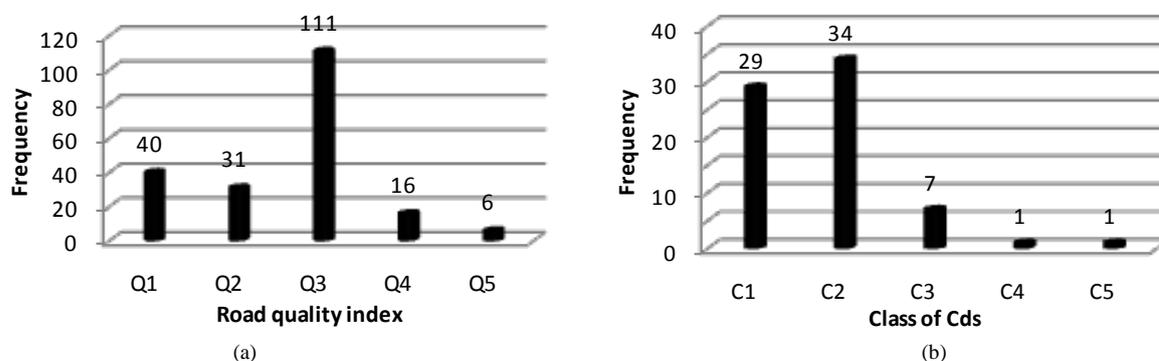
The frequency distribution of the Cd classes, as defined based on **Table 4** and presented in **Figure 5(a)**, revealed that the C1 and C2 class levels are largely dominant, as already shown in **Figure 3**. In addition a cumulative length of approximately 47,686 m (that is about 89.67% of the total length of the road section) has Cd values in the C1 and C2 class levels; thus exhibiting low deflections. This implies a good bearing capacity of the road structure and a relatively good to moderate road quality level. In contrast, a cumulated length of 3,212 m (corresponding to 6.04% of the total length of the road) has Cd values of medium C3 class level which implies a questionable (doubtful) road structure quality level, while a section of 2,279 m (about 4.29% of the road length) exhibited a road structure in the bad quality category (*i.e.* C4 and C5 class levels).

With reference to **Table 7 [3]** which orients the choice of possible solutions in tropical countries according to the profile of Cd values and the apparent surface deteriorations of a road, it can be seen in **Figure 5(b)** that most of the monitored road sections have quality level of the order $\geq Q3$, which imply a doubtful road quality and the necessity for further investigations.

Figure 5. Frequency distribution of the road quality levels (a) and the Cd classes for the monitored road. (Note: The deflection classes C_i are defined in **Table 3**, while the quality indices Q_i are given in **Table 7**).

1) some “*maintenance*” works on road segments with quality levels $< Q3$; that is to say, a rehabilitation of the road pavement by installing a new asphalt layer coating for the degraded zones. The concerned road length is estimated to be about 16.250 km (equivalent to 30.56% of the monitored road section).

2) some “*reinforcement or strengthening*” works on a distance of 36.924 km (nearly some 69.44% of the road length) by providing a new base course of cement treated lateritic gravels (in the usual mixing level of 3% cement) to address the low bearing capacity of the road edifice, and then setting up a bituminous pavement.
