Effectiveness of Gully Erosion Control Measures in Edo State, Nigeria

How to cite this paper: Osayande, A., Edobor, W.W. and Kato, S. (2019) Effectiveness of Gully Erosion Control Measures in Edo State, Nigeria. *Open Access Library Journal*, 6: e5018.

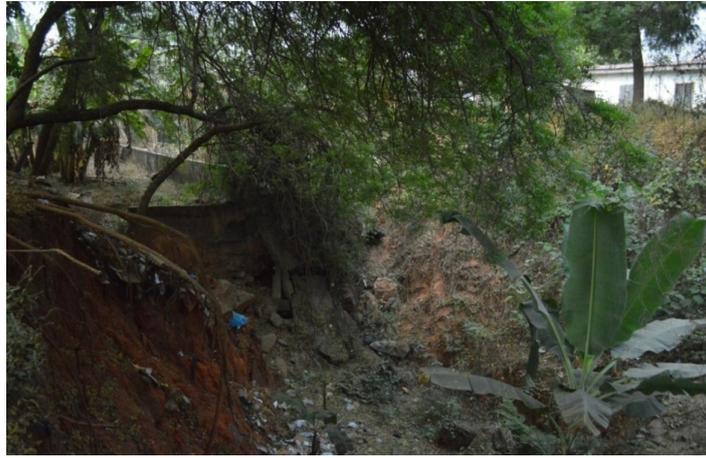
Figure 2. Shows uses of neem trees and plantain as control measure at Ikabigbo Gully in Edo North (Biological Control measures).

are not effective (27%) while 58% think they are either slightly effective or effective (15%) (**Figures 2-5**).

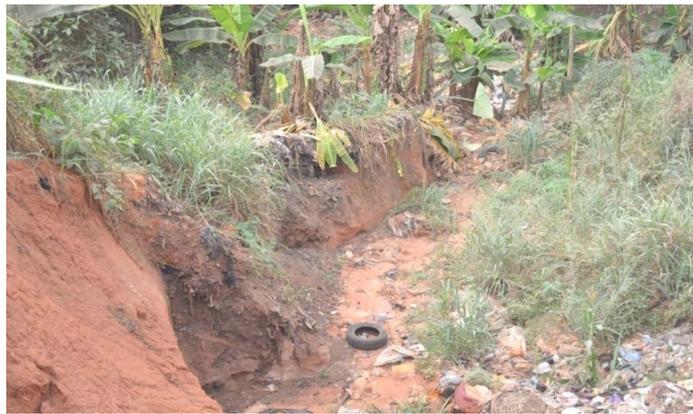
Figure 3. Shows use of plantain as control measure at Ikpoba slope gully in Edo South (Biological Control methods).

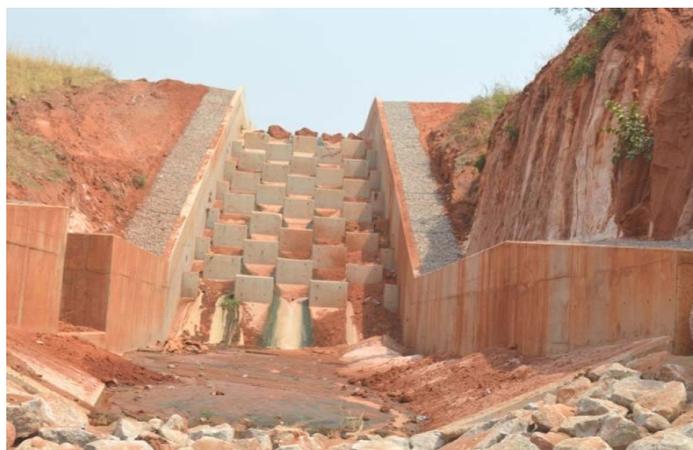
Figure 4. Shows use of speed breakers as control measure at GazMomoh Gully in Edo North (Mechanical methods).

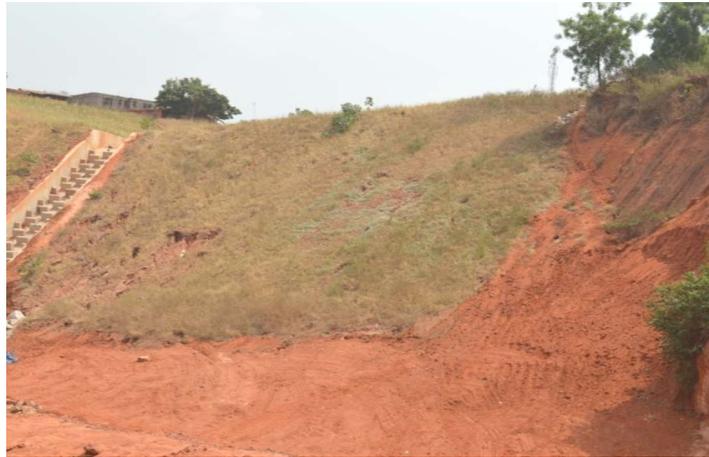
Figure 5. Shows use of rice grass as control measure at GazMomoh Gully in Edo North (Mechanical and Biological measures).
